# Arboricultural Consultancy for Covéa Insurance

## 1. Case Details

Insured	Nainesh Jain	Address	16 Goldhurst Terrace, London, NW6 3HU		
Client	Subsidence Management Services	Contact	Grace Parker	Claim No.	IFS-COV-SUB-17-0068212
ES Ref	SA-73305	Consultant	Lewis Fraser	Contact No.	0330 380 1036
Report Date	18/08/2017

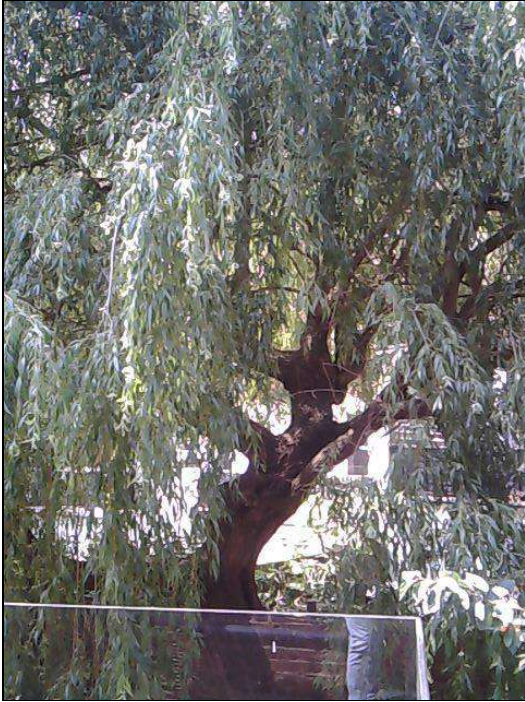
T1 - Willow (Weeping)

Some of the remaining vegetation recorded (T1) was found to be at such proximity to the insured property that pruning to reduce the risk of future subsidence is not deemed viable (with a view to achieving long-term stability).

The only certain option in respect of mitigating future risk would be to remove as recommended.

Tree No.	Species	Age Cat	Approx. Height (m)	Distance to Building (m) *	Ownership	Action	Requirement
T1	Willow (Weeping)	3	14	6	C - Insured	Action to avoid future risk	Remove close to ground level and treat stump to inhibit regrowth.
T2	Lime	1	15	15	A - Third Party 20 Goldhurst Terrace London NW6 3HU	Action to avoid future risk	Crown reduce by 3m – 4m all around and maintain at reduced dimensions by way of regular re-pruning (3-year max).
TG1	Lime	1	7	10	A - Third Party 14 Goldhurst Terrace London NW6 3HU	Action to avoid future risk	Do not allow to exceed current dimensions by way of regular pruning.

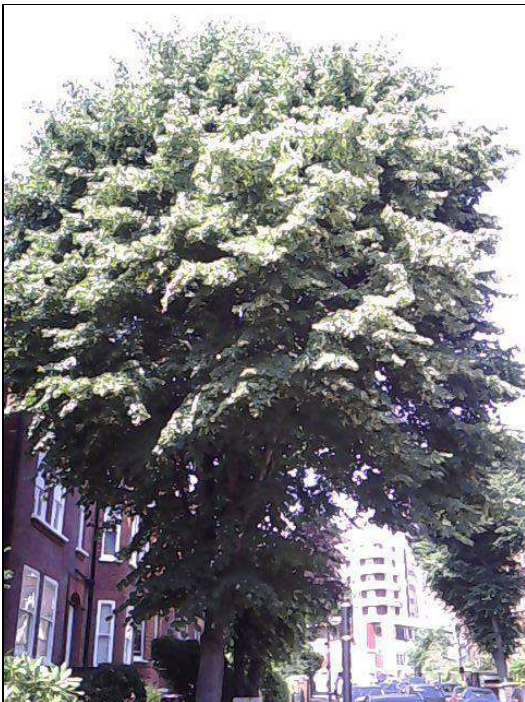
T3 - Lime

Based on our observations on site, T3 (Lime) will, in our opinion, be the source of the *Tilia* spp roots recovered from TP/BH1.

In assessing the potential drying influence of the vegetation on site, T3 (Lime) is clearly the dominant feature proximate to the front elevation of the insured property and accordingly we have identified it as the principal cause of the subsidence damage.

The size, orientation and proximity of T3 (Lime) is consistent with the location of damage and mechanism of movement.

Removal of T3 (Lime) will offer the most certain and reliable arboricultural solution likely to restore long-term stability.

Tree No.	Species	Age Cat	Approx. Height (m)	Distance to Building (m) *	Ownership	Action	Requirement
T3	Lime	1	14	5	C - Insured	Remove	Remove close to ground level; do not treat stump due to translocation risk. Where such a risk exists, we advise that any emergent regrowth is removed annually.
