10a Great Ormond Street
Planning reference 2016/0402/L
Planning Condition 4b

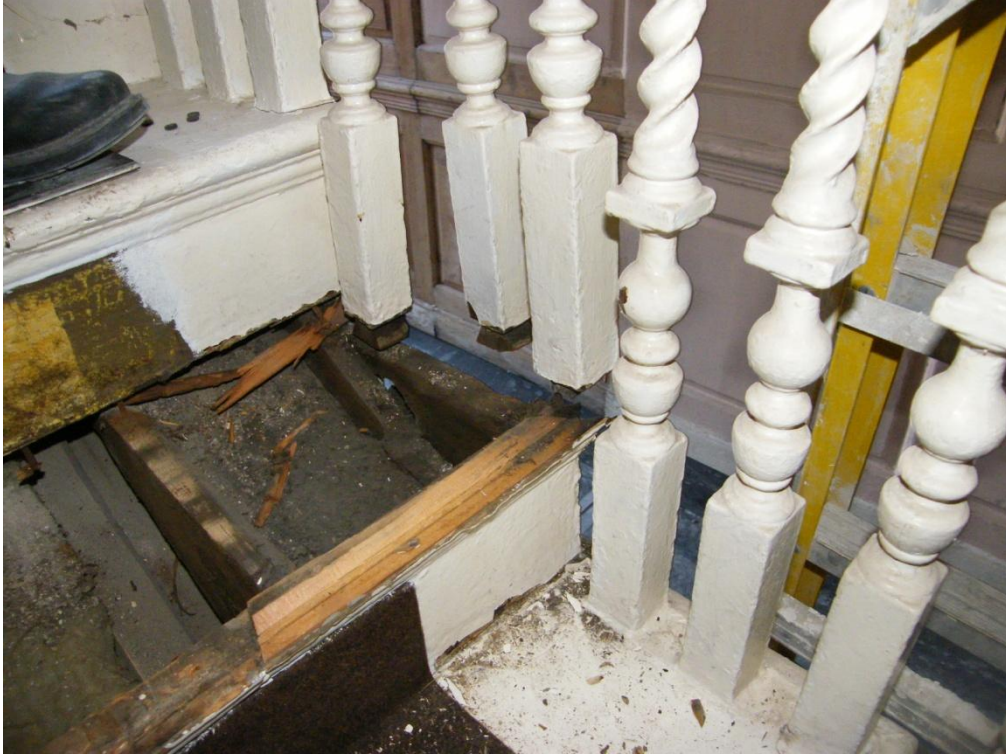
There were four treads on the first two flights where the single piece softwood board has split laterally. The defect has occurred as the irregular triangular blocking pieces have dropped slightly due to historic deflection in the framing below.

This has resulted in a loss of intermediate support to these four treads resulting in the wood splitting under load.
