TECHNICAL REPORT ON A SUBSIDENCE CLAIM

Crawford Reference: SU1703328

**Mr Alasdair Graham
23 Rochester Square
London
NW1 9SA**

SUBSIDENCE CLAIM

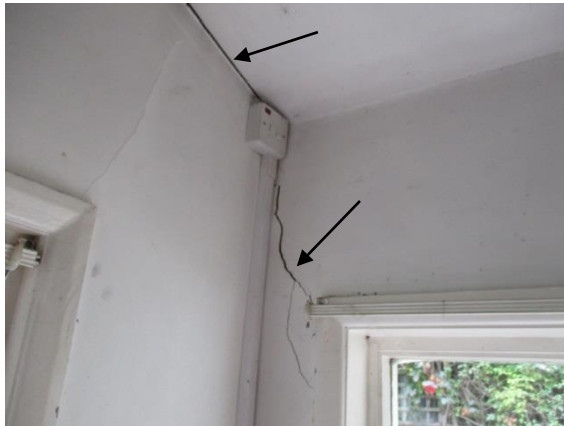
Cracking in utility room

Utility Room - 5mm diagonal tapering crack above left hand side of flank window continues along wall / ceiling junction on rear wall, 5mm previously filled crack to left hand party wall, cracking to ceiling, 3mm separation along ceiling junction with house.

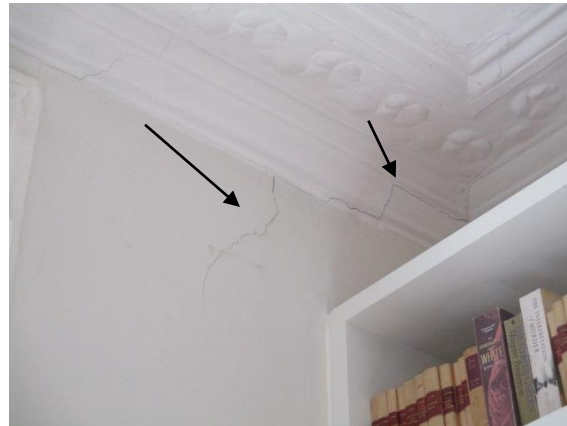
Cracking in lounge

Lounge - Cracking to ceiling and coving in front and rear sections, 1mm diagonal crack to front left hand corner at high level, hairline diagonal crack above right hand side of door to hall, rucking to wallpaper down rear right hand corner junction.

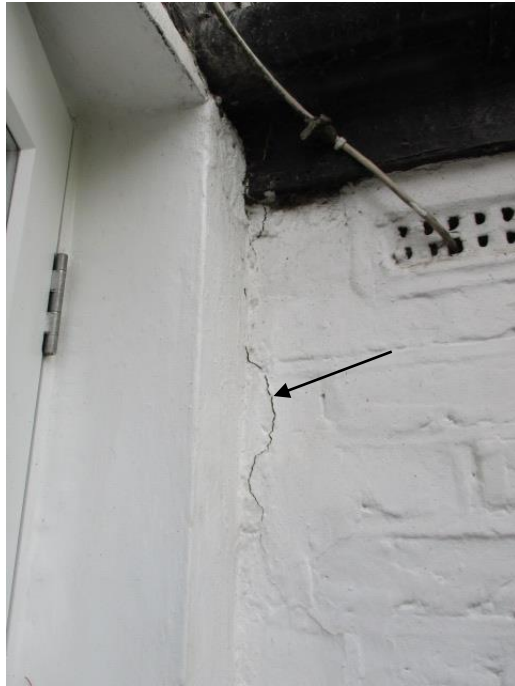
Cracking at rear addition junction

Rear Addition - 2mm vertical crack above right hand side of right hand window, 2mm vertical tapering separation at junction with house.

We suspect that the bay tree within Mr Graham's rear garden is the most likely cause of the movement to the rear addition. The property is located within a conservation area so site investigations will be required to obtain evidence confirming the influence of the relevant vegetation. We will update further on completion of the site investigations.

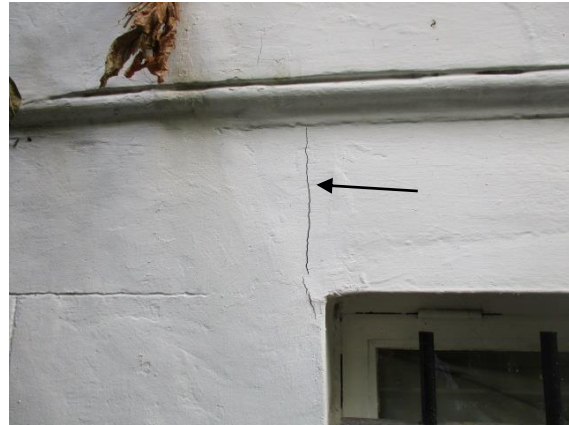
Cracking to front elevation

Front Elevation - 1mm vertical tapering cracking above and below basement window, hairline cracking above right hand side of basement window. Historic cracking to Terrazzo paving at base of front steps, crack below coping to left hand side steps wall - Not subsidence related damage.

The cause of the movement needs to be dealt with first. The adjoining left hand property (number 24) has an ongoing subsidence claim and we understand that their adjusters have recommended vegetation management works relating to shrubs and trees in their front garden. If this work is completed in addition to possible further works to vegetation under the control of Mr Graham, this should assist in restoring stability to the front section of the property.

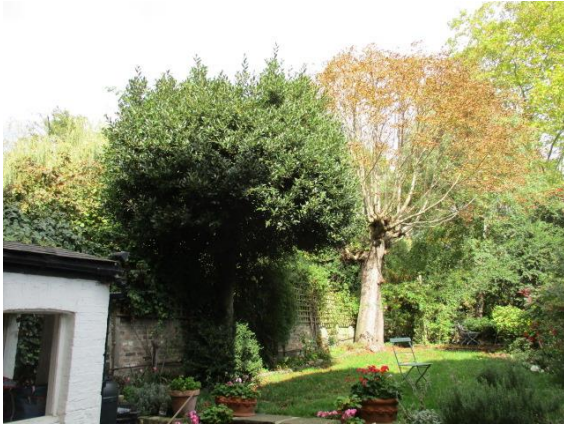
View of trees to rear

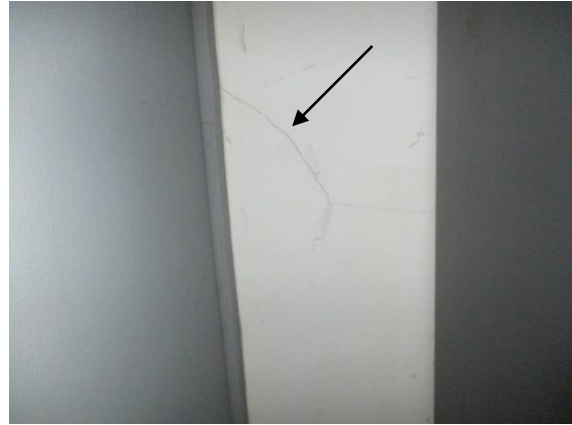
Kitchen - 1mm diagonal crack to left hand party at low level near front wall, various cracks to ceiling, wall / ceiling junction cracking along rear wall, 1mm vertical crack to left hand side of chimney breast above cooker.

Cracking in kitchen

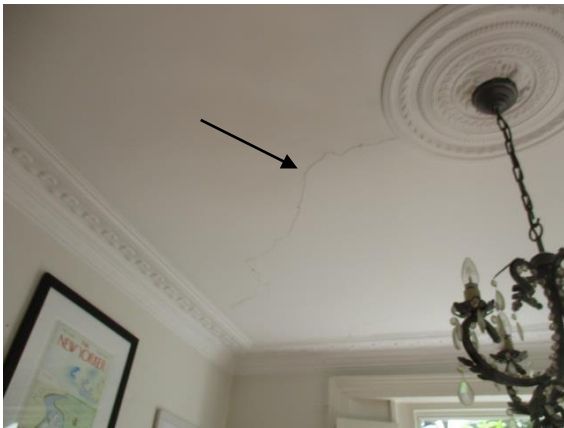
Cracking to ceiling in lounge

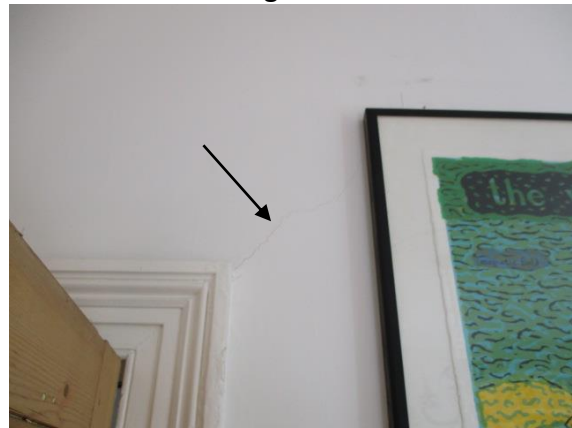
Cracking in lounge

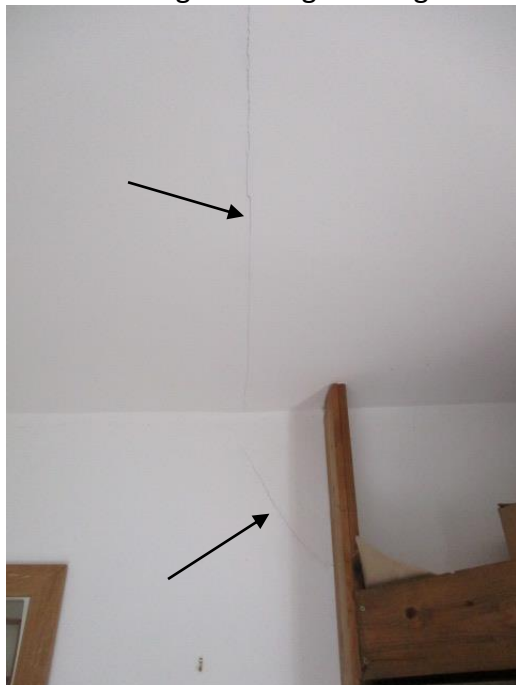
First Floor Front Bedroom - Cracking to ceiling, hairline vertical crack above window, hairline diagonal crack to bathroom partition.

Cracking in front bedroom

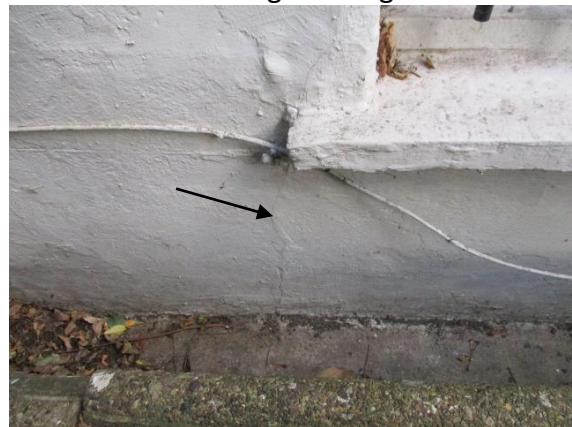
Cracking to front elevation

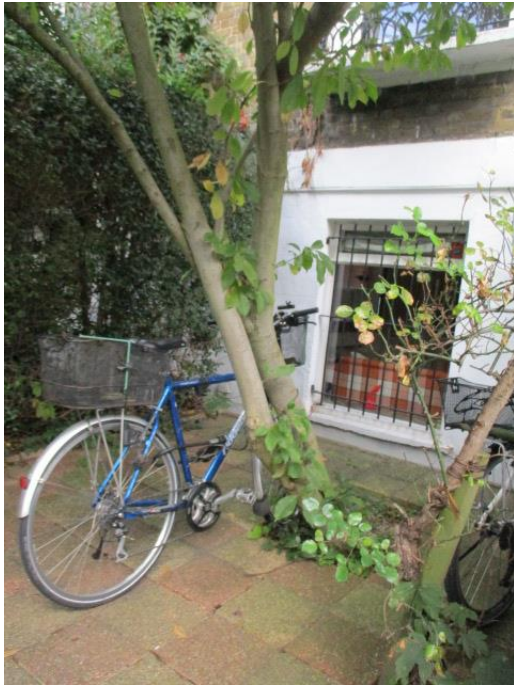
View of insured's magnolia in front garden
