ADDENDUM TECHNICAL REPORT

Crawford Reference: SU1703328

**Mr Alasdair Graham
23 Rochester Square
London
NW1 9SA**

SUBSIDENCE CLAIM

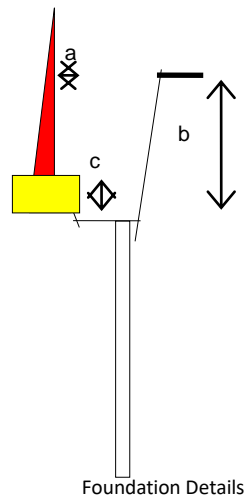
A trial hole was excavated to expose the foundations - see site plan for location and the diagram below for details. Trial Hole 1 revealed a brick footing with no projection founded at a depth of 0.25m below ground level which bears onto a brown slightly sandy silty clay.

No.	Borehole Depth	Footing (a)	Underside (b)	Thickness (c)
TH1	3.00 m.	0 mm.	250 mm.	250 mm.
