Arboricultural Appraisal Report

Subsidence Damage Investigation at:

23 Rochester Square
London
NW1 9SA

| REPORT DATE: | 04/12/2017 |

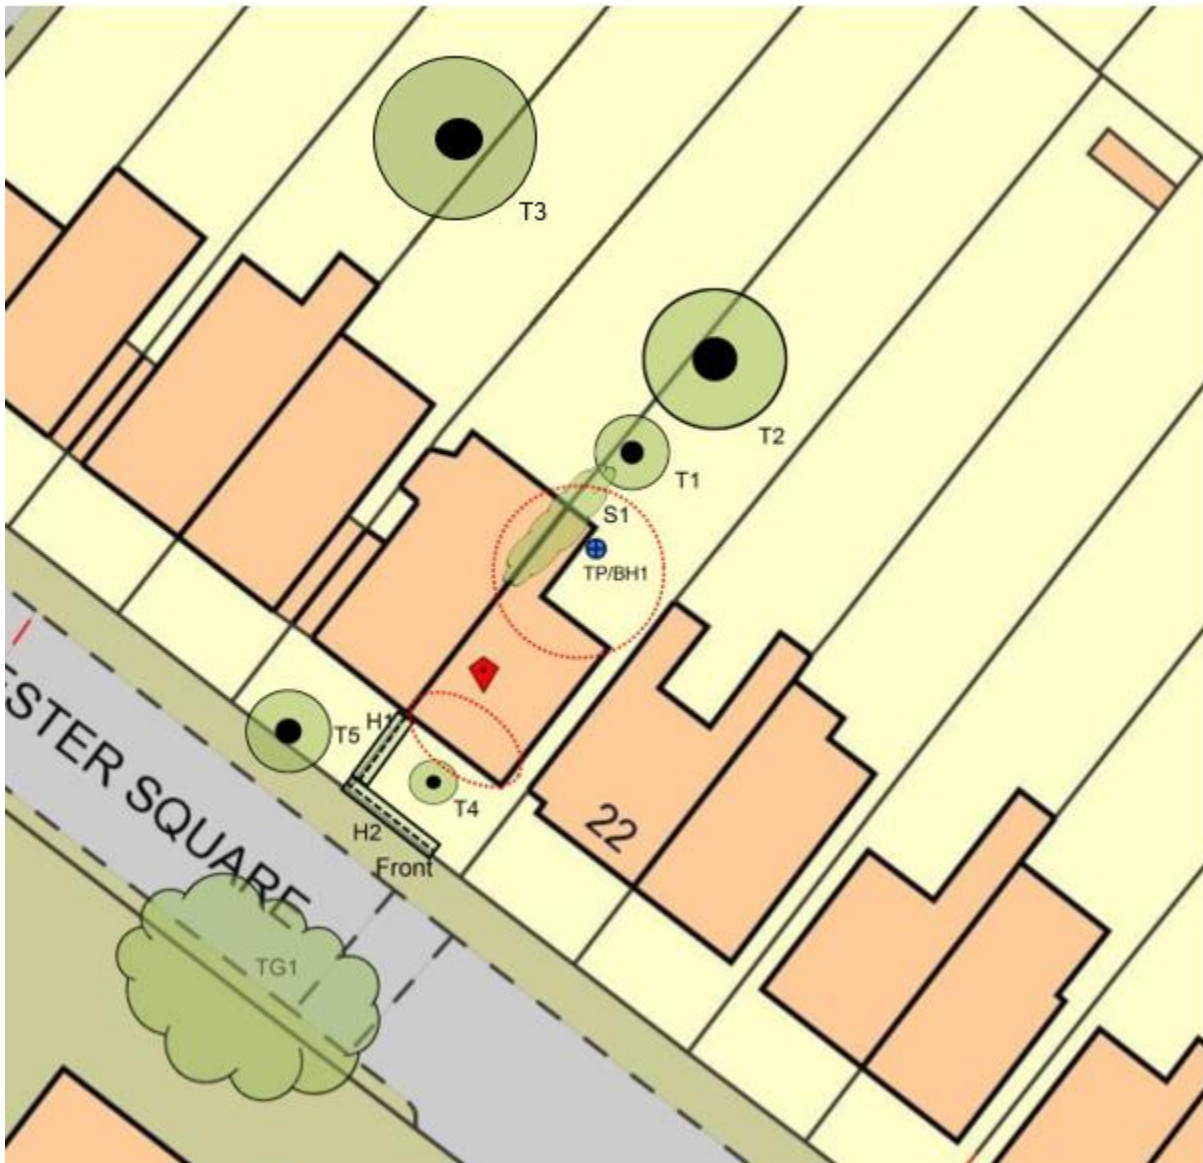
SITE PLAN

Approximate areas of damage

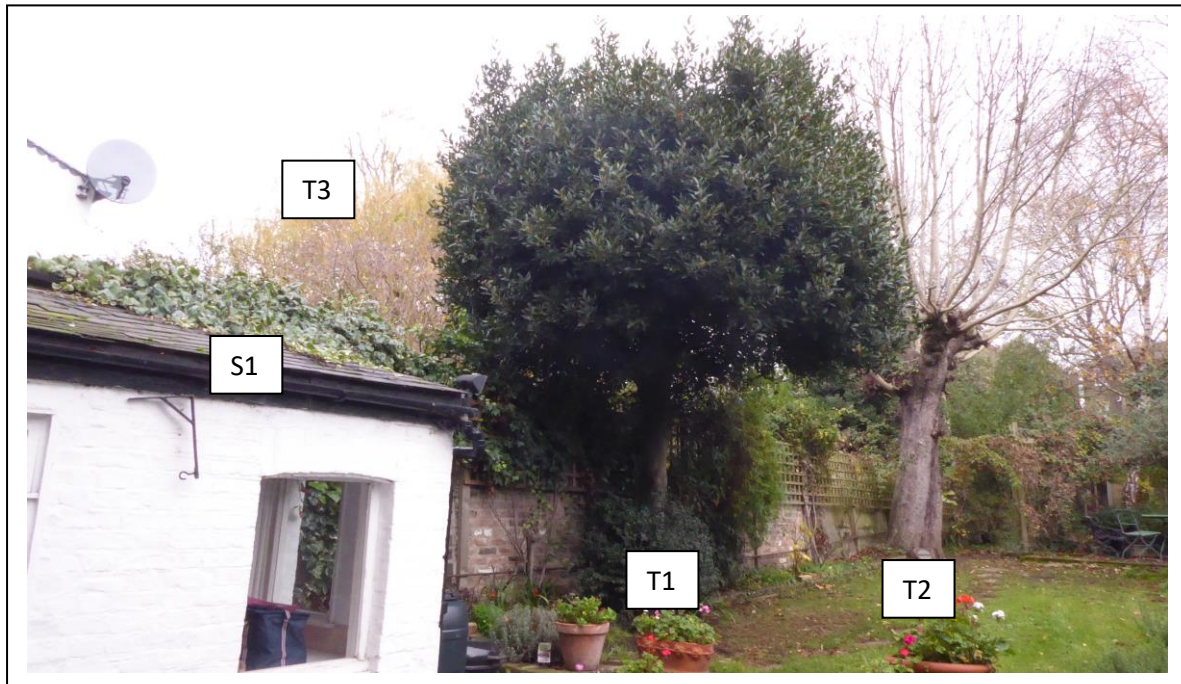
Based on the technical reports currently available, engineering opinion and our own site assessment we conclude the damage is consistent with shrinkage of the clay subsoil related to moisture abstraction by vegetation. Having considered the available information, it is our opinion that T3 Weeping Willow is the principle cause of the current subsidence damage to the rear of the property, with contribution from T1 Bay and S1 Ivy.

| Tree No. | Species | Ht (m) | Dia (mm) | Crown Spread (m) | Dist. to building (m) | Age Classification | Ownership |
|---|---|---|---|---|---|---|---|
| T1 | Laurel (Bay) | 6.5 | 270 | 5.0 | 3.9 | Younger than Property | Policy Holder |
| S1 | Ivy | 2.5 | 20 Ms | 1.5 | 1.0 | Younger than Property | Policy Holder |
| Management history | | No past management noted. Trained over party wall and addition roof | | | | | |

View of T1 Bay, T2 Horse Chestnut and S1 Ivy [T3 Weeping Willow also visible to rear of T1 Bay]

If an arboricultural solution is to be implemented to mitigate the current damage and allow the soils beneath the rear of the property to recover to a position such that an effective repair solution can be put in place, we recommend that T1 Bay, S1 Ivy and T3 Weeping Willow are removed.

| Tree No. | Species | Ht (m) | Dia (mm) | Crown Spread (m) | Dist. to building (m) | Age Classification | Ownership |
|---|---|---|---|---|---|---|---|
| Recommendation | | Fell to ground level and treat stumps to inhibit regrowth | | | | | |

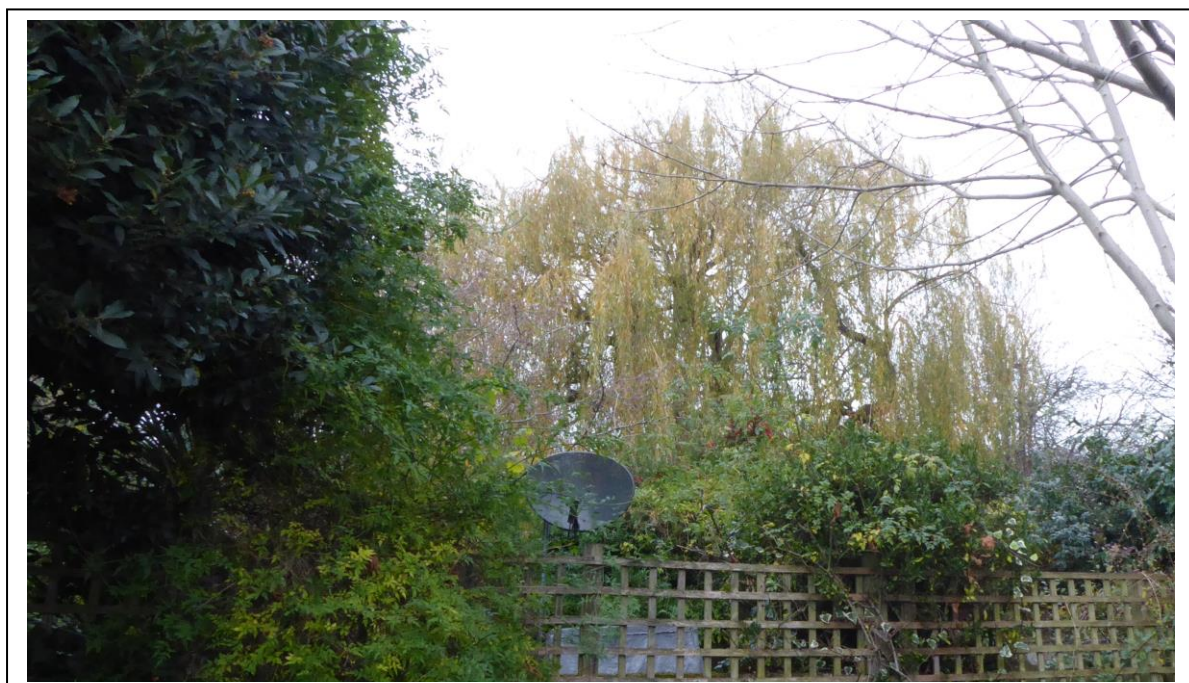
Roots were observed to a depth of 1.6m bgl in TP/BH1 and recovered samples have been tentatively identified (using anatomical analysis) as Salicaceae spp.; the origin of which will be T3 Weeping Willow as the only Salicaceae spp. nearby, suggesting the influence of this tree on the soils below the foundations to the rear of the property.

| Tree No. | Species | Ht (m) | Dia (mm) | Crown Spread (m) | Dist. to building (m) | Age Classification | Ownership |
|---|---|---|---|---|---|---|---|
| T3 | Willow (Weeping) | 15.0 | 600 | 12.0 | 18.0 * | Younger than Property | Third Party:- 26 Rochester Square |

View of T3 Weeping Willow

| Tree No. | Species | Ht (m) | Dia (mm) | Crown Spread (m) | Dist. to building (m) | Age Classification | Ownership |
|---|---|---|---|---|---|---|---|
| Recommendation | | Fell to ground level and treat stumps to inhibit regrowth | | | | | |

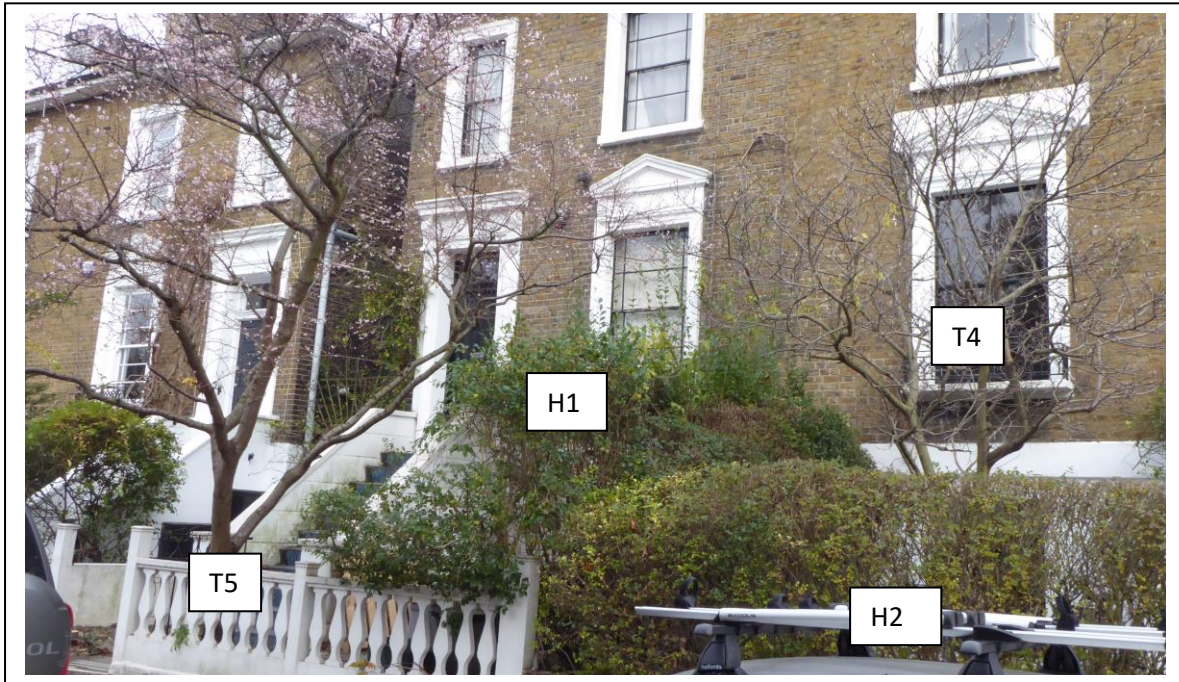
With regards to the damage to the front of the property, the magnolia T4 and eucalyptus within TG1 are potential influences on soil moisture and volumes. We also note a substantial climber (possibly wisteria) has been removed from the front elevation of the neighbouring property to the left which may also have been influencing the soils.

| Tree No. | Species | Ht (m) | Dia (mm) | Crown Spread (m) | Dist. to building (m) | Age Classification | Ownership |
|---|---|---|---|---|---|---|---|
| T4 | Magnolia | 6.0 | 120 | 2.6 | 1.4 | Younger than Property | Policy Holder |

View of T4 Magnolia, T5 Cherry and H1 and H2 Privet

Nevertheless, the removal of both T4 and the eucalyptus offers the most predictable arboricultural solution.

| Tree No. | Species | Ht (m) | Dia (mm) | Crown Spread (m) | Dist. to building (m) | Age Classification | Ownership |
|---|---|---|---|---|---|---|---|
| Recommendation | | Remove to near ground level | | | | | |
