24 Heath Drive Tree Condition Survey

2349 - 24 Heath Drive - Tree Condition
Survey - 1707-21rc.docx

21.07.2017

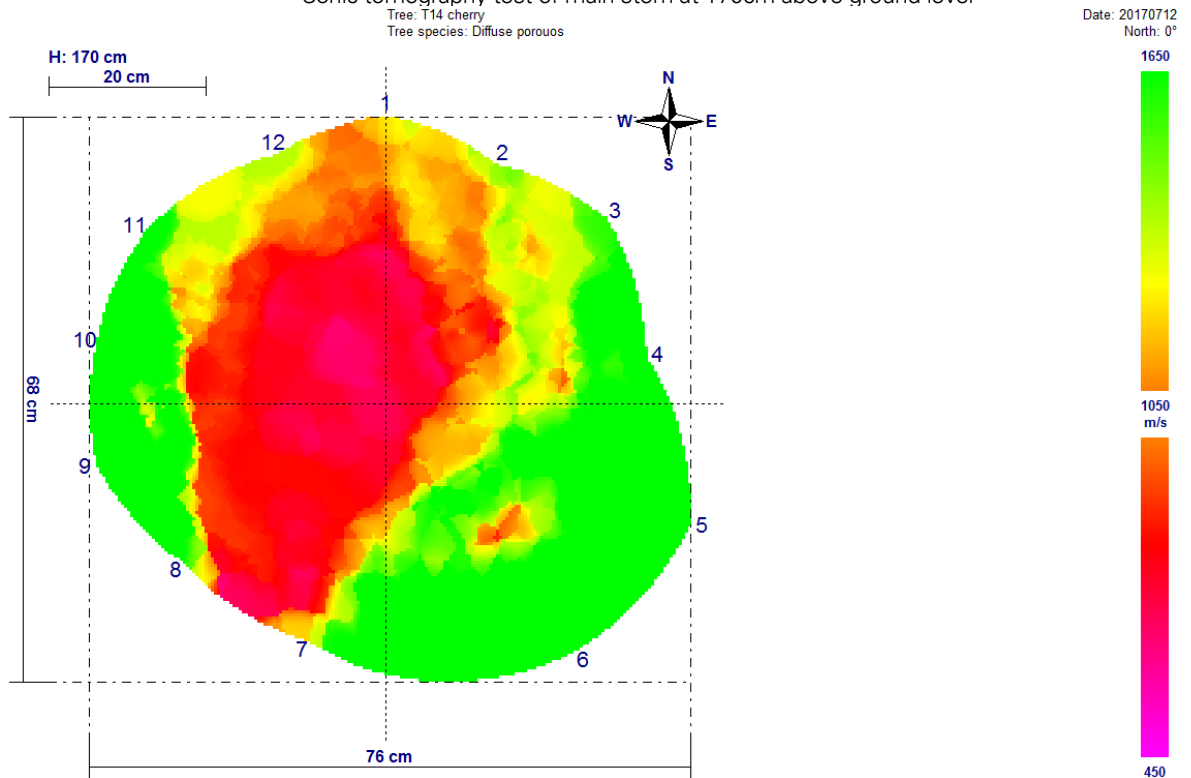
Sonic tomography test of main stem at 170cm above ground level

The Stress-wave ('impulse') tomogram of the main stem at 170cm above ground level in the location of the wound cavity reveals a central zone of decayed/ damaged wood (purple and red colours) and partially decayed wood (orange and yellow). Solid wood is shown in green. The decayed/ damaged wood extends into the stem to the north. The residual wall adjacent to sensors 1, 2 and 12 is shown to be thin.

The sonic tomography testing of the stem has recorded a strength loss of approximately 25% in the zone of the wound at 1.7 metres above ground level. The extent of strength loss is not insignificant. An option to return the tree to an acceptable safety factor would be to reduce the wind-sail of the crown and in-turn the loading on the weakened section of stem. However, this is not considered to be the expedient option for the following reasons;

Recommended works in relation to structural condition	Time scale
Fell to ground level	Within 6 months of this report

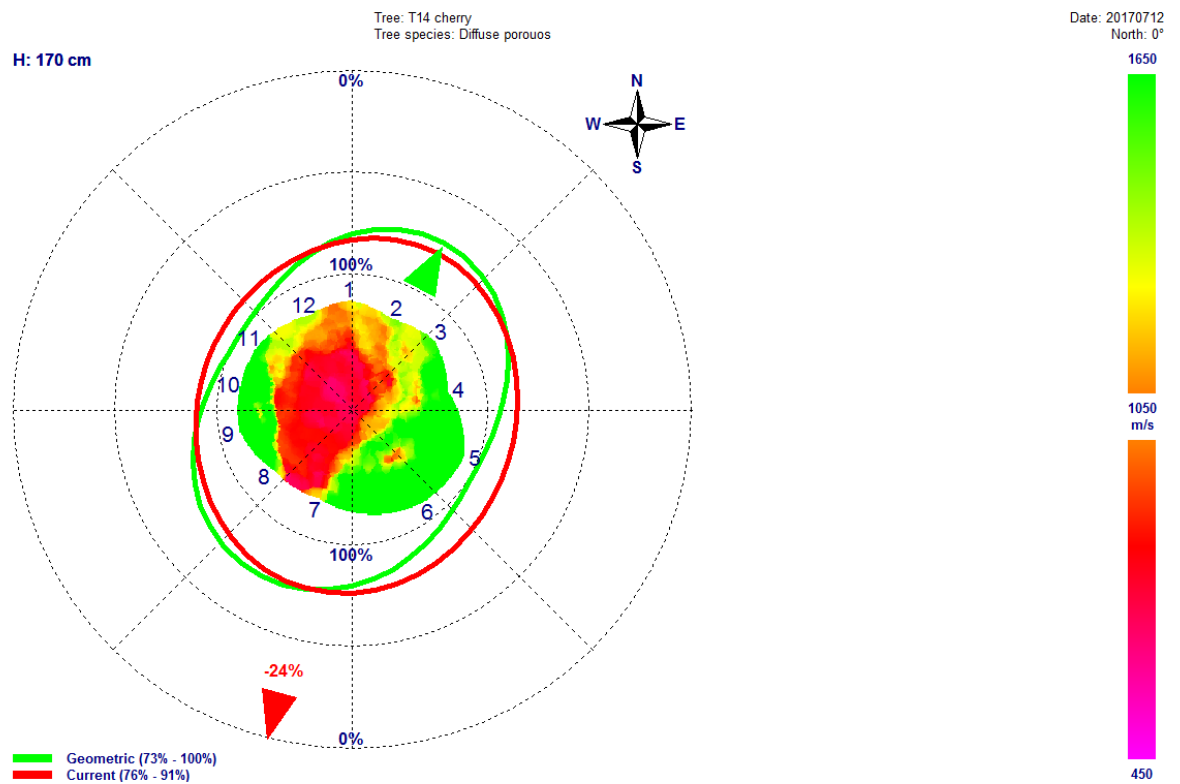
Calculated mechanical strength loss in location of tested 170cm above ground level

The section modulus calculation (indicated by the red ellipse on the graph above) of the decayed/ damaged wood records a loss in load carrying capacity at the testing level of approximately 25% for winds coming from the north-east and south-west.

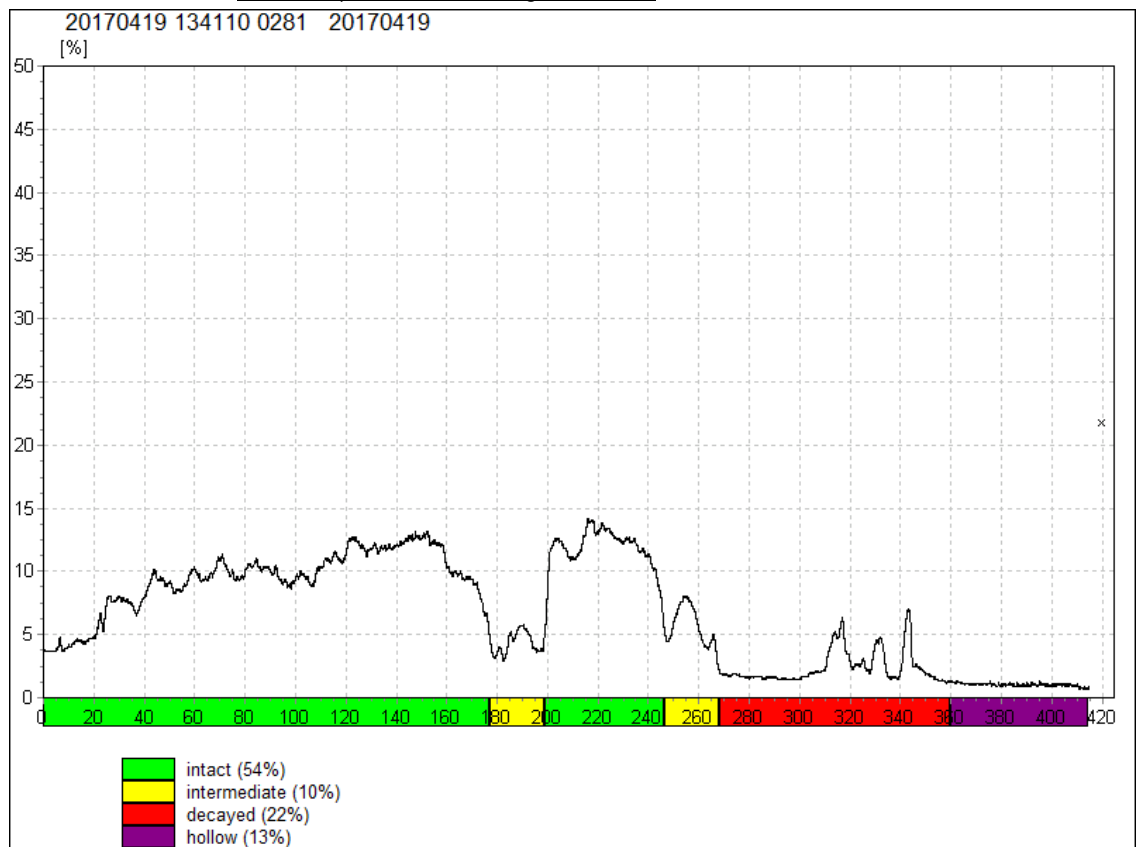
T14 Cherry at 170cm above ground level.

A resistograph test was carried out adjacent to sensor 1 at 170cm above ground level, drilling toward the centre of the stem to corroborate the thin residual wall indicated by the tomogram.

The above test shows that the residual wall, indicated by the intact wood (green) and intermediate wood (yellow) to be only 9cm thick. The thin remaining wall of wood correlates with the tomogram carried out. The test records progressively reducing resistance between 7cm (in the intermediate wood) and 10cm (in the decayed wood) indicative that there is not a strong reaction zone.

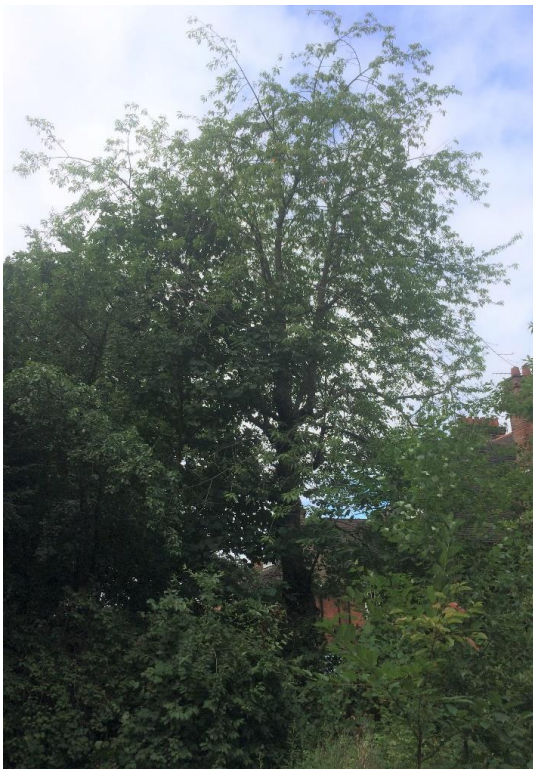
Photo 1: T 14 Cherry as viewed from the north

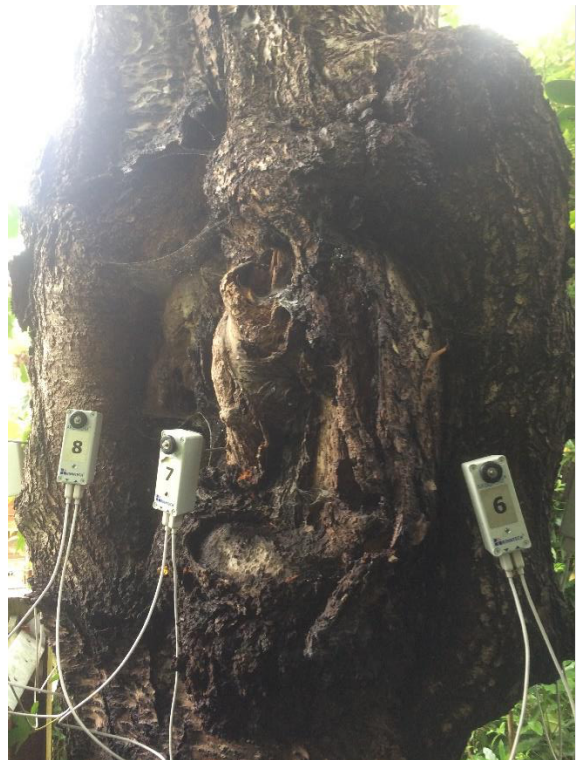
Photo 2: Showing sensors attached to stem at 170cm above ground level in zone of wound.

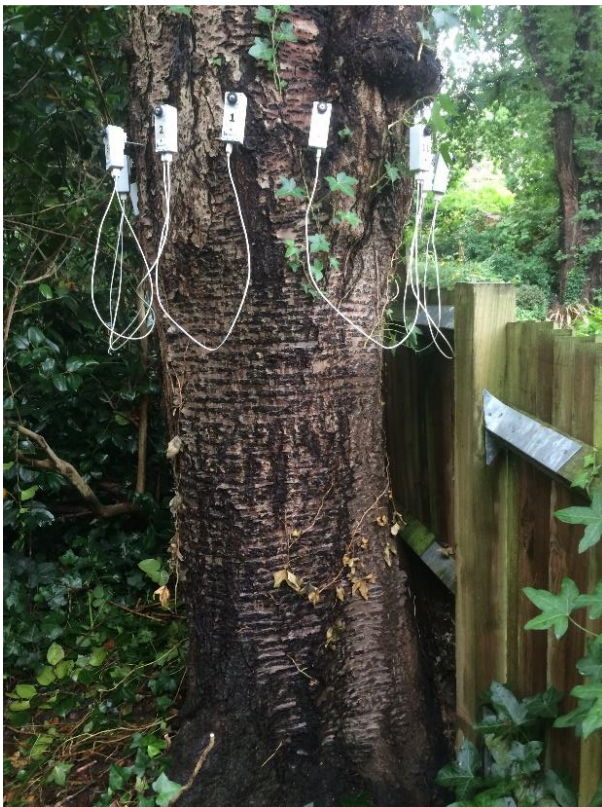
Photo 3: Showing sensors attached to stem at 170cm above ground level, south side

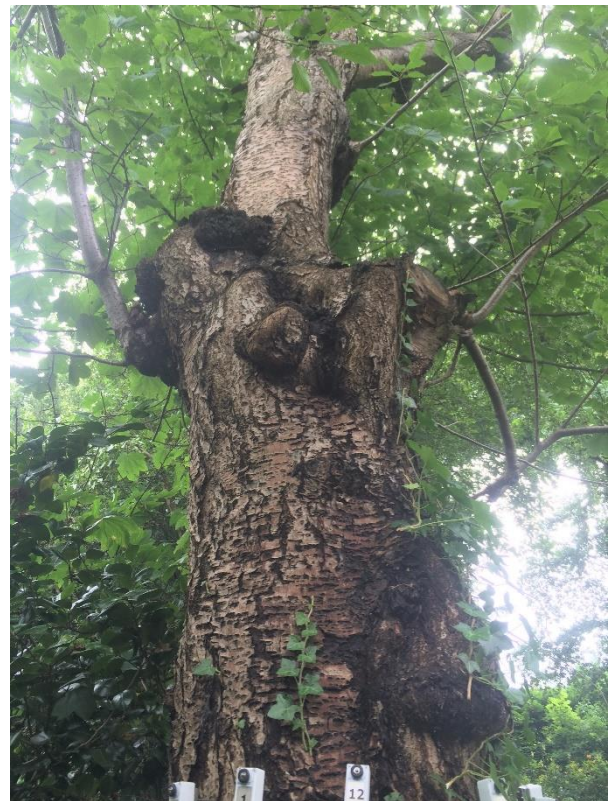
Photo 4: Showing multiple wounds on the main stem between 2m and 5m above ground level.
