Tree at rear of 25 East Heath Road, NW3 1EB

1. Further to your instructions, I carried out a site and tree inspection at the above address on 24th January 2018.

Ref: 25ehrd/sk1

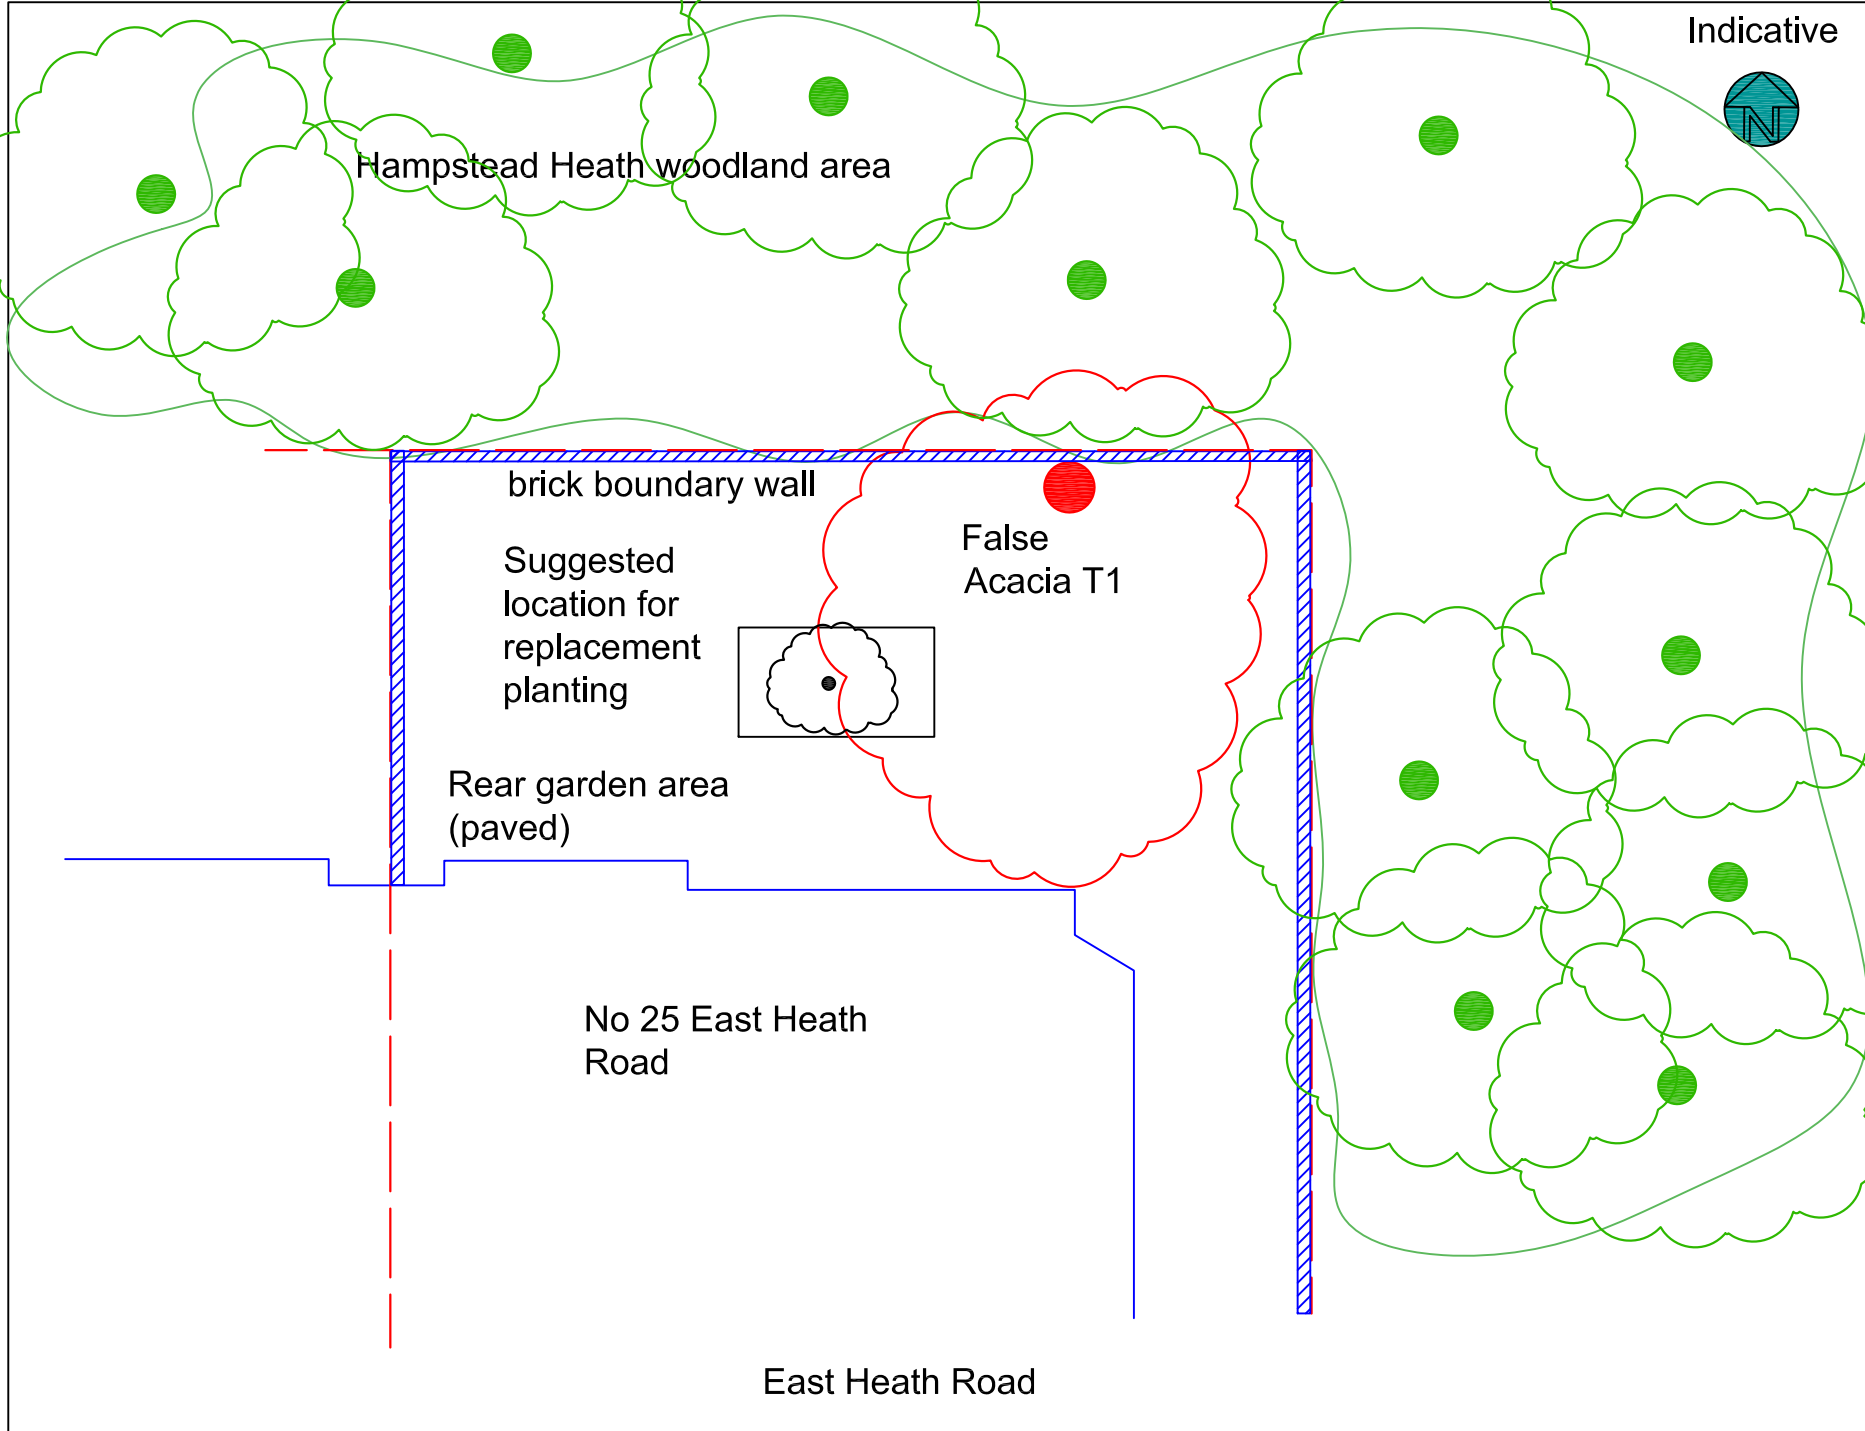
5. The tree subject of this report grows at the northern edge of a paved rear garden area, which serves the ground floor apartment of No 25 East Heath Road. The garden is adjoined upon the northern and eastern sides by Hampstead Heath woodland, comprising many mature trees and understorey vegetation.

6. The tree is a mature False Acacia. It stands around 17m in height with a canopy spreading between 3m and 5m in all compass directions. The canopy extends further south over the garden area. The trunk measures 420mm in diameter at breast height (1.5m). The trunk sweeps south, out toward the rear of the house and leans out over the garden. The base of the tree abuts the northern boundary brick wall.

7. I note that decay has developed at the trunk's base upon the northern side. The bark is loose and unattached to the wood tissue beneath. An area of around 20cm by 20 cm is affected in this way. The dead wood beneath the bark covering has been infected by wood-degrading fungi but no fruting bodies were evident during my inspection to assist with fungal identification. However, it is very common for False Acacia trees to be colonised by *Laetiporus sulphureus* (common name 'Chicken of the Woods'). This is a

8. I also note that the rooting spread of the tree, which for normal support and anchorage would grow radially in all compass directions, has been significantly restricted from growing north by the position of the brick boundary wall. It is possible that some roots may have extended underneath the footings of the wall but I believe insufficient to afford the tree with normal and effective anchorage. Roots will have been deflected, by the position of the wall and its footings, to grow more to the east and west and doubtless also grow south, toward the house (under the paving stones), without restriction. These roots offer some support but crucially, roots to the north are probably absent in any effective quantity. I have already stated that the tree grows south toward the house and the majority of the tree's weight therefore hangs over the garden area. For effective support, especially in windy conditions and when additional weight is added to the tree from rain, leaf emergence and from falls of snow falls, roots growing northward would need to be robust and effective in the case of this tree. This support is significantly impaired and reduced, the result being the development of a risk of the tree up-rooting or breaking from the base. I believe this risk to be moderate¹.

Tree Ident. and location*	Tree Dimensions** (approx.)	Proposed Works (refer to spec.)	Summary Reasons
T1 False Acacia	17 x 5 x 420	Fell(Sp6) and replace	Slender tree with poor, asymmetric rooting spread and low quality anchorage; Decay at base in tension wood; Limited realistic options for effective pruning
		Suggested replacement planting: Rowan - <i>Sorbus aucuparia</i> 20cm girth in planting bed	Replacement with native tree with ecological benefits and suited to the woodland setting

10. The above recommended tree work should be carried out as soon as practicable and with all necessary authority. Any replacement planting is to be carried out in the soonest planting season following tree removal i.e. between November and March.
