St Giles Circus  
26 Denmark Street  
Zone 2 works

Listed Building Consent  
2015/6937/L

Structural works to roof, gable wall and chimney Review

Rev 00  
9<sup>th</sup> February 2018

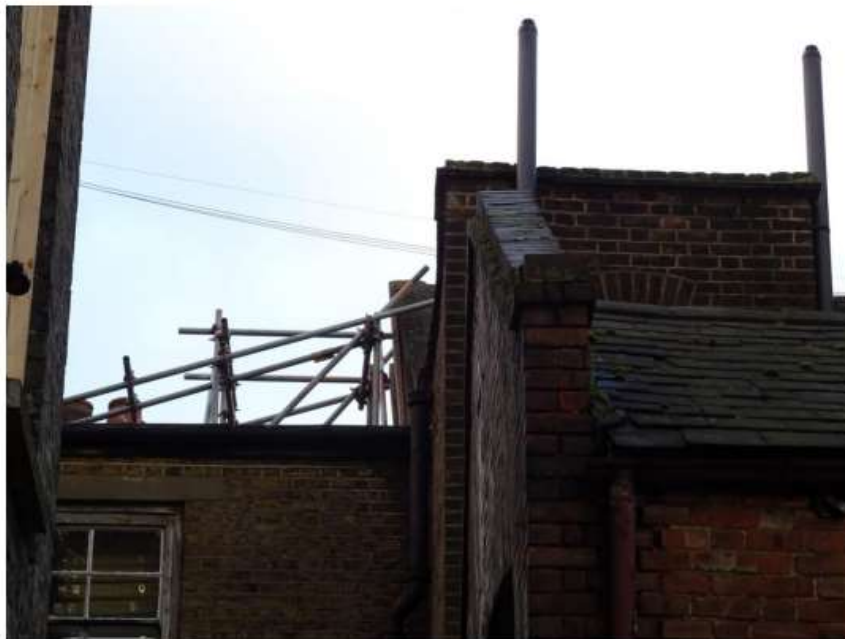
**Figure 4.8.9 Gable End to No.26**

4.8.33 At roof level the movement has resulted in the gable on the No. 27 side leaning over to the extent that its stability is a cause for concern. The gable has been propped by means of a scaffold built on the roof of No. 27 Denmark Street.

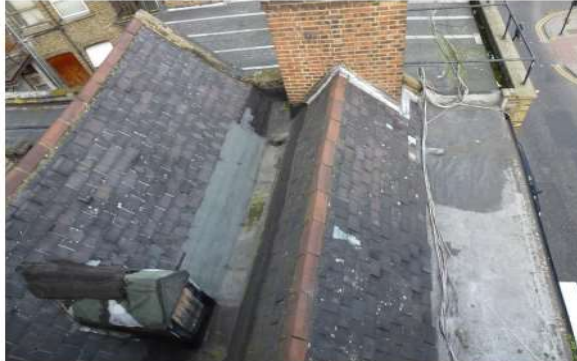
Figure 4.8.10 Valley in Roof to No. 26

- 4.8.34 The valley gutter has an internal downpipe that is prone to blocking and is of inadequate size. The condition of the mansard roof is generally poor with missing flashings.

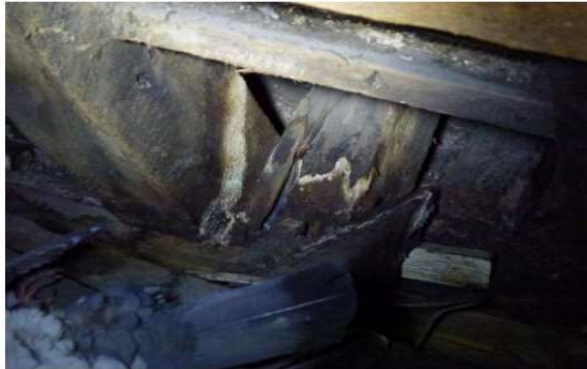
Figure 4.8.11 Rot inside No.26 Roof Space

Description: Existing opening up works has revealed most of roof structure is in poor condition and is to be fully replaced as part of the permanent works.

Recommendation: SKA to consider blocking access to 26 DMS roof via the internal loft hatch to the top of the stairs to prevent roof being unnecessarily loaded.

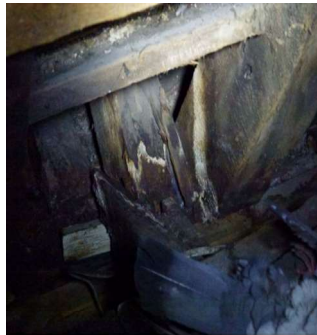
2)

Photo shows: **1)** the movement of the front Façade to number 26 Denmark Street coming away (untied) from the party wall of number 27 Denmark Street **2)** internal roof joist damp and rot **3)** Internal view of gable wall **4,5 & 8)** external view of gable wall (with scaffold buttress support installed) **6&7)** External view of roof
