St Giles - Zone 3 : 7 Denmark Street
Listed Building Application Addendum - Staircase Repair

REVISION 01

Staircase Repairs

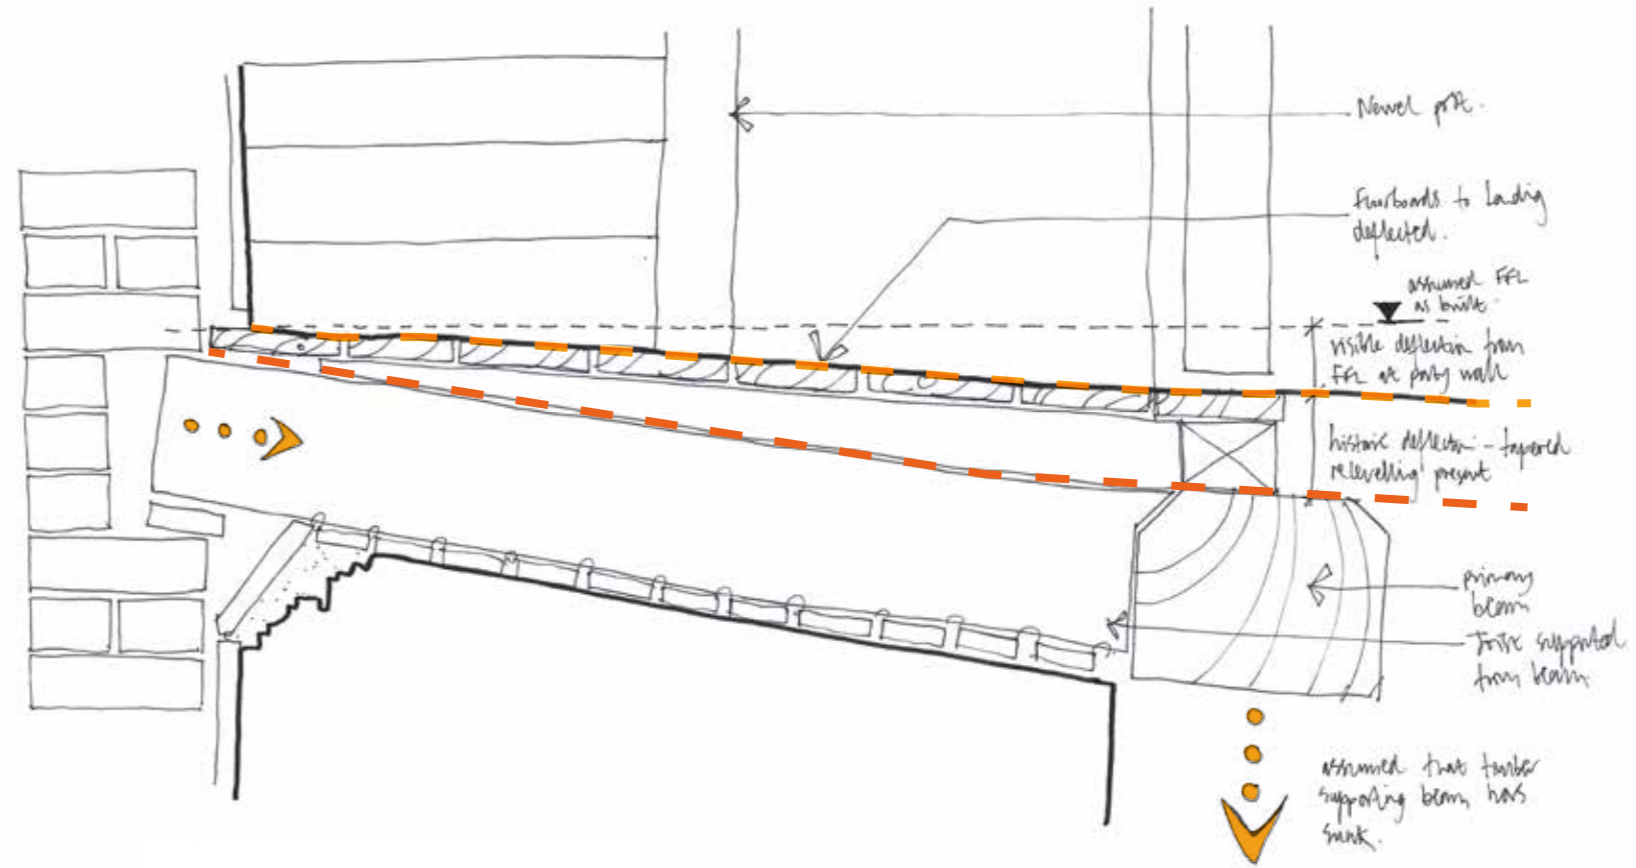
Sketch section - existing landing showing severe deflection

To ensure the long term preservation of the staircase, the flights that meet the second floor landing should be dismantled, repaired and reinstated. Simply moving the stair to its original position would run the risk of causing further movement and affecting the original fabric.

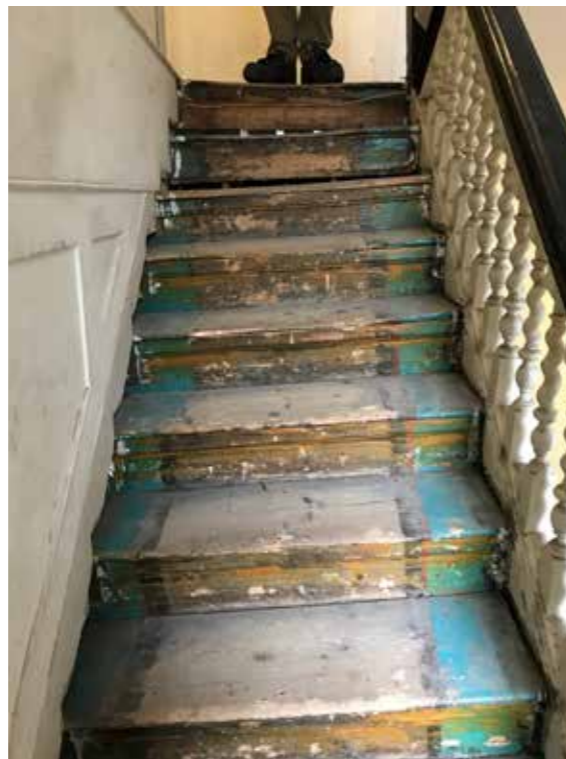
Evidence of severe deflection within the stair wells

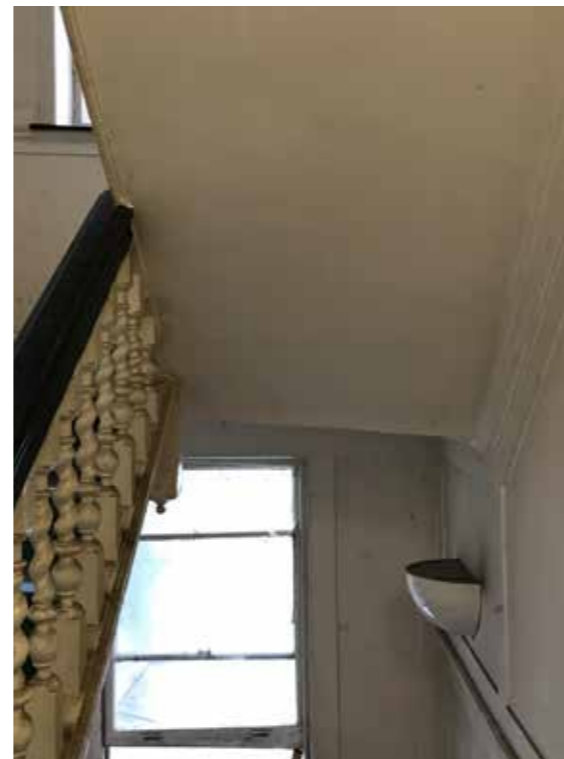
Later plasterboard soffit requires further inspection

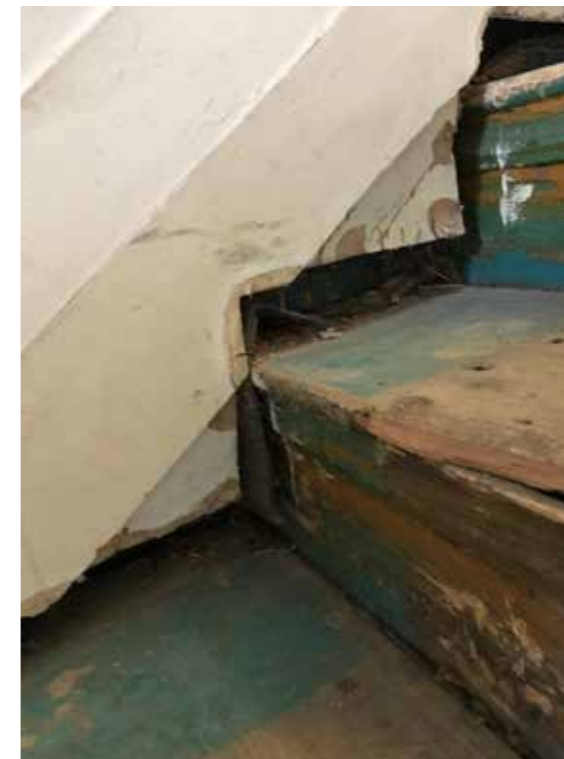
Stair deflection raises significant safety concerns

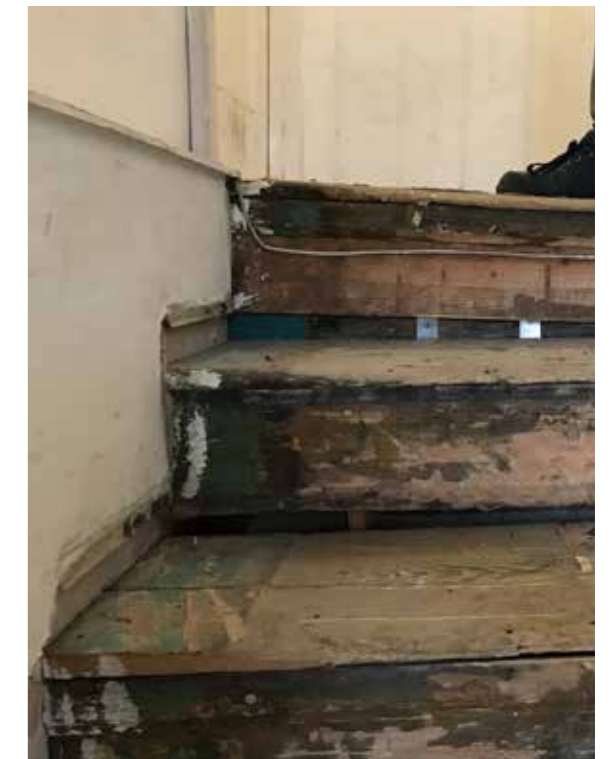
Significant deflection exposes underlying structure

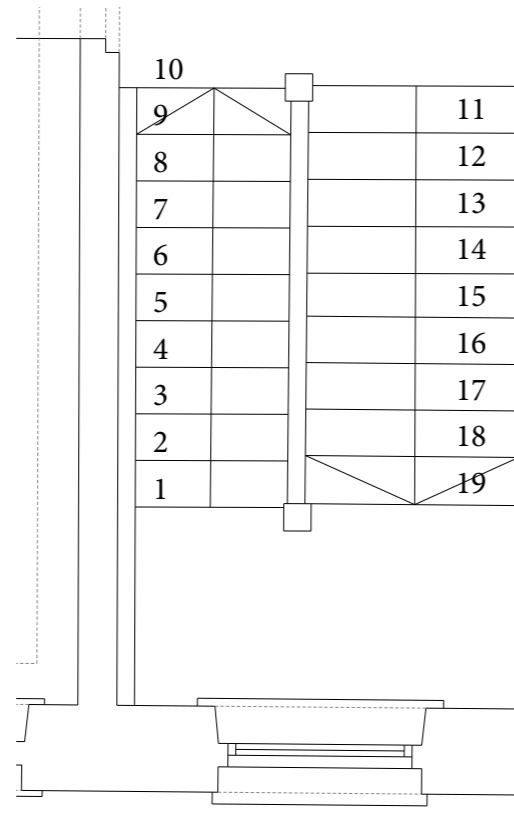
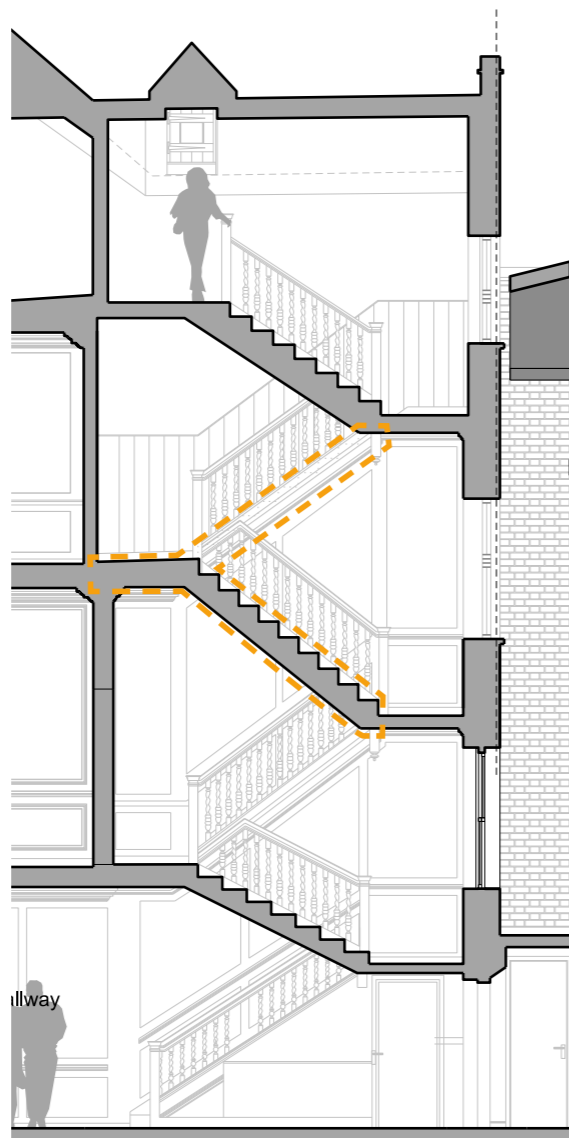
Left:
The flights of stairs that meet the second floor landing are the most affected. It is proposed that these are rebuilt for the safety of the tenants and longevity of the property

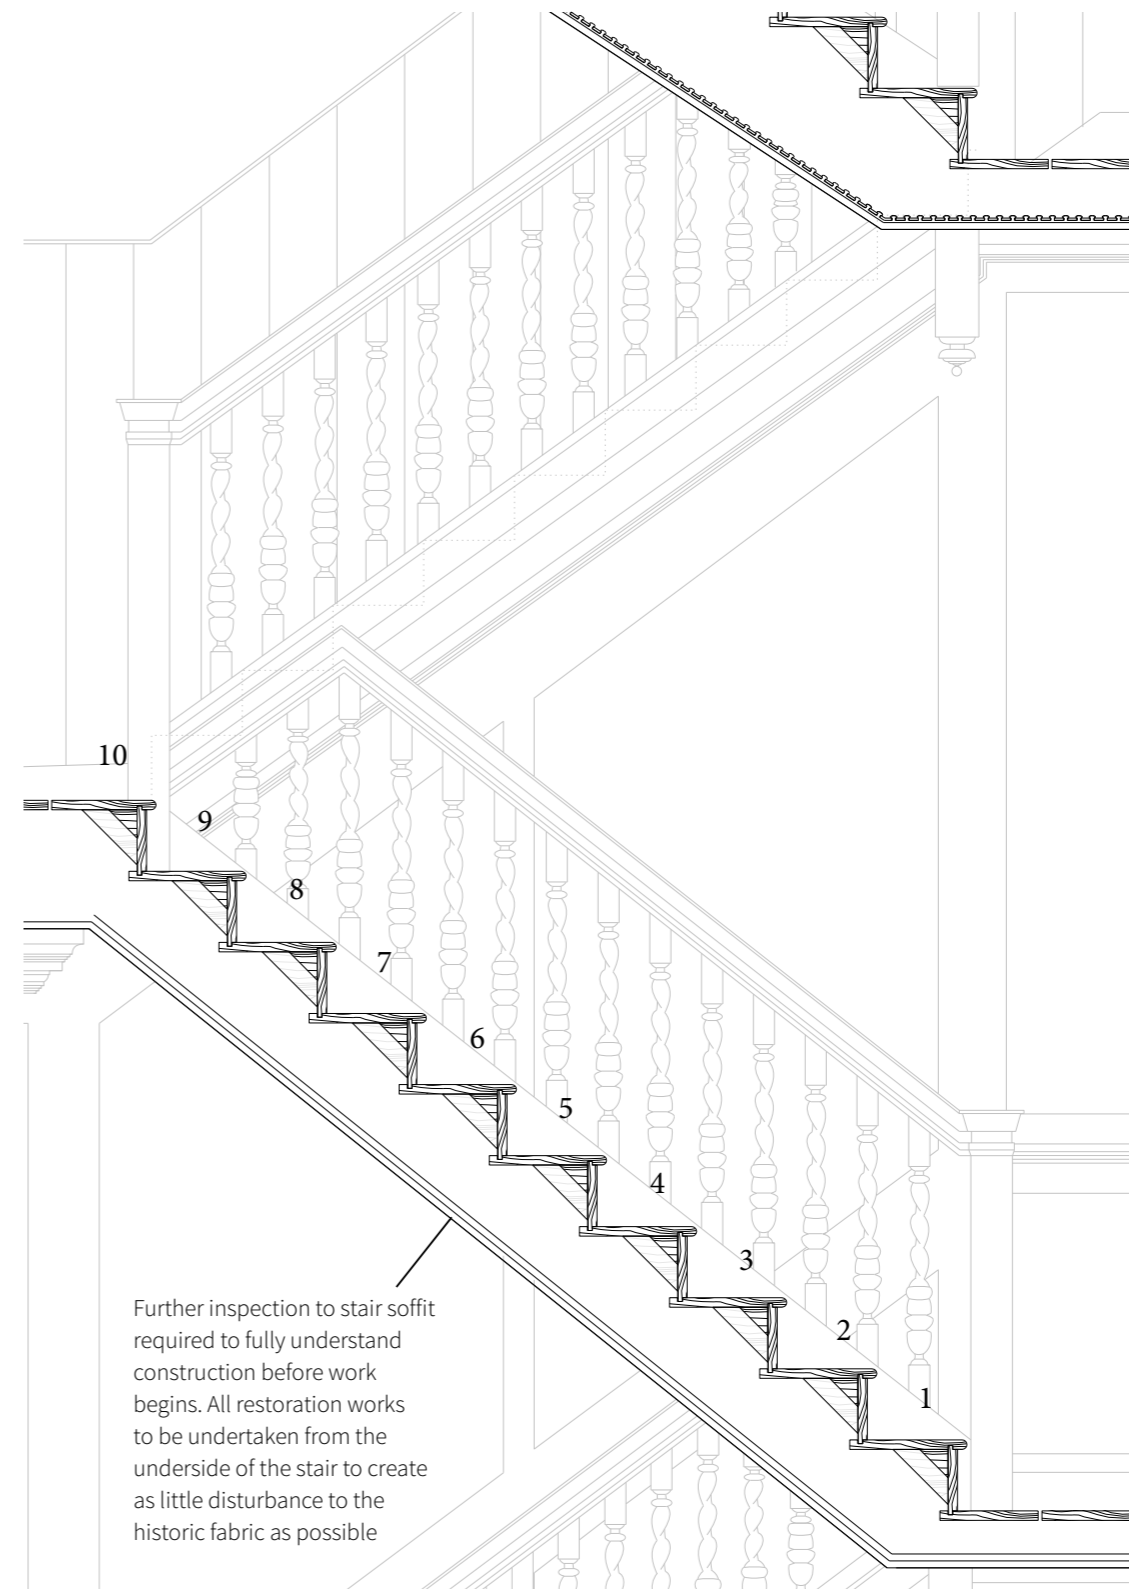
Above:
The treads and risers are assumed to be of a traditional closed stair construction, with evidence of later plasterboard linings to the underside of the soffit
