Subject SU1703328 (client ref), Client: Crawford & Co, Customer: Mr Graham, Auger ref: 74134.1.USI - MM

SITE INVESTIGATION

23 ROCHESTER SQUARE

Insured: Mr Graham
Client's Ref: SU1703328
Auger's Ref: 74134.1.USI
Visit Date: 11/10/2017
Report Date: 12/10/2017
Author: DO
Checked By: MM

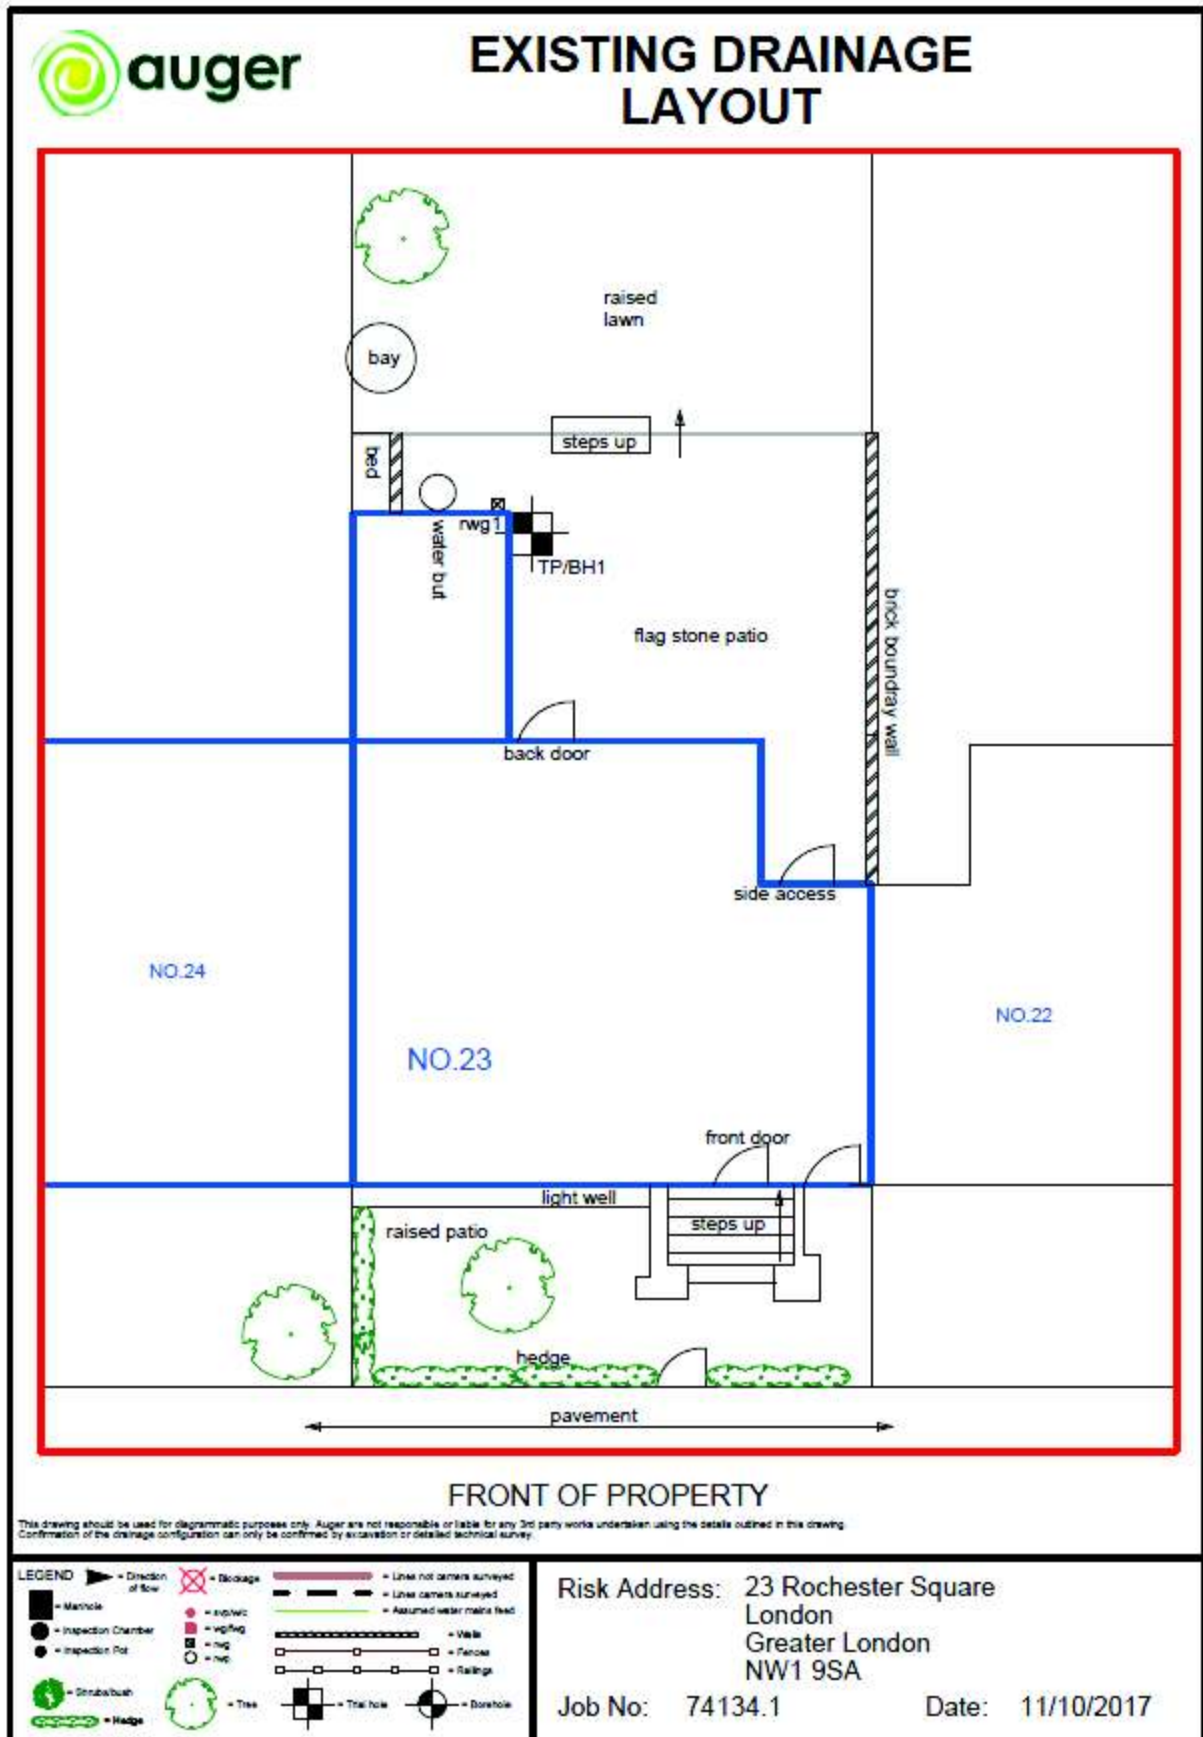
| Trial Hole Log No. 1 | Location : LEFT HAND REAR CORNER ADJACENT TO RWG1 |

| DEPTH METRES | SYMBOLIC LOG | STRATA DESCRIPTION | INSITU TESTS | | Soil Sample | Root Sample | Water / Stability |
|---|---|--|---|---|---|---|---|
| 0.5 | | Brown slightly sandy silty CLAY | SV(19) | 99kpa | Soil @ 0.4m | | |
| 1.0 | | Brown slightly fine gravelly slightly sandy silty CLAY | SV(19) | 111kpa | Soil @ 0.9m | | |
| 1.5 | | Brown slightly sandy silty CLAY | SV(19) | 150+kpa | Soil @ 1.4m | | |
| 2.0 | | Brown slightly fine gravelly slightly sandy silty CLAY | SV(19) | 150+kpa | Soil @ 1.9m | Root @ 1.6m | |
| 2.5 | | Dry hard orange brown slightly sandy CLAY | SV(19) | 150+kpa | Soil @ 2.4m | | |
| 3.0 | | Brown slightly sandy silty CLAY | SV(19) | 150+kpa | Soil @ 3m | | |

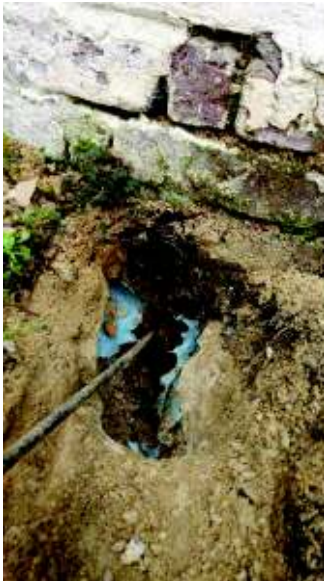
Fig 1.1 – THI.

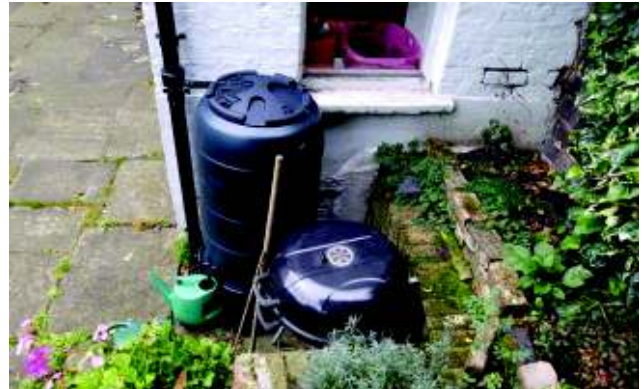
| KEY SUMMARY | |
|---|---|
| Findings: | <p><u>Visual Inspection</u></p> <p>It was necessary to move the position of TH1 slightly from the instructed location due to the presence of a water butt, please see figure 1.2.</p> <p>We were unable to carry out the trial hole at the front of the property as instructed. On arrival it was revealed that there was a light well in the area where the trial hole was to be carried out, and this was noted to be 0.5m deep and very narrow, please see figure 1.3.</p> <p>We were therefore unable to excavate at this position and expose the footings of the property without an extensive excavation through the adjacent raised patio. We attempted to contact the Loss Adjustor to inform of the situation from site, we were however unable to make contact.</p> <p>If it is required for us to re-attend site and carry out a trial pit at the front of the property to expose the footings of the building, it will be necessary to excavate through the flag patio to a depth of 0.5m. It will also be necessary to remove a section of the retaining wall to the raised patio to facilitate the excavation. Please note we would attempt to reinstate the wall, however if this is not possible then a specialist would be required and this would incur further costs.</p> <p>A full day on site would be necessary to undertake these works at a cost of approximately £1000.00.</p> <p>As such we now refer back to the Loss Adjustor for review, and we await your further instruction on how to proceed.</p> |

Fig 1.2 – Water butt in location of THI instructed location.

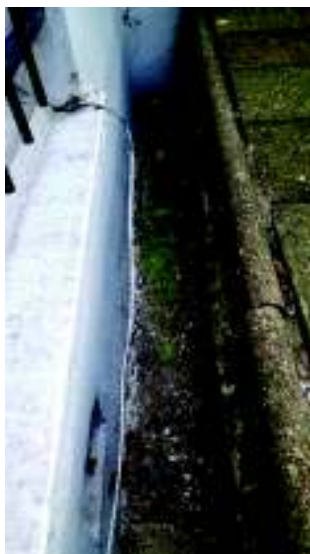
Fig 1.3 – Light well; unable to carry out trial hole.

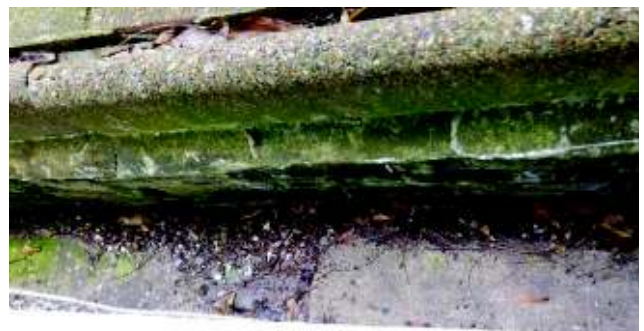
Fig 1.4 – Retaining wall to raised patio.
