Arboricultural Appraisal Report

Subsidence Damage Investigation at:

23 Rochester Square
London
NW1 9SA

CLIENT:	Crawford & Company
CLIENT REF:	SU1703328
MWA REF:	SUB171121-1892
MWA CONSULTANT:	Andy Clark
REPORT DATE:	04/12/2017

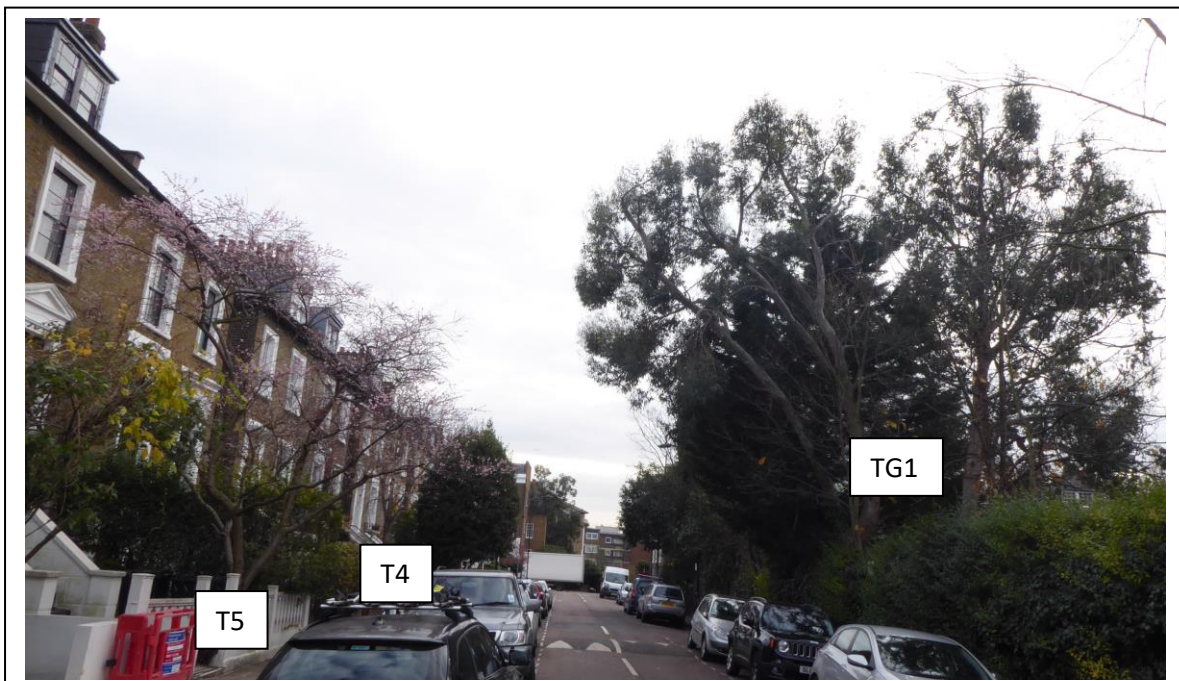
TG1	Eucalyptus and Leyland Cypress group	14.0	500	14.0	14.0	Younger than Property	Third Party:- 1 Rochester Square
Management history		Subject to past management – Eucalyptus recently heavily crown reduced <1yr					
Recommendation		Fell Eucalyptus to ground level and treat stumps to inhibit regrowth Leyland Cypress - Do not allow to exceed current dimensions

Overview of TG1 Eucalyptus and Leyland Cypress group in relation to T4 Magnolia and T5 Cherry

Nevertheless, the removal of both T4 and the eucalyptus offers the most predictable arboricultural solution.
