## ASBESTOS DEMOLITION SURVEY REPORT

S 19055.1

### Keats House, 10 Keats Grove, Hampstead, London, NW3 2RR

## Demolition Survey

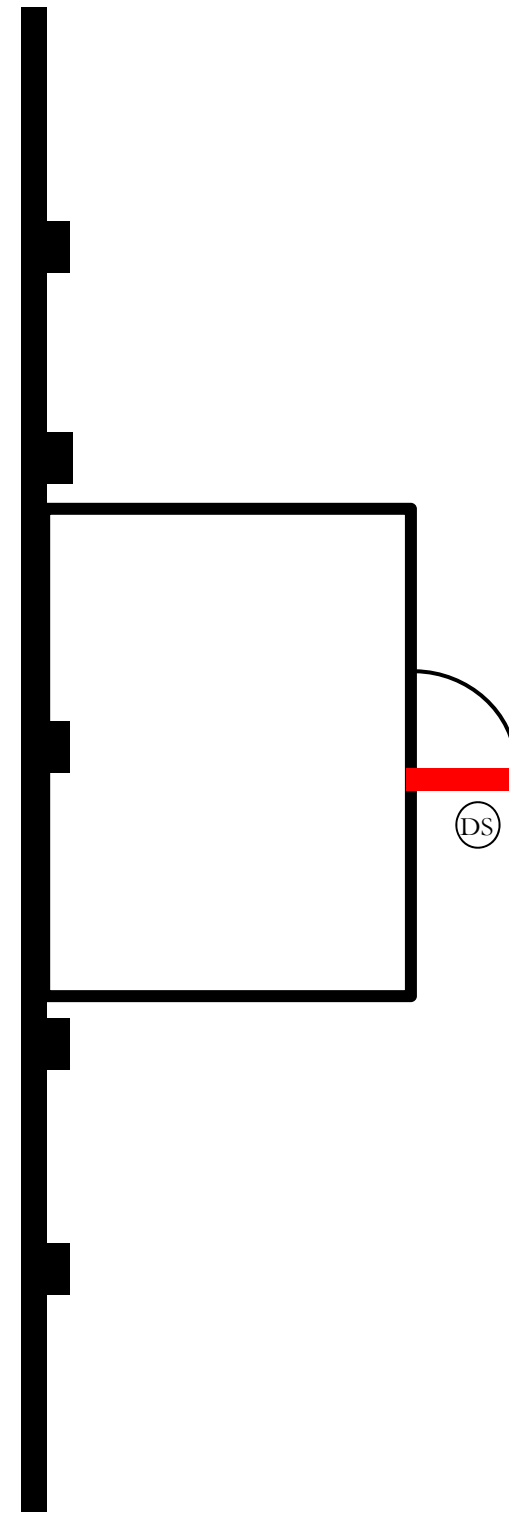
**Drawing Ref:**  
 19055.1/001

- **Ground Floor** – G.01 Oil Store – Durasteel panel forming entrance door.

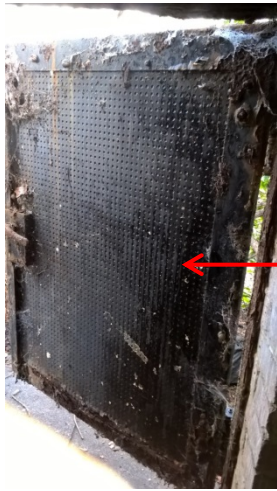
Area/Room	Sample No	Building Component	Asbestos Content	Extent	Condition	Surface Treatment	Material Assessment	Accessibility	Recommendations/ Summary	Photo ID
G.01 – Oil Store	03 A	AC Durasteel	Amosite Chrysotile	2m <sup>2</sup>	Satisfactory condition	Sealed	5/12	Direct access	<b>ASBESTOS PRESENT</b>	01

Durasteel panel forming entrance door.  
 Brick structure with concrete ceiling and floor.  
 Parapet walls originally to roof have been left inside G.01 Oil Store.

**Photograph 1: Ground Floor – G.01 Oil Store – Durasteel panel to internal of entrance door.**

- All planned demolition works should be carried out with reference to asbestos materials already identified or suspected.
- It is recommended that all identified asbestos materials are removed and that this work is carried out separately and prior to any other general building works taking place.

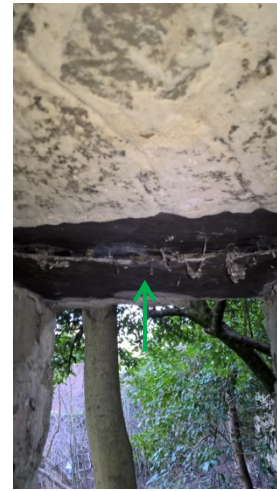
02 A	Slate Shuttering	No Asbestos Detected	1m <sup>2</sup>						<b>MATERIAL SAMPLED; NO ASBESTOS DETECTED</b>	02
------	------------------	----------------------	-----------------	--	--	--	--	--	-----------------------------------------------	----

Slate shuttering to windows and vents found to be non-asbestos.

**Photograph 2: Ground Floor – G.01 Oil Store – Non-asbestos slate shuttering to vents and windows.**

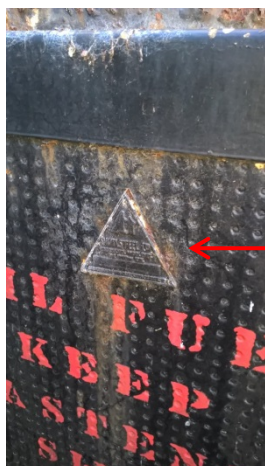
Area/Room	Sample No	Building Component	Asbestos Content	Extent	Condition	Surface Treatment	Material Assessment	Accessibility	Recommendations/ Summary	Photo ID
<b>External</b>	03 A	AC Durasteel	Amosite Chrysotile	2m <sup>2</sup>	Satisfactory condition	Sealed	5/12	Direct access	<b>ASBESTOS PRESENT</b>	03

Asbestos containing Durasteel panel forming entrance door to G.01 Oil Store.

**Photograph 3: External – Durasteel panel to external of entrance door to G.01 Oil Store.**

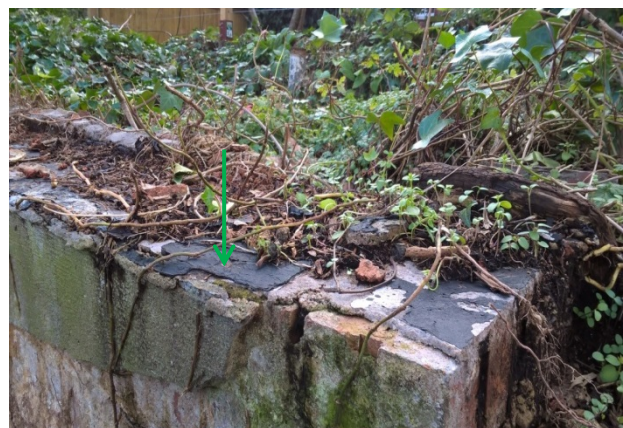
01 A	Bitumen	No Asbestos Detected	<1m <sup>2</sup>						<b>MATERIAL SAMPLED; NO ASBESTOS DETECTED</b>	04 05
------	---------	----------------------	------------------	--	--	--	--	--	-----------------------------------------------	----------

Bitumen to parapet wall found to be non-asbestos.  
Non-asbestos render to external of masonry walls and non-asbestos asphalt to roof.

**Photograph 4: External – Bitumen to top of parapet walls sampled and found to be negative for asbestos.**

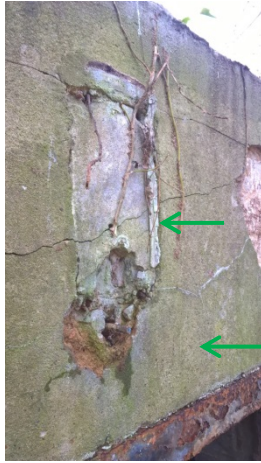
05 A	Mastic	No Asbestos Detected	<1m <sup>2</sup>						<b>MATERIAL SAMPLED; NO ASBESTOS DETECTED</b>	05
------	--------	----------------------	------------------	--	--	--	--	--	-----------------------------------------------	----

Non-asbestos mastic to former light position on external wall.

**Photograph 5: External** – Non-asbestos mastic to former light position. Render to external walls sampled and found to be negative for asbestos.

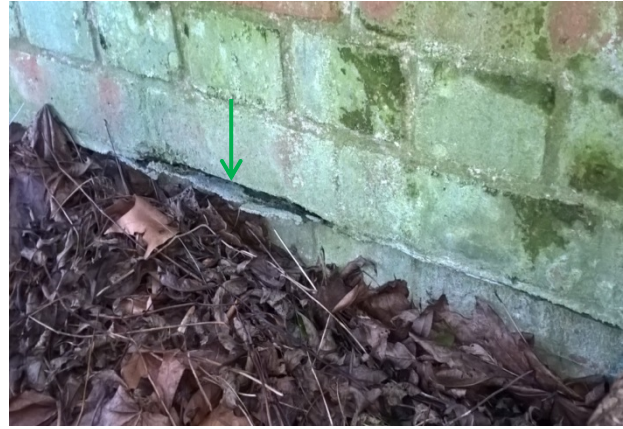
06 A	Bitumen	No Asbestos Detected	<1m <sup>2</sup>						<b>MATERIAL SAMPLED; NO ASBESTOS DETECTED</b>	06
------	---------	----------------------	------------------	--	--	--	--	--	-----------------------------------------------	----

Damp proof course to adjacent boundary wall found to be non-asbestos.

**Photograph 6: External** – Non-asbestos damp proof course to adjacent external wall.
