REPORT

on trees in relation to

7 South Villas, London, NW1 9BS

on behalf of PBA Consulting
for Plum Underwriting
via: Carmichaels
ref: 58703602437

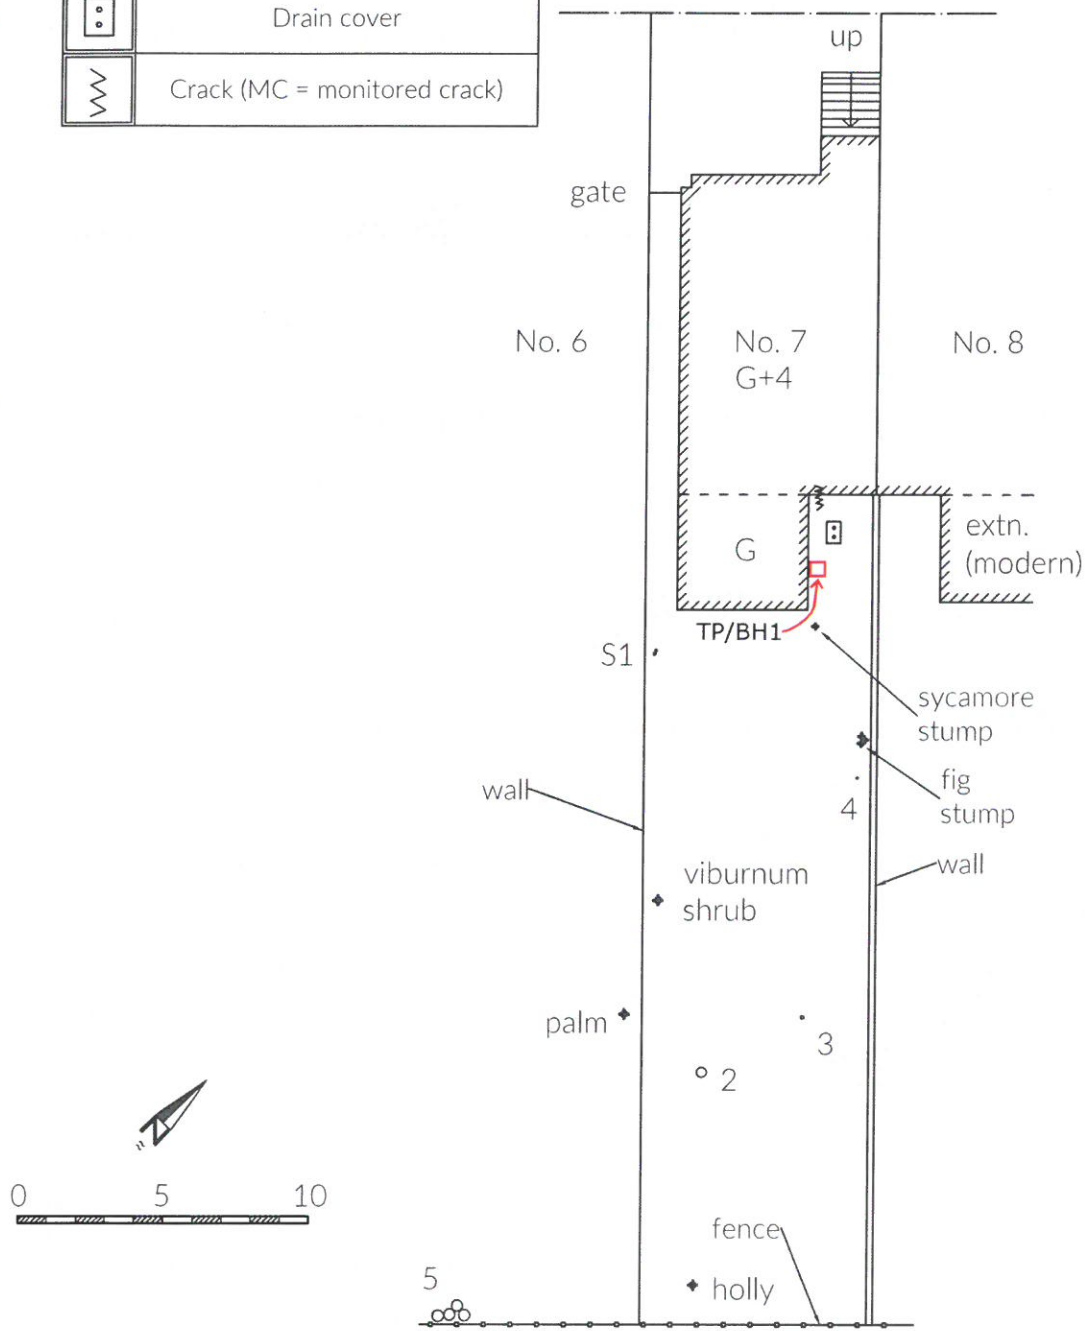
**Trees in relation to 7 South Villas, London, NW1 9BS
1-38-4506/P**

Tree number	Tree type	Height	Stem diameters	Proximity	Comments	Now	Repeat	Reason	Cost
S1	ivy	4	100, 100	1.7	Remove : treat stump.	Y	N	Precaution	150
2	weeping willow	11	<350	16	Remove ; grind stump to 300mm below ground level	Y	N	Suspect	950
3	apple	3.5	120	14		N			
4	wild plum	5	80	6		N			
5	sycamore	17	400, 400, 400, 400	25		N

Tree number	Tree type	Height	Stem diameters	Proximity	Comments
S1	ivy	4	100, 100	1.7	Remove : treat stump.
2	weeping willow	11	<350	16	Remove ; grind stump to 300mm below ground level
