The Lodge  
Flaxman Terrace  
Camden

Heritage and Design and Access Statements,  
Condition Survey and Schedule of Repairs

8 February 2018

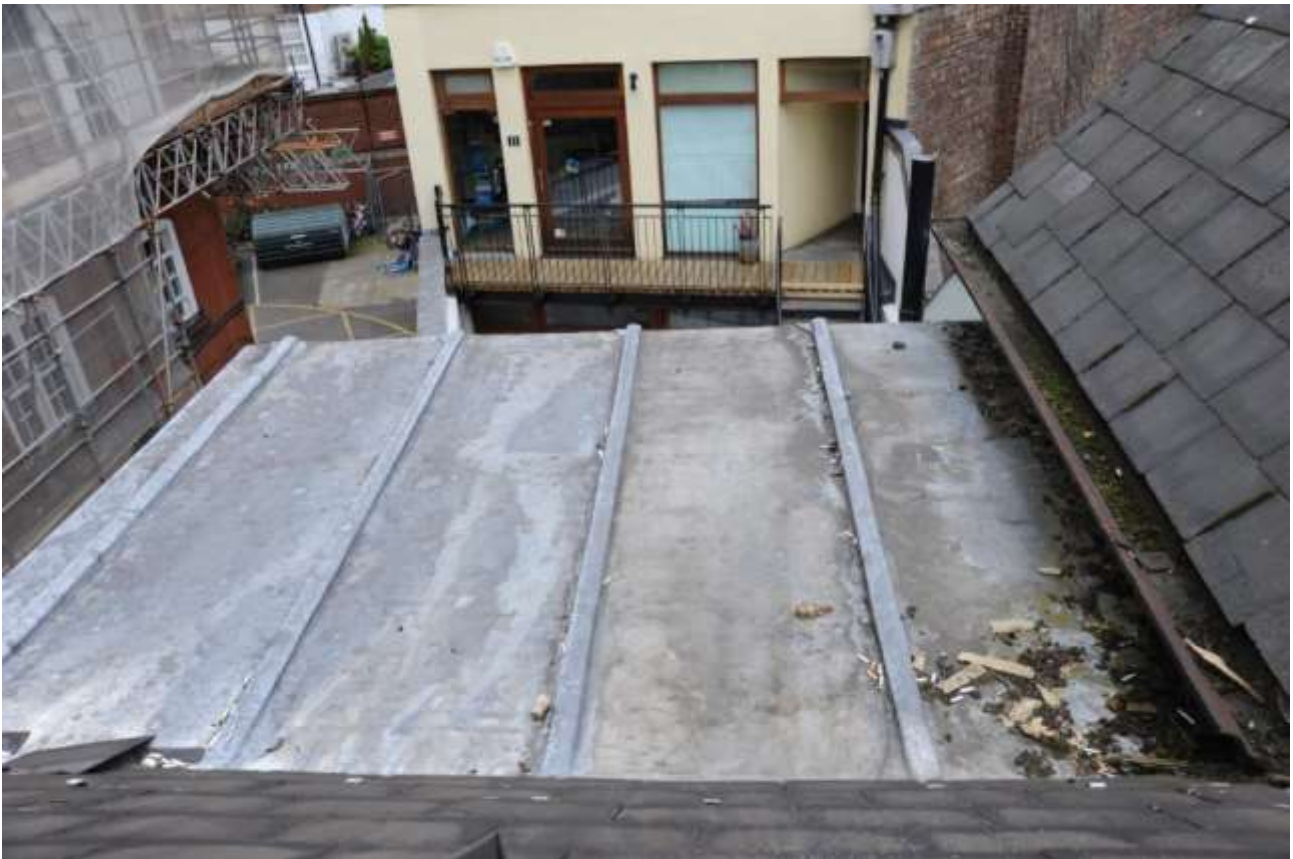
Flat lead roof with four wood coved rolls dating from c.1992 and in a satisfactory condition (Fig.7). There was no visible means of ventilating the roof.

Fig 7 The lead roof over the rear dormer

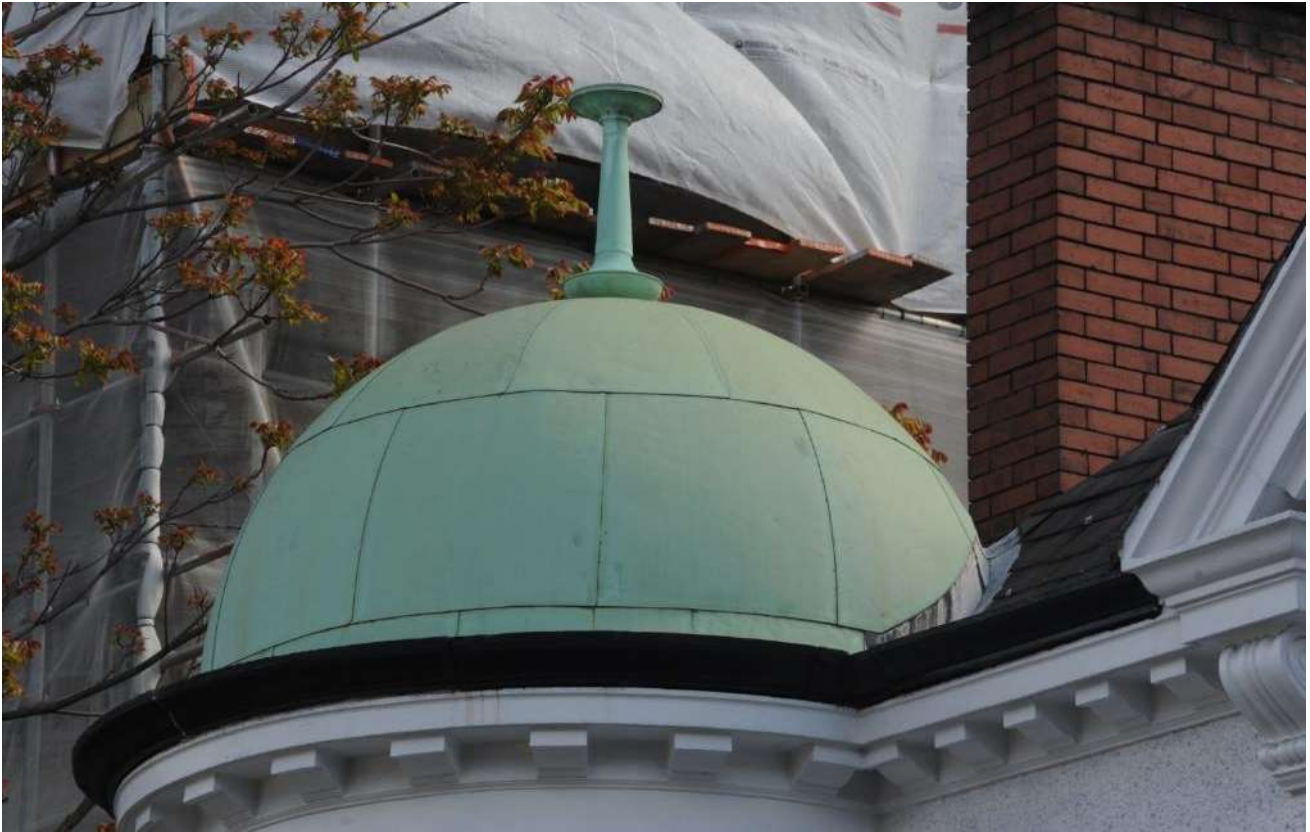
The surfaces of the copper sheeted domes visible from ground level appear to be in a satisfactory condition although this needs to be confirmed by a closer inspection when safe access can be provided (Fig.8). There is no internal evidence of damp ingress due to a defect in the copper sheeting, but see section 3.1.2.1.

Fig 8 The copper dome over the north-west tower

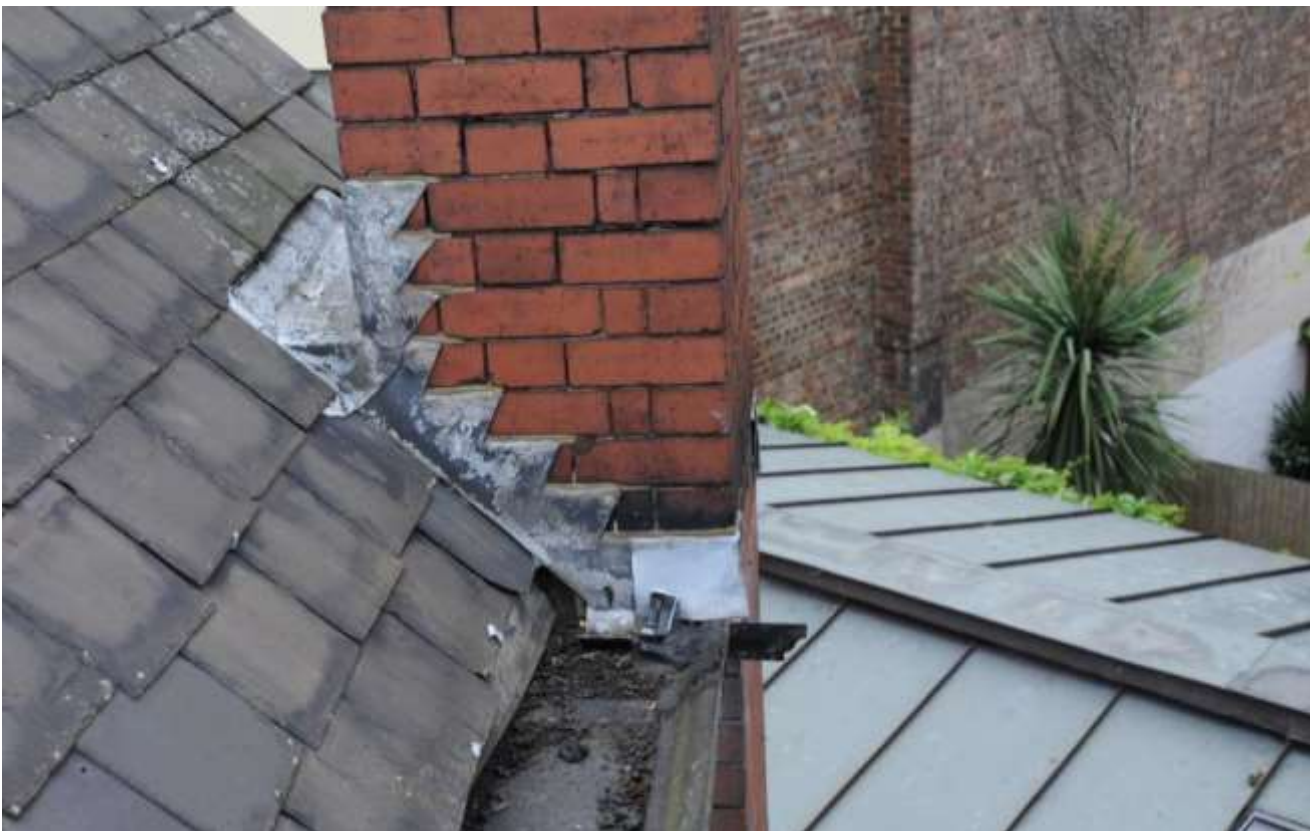
Fig 9 The cast iron gutter and lead flashings at the base of the east chimney stack

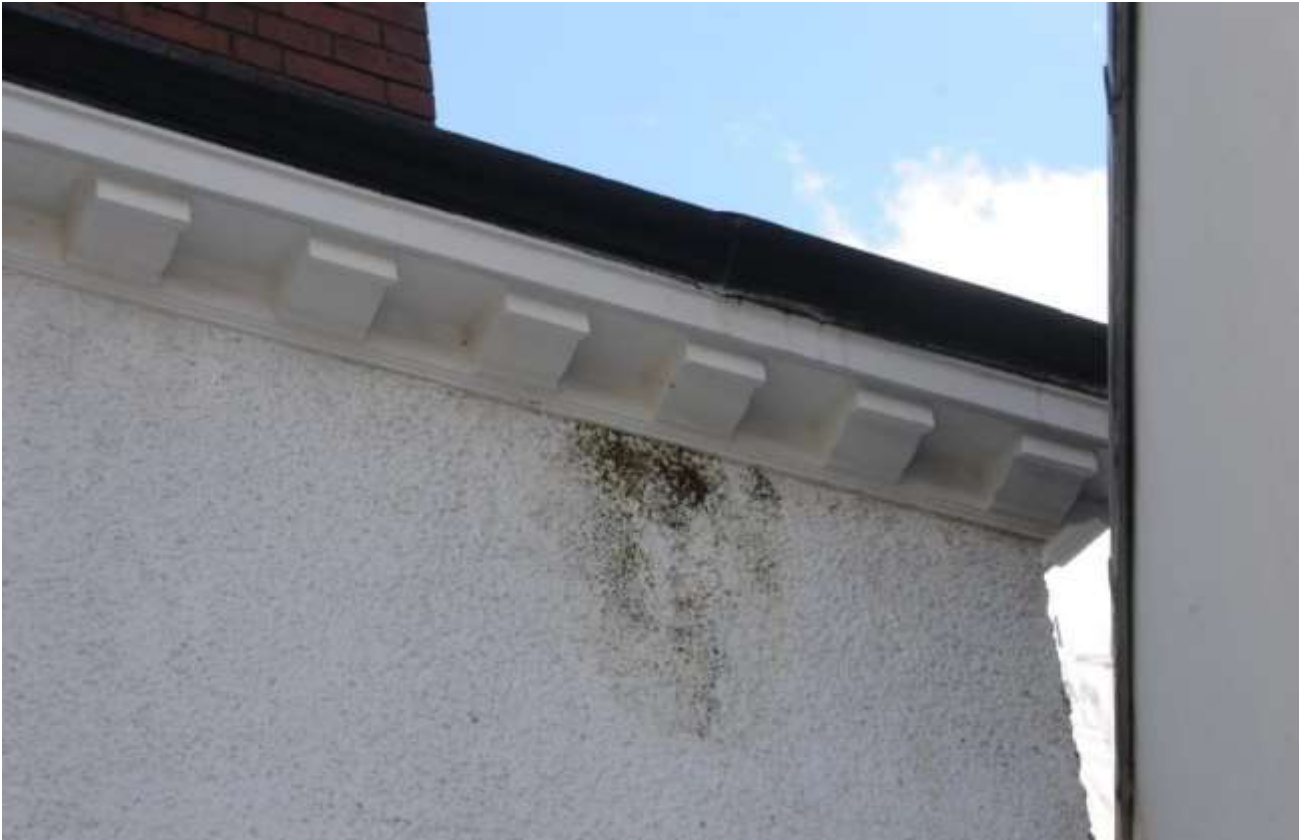
- There is damp at high level in the east and south walls of the south room on the first floor (Fig.27) for which the most likely source are defects in the guttering. Additionally on the external face of the south wall the render is stained immediately below the gutter indicating a defect at this location (Fig. 10).

Fig 10 Algae staining of the render under a defective gutter on the south elevation

- Repair, if possible or replace damaged sections of cast iron guttering and re-decorate. The gutters are unusually wide and it is unlikely they will be available from existing manufacturers. Therefore it may be necessary to make moulds and sand cast new lengths of guttering. If the budget does not allow for the cost of manufacturing replacement gutters at this point an alternative would be to line the gutters with the Quest A4.25 liquid waterproofing system.

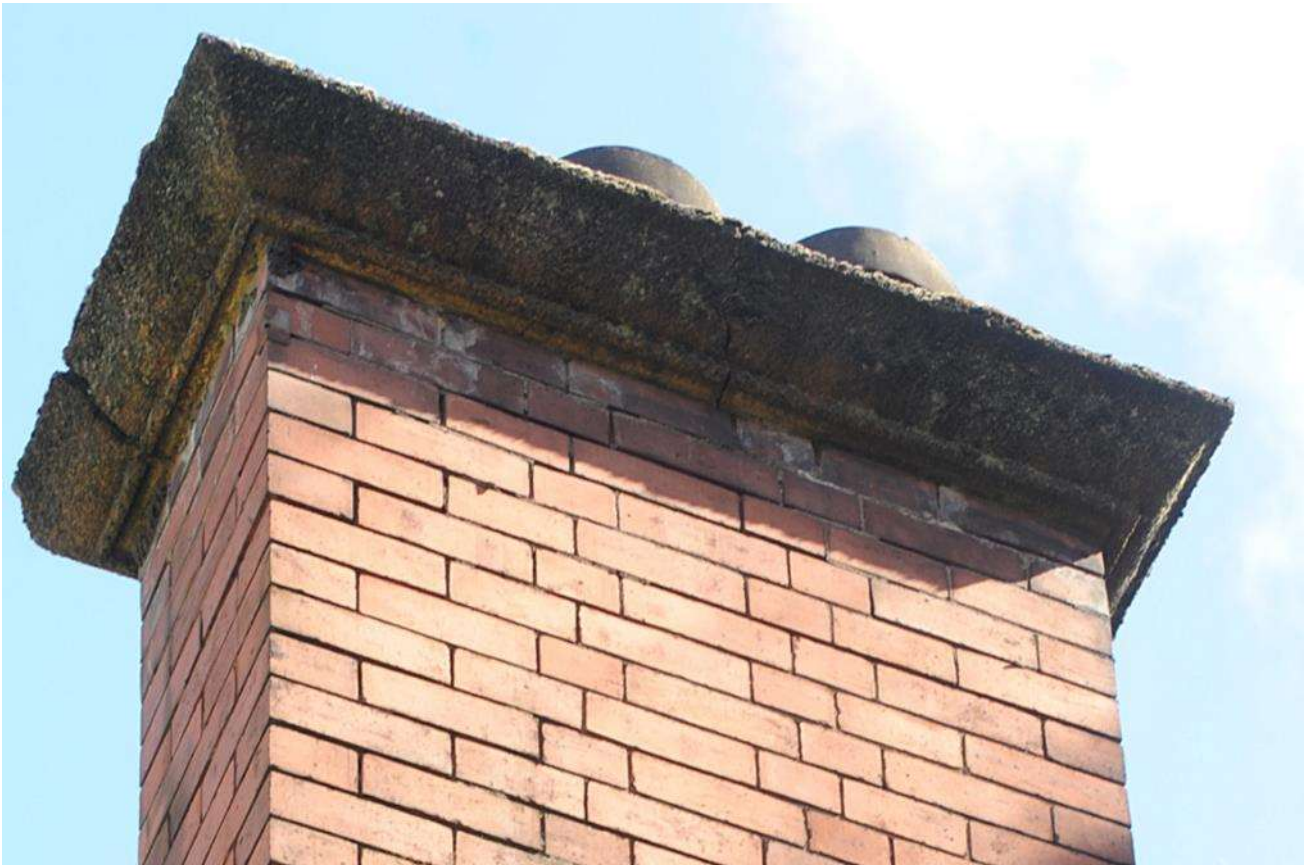
- The pointing on all faces of the stack is deteriorating.
- There is a 15mm wide crack for the full depth of the concrete cap on the west side a s second 15mm wide crack on the south side of the cap (Fig.11).
- The condition of the flaunching is not known because it cannot be seen.
- The western chimney pot is missing.
- The condition of the lead flashing and gutter at the base of the stack cannot be ascertained because they are not visible. On the evidence of the leadwork elsewhere on the roof it will be nearing the end of it useful life.

Fig 11 The cracked concrete cap of the south chimney stack

- Repoint the brickwork on all faces with a mortar to lime match the strength of the existing mortar.
- If safe access becomes available, inspect the condition of the flaunching on top of the concrete cap and replace if necessary.
- If safe access becomes available it is recommended that the structural condition of the cracked concrete cap is ascertained by a structural engineer and appropriate repairs advised. Allowance should be made for an insitu repair using stainless steel dowels across the crack.
- If safe access becomes available ascertain whether there is a ventilated cap protecting the top of the third flue. If not supply and fix a clay ventilated cap to the top of the flue.
- When the roof is re-slatted the lead flashing and gutter at the base of the stack should be replaced.

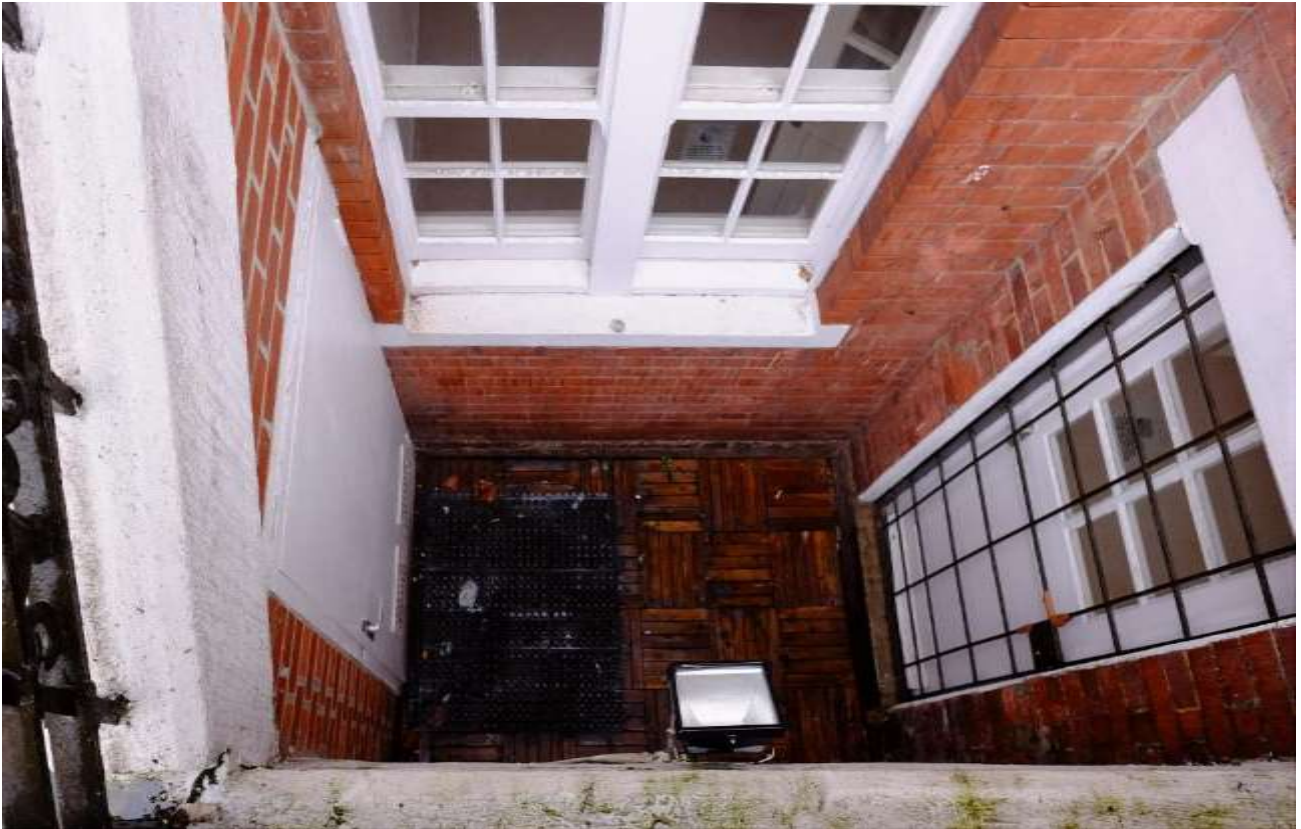
- The deadlock is missing from the external security gate.
- Two junctions between the steel bars of the security gate are being held in place with brown tape (Fig.15).
- If the security gate is to be retained a new deadlock will need to be fitted and the damaged bars will need to be rewelded.

Fig 15 The south lightwell on the west side of The Lodge

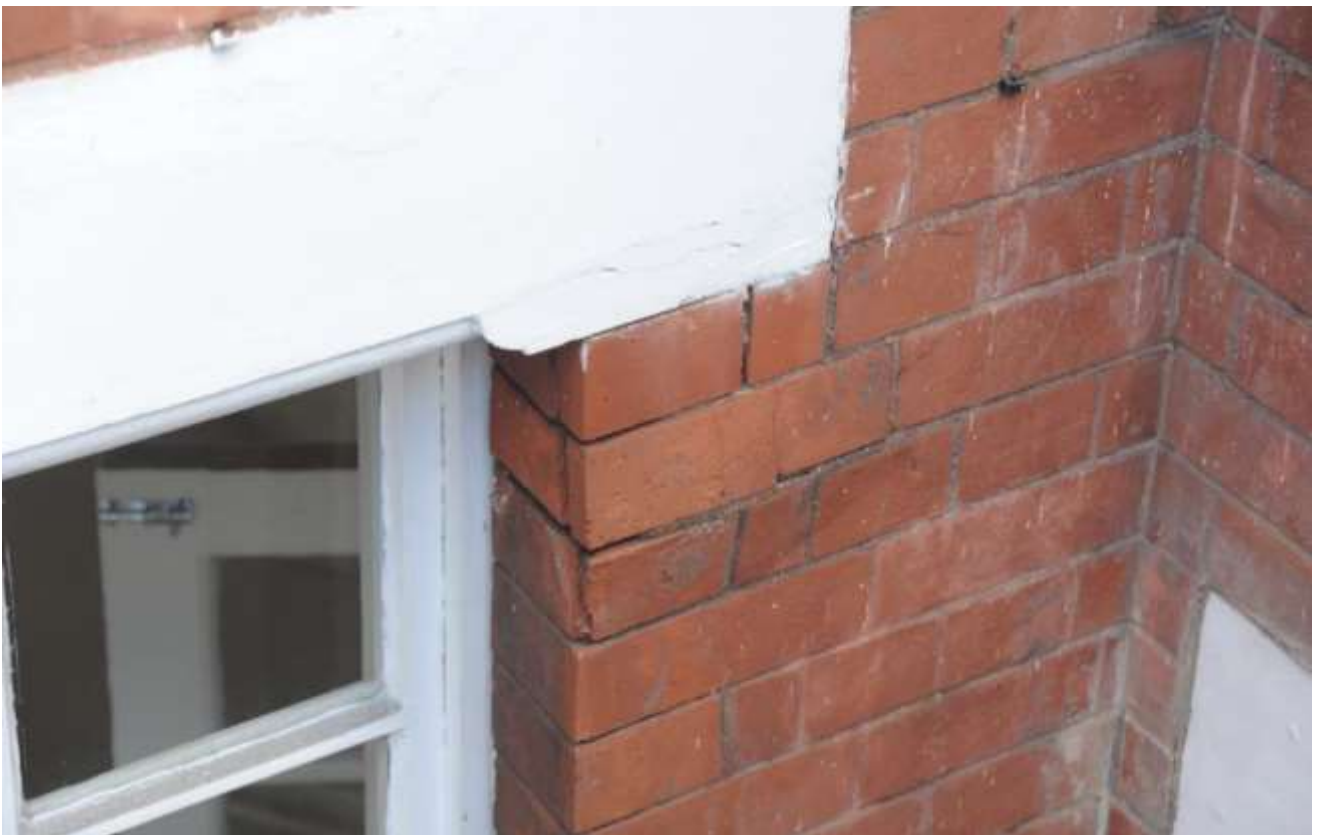
- A previous brick repair in the corner below the south end of the lintel of window W27 has failed (Fig.16).
  - The timber decking is saturated and vegetation is growing in the lightwell.

Fig 16 An earlier repair to the south jamb of window W27

- Remove the timber decking to determine whether the lightwell has any surface water drainage system. If absent provide a gulley to drain the lightwell and connect to the existing drainage system.
- Remove the corrosion and redecorate the two cast iron grilles at ground level.
- Lower the ground level to 150mm below the dpc and resurface.

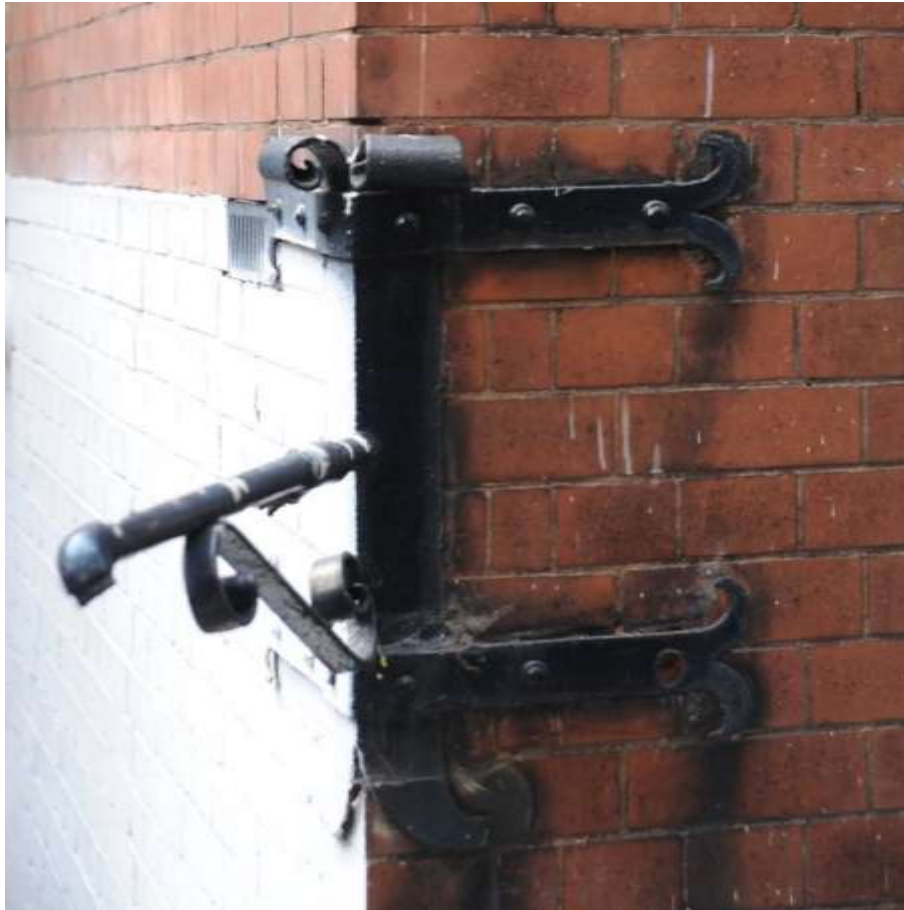
- At the north-east corner is the iron bracket and gas supply pipe of an original gas light, missing only its glazed lantern (Fig.17). This feature should be retained and if possible an appropriate lantern sourced and fixed to the bracket. There is a fixing missing on the lower strap.

Fig 17 The gas light bracket on the north-east corner of The Lodge

- Repoint the washed out joints behind downpipe R1 with a lime mortar matching the strength of the original mortar.
- Replace the missing fixing on the gas light, remove the corrosion and re-decorate.

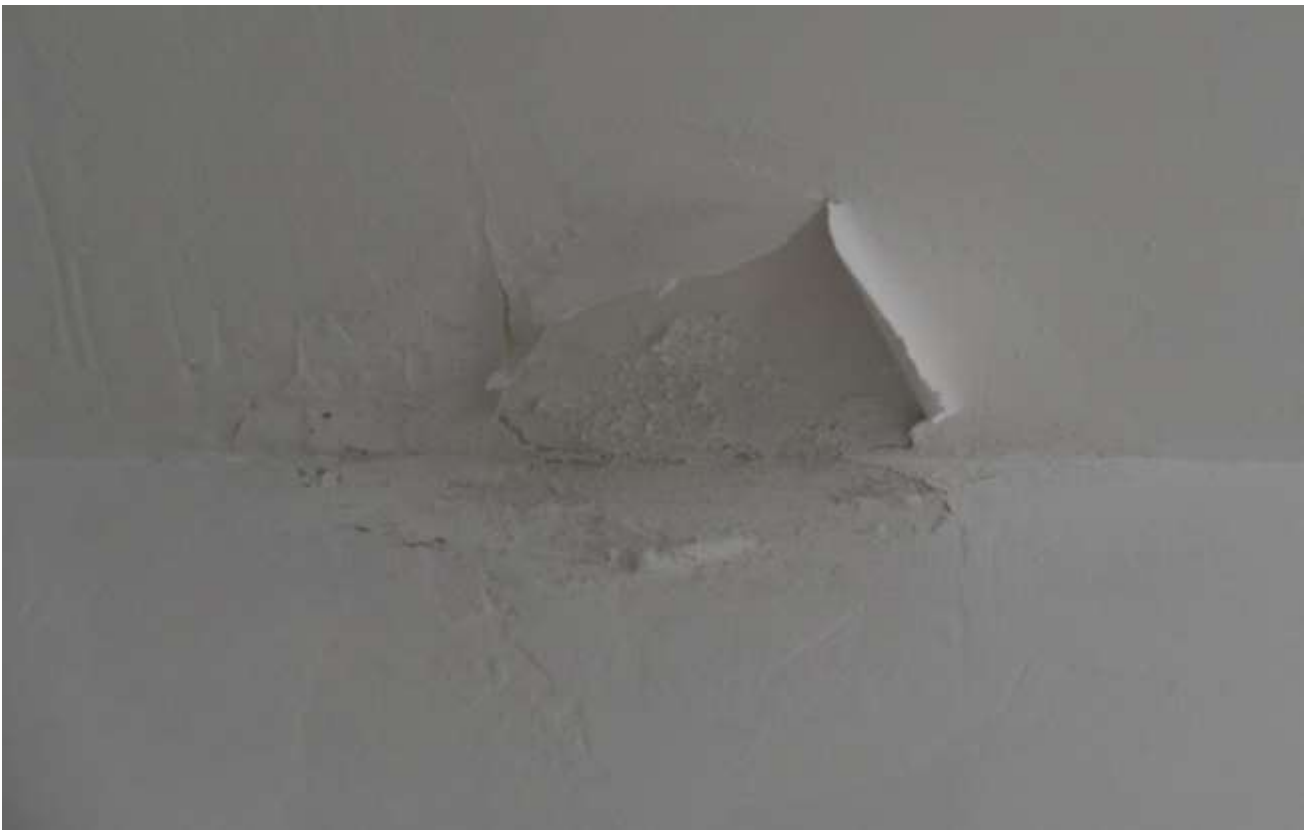
Fig 24 The damp ingress on the ceiling and south wall of the passage in the basement

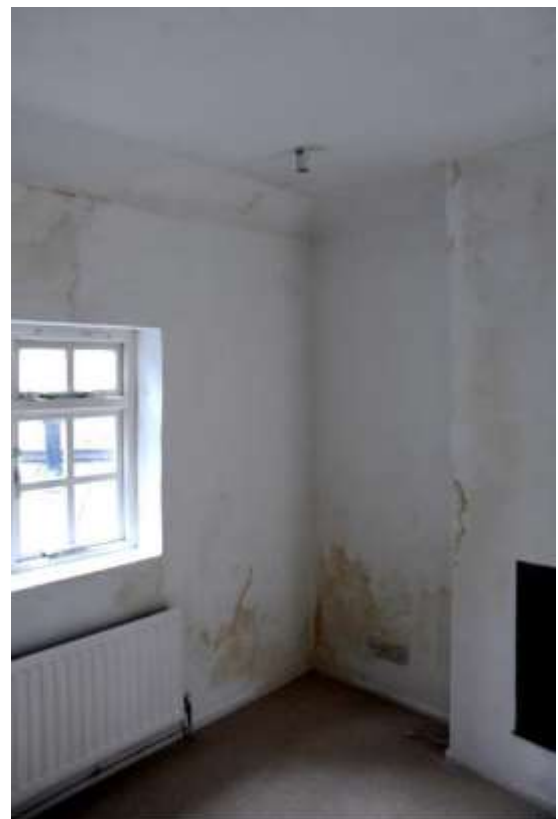
Fig 27 The south-east corner of the south room on the first floor

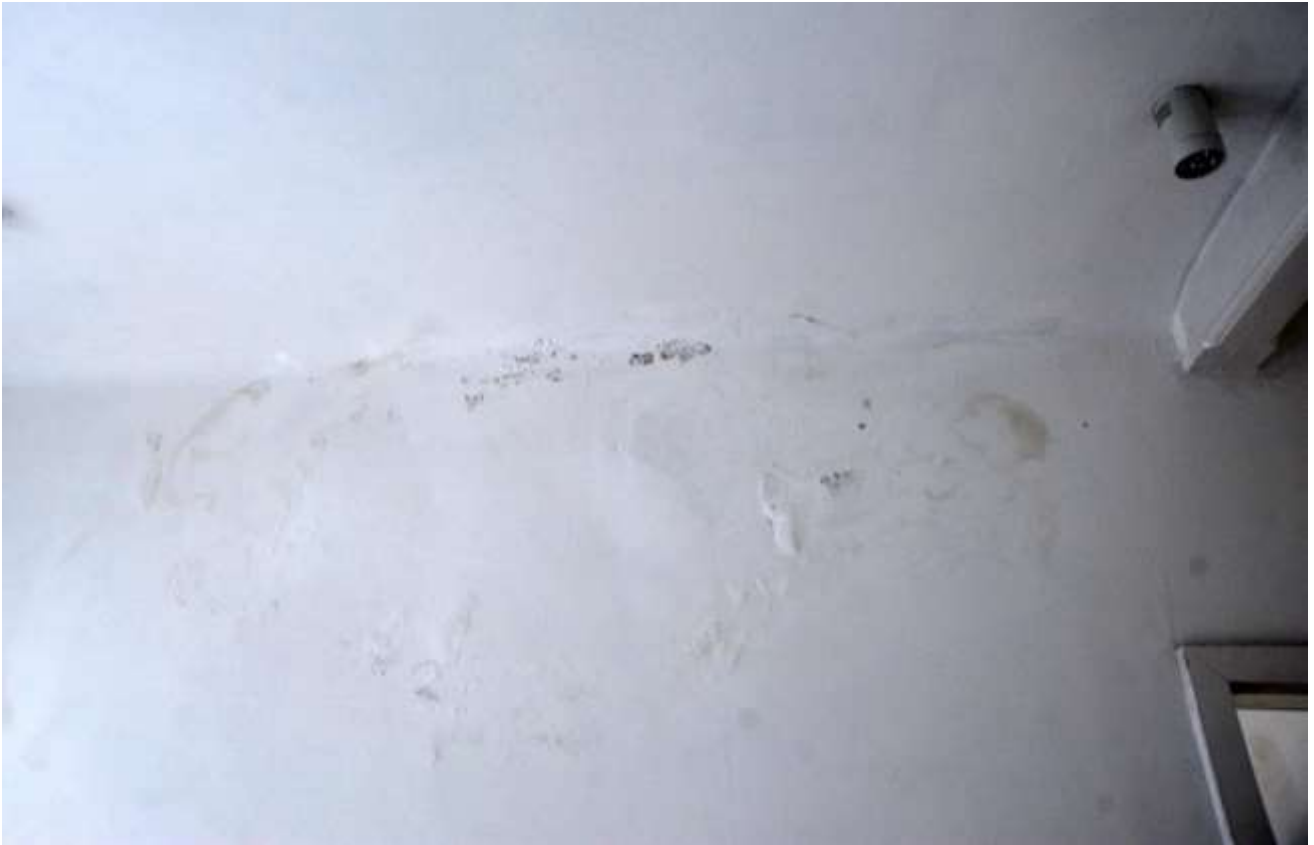
- There are some signs of corrosion at the joints of the cast iron rainwater goods.
  - The cast iron gutter at eaves level on the south side of the east double pitched roof finishes against the side of the eastern chimney stack with a right angled internal return, with the return broken off. The broken end of the gutter has been closed with a large amount of mastic sealant (Fig.9). There is damp visible internally on the wall immediately below this gutter and this is the probable source (Fig.28).

Fig 28 The damp ingress on the south wall of the stair

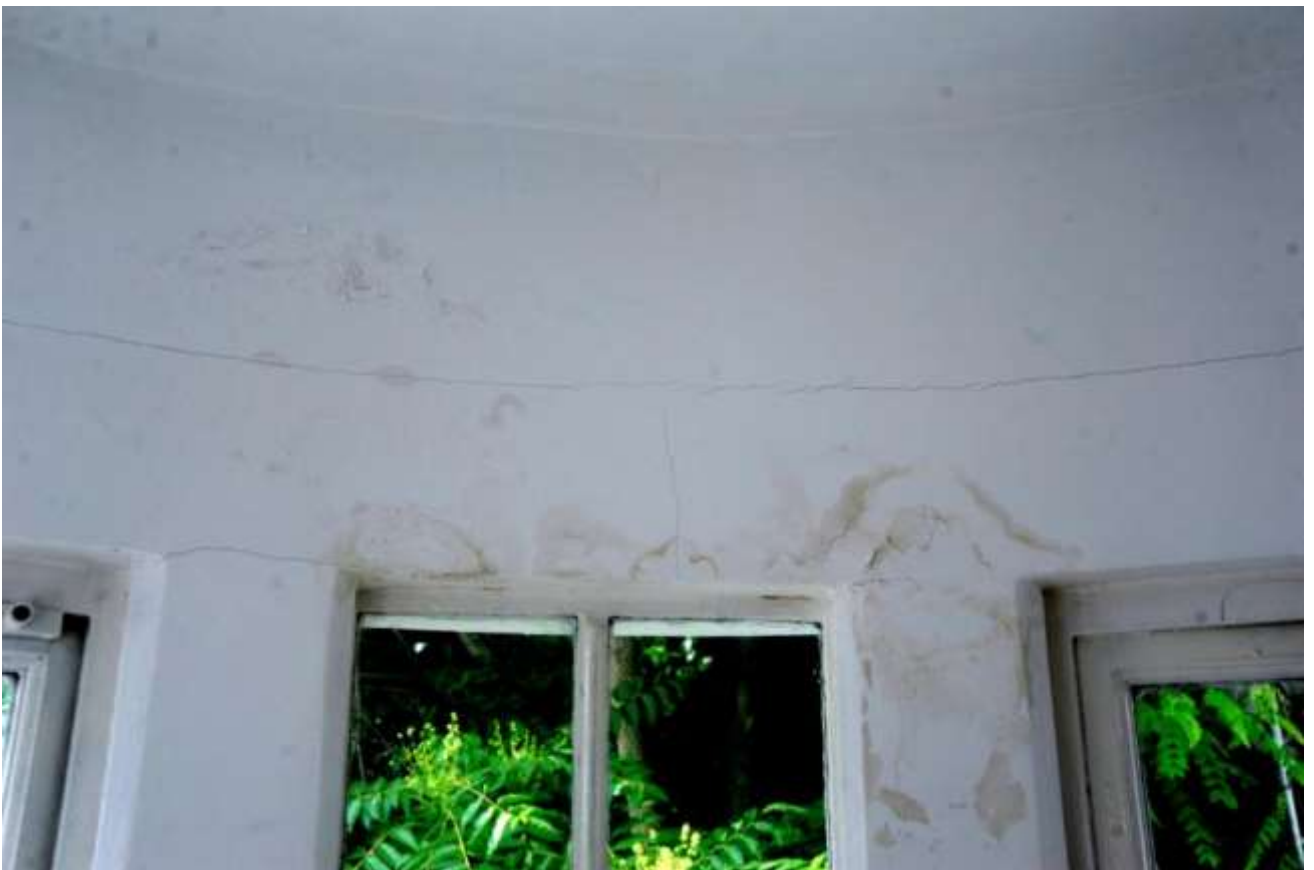
- There is damp at high level on the wall in the north-west tower above windows W49 and W50 (Fig.29) and on the wall at the junction between the tower and the north wall of the north first floor room (Fig.30). The most likely source of the damp are defects in the gutter.

Fig 29 Damp staining above window W50

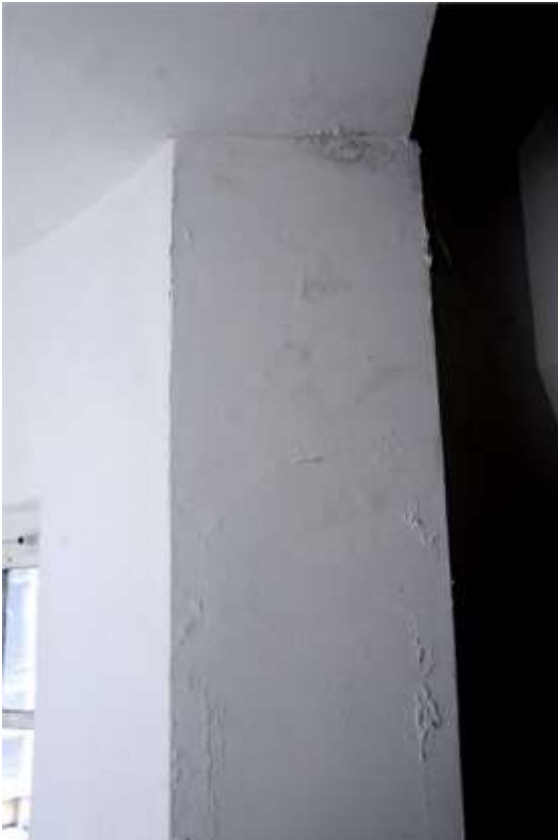
Fig 30 The damp ingress on the wall at the transition between the north-west tower and north room on the first floor

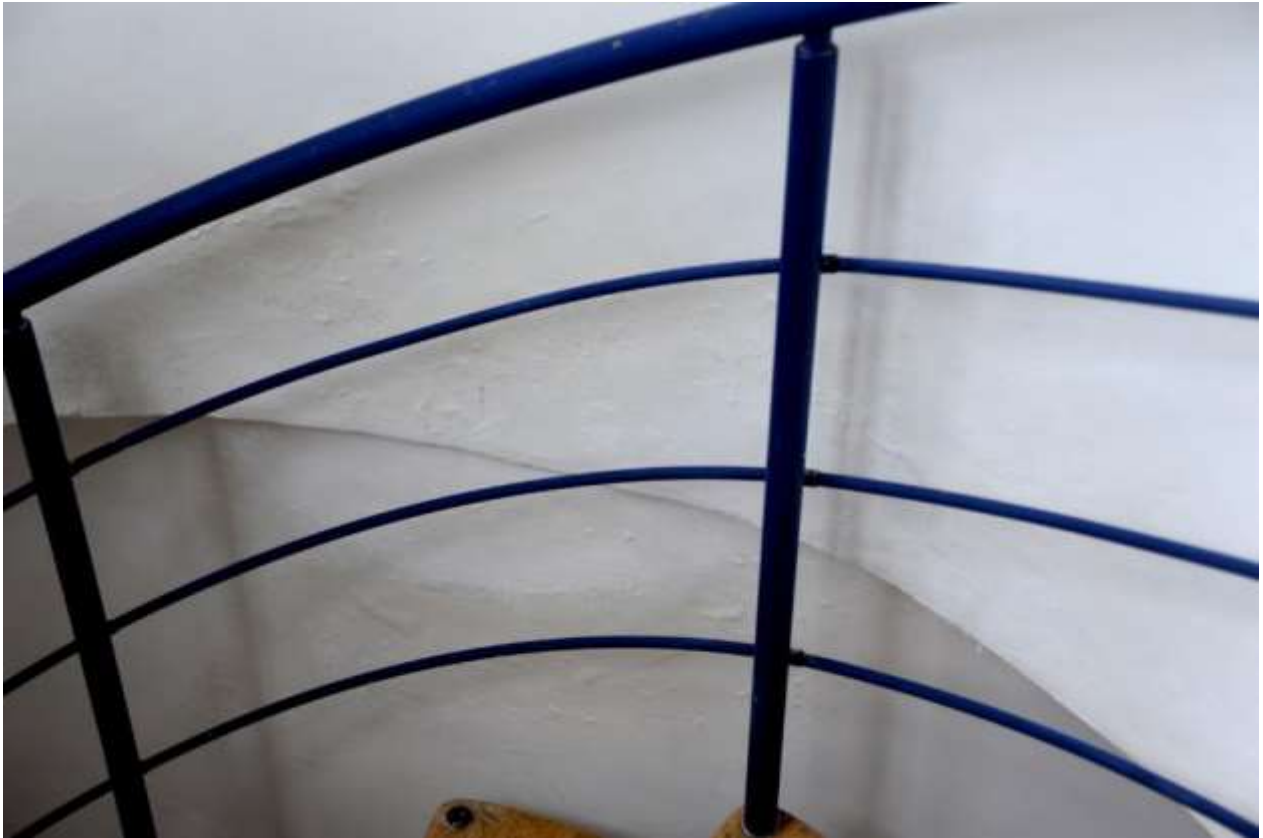
Fig 38 The wall affected by damp at ground floor level in the north-west tower

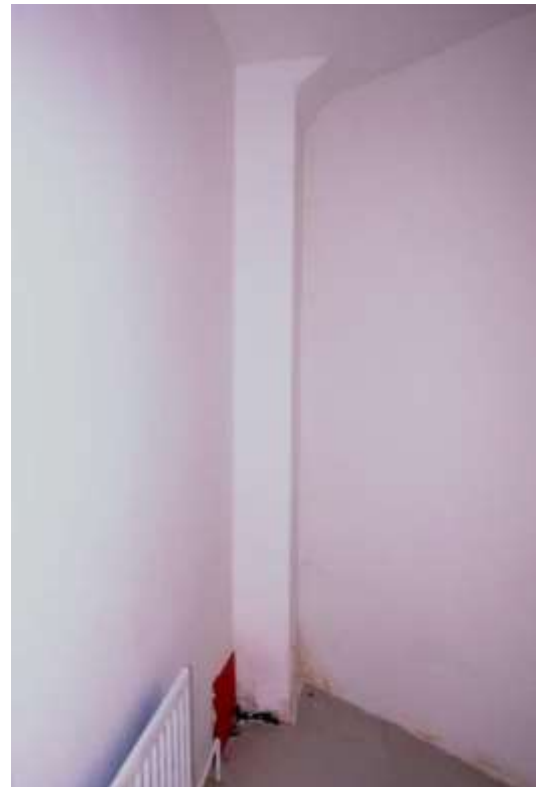
Fig 42 The damp ingress at the bottom of the north-east pier in the south-east room of the basement

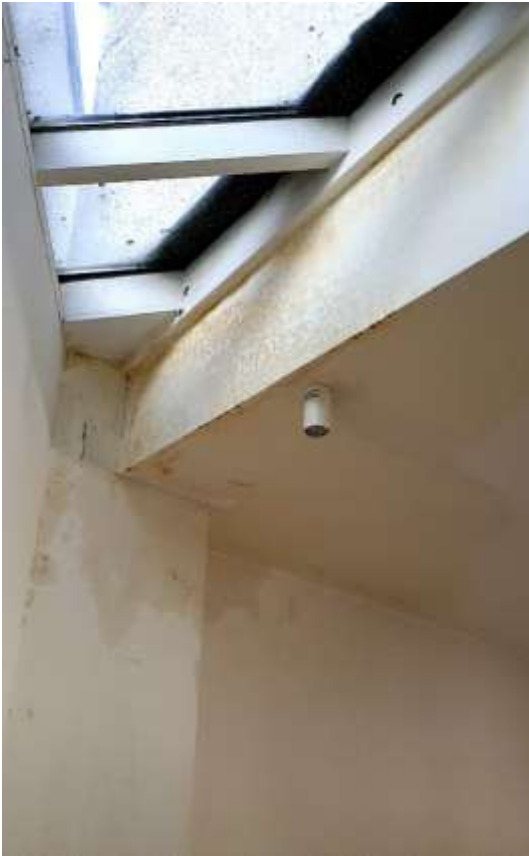
Fig 53 The damp at the south end of the glazed roof on the ground floor.

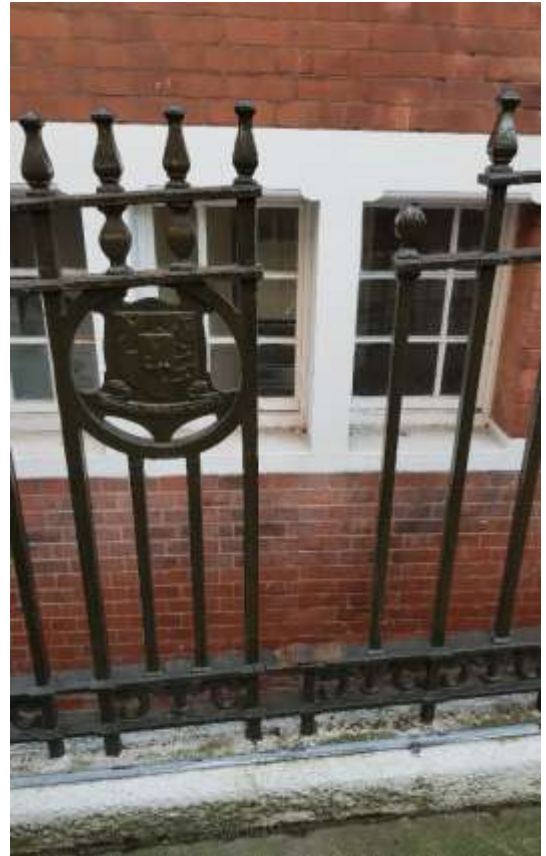
Fig 54 The damaged railing on the north boundary.

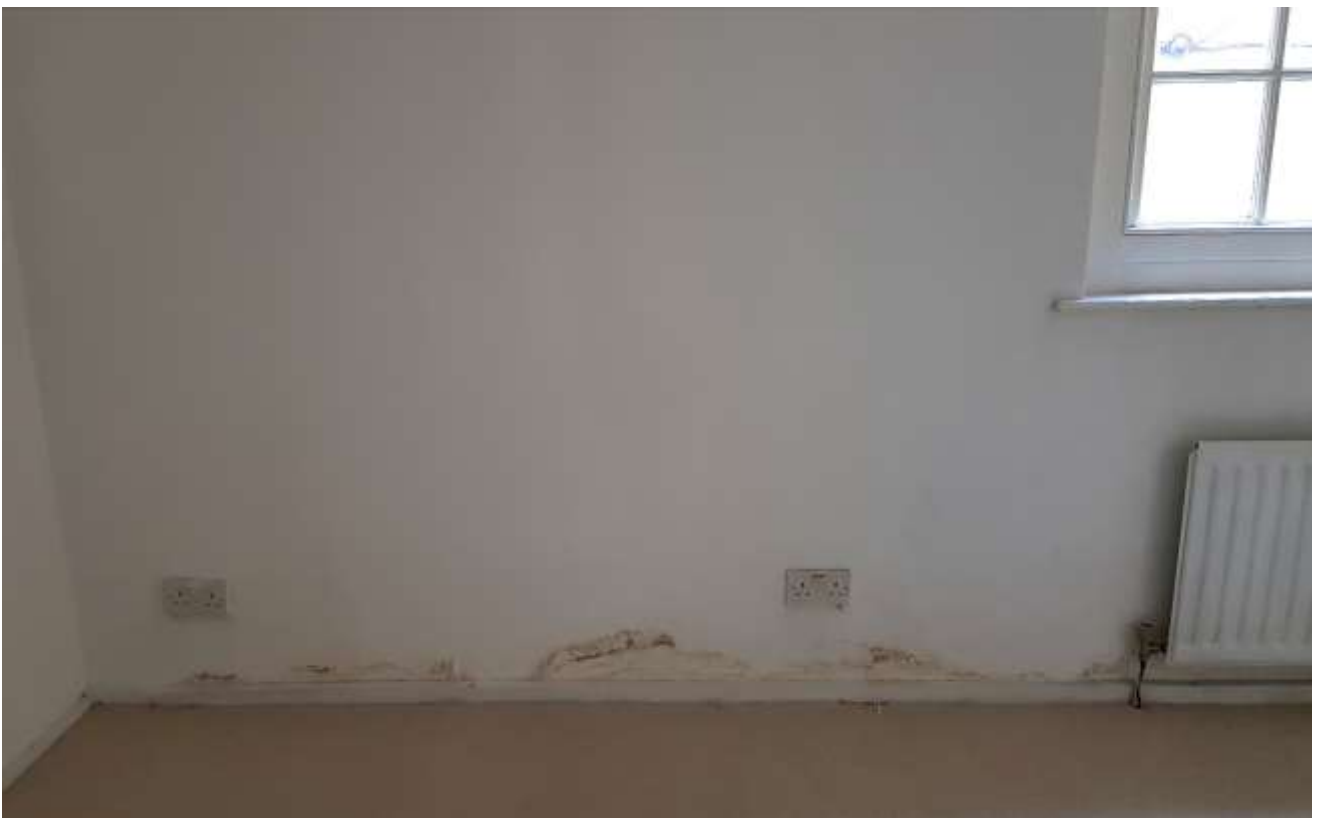
Fig 55 The damp on the west wall
