35 TEMPLEWOOD AVENUE, NW3
EXISTING FABRIC ASSESSMENT/
REINSTATEMENT METHODOLOGY
FEBRUARY 2018

35 TEMPLEWOOD AVENUE, LONDON, NW3

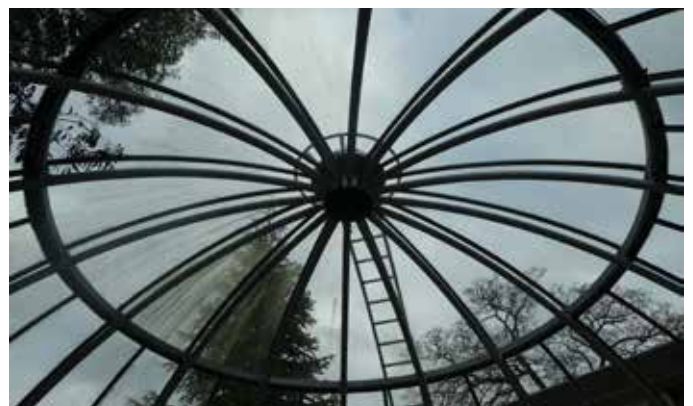
8. Interior view of the dome

In terms of the glazing to the dome, the existing glass is not original, this having been replaced with laminated panels which in some instances are delaminating. It is therefore intended that existing glazed panels will be replaced with new clear georgian wired panels to replicate the original installation.

The existing main tubular metal framework, and associated metalwork, forming the primary structure of the dome is a bolted assembly. Prior to disassembling, each metal member will be given a unique reference, so the frame can be reassembled in the same configuration. After disassembly the metal components will be taken off site for specialist shot blasting and galvanising prior to off site redecoration. On completion of this process the metal components will be returned to site and reinstalled in the original configuration.

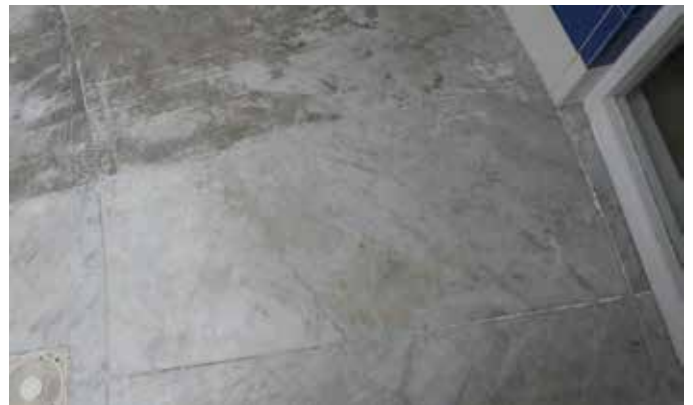
10. Detailed view of the marble floor to the pool surround

It is intended that the existing marble will be carefully lifted and reinstated. The process for this will be as follows:

- 01 Undertake a full survey of the existing marble arrangement and prepare a drawing that records the existing layout with each piece of marble being given a unique reference number to ensure that each piece can be re-laid in its original position.

- 02 To each marble slab a templated piece of marine grade ply will be bonded to the surface prior to carefully cutting the joints between each slab with a diamond tile saw. The adhesive underlayment will be broken mechanically, or potentially by sonic vibration, to enable the slabs to be lifted. Each slab will then be put in dry storage, stacked on timber pallets until reinstatement. It can not be guaranteed that the above process will successfully enable all slabs to be lifted without damage and there may therefore be a requirement to replace some slabs with new marble to match. Edilmarmi of Pietrasanta have identified a local quarry where the marble can be sourced.

- 03 Once each slab has been reinstalled the marble will be polished and sealed. Resealing of the marble will be required at periodic intervals to protect it from degradation.

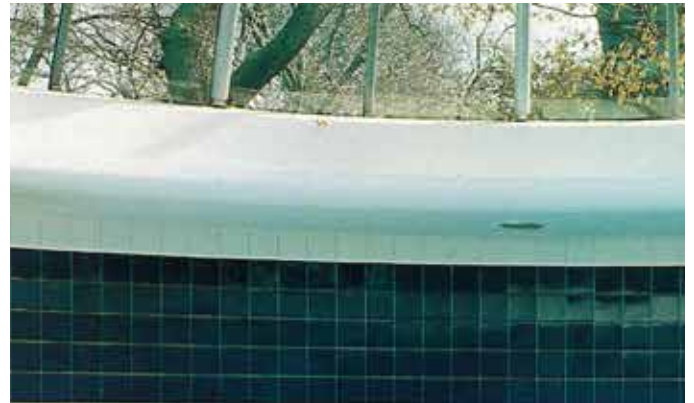
The existing GRG light trough to the perimeter of the base of the glazed dome / roof structure is not part of the original fabric as evidenced by the image below.

17. Existing Perimeter light trough

It is however intended to reinstate the GRG light trough to match the existing arrangement to enable new recessed lights and speakers to be installed.

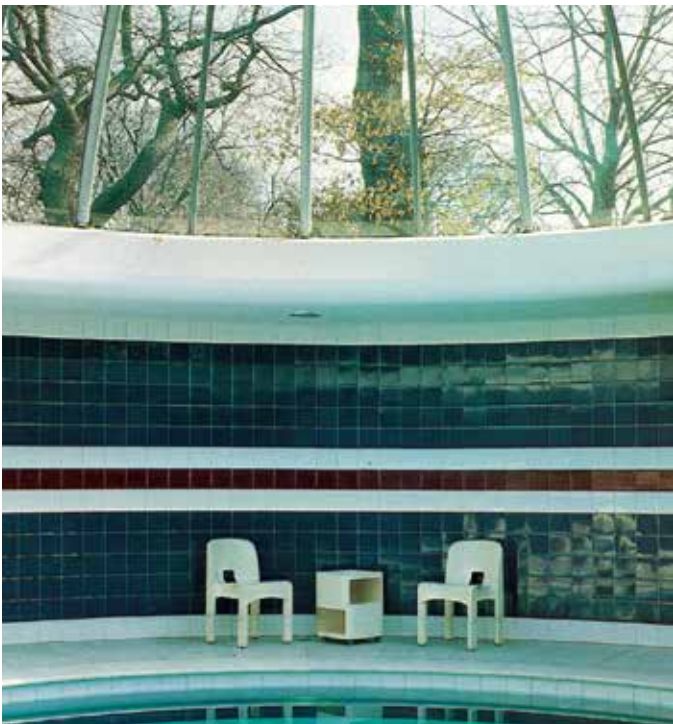
None of the existing blue and white glazed ceramic wall tiling is original as evidenced by comparison of the original tiling shown in the image below and the tiling that exists currently. It is therefore intended to remove all the existing ceramic tiles and replace with new glazed ceramic tiles to match the original colour scheme and arrangement.

18. Existing Tiling

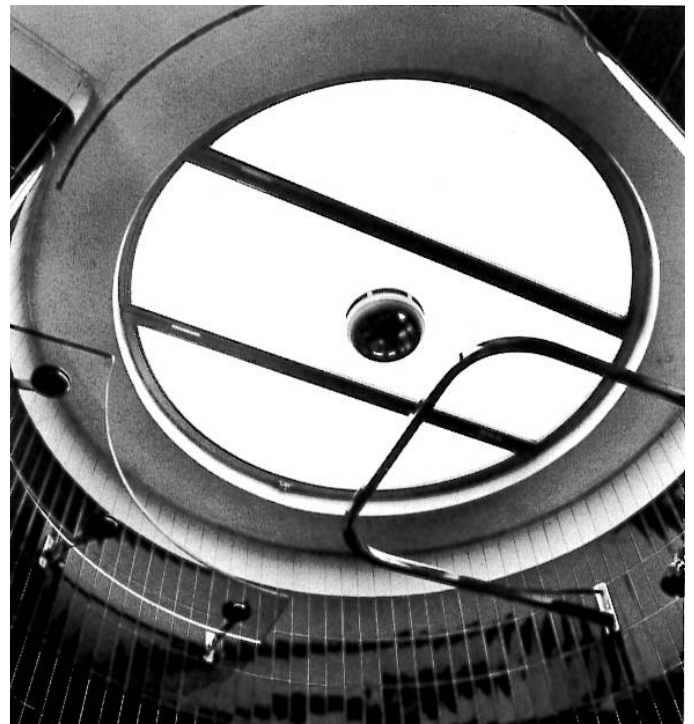
None of the existing fixtures and fittings within the pool building are original, or of any significance, evidenced by the image below showing the original fixtures within the shower. It is therefore intended to replace the existing fixtures and fittings with new.

19. Existing Shower

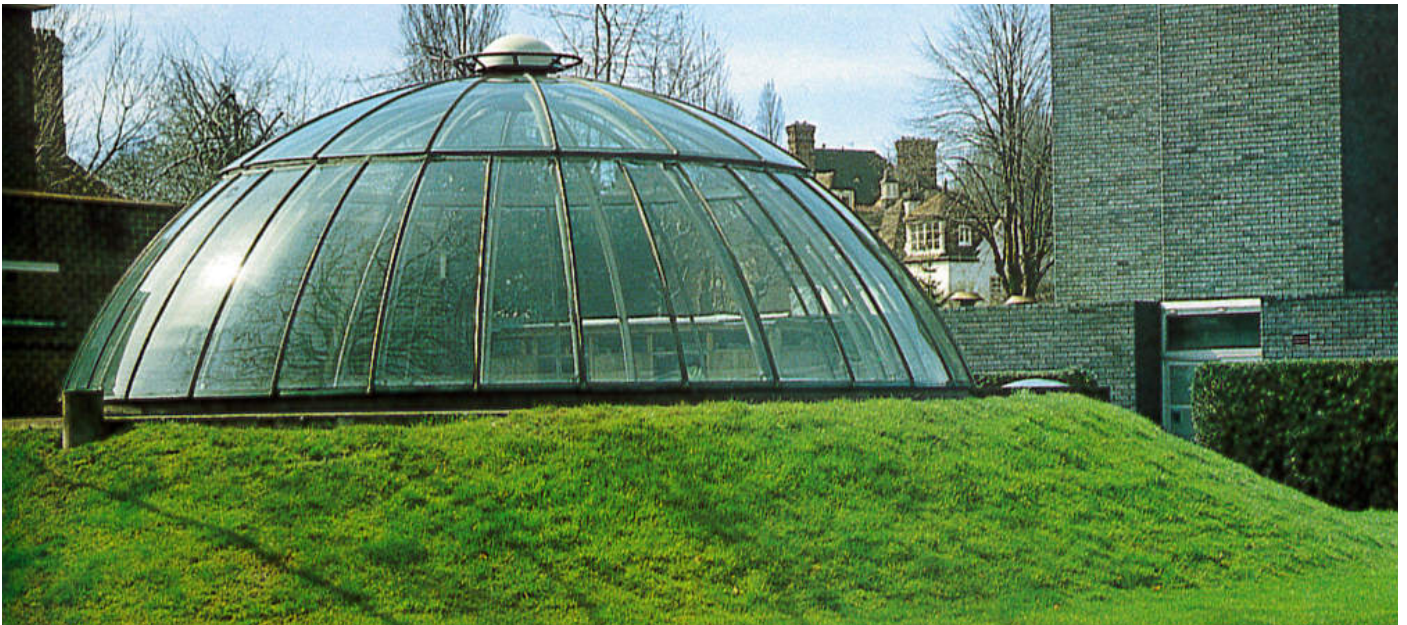
20. Exterior view of the pool building

The reinforced concrete walls that became exposed when the grass mound was removed, due to their construction, can not be dismantled and reinstated. New reinforced concrete walls will therefore be constructed to the same dimensions as the original and associated membranes installed to the external face of the concrete prior to reinstatement of the grass mound / landscaping, replicating the original design shown in the image below.
