**14 Rochester Road,
London, NW1 9JH**

Circumstances

CCTV Results and Recommendations

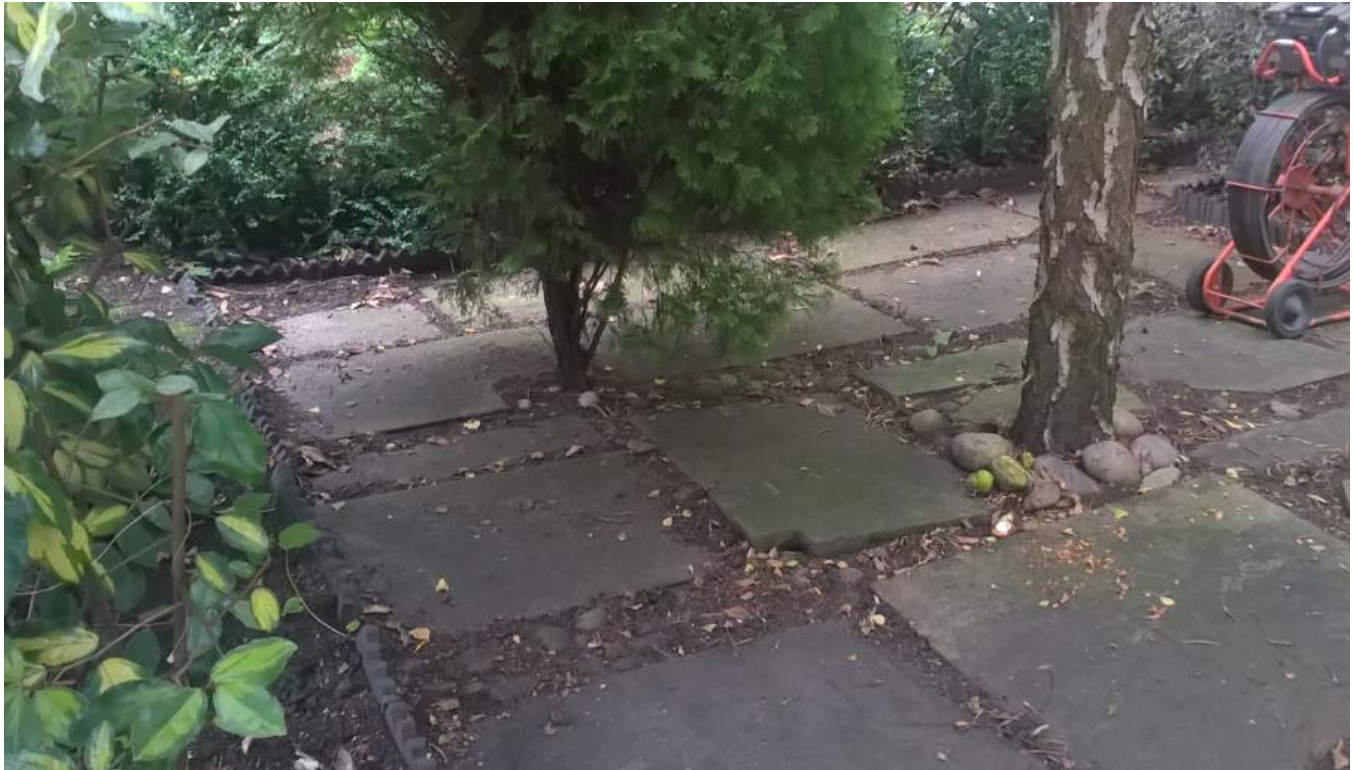
Trees Removed previously – area of excavation is below shrub in centre of picture.

- Excavate to a depth of up to 3 meters at 5.6 meters downstream FMH1 using a digger.
- Excavation will require trench support/shoring to comply with health and safety requirements.
- Remove section of pipe and CCTV downstream to ascertain pipe condition.
- Call from site with findings
- Backfill and reinstate as per current ground conditions (slabing)
- Remove all spoil and waste from site as required.

Please note before the excavation can be completed an arbour culturist will be required to remove trees/shrubbery so the repair can be completed.

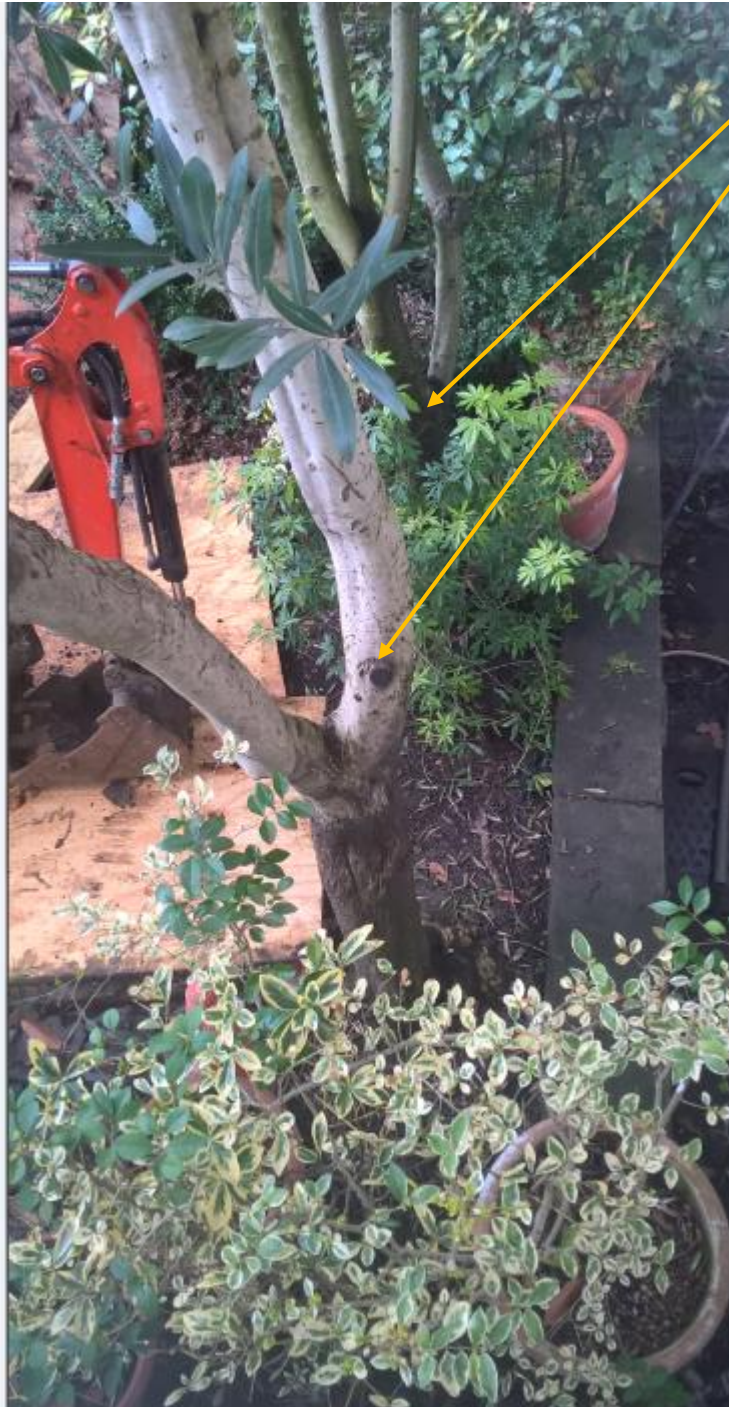
Trees to be removed approx. 7 meters high

Following a site visit by a technical manager it is has been found that for the excavation to be completed 2 trees located above the suspected area of damage will be required to be removed.

Post this an excavation is to be carried at the very rear of the chamber to locate the pipework.

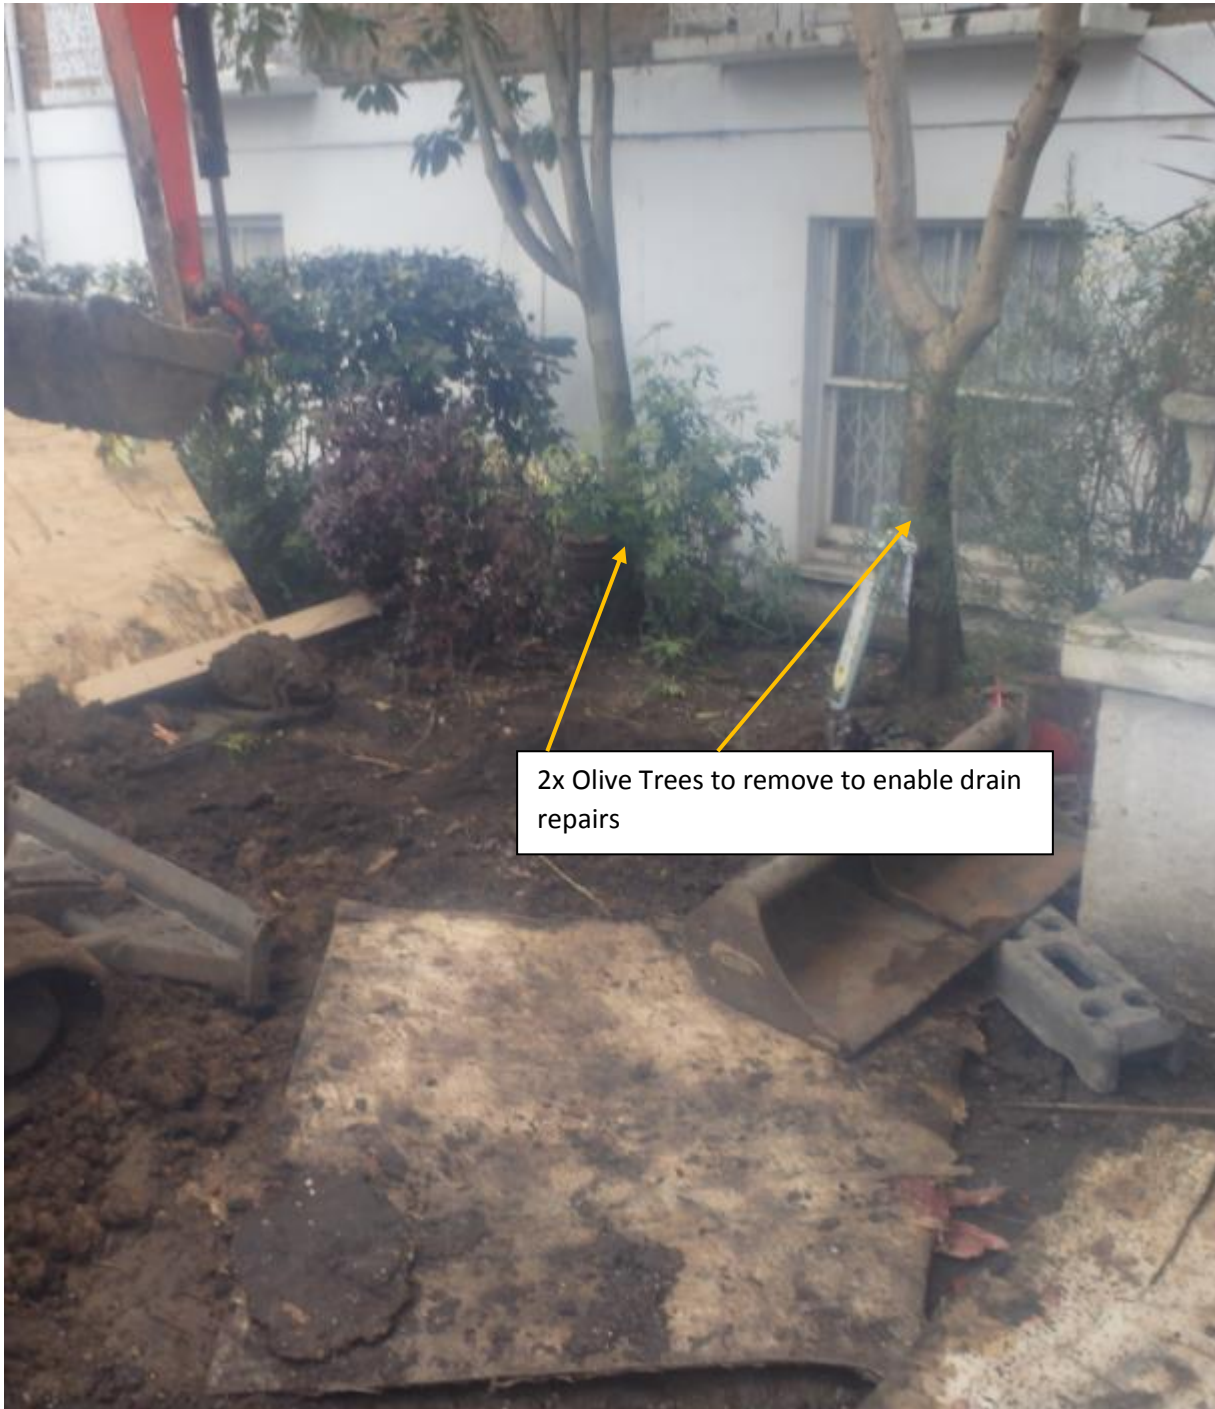
2x Olive Trees to remove to enable drain repairs
