Heritage Statement

Internal Structural and Fabric Repairs, 28 Russell Square

March 2018

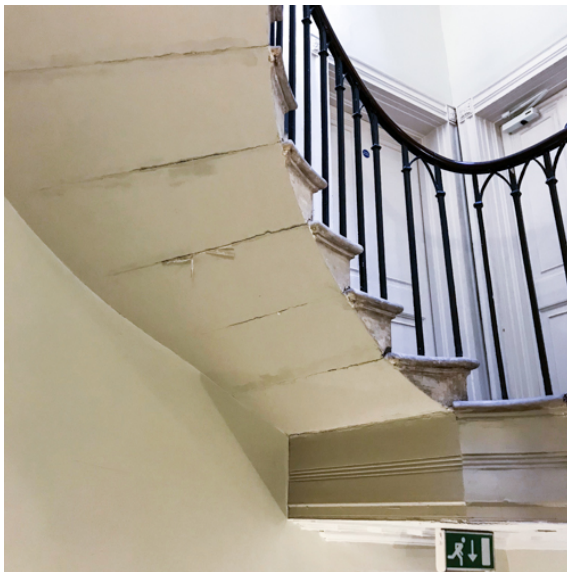
Image 5, View Internal Staircase Damage

The damage to the internal structure of the upper floors comprises settlements within the first, second and third floors, and severe deformation of internal walls, also within the first, second and third floor storeys. The causes of this damage can be summarised as inappropriate removal of internal structural walls, allowing the upper floors and walls to settle downwards.

The approach used to repair the main curved stone staircase has been to replace the existing repair mortar between the existing stone joints with a natural hydraulic lime mortar putty that is rammed into the joints. It is intended that this new mortar will be installed throughout all of the staircase joints and provide a sustainable long term solution that deals with the effectiveness of the wall distortions caused by the inappropriate removal of the lower ground walls within the house, and also possible issues created by the use of other repair mortars used previously. The top step of the upper flight requires a more localised repair, possibly using resin bonded steel dowel bars through the stone and keying into the upper landing structure which is of timber framing. The precise form of these repairs will be the subject of detailed investigation once access and support scaffolding has been installed. However, it is intended that any repairs will not adversely affect the appearance of the upper tread, which is badly separated from the main flight at present.
