ARBORICULTURAL ASSESSMENT REPORT

For:	Client:	Oriel Services Limited
	Insurer:	Prestige Underwriting Services Ltd.
Site:	Policyholder:	Miss Eugenia Hartono & Mr Alexander David Howson
	Risk Address:	88 Albert Street, London, NW1 7NR
Refs:	OCA Ref:	70838
	Client Ref:	6743750
	Insurer Ref:	266664

Arborist Name:	Sorrell Kiamil	Date:	09/03/2018
QC:	Thomas Peppiatt	Date:	15/03/2018

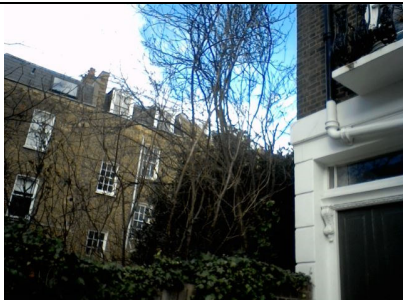
<p>T2 - Lime</p>	<p>T2 - Lime</p>

TP 1 (USF) 10 mm	Tilia spp.
TP1 (USF) 8 mm	Vitaceae spp.
BH1 (1.5-2.2m) 1.5 mm	Fuchsia spp.
BH1 (1.5-2.2m) 1 mm	Vitaceae spp.
BH1 (1.5-2.2m) 1 mm	Tilia spp
BH2 (to 2.8m) 1 mm	Cupressaceae spp.

Tree No:	Species	Works Required
T2	Lime	Fell and treat stump
T3	Cherry	Fell and treat stump
SG1	Mixed Species Shrubs	Fell and treat stump
SG2	Fuscia and Virginia creeper	Fell and treat stump
