**Report Ref: 20640/GC**

Site Address: 15 SOUTHAMPTON PLACE, LONDON WC1A 2AJ

PROTEN SERVICES INSPECTION REPORT

REPORT REF:	20640/GC
CLIENT NAME:	OD INTERIORS LTD
PROPERTY ADDRESS:	15 SOUTHAMPTON PLACE, LONDON WC1A 2AJ
SURVEYOR:	GARY CARTY <i>CSRT CSSW</i>

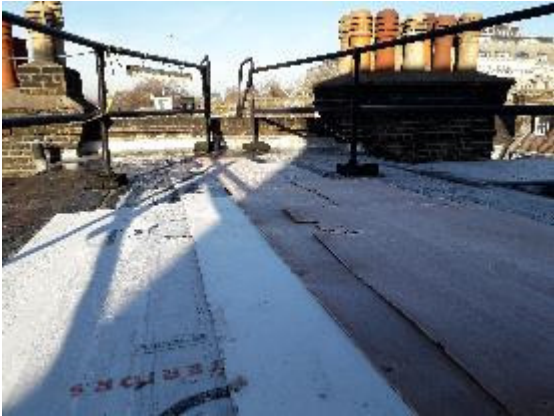
EXTERNAL

The existing flat roof coverings have failed causing significant water ingress.

- Engage a roofer to strip off the existing roof coverings and boards and replace immediately on completion of our works.
- Provide electricity supply.
- Provide clean water.

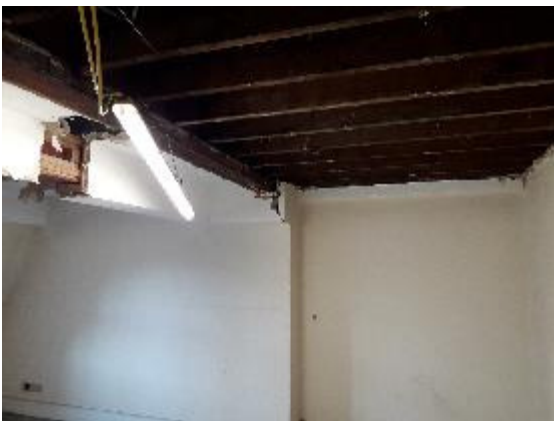
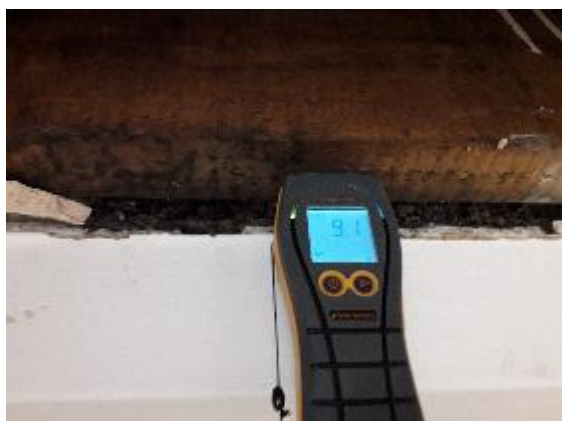
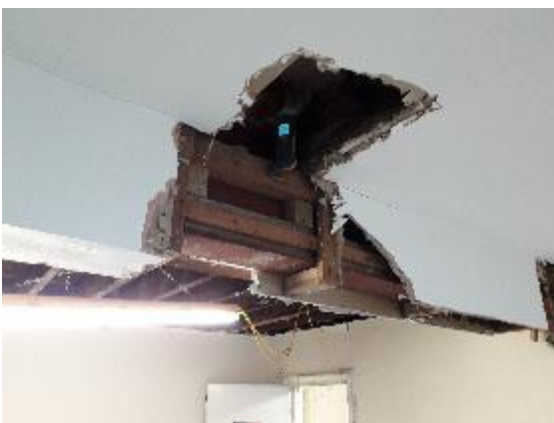
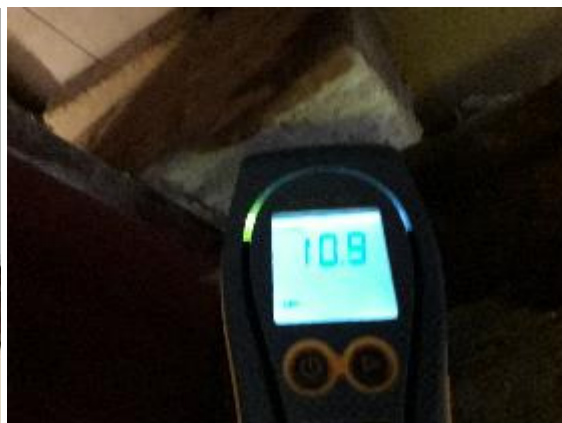
Third Floor Level: Rear Room

Accessible timbers were inspected and whilst stained, no undue moisture readings were noted. There was no visible evidence of attack by Wood Rotting Fungi.

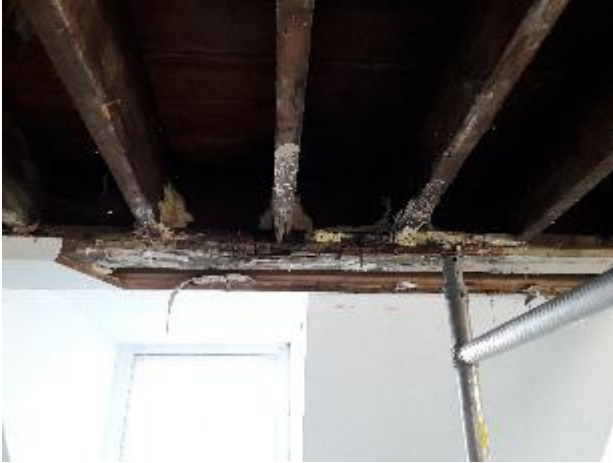
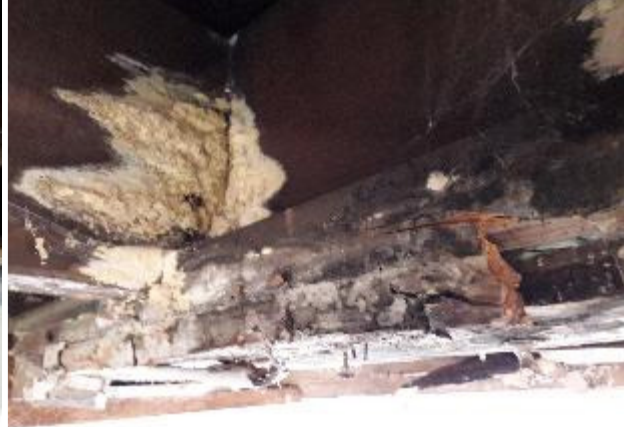
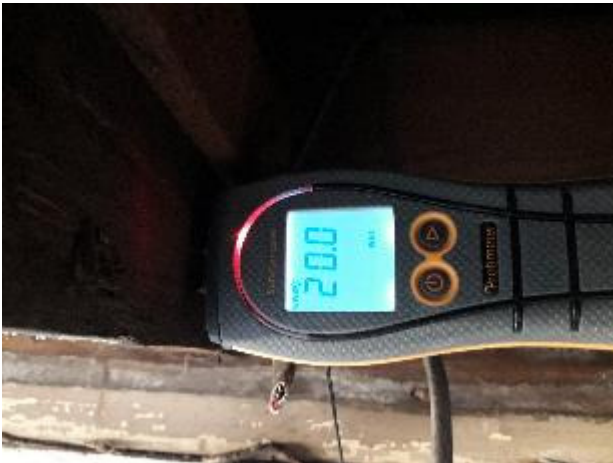
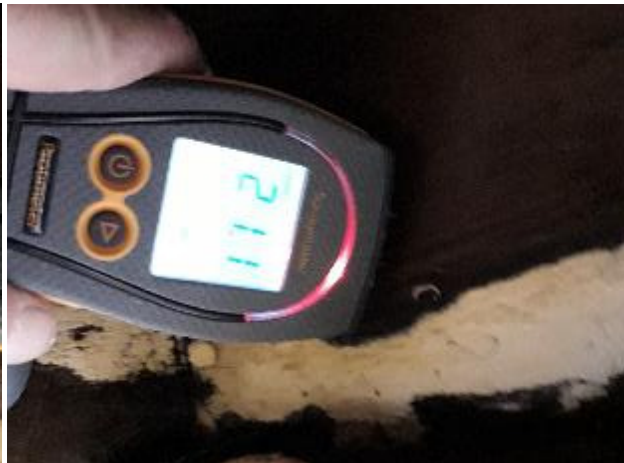
Fourth Floor Level:

Attack by *Serpula lacrymans*, the true dry rot fungus, was seen in the front wall plate and nearby joists. The principal timbers seen to be attacked are shown on this plan. Moisture responsible for this attack appears to be due to rainwater ingress as noted above.

The remaining joists and rear wall plate are highly vulnerable to fungal decay.

Timber that has a moisture content above 18-20% is at risk to fungal attack. Readings above this level were found in the rear wall plate and joists marked for replacement on the attached sketch. Again, the moisture responsible appears to be due to rainwater ingress due to defective roof coverings.

- Provide temporary support to the existing joists and roof timbers.
- Cut out and remove 500mm of each of 32no. Joists ends, and feathered fillets as indicated on the sketch.
- Cut out and remove the front and rear plates as indicated on the sketch.
- Renew the front and rear wall plates ensuring the ends in contact with masonry and on the upright support are wrapped/capped or laid in/on DPC membrane.
- Renew the 32no. joist ends overlapping by 500mm and attached each using 4no. coach bolts and star washers at staggered centres. Replacing fillet by trimming down timber.
- Remove debris from site.

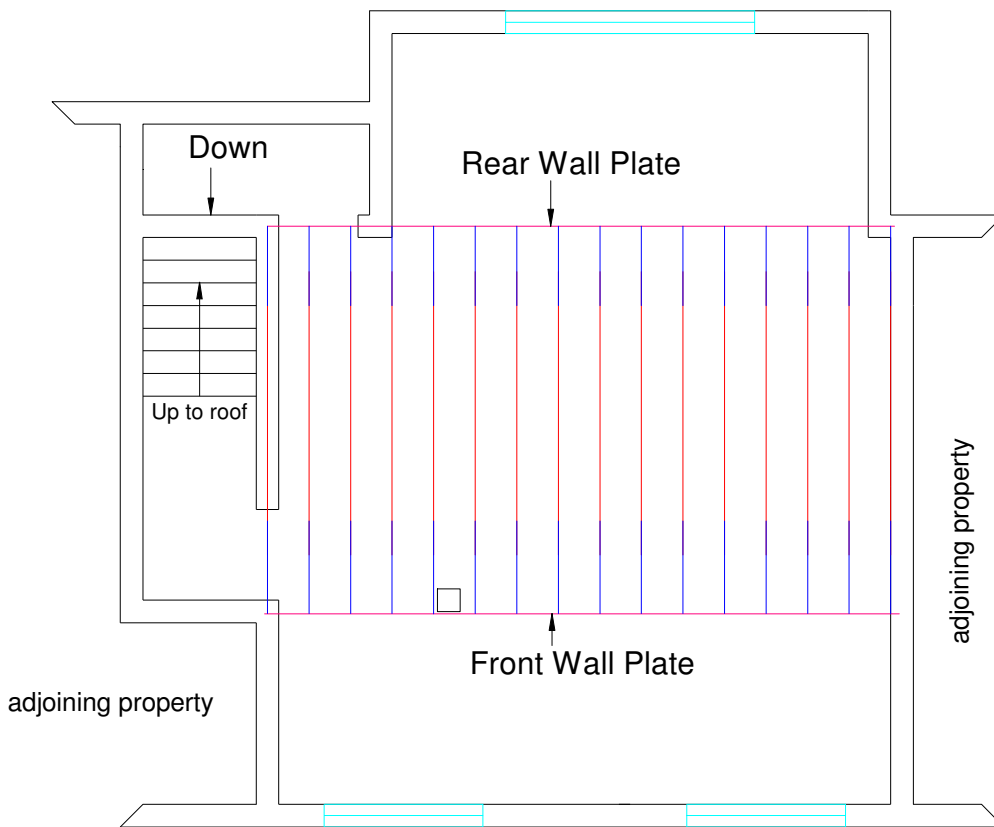
SKETCH

— Existing Joists cut back 500mm at each end

— 2No. Wall Plate 140 x 70

— 32No. joist ends 1m x 250 x 50
plus 100 x 50 x 1m planed down to fillet

Each Joist end to be attached
with 4No. Coach Bolts and star washers
at staggered centres
