APPENDIX C SITE PHOTOGRAPHS AND WALKOVER **CHECKLIST**

PHOTOGRAPHIC LOG

WALKOVER SURVEY CHECKLIST: GEOSCIENCES

Mount Pleasant, Phoenix Place

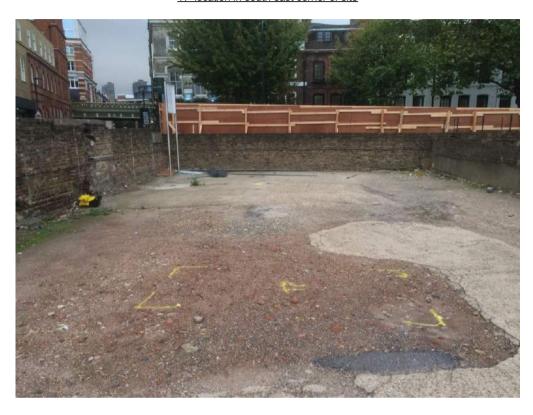
TP location in south east corner of site

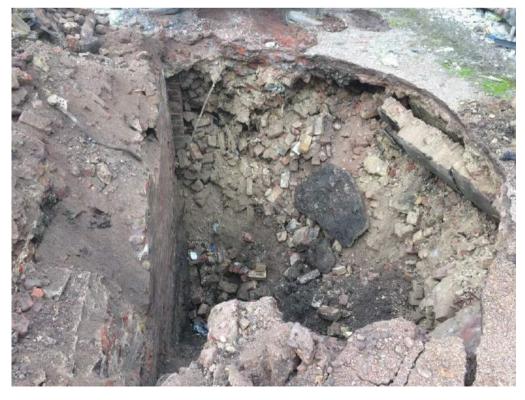
View to north west pit side

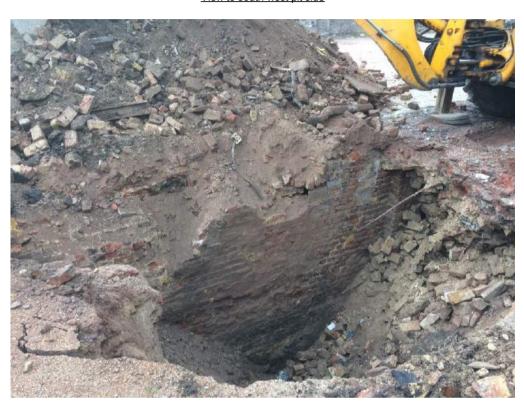
View to south west pit side

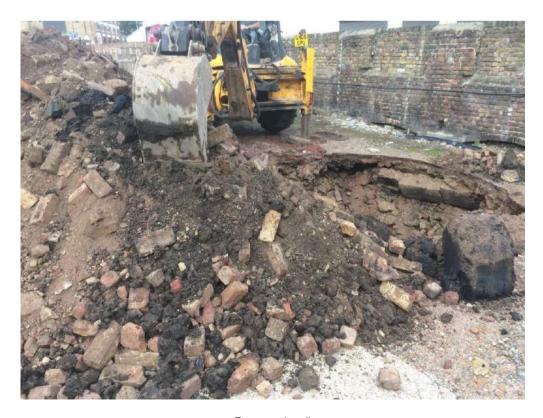
Recovered spoil

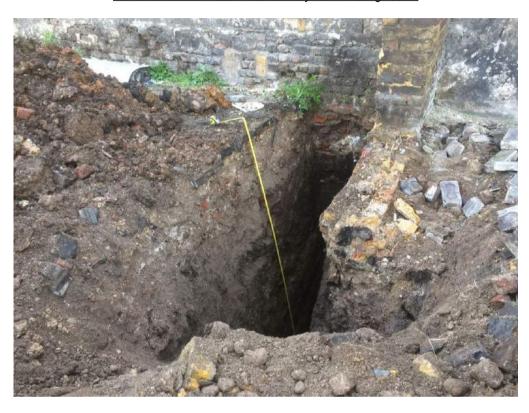
View towards south western site boundary wall with Gough Street

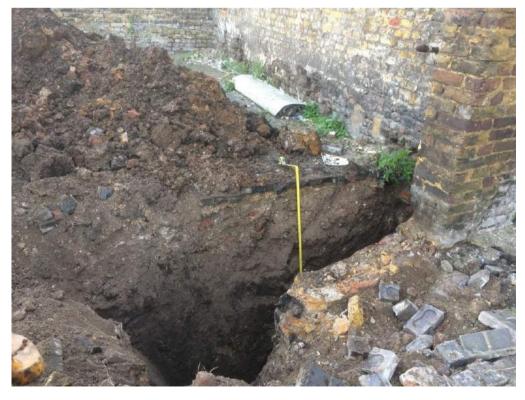
Southern (south eastern) pit side

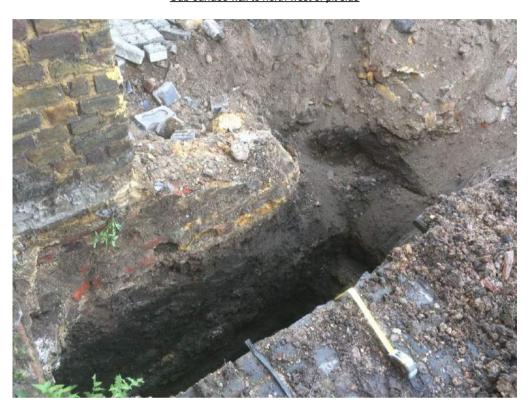
Sub-surface wall to north west of pit side

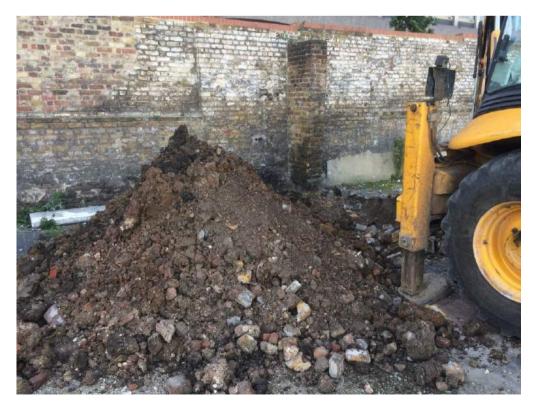
Recovered spoil

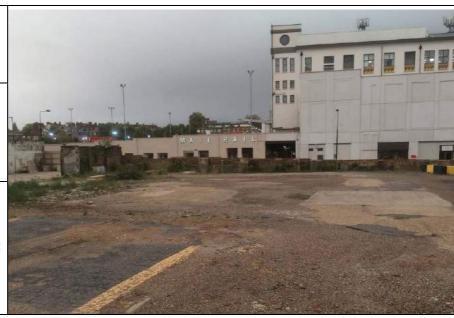
1

View east from centre of the site towards Royal Mail Mount Pleasant (Calthrope) site and Mail Rail Museum.

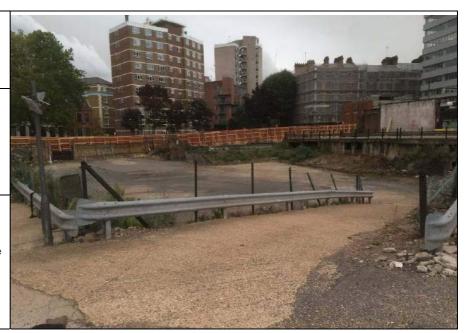
2

View towards the south western corner of the site, the lower southern section of the site is accessed by a ramp.

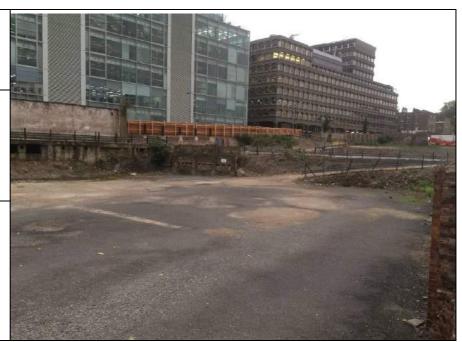
3

View of the site towards north western corner from south eastern corner. The lower southern section of the site is shown.

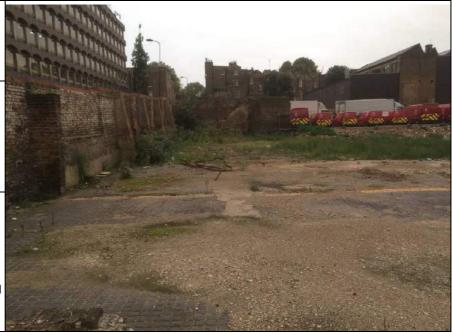
View of the site towards north western corner along western boundary. The retaining wall is shown on the western site boundary between the site and Gough Street. Small areas of the site are partially vegetated.

Features	Description		Map ref.
d) Describe the site in terms of ground slopes and changes in slope. Is there any evidence of subsidence or landslip/slope erosion? Old scarps or hummocky ground may be evidence of previous landslips that could be reactivated. A terraced appearance may be indicative of superficial solifluction movement or cambering. Trees that are leaning may indicate instability or general slope movement.	The southern section of the site is lower than the north (change in elevation approx 2m). It is accessed from a ramp in the centre of the site. To the west of this area there is a raised platform former used for parking constructed of a concrete slab and beams. A retaining structure is present at the western boundary along Gough Street, its height varying between 1 m and 3 m.	2, 3, 4

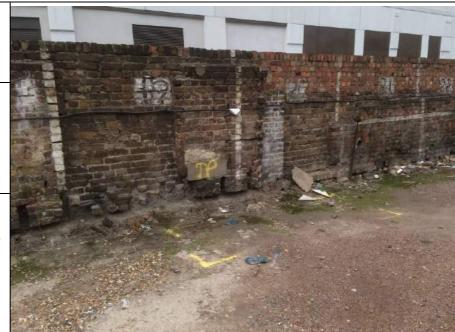
View along eastern boundary. The wall is in poor condition.

g) Describe any evidence of animal activity. For example obvious animal paths or areas of excavations and burrows.	N/A		
h) Describe any damage to existing structures on site or adjacent to the site For example, cracks in buildings both on the site and in the neighbourhood, and other evidence of settlement or differential settlement. Note presence of any suspected asbestoscontaining materials (ACM)	The wall bounding the east of the site appears to be in poor condition with a number loose bricks visible.	5

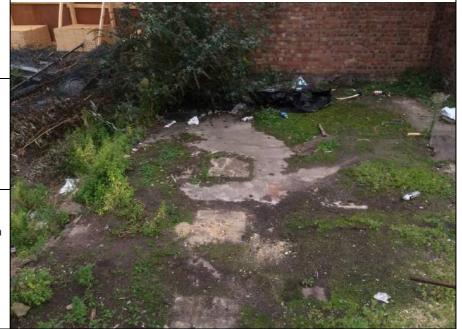
6

View of possible interceptor in south western corner of the site.

w) Identify any old structures, pipework etc. wherever possible and, if safe, inspect for evidence of stored waste. Old tanks may contain oil. Old electricity transformers should be noted. Asbestos risk should be assessed together with the need for a specialist hazardous materials survey. 	There appears to be a former interceptor tank located in the south western corner of the site.	6,7

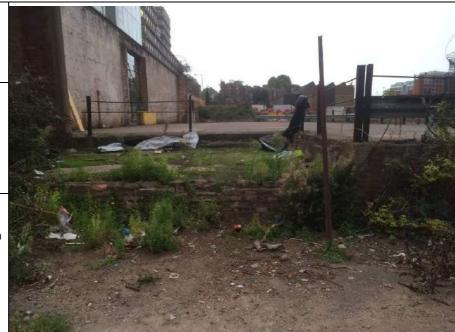
7

View of possible interceptor in south western corner of the site.

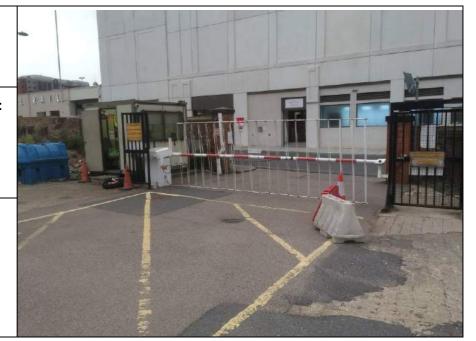
8

Access to site from Phoenix Place.
