Demolition / Refurbishment Asbestos Survey Report

Former Pub

317 – 319 Finchley Rd

27th January 2016

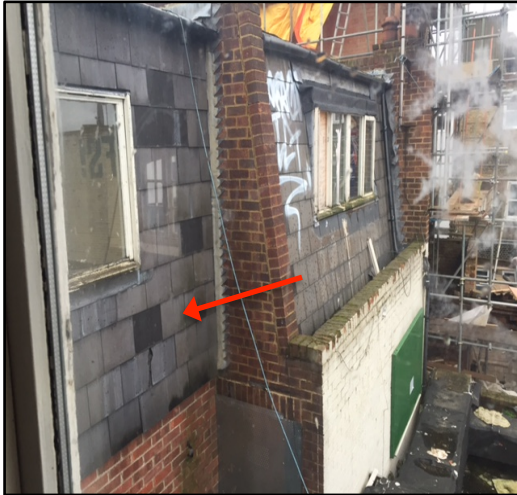
Sample Ref: B01

Location: High Level, External

Material Sampled: Asbestos Cement slate tiles to roof elevations

Analysis Result: **Chrysotile (white) Asbestos**

Approximate Quantity: 60 Sqm

Condition: **Good Condition**

Material Assessment Score: **3**

Damage has occurred resulting in roof slate debris to the floor of the rear elevation.

Remarks / Recommendations: Remove.

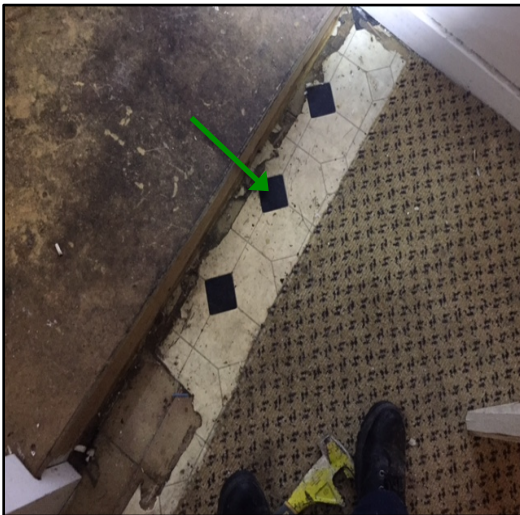
Sample Ref: B02

Location: 2nd Floor, Stairs to 3rd Floor

Material Sampled: Floor lino

Analysis Result: **No Asbestos Detected**

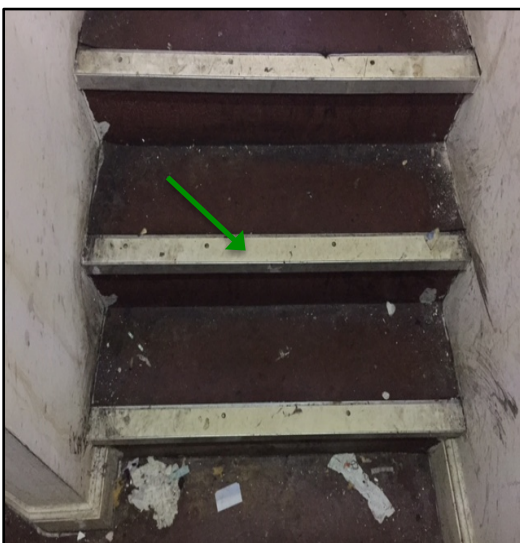
Sample Ref: B03

Location: Stairwell, 1st Floor to 2nd Floor

Material Sampled: Nosing strips to steps

Analysis Result: **No Asbestos Detected**

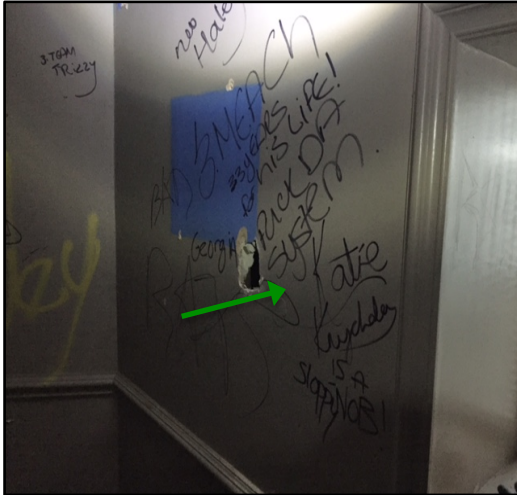
Sample Ref: B04

Location: Throughout Pub Areas (LGF, GF & 1st)

Material Sampled: Fibrous plasterboard to walls

Analysis Result: **No Asbestos Detected**

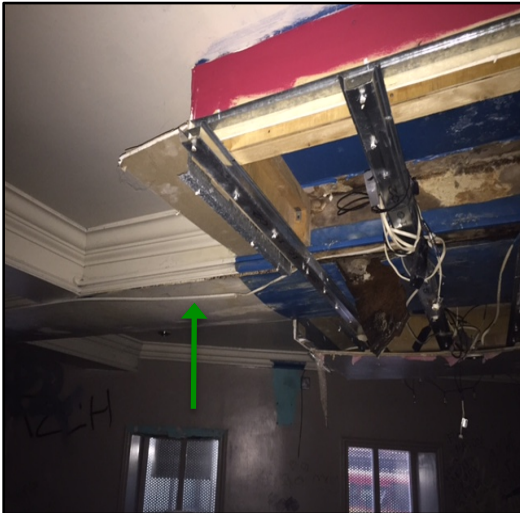
Sample Ref: B05

Location: Throughout Pub Areas (LGF, GF & 1st)

Material Sampled: Fibrous plasterboard to ceilings

Analysis Result: **No Asbestos Detected**

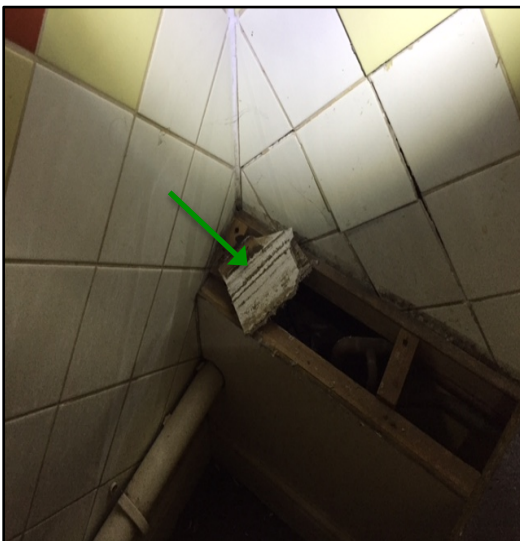
Sample Ref: B06

Location: 1st Floor, Gents WC

Material Sampled: Loose panel in boxing

Analysis Result: **No Asbestos Detected**

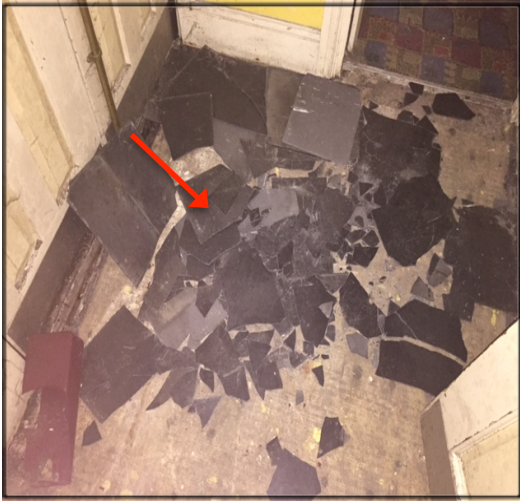
Sample Ref: B07

Location: 1st Floor, Lobby adj Ladies WC

Material Sampled: Asbestos Cement roof slate debris to floor

Analysis Result: **Chrysotile (white) Asbestos**

Approximate Quantity: 3 Sqm

Condition: **High Damage**

Material Assessment Score: **6**

Remarks / Recommendations: Remove.

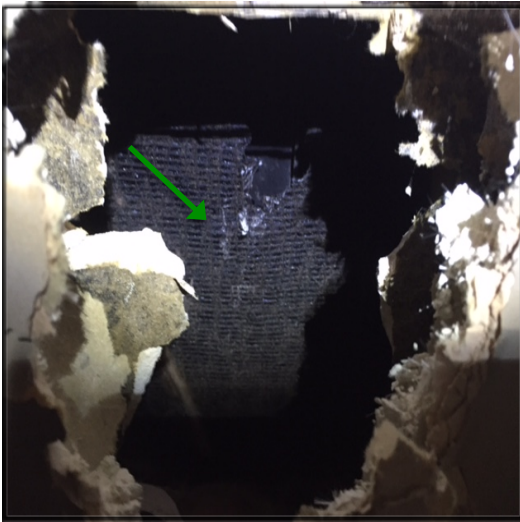
Sample Ref: B08

Location: 1st & 2nd Floor, Roof Line

Material Sampled: Bitumen lining to roof

Analysis Result: **No Asbestos Detected**

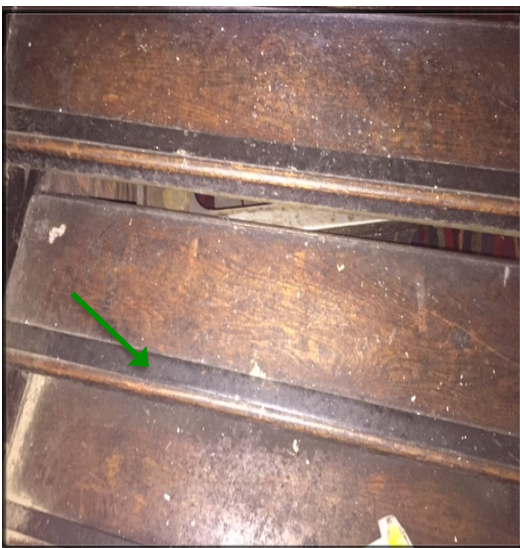
Sample Ref: B09

Location: Stairwell, GF to LGF

Material Sampled: Nosing strips to steps

Analysis Result: **No Asbestos Detected**

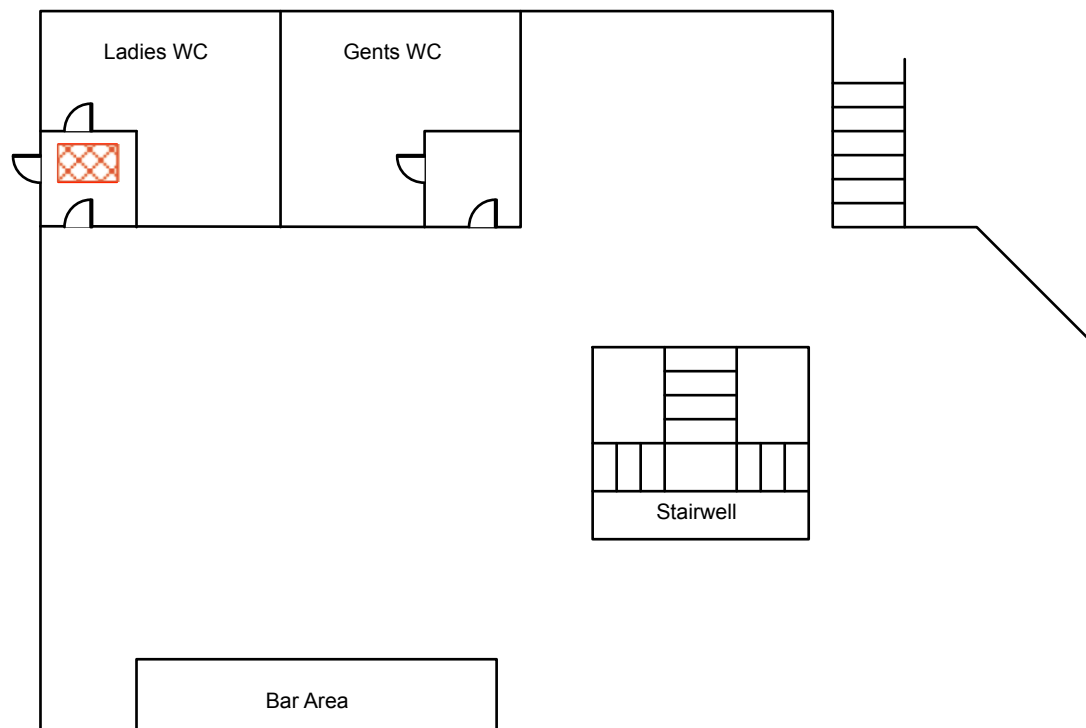
1st Floor
317-319 Finchley Rd
London

Asbestos Cement roof
slate debris

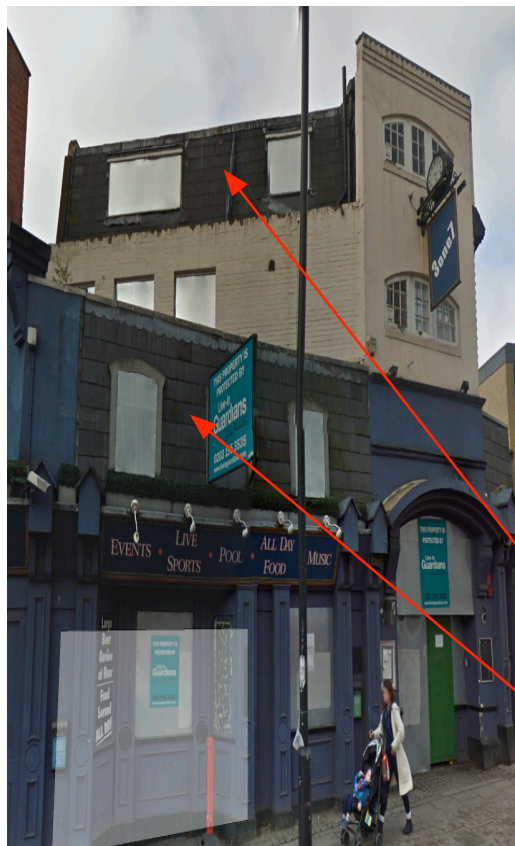
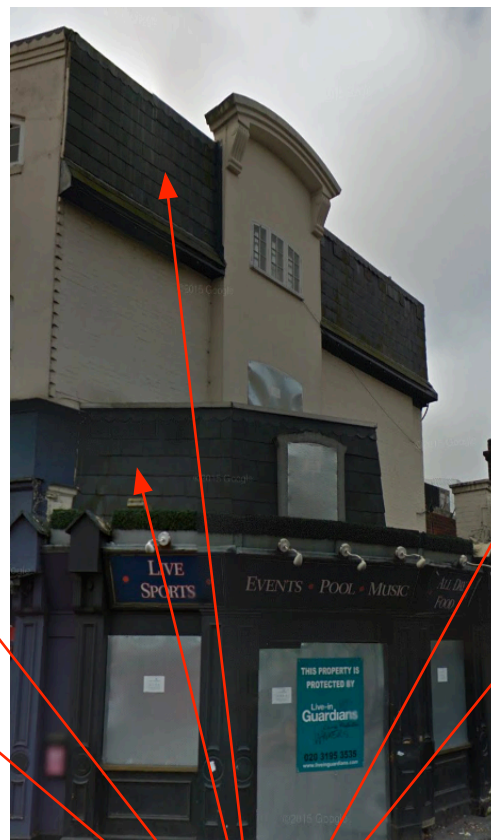
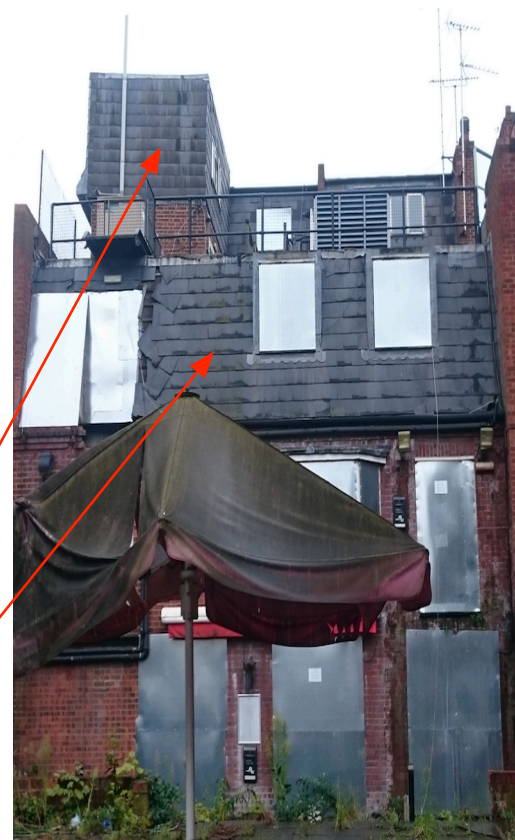
External
317-319 Finchley Rd
London

Asbestos Cement slates to roof elevations
