For the attention of Mr. Tulloch,  
with reference to planning application 2017/4622/p  
At 58 Grafton Road NW5 3DY

**Anthony Fieldhouse & Co**  
CHARTERED BUILDING SURVEYORS

**58 Grafton Road, London NW5 3DY – Dangerous Structure**  
**Provisional Date for Inspection – 1 or 2 July 2014**

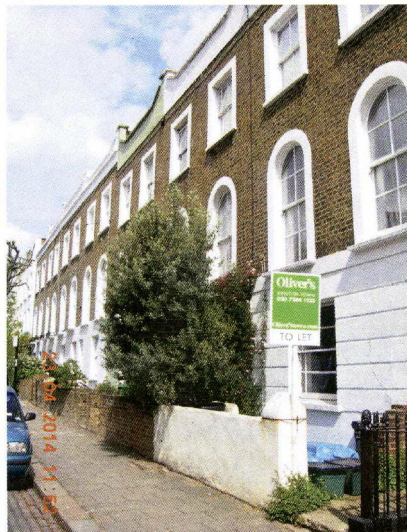
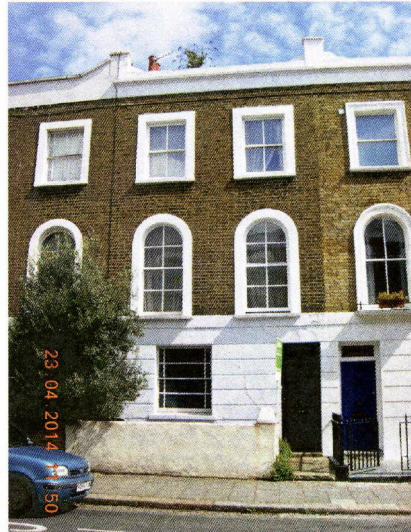
1. 58 Grafton Road. No 60 is the house to the left.

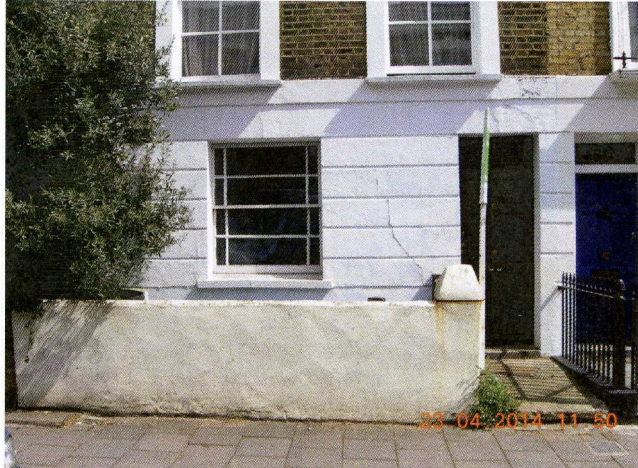
4.

Externally there are diagonal cracks across the front of the building at ground floor level.

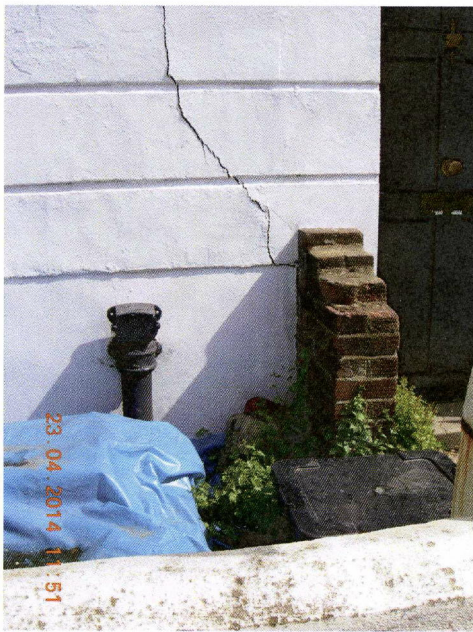
5.

*Front wall of 58 Grafton Road*

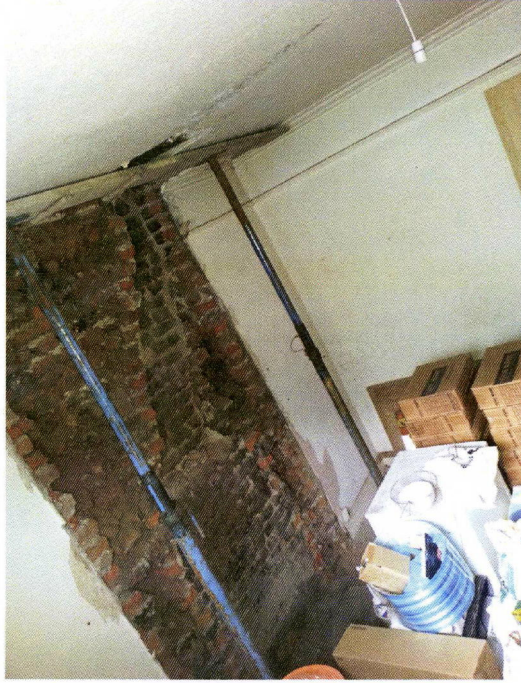
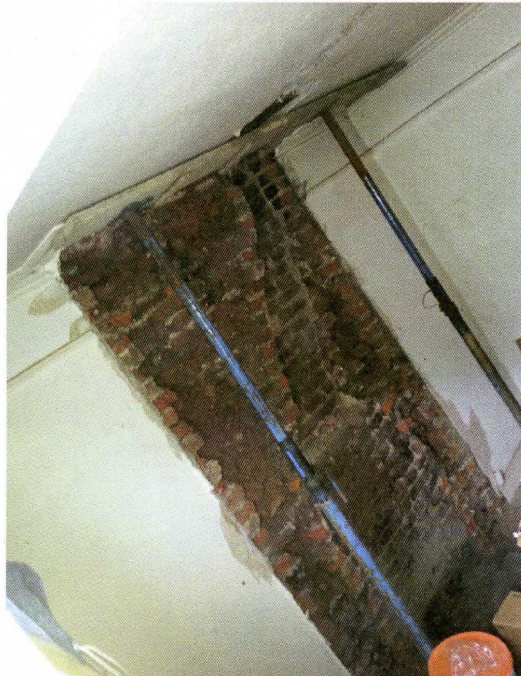
58 Grafton Road. <sup>7</sup>Ground floor chimney breast on party wall shared with 60 Grafton Road

Clearly, some work has taken place but appears to have been abandoned, leaving the property, and [REDACTED], in a potentially dangerous condition.
