Refurbishment Survey

102 Parkway
NW1 7AN

Inspectas Compliance Ltd

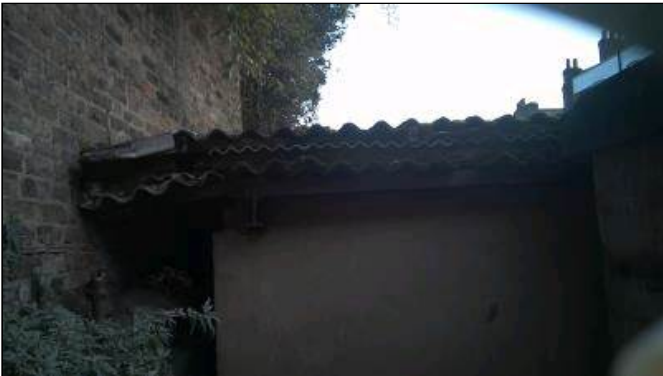
Survey Date:	Lead Surveyor	Survey Type	Floor	Analysis
	23 Feb 2018	Craig Candlish	Refurbishment Survey	Ground Floor	Chrysotile (1)
	Building	Room	Item	Quantity	
	Back of Number 102	Lounge Diner - G01	Corrugated cement roof to the main building	46m ²	
	Sample No (S,SP,P,As)	Product Type	Surface Treatment	Condition	Accessibility
	S AS000041	Asbestos Cement (1)	Surface Sealed (1)	Medium Damage (2)	Routinely disturbed
	Material Risk Score				
Recommended action		Remove			
Surveyor comments		The area of the roof is based on the visible upper layer of the cement. There are numerous layers below which are only visible from the rear of the dry cleaners. To obtain an accurate cost for the removal of the cement, it is strongly recommended that a site visit is undertaken by the contractor to obtain an accurate cost.

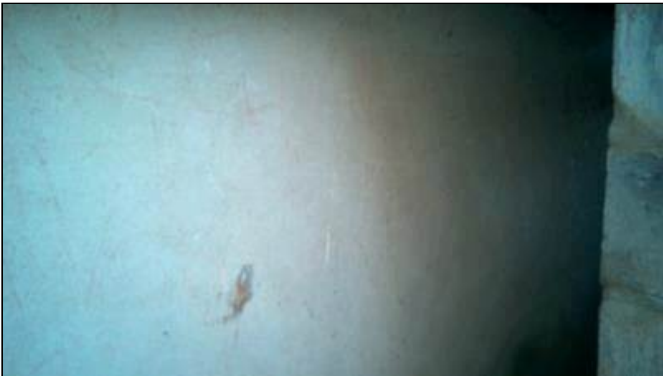
Survey Date:	Lead Surveyor	Survey Type	Floor	Analysis
	23 Feb 2018	Craig Candlish	Refurbishment Survey	Ground Floor	N/A
	Building	Room	Item	Quantity	
	Back of Number 102	Lounge Diner - G01	Block and render walls to be removed	N/A	
	Sample No (S,SP,P,As)	Product Type	Surface Treatment	Condition	Accessibility
	N/A	N/A	N/A	N/A	N/A
	Material Risk Score				
Recommended action		No further action required			
Surveyor comments		N/A

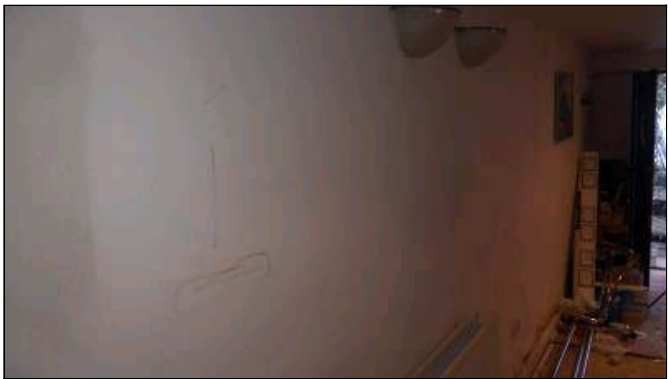
Survey Date:	Lead Surveyor	Survey Type	Floor	Analysis
	23 Feb 2018	Craig Candlish	Refurbishment Survey	Ground Floor	N/A
	Building	Room	Item	Quantity	
	Back of Number 102	Lounge Diner - G01	Refurb location: Block and plaster walls	N/A	
	Sample No (S,SP,P,As)	Product Type	Surface Treatment	Condition	Accessibility
	N/A	N/A	N/A	N/A	N/A
	Material Risk Score				
	N/A				
Recommended action		No further action required			
Surveyor comments		N/A

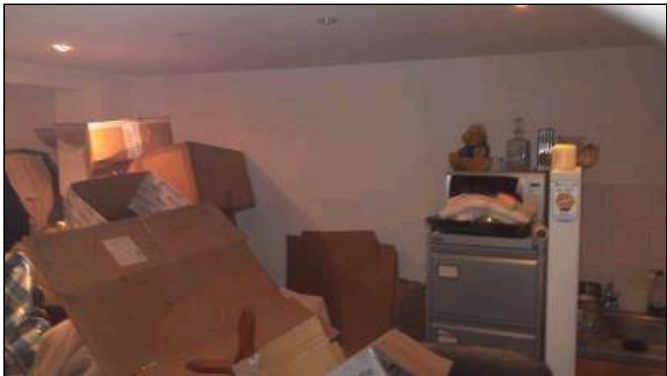
Survey Date:	Lead Surveyor	Survey Type	Floor	Analysis
	23 Feb 2018	Craig Candlish	Refurbishment Survey	Ground Floor	N/A
	Building	Room	Item	Quantity	
	Back of Number 102	Lounge Diner - G01	Refurb location: Block and plaster walls	N/A	
	Sample No (S,SP,P,As)	Product Type	Surface Treatment	Condition	Accessibility
	N/A	N/A	N/A	N/A	N/A
	Material Risk Score				
	N/A				
Recommended action	No further action required				
Surveyor comments	N/A

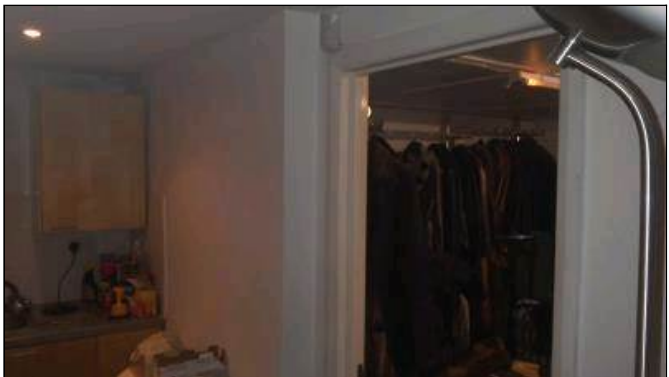
Survey Date:	Lead Surveyor	Survey Type	Floor	Analysis
	23 Feb 2018	Craig Candlish	Refurbishment Survey	Ground Floor	N/A
	Building	Room	Item	Quantity	
	Back of Number 102	Lounge Diner - G01	Refurb location: Plasterboard partition	N/A	
	Sample No (S,SP,P,As)	Product Type	Surface Treatment	Condition	Accessibility
	N/A	N/A	N/A	N/A	N/A
	Material Risk Score				
	N/A				
Recommended action		No further action required			
Surveyor comments		N/A

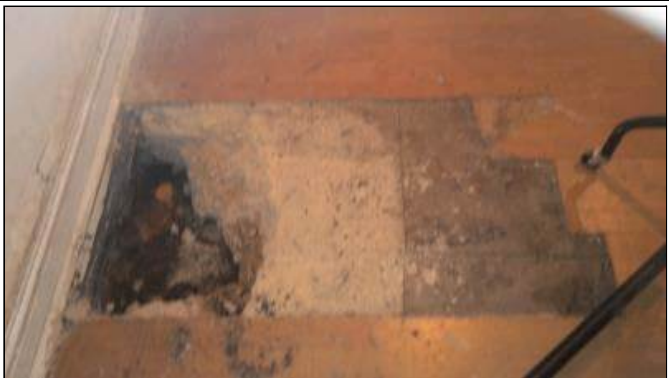
Survey Date:	Lead Surveyor	Survey Type	Floor	Analysis
	23 Feb 2018	Craig Candlish	Refurbishment Survey	Ground Floor	N/A
	Building	Room	Item	Quantity	
	Back of Number 102	Lounge Diner - G01	Refurb location: Concrete floor	N/A	
	Sample No (S,SP,P,As)	Product Type	Surface Treatment	Condition	Accessibility
	N/A	N/A	N/A	N/A	N/A
	Material Risk Score				
	N/A				
Recommended action		No further action required			
Surveyor comments		N/A

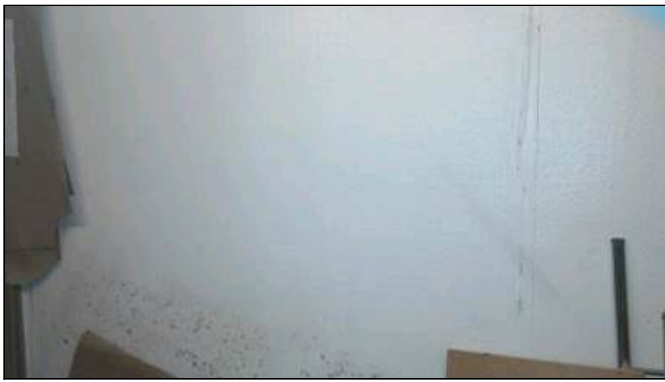
Survey Date:	Lead Surveyor	Survey Type	Floor	Analysis
	23 Feb 2018	Craig Candlish	Refurbishment Survey	Ground Floor	N/A
	Building	Room	Item	Quantity	
	Back of Number 102	Store Room - G02	Refurb location: Wood walls	N/A	
	Sample No (S,SP,P,As)	Product Type	Surface Treatment	Condition	Accessibility
	N/A	N/A	N/A	N/A	N/A
	Material Risk Score				
	N/A				
Recommended action		No further action required			
Surveyor comments		N/A

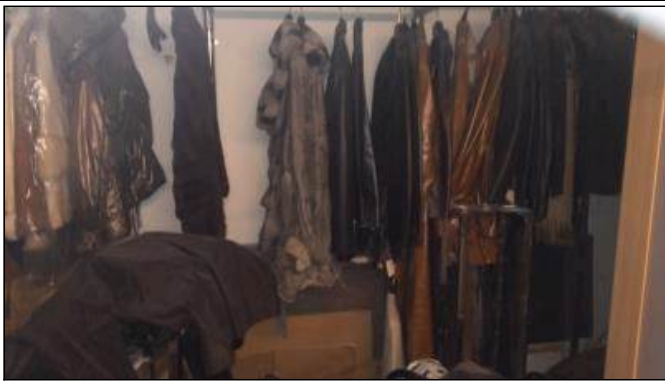
Survey Date:	Lead Surveyor	Survey Type	Floor	Analysis
	23 Feb 2018	Craig Candlish	Refurbishment Survey	Ground Floor	N/A
	Building	Room	Item	Quantity	
	Back of Number 102	Store Room - G02	Refurb location: Block and plaster walls to the rear of wood partitions.	N/A	
	Sample No (S,SP,P,As)	Product Type	Surface Treatment	Condition	Accessibility
	N/A	N/A	N/A	N/A	N/A
	Material Risk Score				
	N/A				
Recommended action	No further action required				
Surveyor comments	N/A

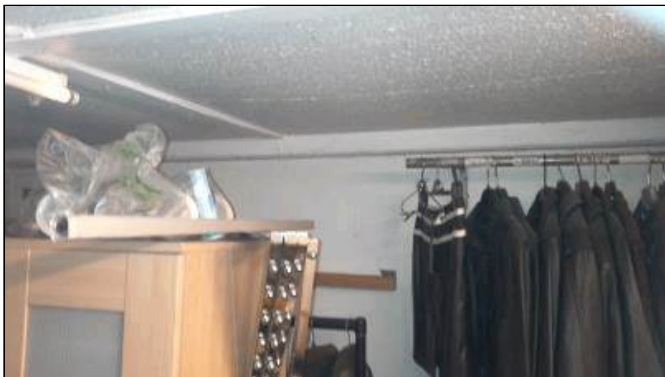
Survey Date:	Lead Surveyor	Survey Type	Floor	Analysis
	23 Feb 2018	Craig Candlish	Refurbishment Survey	Ground Floor	N/A
	Building	Room	Item	Quantity	
	Back of Number 102	Store Room - G02	Refurb location: Block and plaster walls	N/A	
	Sample No (S,SP,P,As)	Product Type	Surface Treatment	Condition	Accessibility
	N/A	N/A	N/A	N/A	N/A
	Material Risk Score				
N/A					
Recommended action	No further action required				
Surveyor comments	N/A

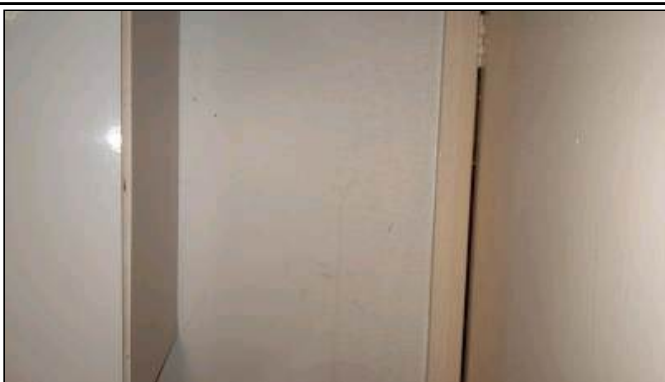
Survey Date:	Lead Surveyor	Survey Type	Floor	Analysis
	23 Feb 2018	Craig Candlish	Refurbishment Survey	Ground Floor	N/A
	Building	Room	Item	Quantity	
	Back of Number 102	Store Room - G02	Refurb location: Plasterboard partition	N/A	
	Sample No (S,SP,P,As)	Product Type	Surface Treatment	Condition	Accessibility
	N/A	N/A	N/A	N/A	N/A
	Material Risk Score				
	N/A				
Recommended action		No further action required			
Surveyor comments		N/A

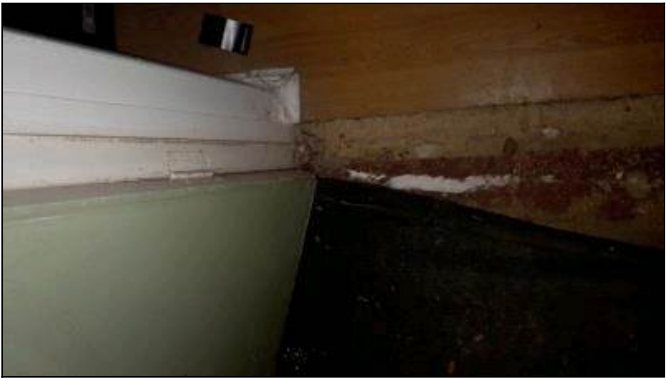
Survey Date:	Lead Surveyor	Survey Type	Floor	Analysis
	23 Feb 2018	Craig Candlish	Refurbishment Survey	Ground Floor	N/A
	Building	Room	Item	Quantity	
	Back of Number 102	Store Room - G02	Refurb location: Concrete floor	N/A	
	Sample No (S,SP,P,As)	Product Type	Surface Treatment	Condition	Accessibility
	N/A	N/A	N/A	N/A	N/A
	Material Risk Score				
Recommended action		No further action required			
Surveyor comments		N/A

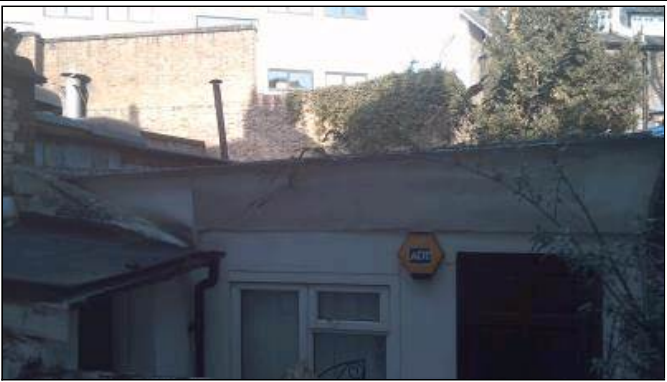
Survey Date:	Lead Surveyor	Survey Type	Floor	Analysis
	23 Feb 2018	Craig Candlish	Refurbishment Survey	External	Chrysotile (1)
	Building	Room	Item	Quantity	
	Back of Number 102	External - E01	Corrugated cement roof [Numerous layers]	46m ²	
	Sample No (S,SP,P,As)	Product Type	Surface Treatment	Condition	Accessibility
	As AS000041	Asbestos Cement (1)	Surface Sealed (1)	High Damage (3)	Routinely disturbed
	Material Risk Score				
Recommended action		Inspection required			
Surveyor comments		The area of the roof is based on the visible upper layer of the cement. There are numerous layers below which are only visible from the rear of the dry cleaners. To obtain an accurate cost for the removal of the cement, it is strongly recommended that a site visit is undertaken by the contractor to obtain an accurate cost.

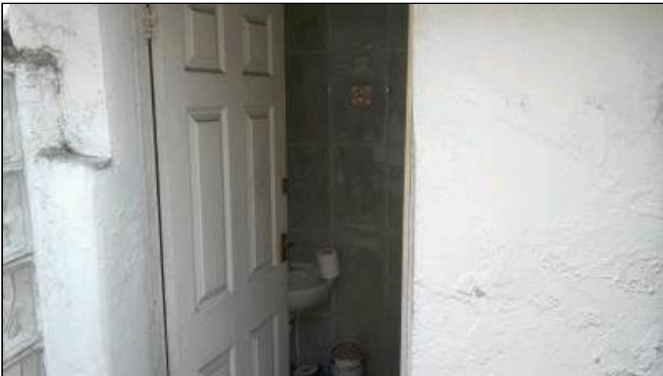
Survey Date:	Lead Surveyor	Survey Type	Floor	Analysis
	23 Feb 2018	Craig Candlish	Refurbishment Survey	External	N/A
	Building	Room	Item	Quantity	
	Back of Number 102	External - E01	Plasterboard ceiling in external store, block walls, solid floor with ceramic tiles.	N/A	
	Sample No (S,SP,P,As)	Product Type	Surface Treatment	Condition	Accessibility
	N/A	N/A	N/A	N/A	N/A
	Material Risk Score				
Recommended action		No further action required			
Surveyor comments		N/A

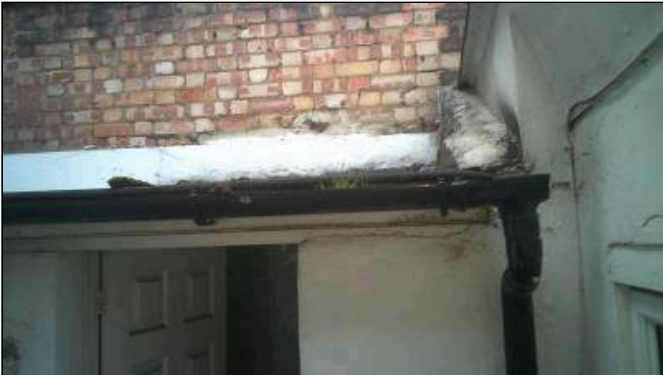
Survey Date:	Lead Surveyor	Survey Type	Floor	Analysis
	23 Feb 2018	Craig Candlish	Refurbishment Survey	External	N/A
	Building	Room	Item	Quantity	
	Back of Number 102	External - E01	Modern roof to bitumen to roof	N/A	
	Sample No (S,SP,P,As)	Product Type	Surface Treatment	Condition	Accessibility
	N/A	N/A	N/A	N/A	N/A
	Material Risk Score				
Recommended action		No further action required			
Surveyor comments		N/A
