# TECHNICAL REPORT ON A SUBSIDENCE CLAIM

Crawford Reference: SU1604340

14 Parsifal Road  
London  
NW6 1UH

**SUBSIDENCE CLAIM**

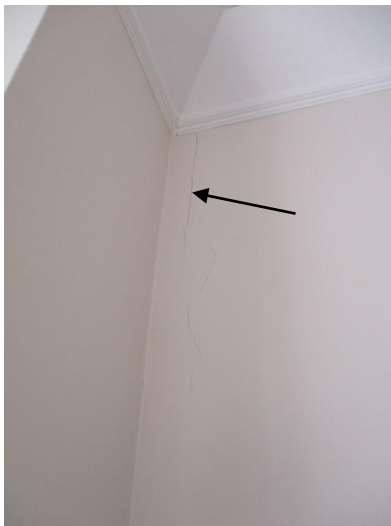
Cracking in flat 1 front bedroom

**Flat 1 Front Right Hand Bedroom** - 1mm vertical crack on communal hall partition by front wall, cracking to ceiling across bay window.

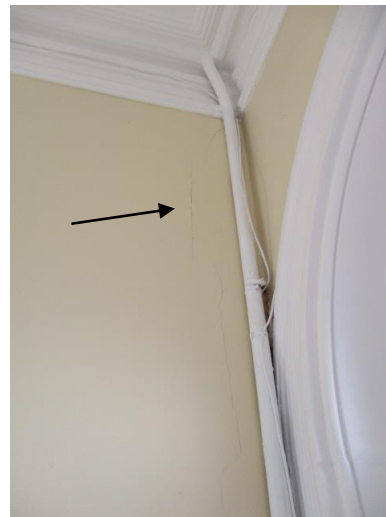
Cracking in communal entrance hall

**Communal Entrance Hall** - 1mm vertical crack to flat 1 partition by front door, cracking to coving along front wall.

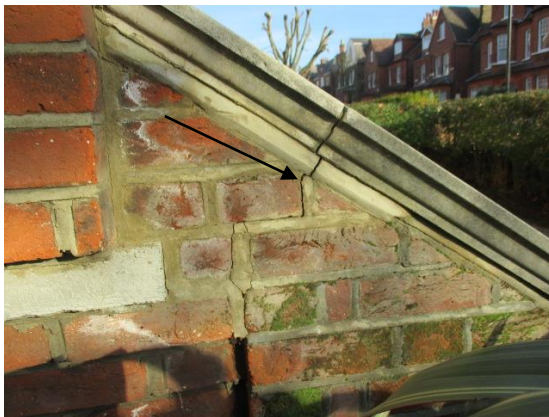
Cracking to left hand side of steps

**Front Steps** - 4mm stepped crack to left hand wall, 2mm stepped crack to left hand side porch wall, 6mm separation at right hand step wall junction with main house.

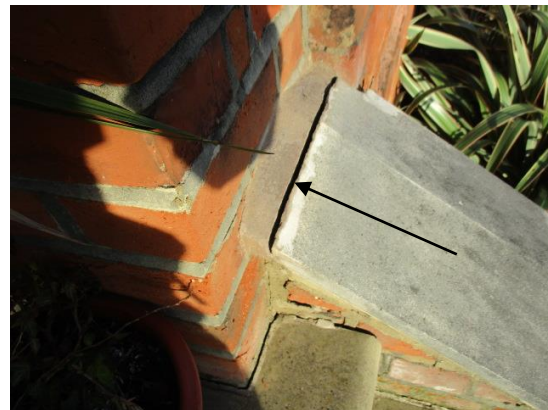
Cracking to right hand side of steps

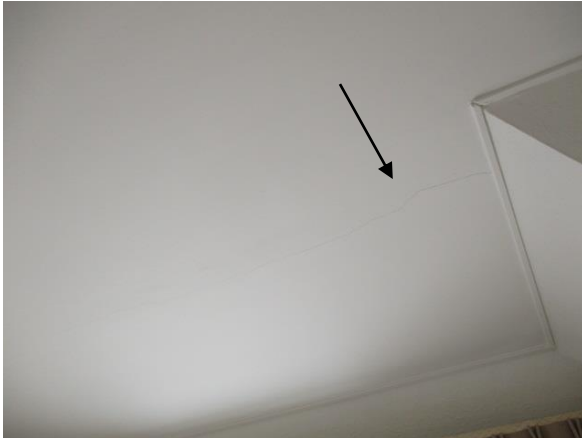
Cracking in flat 1 front bedroom

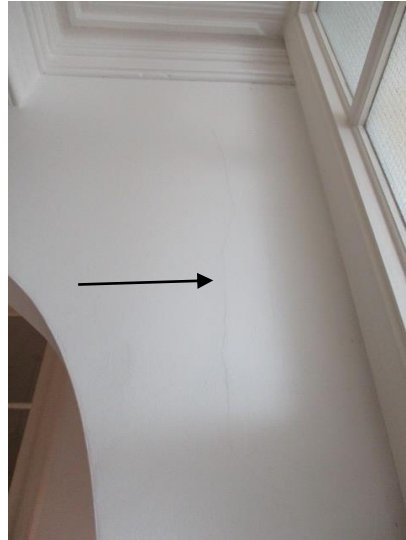
**Hallway** - 1mm vertical crack to right hand side of door to front bedroom, cracking to ceiling.

Cracking in flat 1 hallway

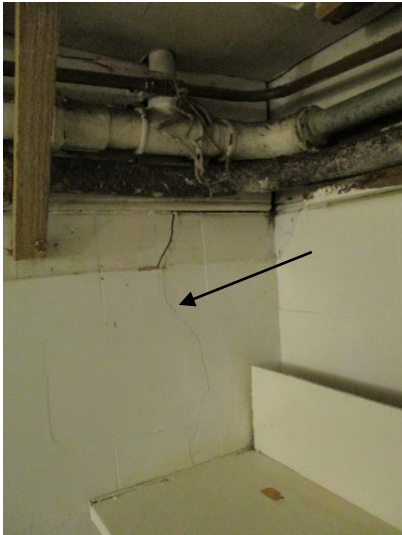
**Basement Utility Room** - 3mm diagonal crack to left hand wall.

Cracking in flat 1 utility room

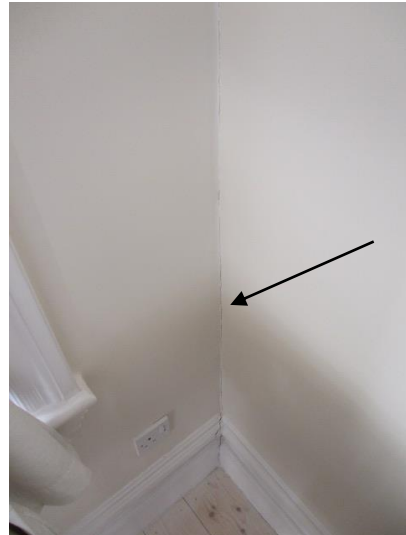
**Flat 3 - Lounge** - 1mm vertical crack down junction of kitchen partition and front wall.

Cracking in flat 3 lounge

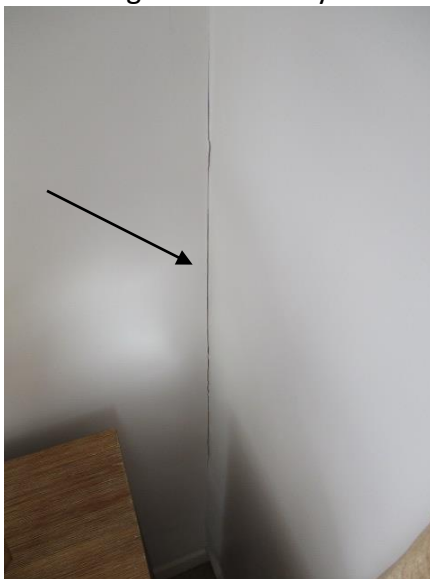
**Front Bedroom** - 1mm vertical crack down junction of kitchen partition and front wall, hairline vertical crack below front window.

Cracking in flat 3 front bedroom

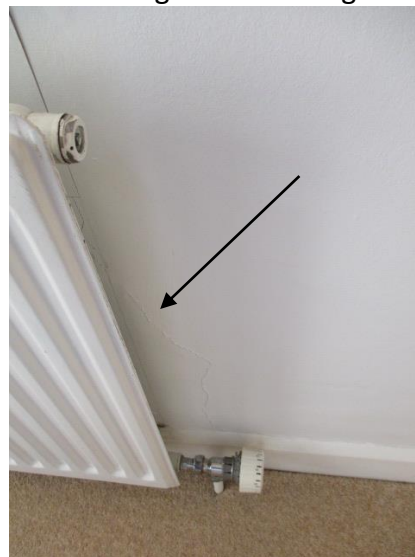
Cracking in flat 3 front bedroom

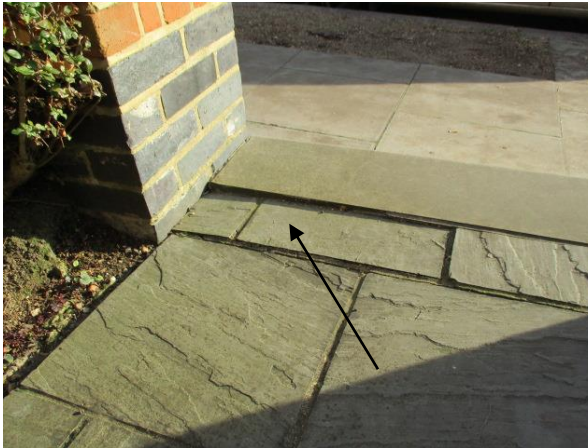
**Front Garden Area** - Movement to entrance step and cracking and movement to slabs forming front path.

View of movement to front step

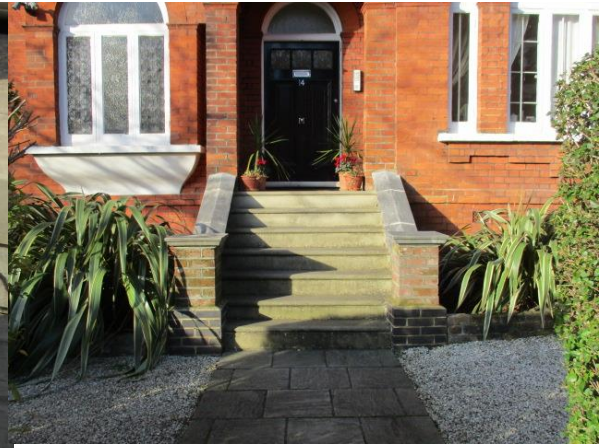
View of steps
