Arboricultural Appraisal Report

Subsidence Damage Investigation at:

14 Parsifal Road
London
NW6 1UH

CLIENT: Crawford & Company
 CLIENT REF: SU1604340
 MWA REF: SUB180316-2204
 MWA CONSULTANT: Andy Clark
 REPORT DATE: 22/03/2018

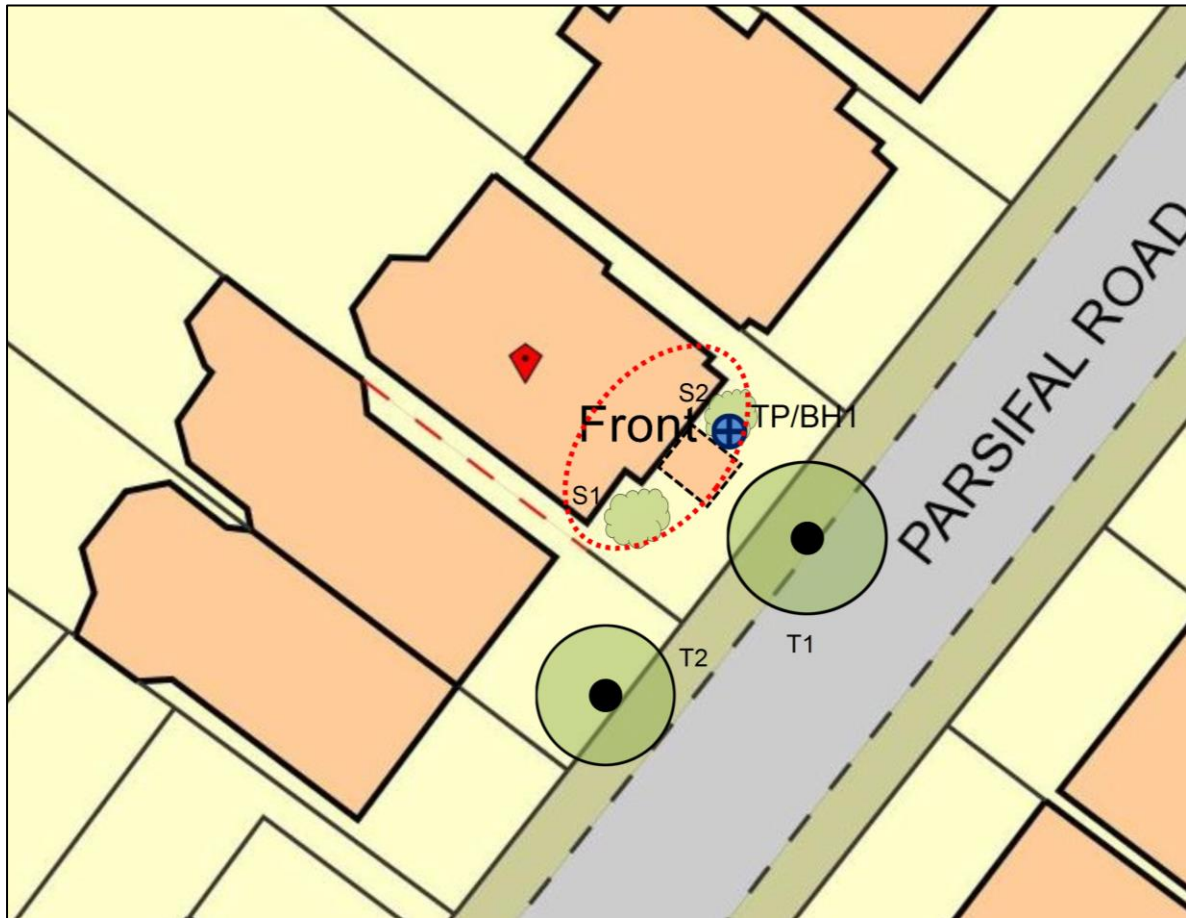
SITE PLAN

Approximate areas of damage

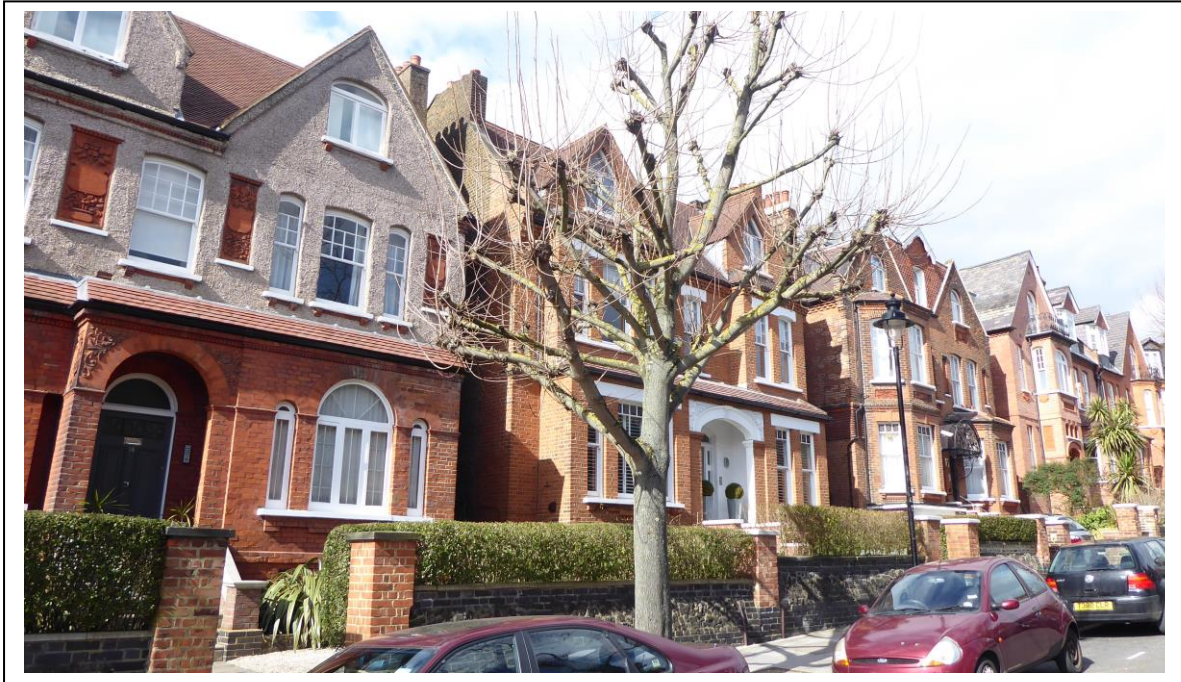
Roots were observed to a depth of 1.7m bgl in TP/BH1, and recovered samples have been positively identified (using anatomical analysis) as Monocotyledon spp. and Acer spp. The origin of the Acer spp. roots will be T1 Norway Maple, confirming the influence of this tree on the soils below the foundations. The Monocotyledon spp. roots will emanate from the nearby ornamental grasses of S2.

Tree No.	Species	Ht (m)	Dia (mm)	Crown Spread (m)	Dist. to building (m)	Age Classification	Ownership
T1	Maple	9.5	340	6.0	6.7	Younger than Property	Local Authority
Management history		Subject to past management -appears regularly pollarded. Regrowth appears <1yr					
Recommendation		Do not allow to exceed current dimensions by a programme of regular [biennial] re-pollarding.					
S1	Ornamental Grass	1.0	10 Ms	2.0	1.5	Younger than Property	Policy Holder
Management history		No significant past management noted					
Recommendation		Remove (fell) to near ground level and treat stump to inhibit regrowth					
S2	Ornamental Grass	1.0	10 Ms	2.0	1.5	Younger than Property	Policy Holder
Management history		No significant past management noted					
Recommendation		Remove (fell) to near ground level and treat stump to inhibit regrowth

View of T1 Norway Maple

If an arboricultural solution is to be implemented to mitigate the current damage and allow the soils beneath the property to recover to a position such that an effective repair solution can be put in place, we recommend that T2 Cherry is removed and that T2 Norway Maple be subject to regular [biennial] pollarding. If movement persists following the removal of the cherry, the council maple T2 may need to be removed.

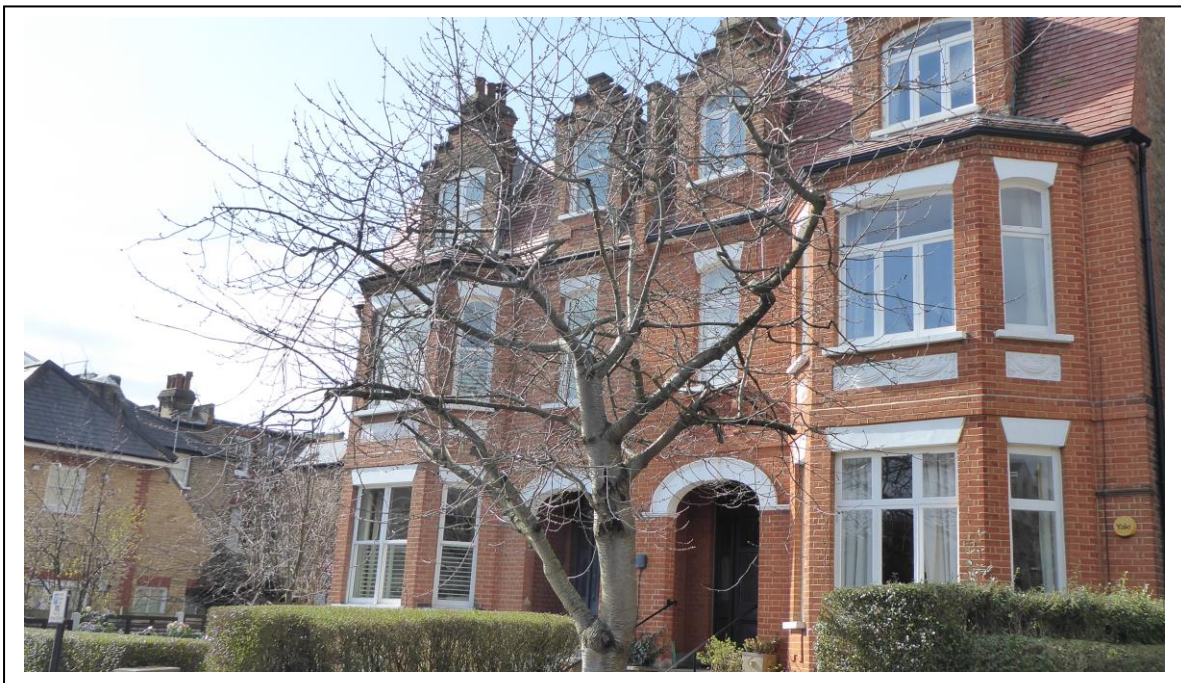
Irrespective of the roots found at the TP/BH1 location however, given the size and proximal location of T2 Cherry, the roots of this tree are also very likely to be present below the foundations and influencing soil moisture content – particularly to the left-hand side of the property.

Having considered the available information, it is our opinion that T2 Cherry is the principal cause of the current subsidence damage, with contribution to a lesser extent from T1 Norway Maple.

Tree No.	Species	Ht (m)	Dia (mm)	Crown Spread (m)	Dist. to building (m)	Age Classification	Ownership
T2	Cherry	8.4	330	7.5	8.0 *	Younger than Property	Third Party: 16 Parsifal Road
Management history		Subject to past management – appears previously crown reduced. Regrowth appears <5yrs					
Recommendation		Remove (fell) to near ground level and treat stump to inhibit regrowth

View of T2 Cherry

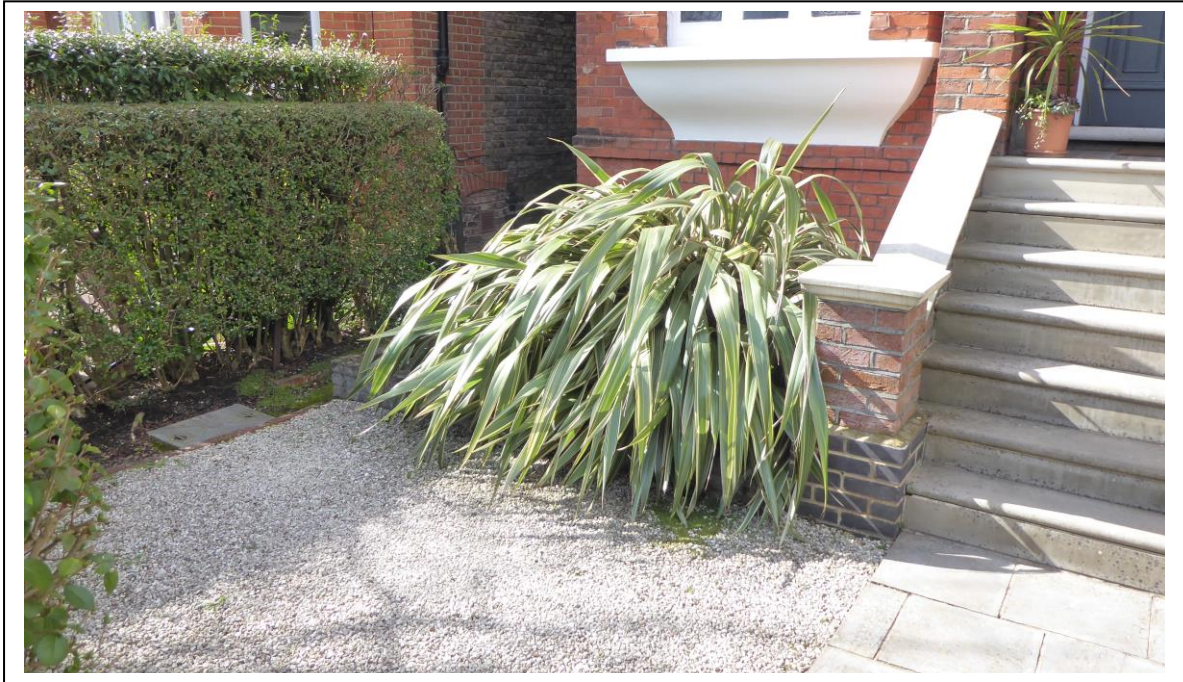
View of S1 Ornamental Grass

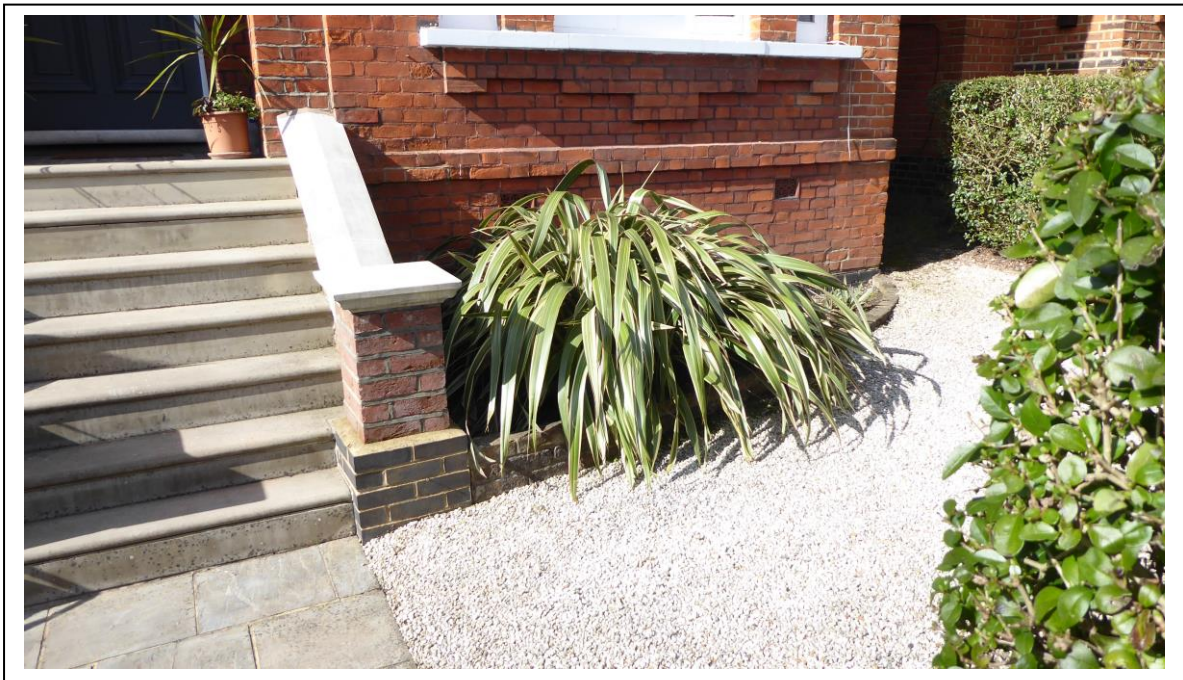
The ornamental grasses will also impact upon soil moisture.

View of S2 Ornamental Grass
