Area 6. PAR area to the east of the concrete path by pond.	Restoration works

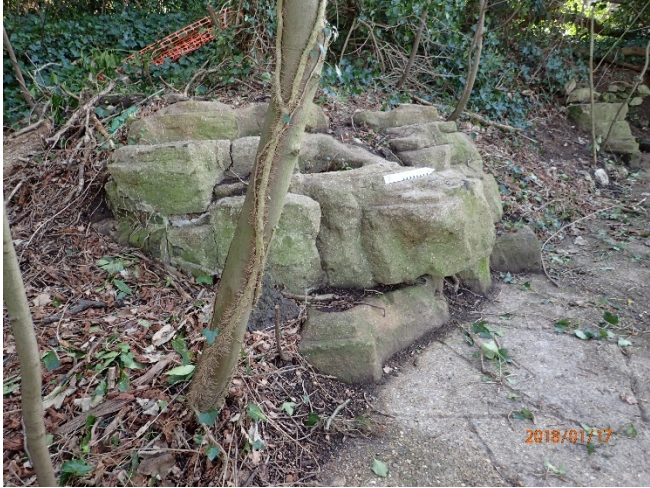
<p>6a. Tree no 2960 (at the north end of area 6).</p> <p>Pulhamite outcrop is built into the bank with plant pockets with natural vertical fissure through the centre of the outcrop.</p> <p>There is a loose lump of brick burr sitting adjacent to outcrop.</p>	<p><i>The edges of the PAR will be defined by drawing back soil that covers the top and edges.</i></p> <p><i>Loss of PAR to the north end, due to cracking and surface loss, will be consolidated.</i></p> <p><i>Ivy growth is evident and will be treated with herbicide. Local trees will be managed for root growth control.</i></p> <p><i>Retain and store loose burr section unless an area of missing material is found.</i></p>

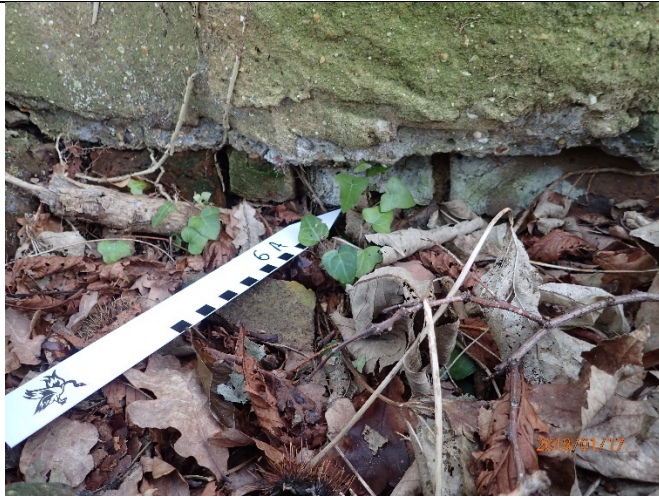
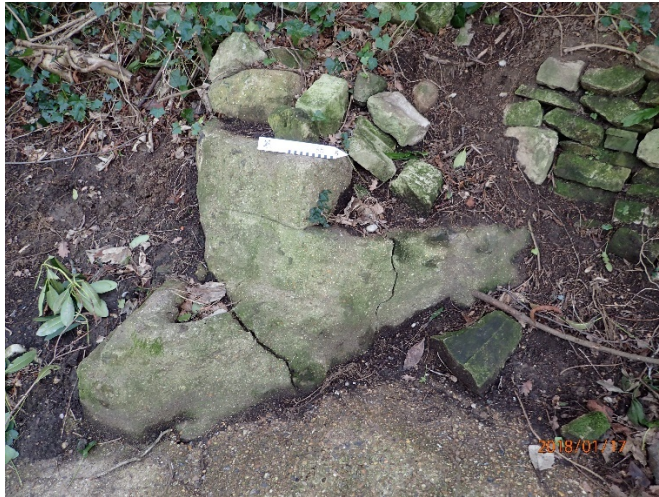
<p>6b. PAR outcrop,</p> <p>This is a small intermediate section between 6a and 6c. It may be connected to 6b but the area is extensively covered with soil and the partially collapsed dry rubble retaining wall. This will be cleared for further examination.</p>	<p><i>The retaining wall on the top will be removed and carefully excavated to the top and sides. 2 major cracks are evident but it is difficult to determine the full extent of the condition due to the collapse of the wall on top.</i></p> <p><i>Management of ivy growth and tree roots will be undertaken.</i></p> <p><i>Plant pockets will be emptied.</i></p>

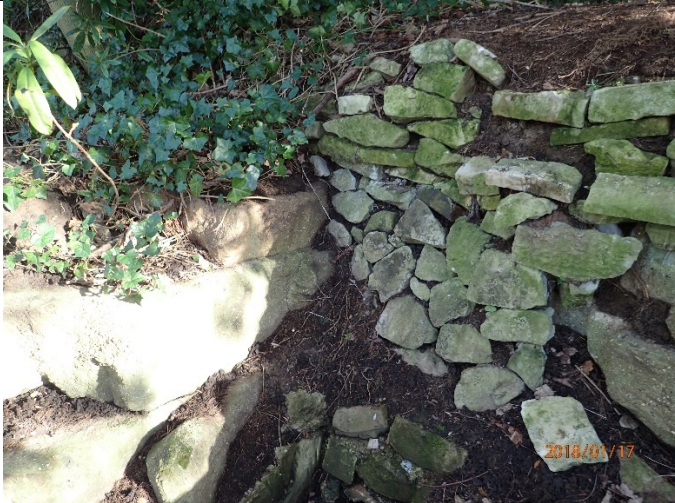
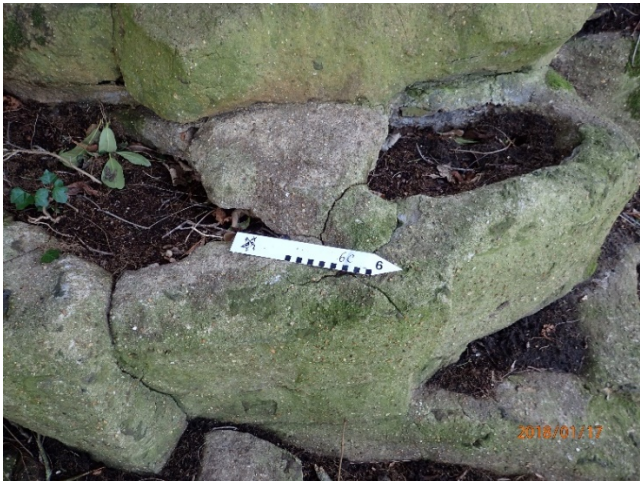
<p>6c. Pulhamite outcrop running south to Ravine/Waterfall.</p> <p>This outcrop has extensive smaller plants pocket, and</p>	<p><i>Several areas of fine cracking and</i></p>

<p>many are extensively cracked. The complete outcrop needs to be defined.</p>	<p><i>partially loose and detached PAR will be consolidated.</i></p> <p><i>Soil and the retaining wall over the top will be cleared and the full extent of the PAR will be defined. Note also that the retaining wall and soil over the adjacent "source" will be carefully excavated to reveal the extent of Pulhamite in this area.</i></p> <p><i>Plants pockets will be carefully emptied and tree and other growth restricted to stop damage by roots. (large trees, rhododendron, ivy growth).</i></p>

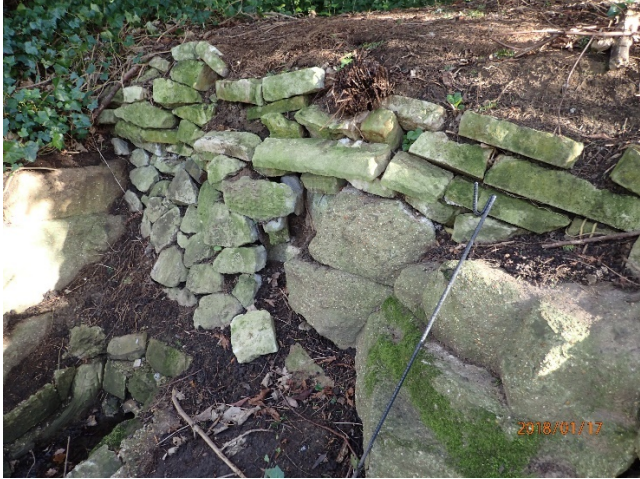
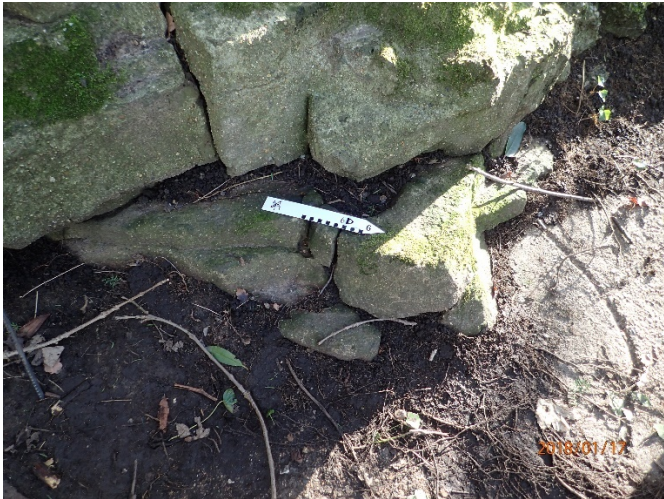
<p>6d. Pulhamite outcrop leading to a section of concrete rubble formed as a plant pocket.</p> <p>The PAR may extend behind the retaining wall over the "source" (of the ravine). This area will be uncovered and</p>	<p><i>See advice in adjacent column about uncovering extent of original</i></p>

<p>investigated to see if some original detailing survives.</p> <p>The retaining wall over this PAR appears to cover the PAR and will be excavated back to reveal the full extent of the PAR.</p> <p>The plant pocket to the south formed in lumps of concrete will be removed to allow inspection of the extent of the original PAR.</p>	<p><i>PAR, and defining the limits of the original PAR.</i></p> <p><i>There is one principle crack. In the lower section there are some small areas of PAR that may be lost if not consolidated urgently.</i></p> <p><i>Management of root growth, ivy and trees is urgently needed.</i></p>

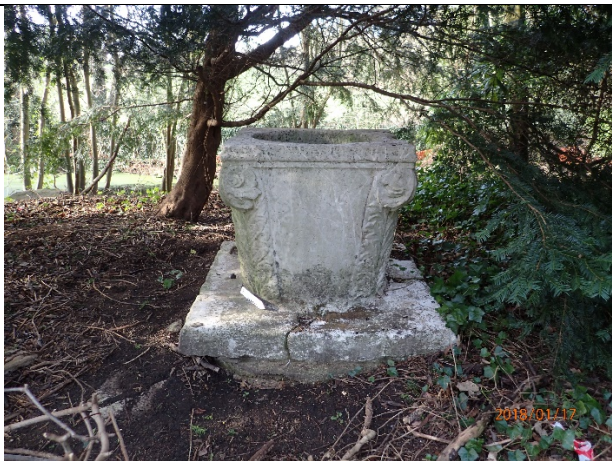
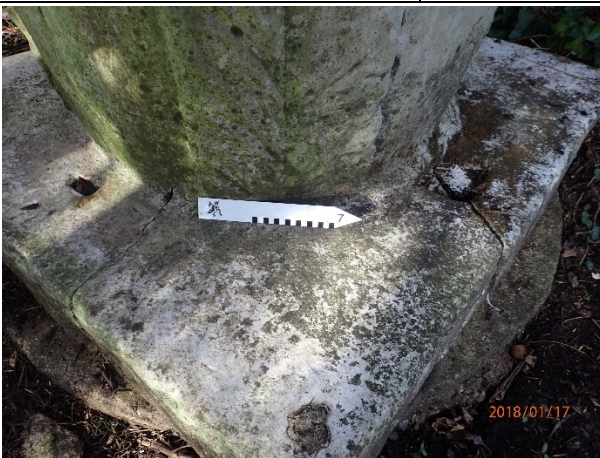
7. Dropping Well/Well head.

Item	Description	Condition and Restoration works
	<p>Dimensions: well head, 920mm high by 1000mm wide/ 920mm high by 1090mm wide (width measured at top). Base stone, 1440mm x 1380mm by 150mm deep.</p> <p>The dropping well is located east of the ravine/water fall of the Pulhamite scheme. It has a ferrous metal superstructure which has been removed and is in storage (this was not inspected on this visit).</p> <p>The well head is situated over a well and there is a concrete capping to the well which is just visible above ground level at present. This is probably C19th concrete and may bear some similarities to the materials used in the Pulhamite rockwork (though further inspection would be required to determine this).</p> <p>Over the concrete is a square stone base for the well head. The well head itself is circular in plan with carvings to the sides. It appears to be mortar bedded onto the stone base. The well head was most probably produced by J.P. White &Co. (see Garden Ornament, John Davis, published 1991).</p> <p>It appears to be a stone type that is generally referred to as Istrian Marble; the following comments were offered by Dr Tim Palmer (geologist) on the well head at Swiss Garden:</p> <p><i>The well-head in the Well Glade of the Quarry Garden is described as being of Istrian Stone and was presumably imported as a finished product. Istrian Stone is a hard, fine-grained limestone from modern north-west Croatia, extensively used in north-east Italy. Though not a marble, it has hard marble properties and was used as a marble substitute. A horizontal crack in the upper rim appears to be a stylolite (a solution seam that is a natural feature of the stone) and is not a sign of impending cracking (Picture 8, following). The identification of the stone has not been confirmed because the lichen</i></p>	<p>Well head:</p> <p>There is some visible cracking that appears to be stylolite related and probably requires no action unless elements are threatened i.e. there is a potential for sections to be lost.</p> <p>The ferrous metal (remnant) fixings in the upper surface of the well head, will be carefully drilled out, (as they may cause cracking). If the subsequent holes are not filled during the re-fixing of the conserved metal superstructure, then they will be filled in a colour matched hydraulic lime mortar (NHL 3.5 binder; 1 vol. binder 2 vol. sands and 1 vol. appropriate limestone dust such as Portland stone, or similar subject to trials).</p> <p>If there is a desire to clean the well head this will be done with soft fibre brushes and water.</p> <p>Square base stone:</p> <p>The square base is badly cracked in places, and some further investigation will be carried out to see if there is any embedded iron in this stone (causing the cracking). Otherwise the cracks will be consolidated by drilling and inserting stainless steel pins across the crack (as previously specified for Pulhamite Rockwork). Raking out the cracks, inserting a suitable hydraulic lime grout and packing the open face of the crack with mortar, similar to the above specified</p>

Item	Description	Condition and Restoration works
	<p><i>patina on the surface covers all the geological features, but there is no reason to doubt the identification.</i></p> <p>The proposal to create a new water supply to the pond ravine/waterfall, must not interfere with the well head or the stone base with the works kept below ground level and the structural stability (unassessed) of the well walls maintained.</p>	<p>for the well head is required. (And colour matching to the stone by necessary trial work).</p> <p>Open voided hollows in the stone surface, if these are not filled by the re-fixing of the metal super structure, should be filled with mortar as indicated above. Suitable preparation should be made to ensure the mortar is well keyed.</p> <p>Metal super structure:</p> <p>The conservation of the metal work will be carried out by an accredited metals conservator: e.g. Hall Conservation Ltd; who can make an assessment, report.</p> <p>One should avoid re-fixing the ends of the super structure into the stone well head with ferrous metal, such end sections may need to be fixed with stainless steel or lead tips.</p>
