Athlone House,
Hampstead Lane, London N6:

Restoration of historic landscape: Conservation of the Pulhamite artificial rockwork and other associated historic garden landscape structures

Appendix 3;

Condition survey & restoration

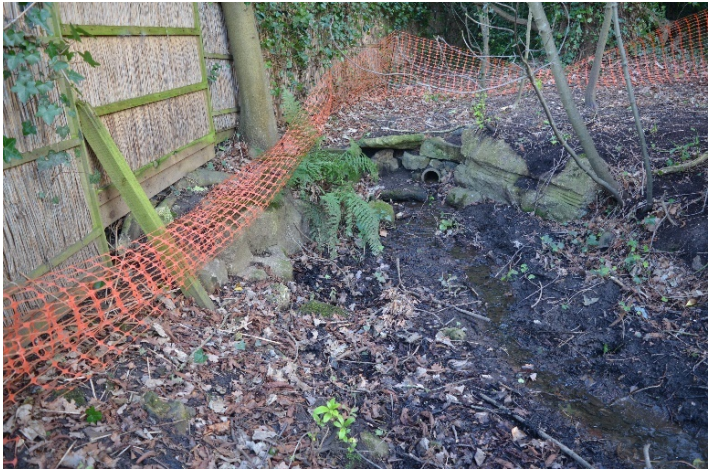
Area 1 Pulhamite pond: source at the north end	Restoration works	
<p>Area 1 Encompasses the source at the north end (Rock head wall) up to the stepping stones. Trees no: 2976/2977/2738.</p> <p>Area 1 is subdivided into four 1a)-1d) below.</p>

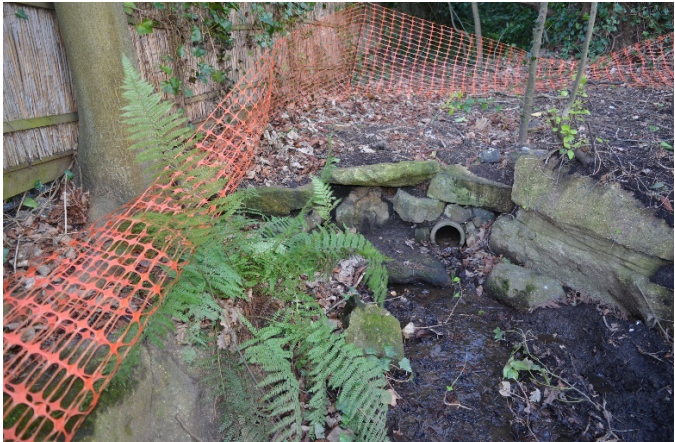
<p>1a. The area around the source pipe seems to be disrupted and is now largely a collection of loose laid natural stones. Some original Pulhamite features may exist either below this (under pipe area something is just visible) or further back up the route of the source. The current plan of this area is particularly different to earlier mappings. Looking at the historic maps and plans of the pond it is obvious that this area has changed radically, there was apparently significantly more to the north of this area, i.e. the current pipe wall.</p> <p>It is also possible that areas 1b and 1c (see below) were the bridge abutments or fixing points. This may become apparent when the PAR surfaces are cleared of soil etc.</p>	<p><i>Further careful investigation and excavation or digging around required to try and define extent of Pulhamite, which may be either lost or partially buried. Control of root growth to adjacent trees/saplings.</i></p>

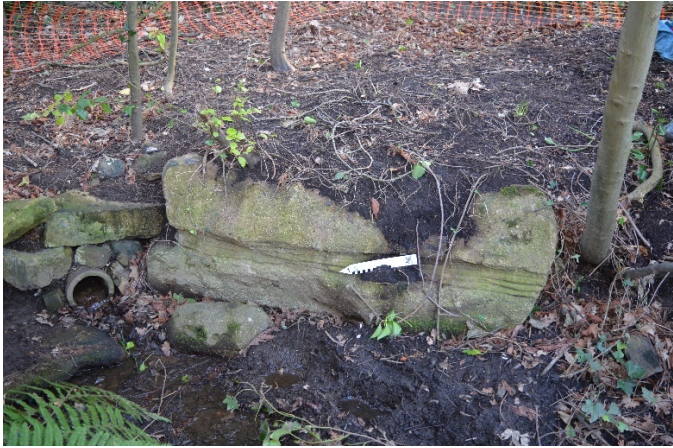
<p>1b. To the east of the source and adjacent; there is a substantial section of PAR. And a smaller section in front of this which appears to be partially submerged in mud. The larger section may include a plant pocket (to upper surface) or evidence of the bridge abutment fixings. The surface is now totally over filled and colonised by tree saplings.</p> <p>Other young trees established around the Pulhamite will threaten its integrity if allowed to continue to grow.</p>	<p><i>Further careful investigation and excavation or digging will be undertaken to try and define extent of Pulhamite, which may be either lost or partially buried. Control of root growth to adjacent trees/saplings.</i></p> <p><i>Include excavation of plant pocket for future suitable planting.</i></p>

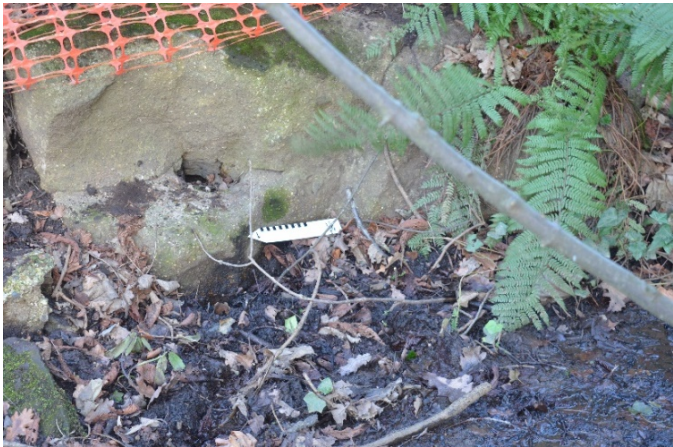
<p>1c. To the west of the source is a substantial PAR. With established tree growing on top and with boundary wall over. This area needs general cleaning and further careful excavation. The established fern is appropriate and should be retained.</p> <p>The tree (no 2977) will need to be cut down as it is likely to cause problems, though as yet there are no signs of structural cracking apparent.</p>	<p><i>Further careful investigation and excavation or digging around will be undertaken to try and define extent of Pulhamite, which may be either lost or partially buried. Control of root growth to adjacent trees/saplings.</i></p>

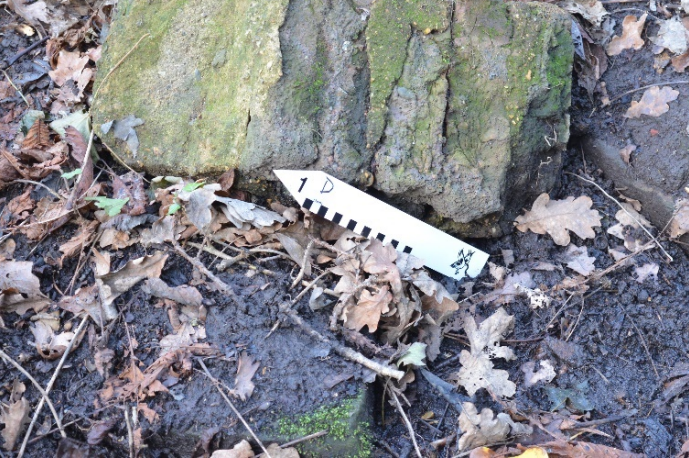
<p>1d. To the south of 1c, on the west bank, and as far as the stepping stone there is partially broken PAR, in pieces and partially dispersed in the mud.</p> <p>This area and the area back to the boundary wall needs careful excavation and reassessment. At least one loose section of PAR here may belong to PAR area 3 (see below) which has a large missing section in the NW corner. Such items should be retained and re-bonded. At this stage all loose broken sections of PAR should be retained for the conservation phase works.</p> <p>It is possible that this area was the location of the bridge abutment, which would mean that the bridge was adjacent to the stepping stones. There is a large tree on the opposite bank (tree no. 2976), and young trees adjacent to area 1b and no obvious visible signs of PAR. Further excavation and investigation is recommended.</p>	<p><i>Careful investigation of the area will be undertaken by excavation, trying to define any PAR that survives below the existing surface. All broken PAR elements will be retained, in situ if possible. Any exposed Pulhamite can be washed down with a simple hose pipe water supply.</i></p> <p><i>A re-assessment will be made for the full repair schedule.</i></p>

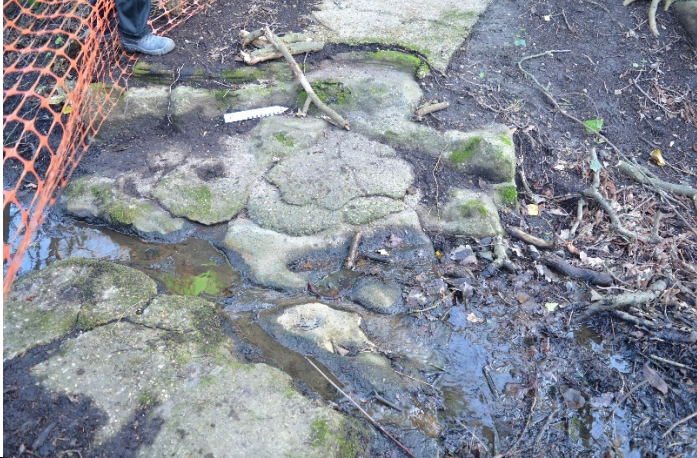
<p>Area 2. Pulhamite pond: Stepping stones</p>	<p>Restoration works</p>	
<p>The Stepping Stones are partially repaired with concrete (probably) with some loss of historic PAR surface. The repair area is cracked on the south side, and will need consolidation once this area has been fully defined. Needs careful excavation around area and further close inspection.</p> <p>There has been a suggestion that the concrete repairs may indicate that the stepping stones replace the bridge which may have been located here; however, it is not unusual for stepping stones to have such modern repairs and cautious investigations should be made. This will inevitably include some careful excavations around the stepping stones and closer investigation of any potentially historic PAR.</p>	<p><i>Further careful investigation and excavation or digging around PAR will be undertaken to try and define the extent of Pulhamite, which may be either lost or partially buried. Control of root growth to adjacent trees/saplings is urgently required</i></p>

<p>It is possible that this area may have been a cascade as well and an investigation into the original water levels either side of the stepping stones should be made.</p> <p>Most (possible) repairs do not seem to be the same phase of work as the modern concrete pathway.</p>

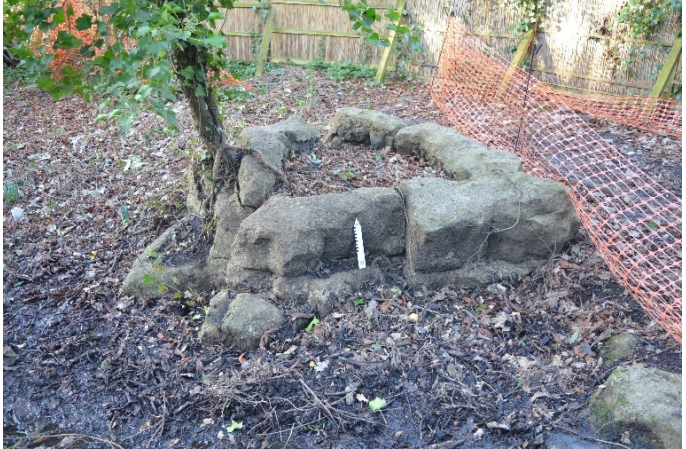
<p>Area 3. Pulhamite pond: To the south west of the stepping stones or west side of the pond.</p>	<p><i>Restoration works</i></p>	
<p>There is a large Pulhamite rock with plant pockets with an established tree (no 2979) to the south end causing disruption. There is a large missing section to the north end: this piece may be one of the loose/detached sections observed in area 1d. Small sections of PAR are partially buried on the east side.</p>	<p><i>Further careful investigation and excavation or digging around will be undertaken to try and define the extent of Pulhamite, which may be either lost or partially buried. Control of root growth to adjacent trees/saplings.</i></p> <p><i>Cracking and detachment caused by tree and ivy growth will be consolidated after the tree is felled. Plant pockets will be emptied if possible in preparation for replanting. The missing area at north end will be re-fixed or rebuilt.</i></p>

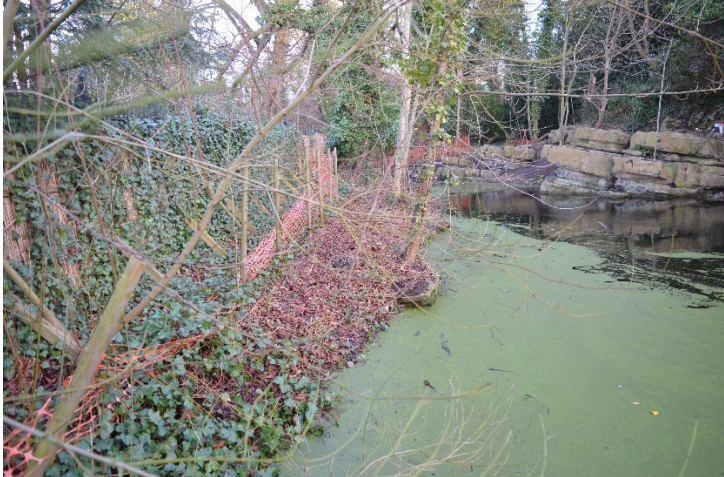
<p>3a. To the west and south side of the pond.</p> <p>The west side of the pond is low level and has some natural sand stone forming a bank with some possible low-level elements of PAR. This area will need further investigation once further clearing and possibly dredging have taken place.</p>	<p><i>Further careful investigation and excavation or digging will be undertaken to try and define extent of Pulhamite, which may be either lost or partially buried. Control of root growth to adjacent trees/saplings.</i></p>

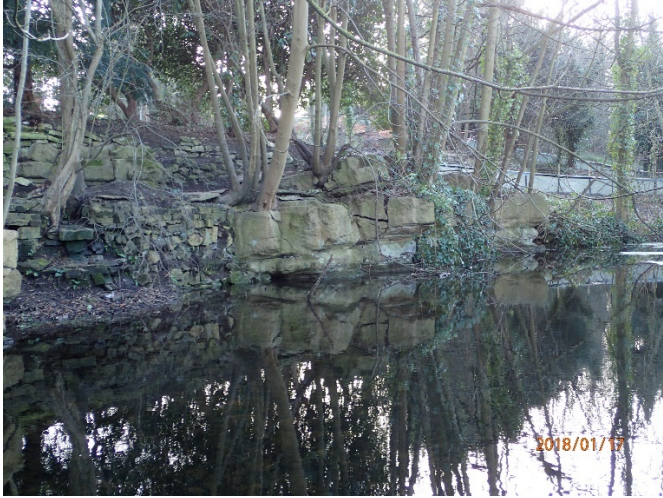
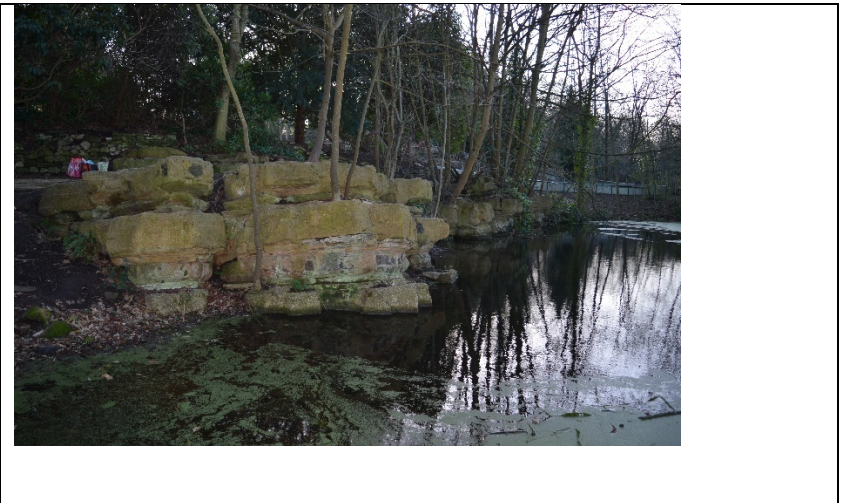
<p>Area 4. East side of pond (from tree no.2975 and south along the east side)</p>	<p>Restoration works</p>	
<p>General description: Note that the geological bedding gently dips down towards the east, and that bedding strata are continuous throughout the scheme. It has a clearly cantilevered and recessed profile representing hard and soft bedding strata. There is vertical fissure through the rocks which appears to be “continuous” with the PAR scheme east of the concrete path. These are all indications of geological authenticity which is characteristic of Pulhamite.</p>
