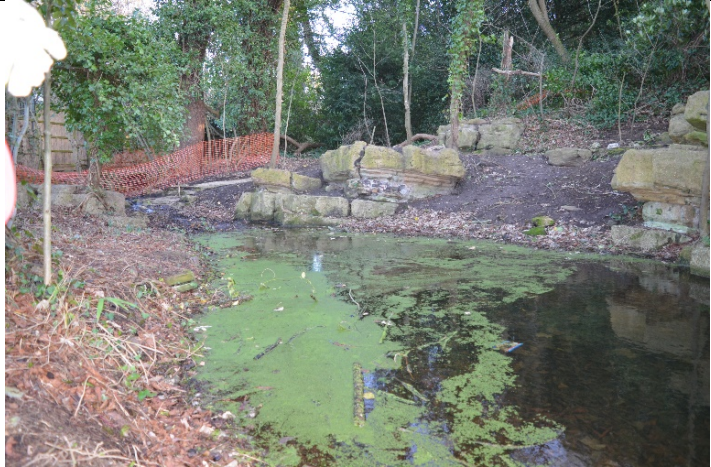
There is some PAR adjacent to the path and there is a collection of bricks and rubble down at the water line.

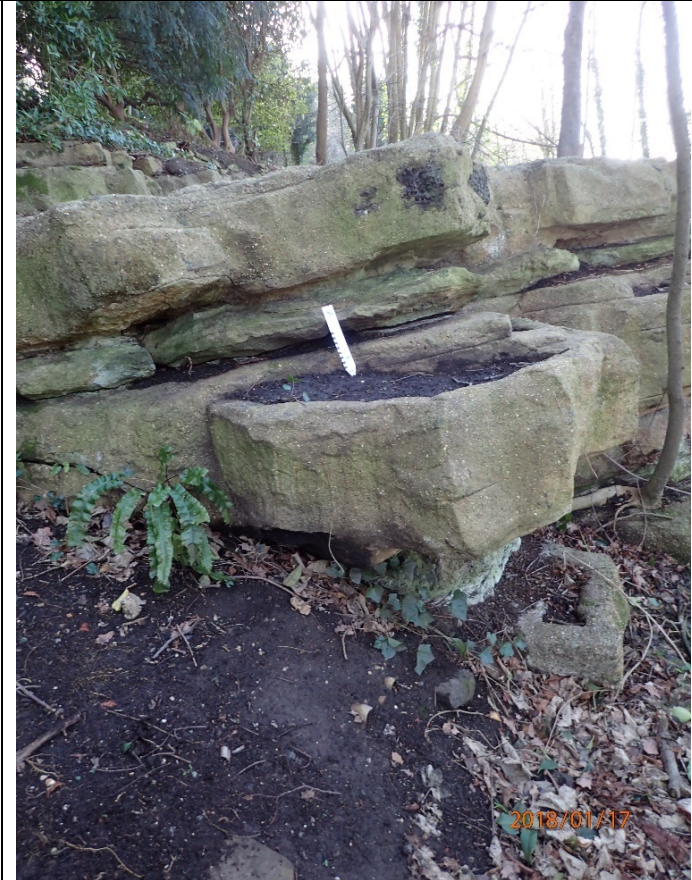
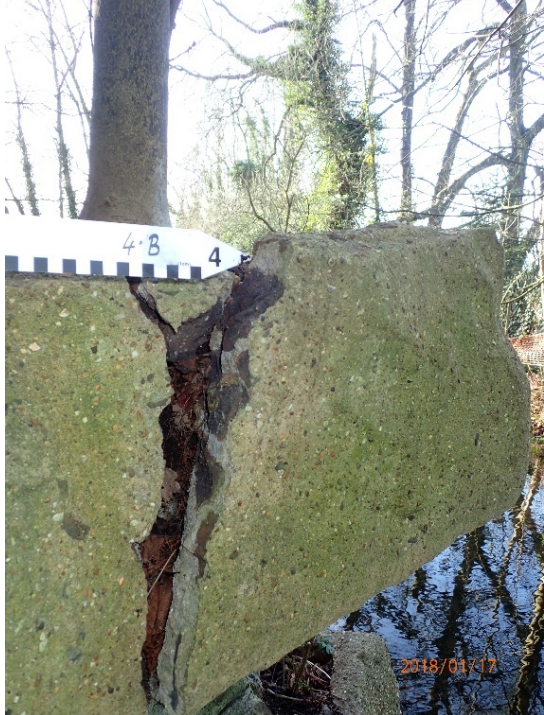
Note areas of cracking mainly due to root growth. Root growth will be controlled.

There is evidence of ivy growing and this will be killed off, because it is invasive into wet masonry (i.e. Pulhamite).

There is cracking and cracked plant pockets with major ivy growth under top plant pocket.

All cracking will be attended to, to consolidate the Pulhamite.

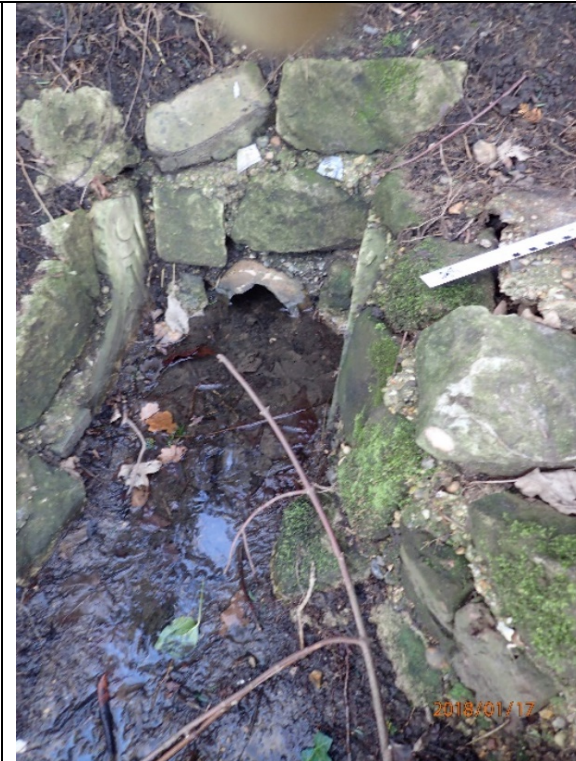
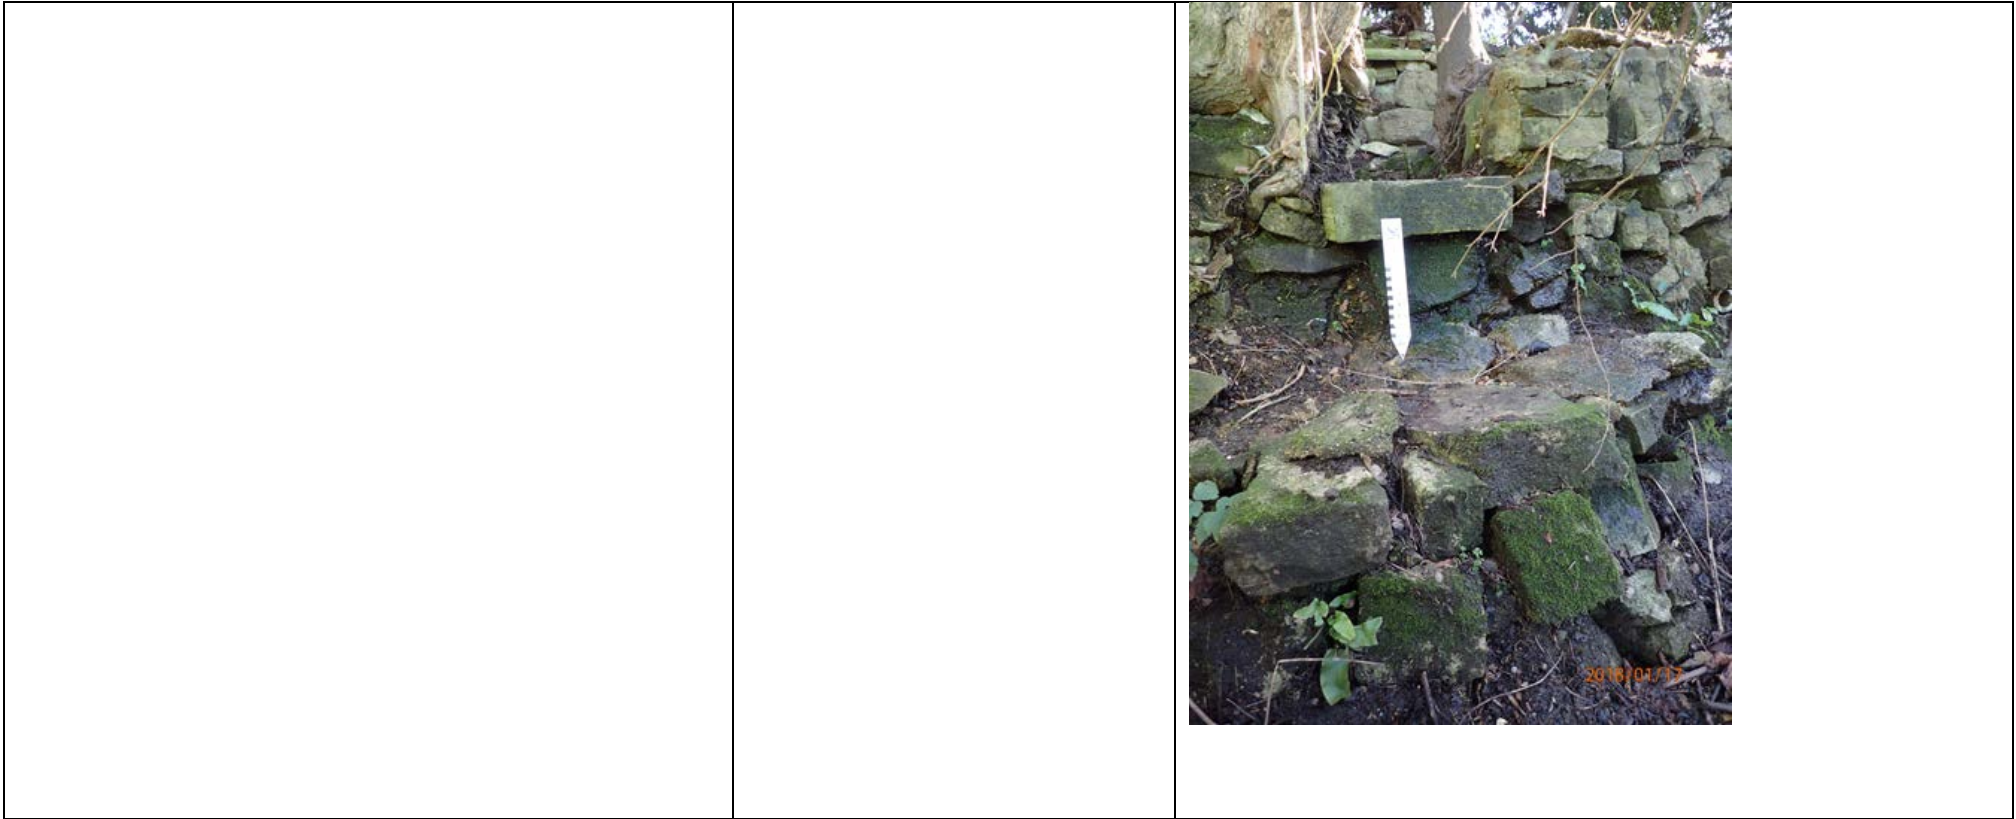
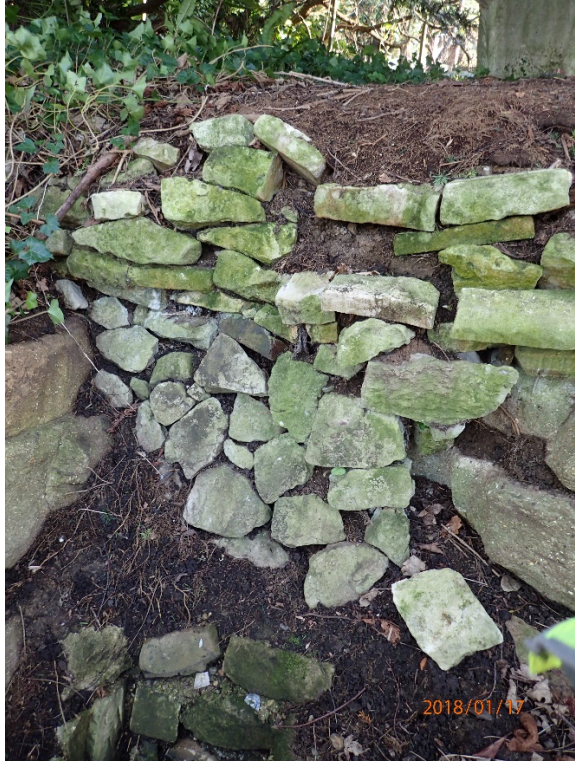
There are marble dolphin scrolls (decorative slabs) inserted into sides of the channel at the east end and the one which provides a water chute at the west end of the channel. These are not thought to be original. Below the chute at the west end there is a rubble shelf under the waterfall with possible remnant of PAR coating (the possible “table stone” described above). If this is an original feature most of the PAR coating is lost and some PAR is possibly buried in mud.

The channel might have been cut into what was once a wide waterfall/cascade (to the west of the path) and there was water flowing over the path, with possible stepping stones or a small bridge); the water fall would have flowed down the visible brick burr wall (with traces of possible Pulhamite coating still) onto a lower stage (visible, possible “table stone”) and this would have splashed further down into the pond.

Consolidate walls of channel (subject to above) and front edge and excavate silt from channel.

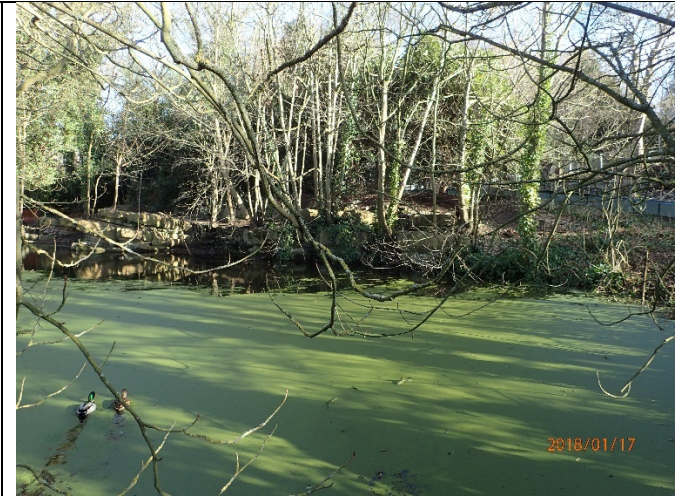
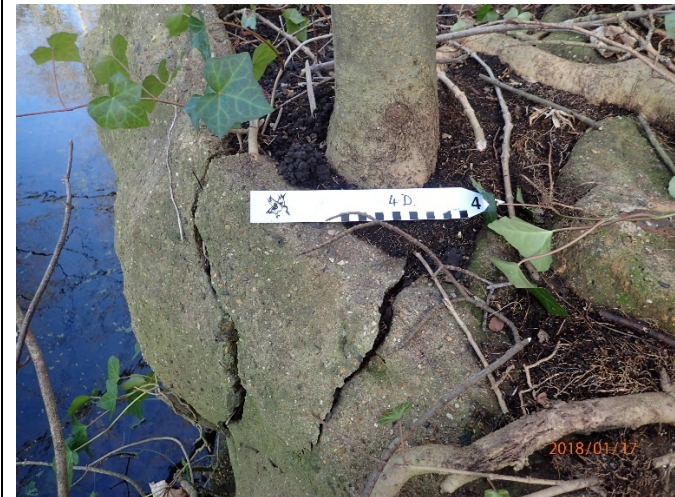
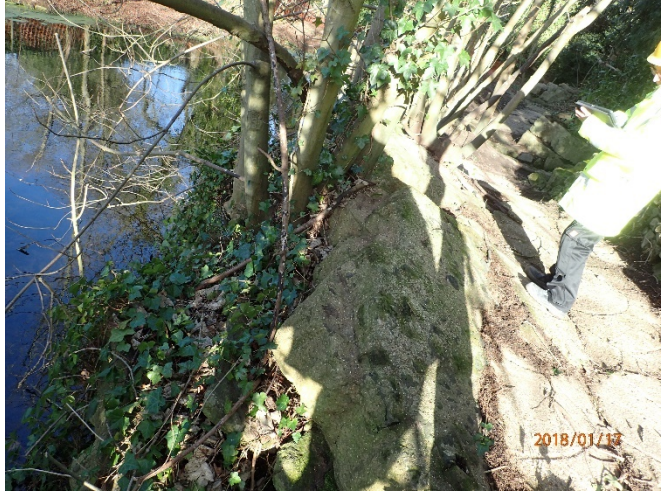
There are clearly cracks and structural damage to plant pockets which will be attended to. There are also detached sections of Pulhamite which will be consolidated.

The area to the south of the visible outcrop will be investigated by further clearance to see what rockwork may be present, if any.

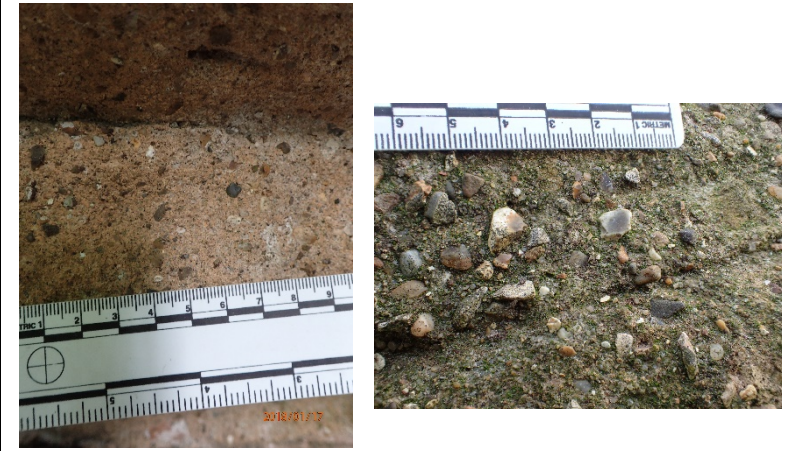
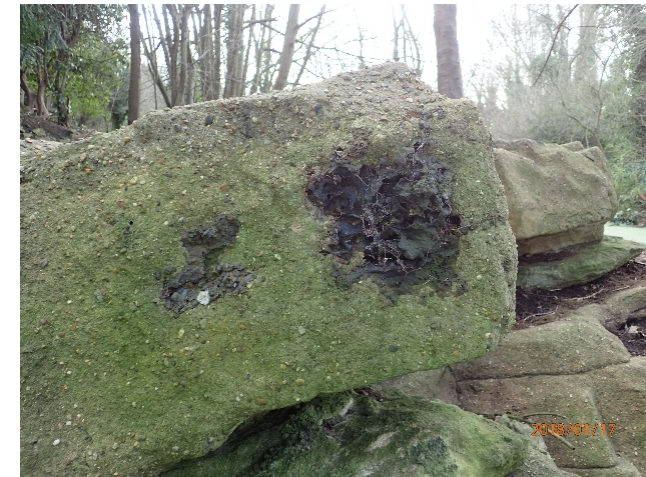
The aggregates appear to be quartz type aggregates with colour variations from black, yellow orange and white, and vary in size from about 1-2mm to 10-12mm diameter.

Another significant surface character is the visible brick burrs/molten brick, showing through the surface, providing darker patterning and variation in the Pulhamite surface.
