Tree inspection & Decay detection Report

Lombardy poplar tree

10 Fitzroy Park
London
N6 6HU

Tree No.: 1 **Species:**
Populus nigra 'Italica'
(Lombardy Poplar)

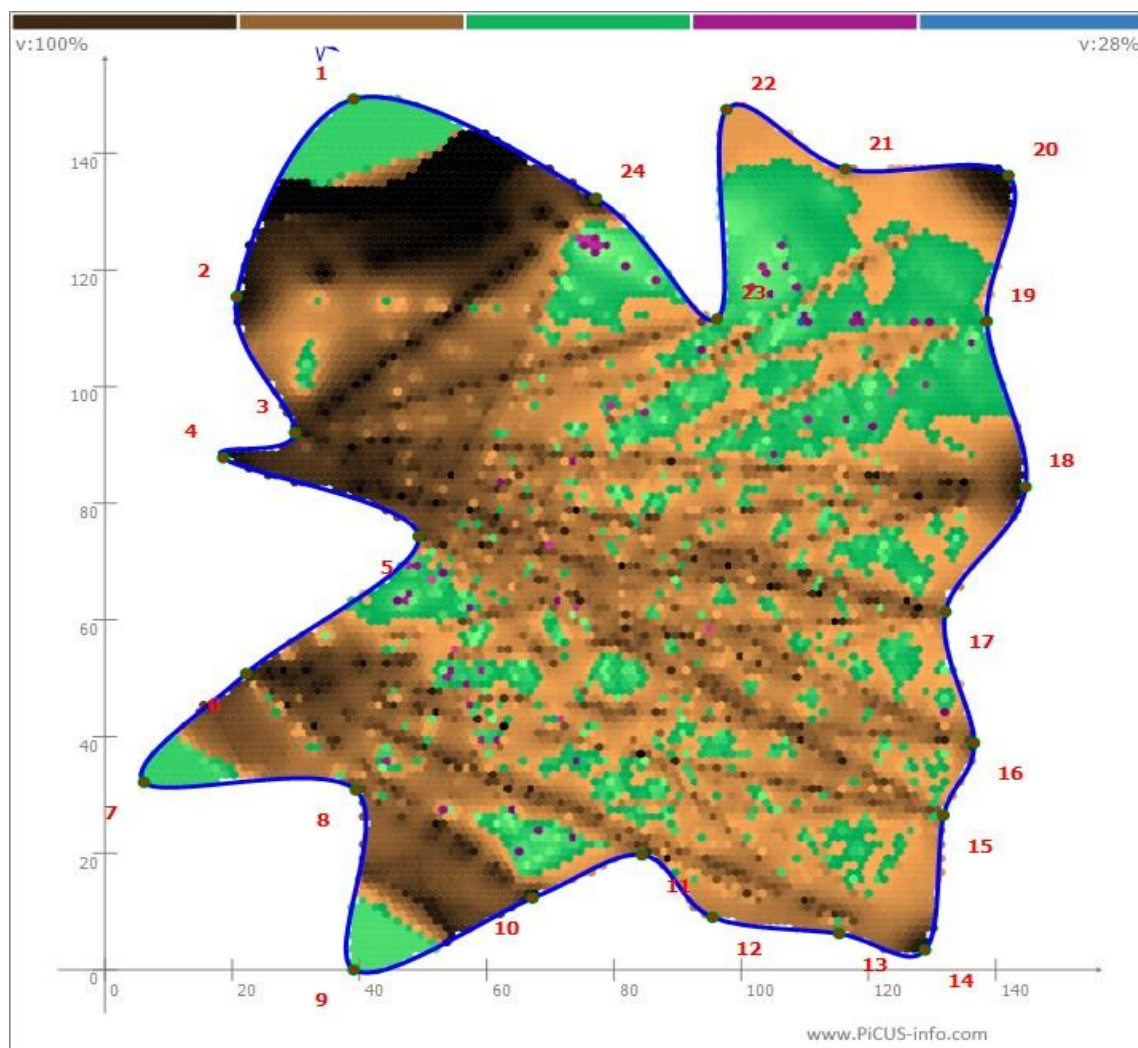
PiCUS sonic tomogram at approximately 15cm above ground level

The PiCUS tomogram shows wood which is in the early stages of decay (light brown, green) across the stem at the test height, as indicated in the scale at the top of the tomogram.

The shape of the tomogram is due to the extensive buttress root formation at the base of the tree, which not only made measuring the sensor positions difficult but may have had some effect on the recorded speeds where sound waves had to travel to and from measuring points (mp) out on the tips of the buttresses.

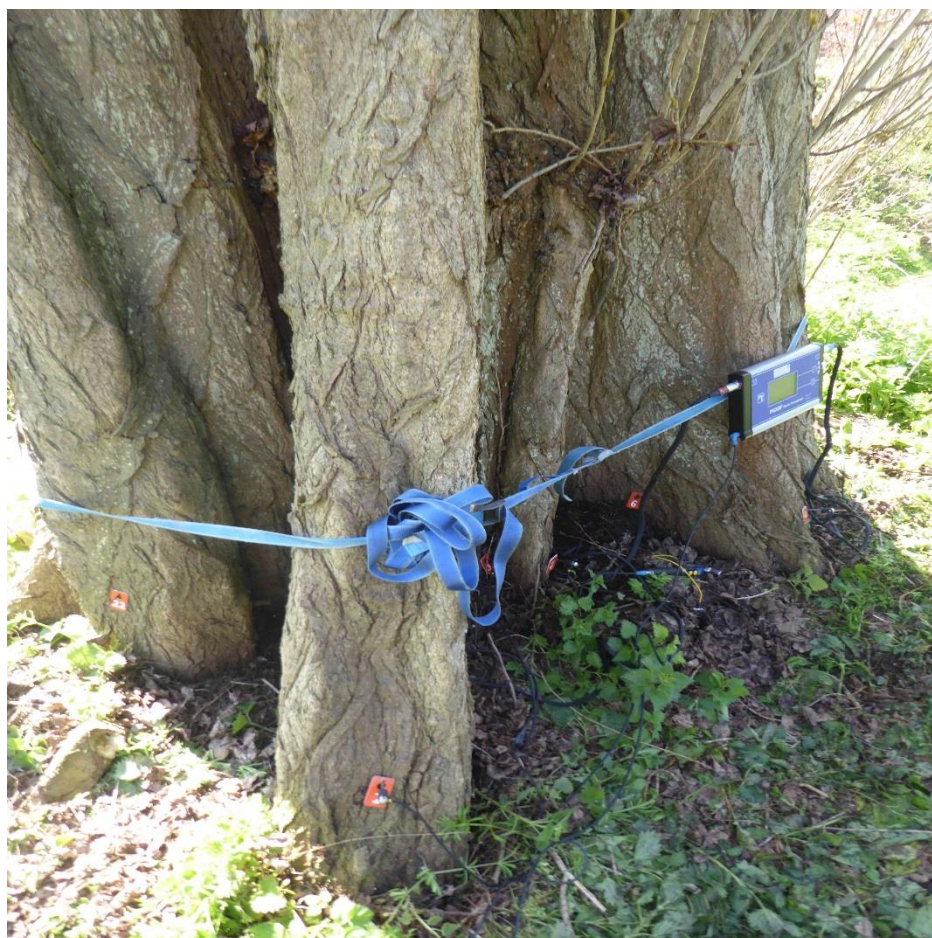
The base of the tree from the north, with the PiCUS equipment set up

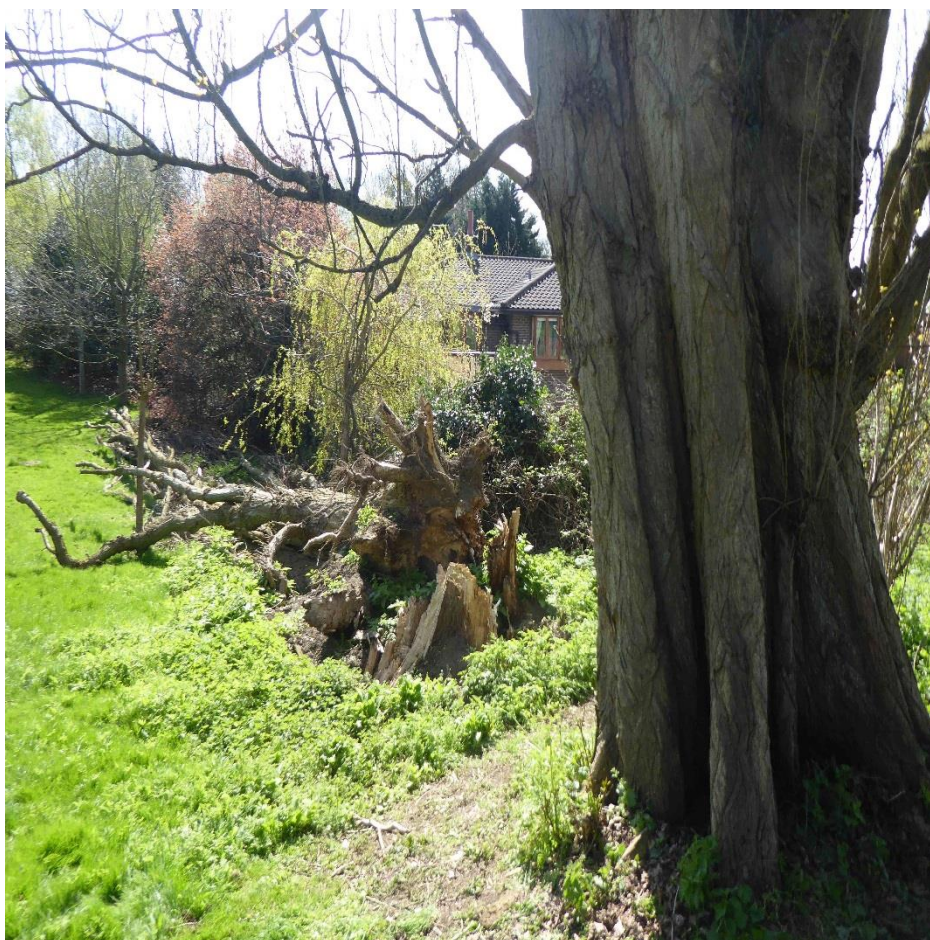
The neighbouring tree which failed recently. It should be noted that the fallen tree had also been topped and failed at the base.

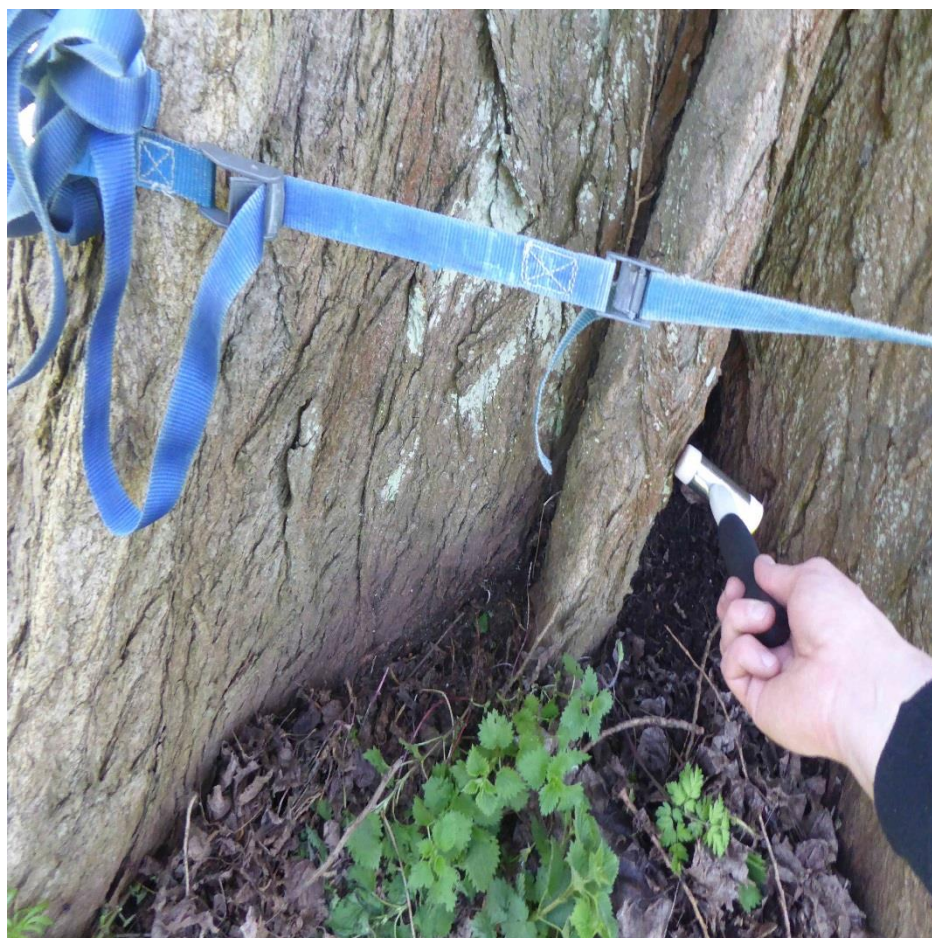
Surveyor's Note: Unbalanced crown due to neighbouring tree which failed recently.
Sounding mallet test - hollowing suspected in buttresses to the north and 'rib' to the west (by mp4)
Root decay suspected following historic topping.

The rib formation at mp 4, which sounded hollow following tap tests

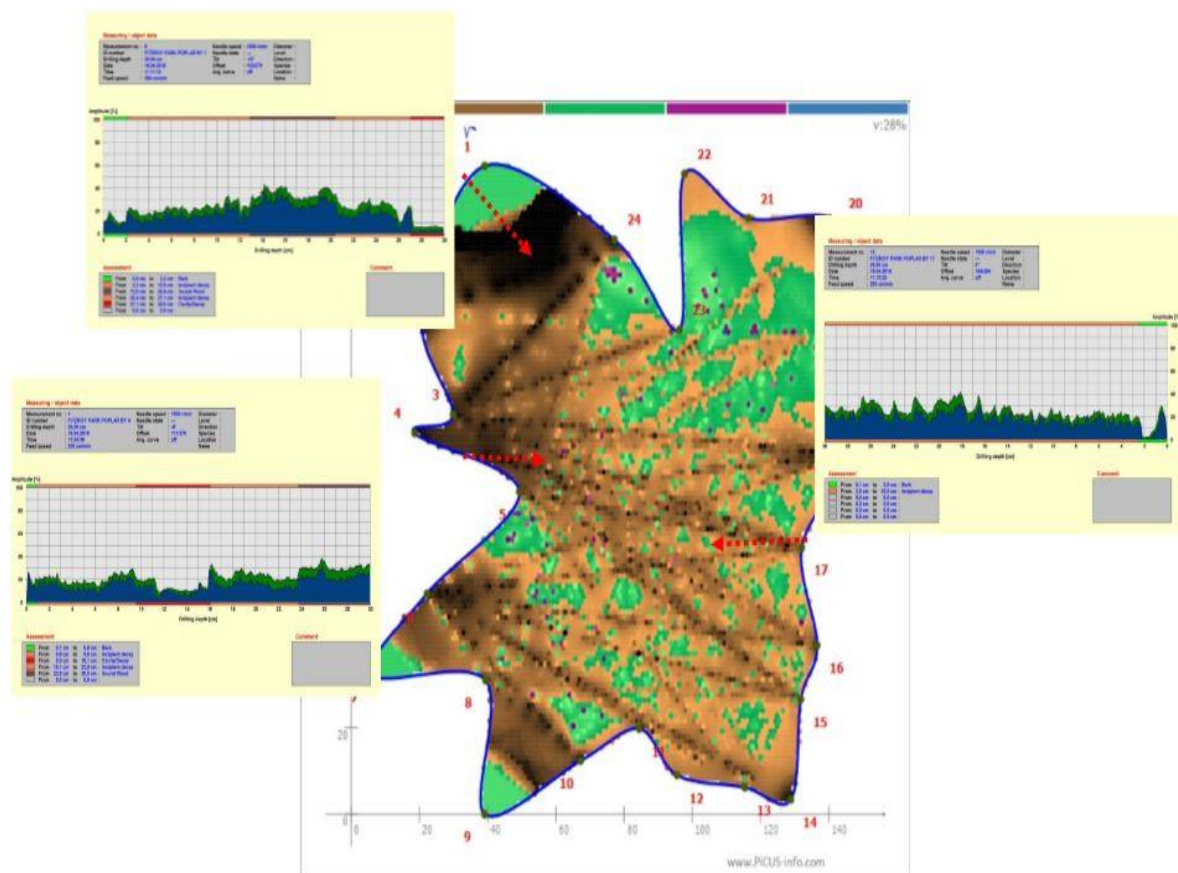
The RESI PD results (below) confirm the early development of decay across the stem, which, along with the alterations in wind dynamics due to the recent failure of the neighbouring tree, mean that the tree is in weakened condition and remedial tree works are required. Recommendations follow below.

RESI PD drill traces overlaid in their approximate positions on the PiCUS tomogram

Fell tree to ground level due to poor structural condition, with deteriorating wood condition in stem and base and probable root decay – works recommended to remove risk of tree failure on to neighbouring property and recreational features near the tree

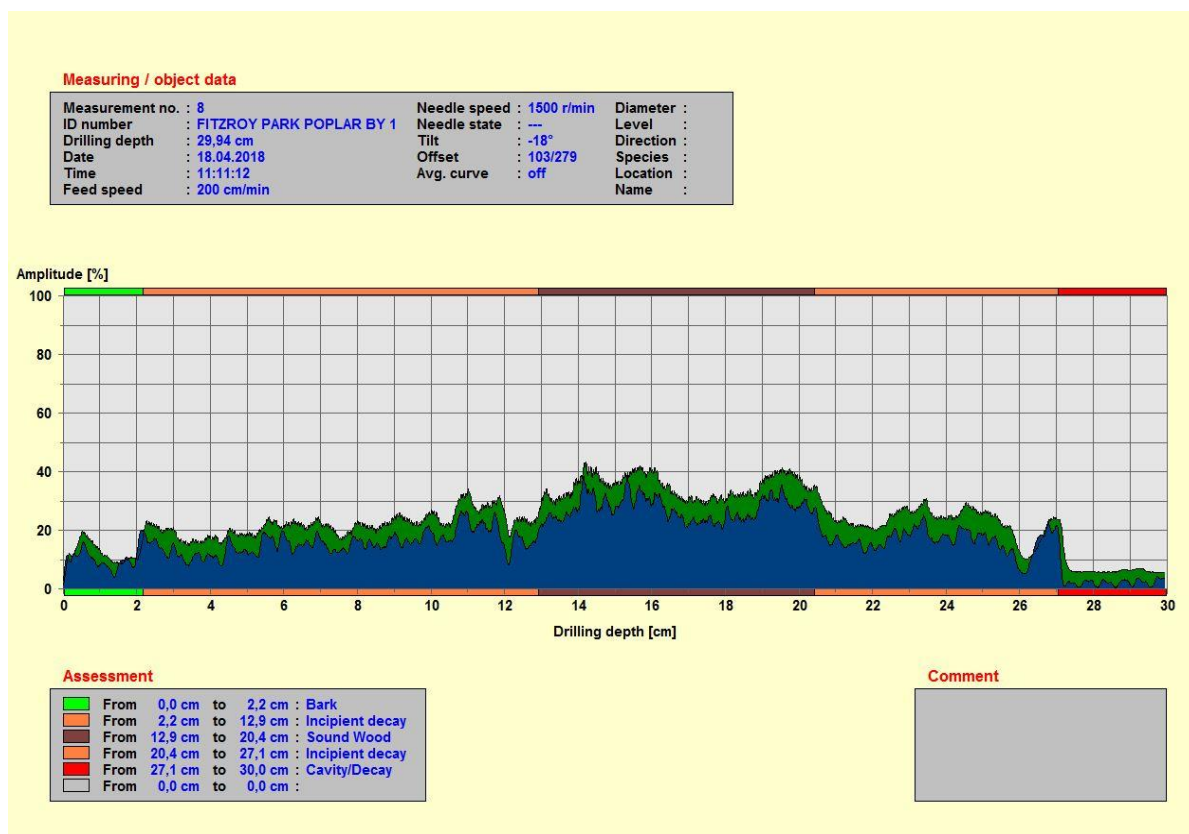
RESI PD Drill trace (read from left to right) by mp 1 showing incipient (early stage) decay between 2cm and 13cm, sound wood between 13cm and 20cm where incipient decay and decay follows

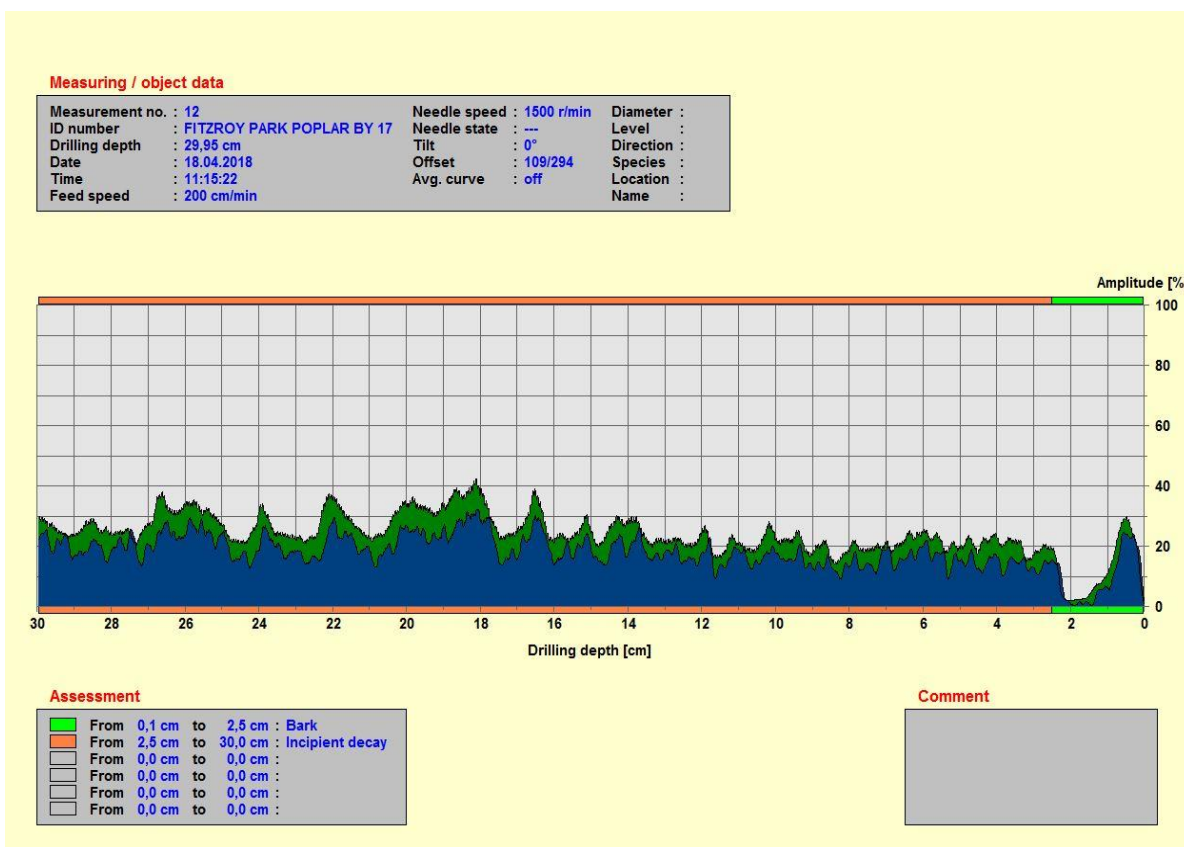
RESI PD Drill trace (read from right to left) by mp 17 showing incipient (early stage) decay from 2.5cm onward

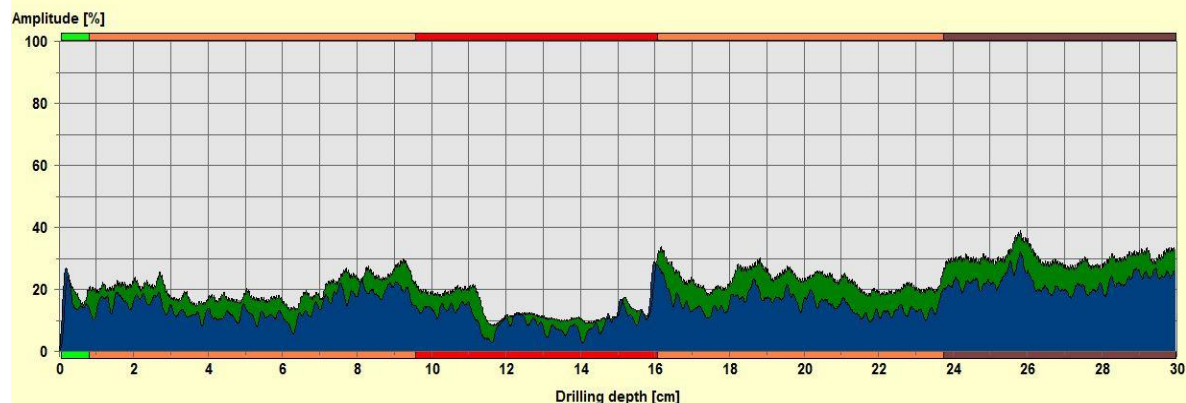
Green	From 0,1 cm to 0,8 cm : Bark
Orange	From 0,8 cm to 9,6 cm : Incipient decay
Red	From 9,6 cm to 16,1 cm : Cavity/Decay
Light Orange	From 16,1 cm to 23,8 cm : Incipient decay
Brown	From 23,8 cm to 30,0 cm : Sound Wood
White	From 0,0 cm to 0,0 cm :

RESI PD Drill trace (read from left to right) by mp 4 showing incipient decay to approximately 9.5cm then a small pocket of more advanced decay until 16cm, where incipient decay continues until sound wood at 24cm.

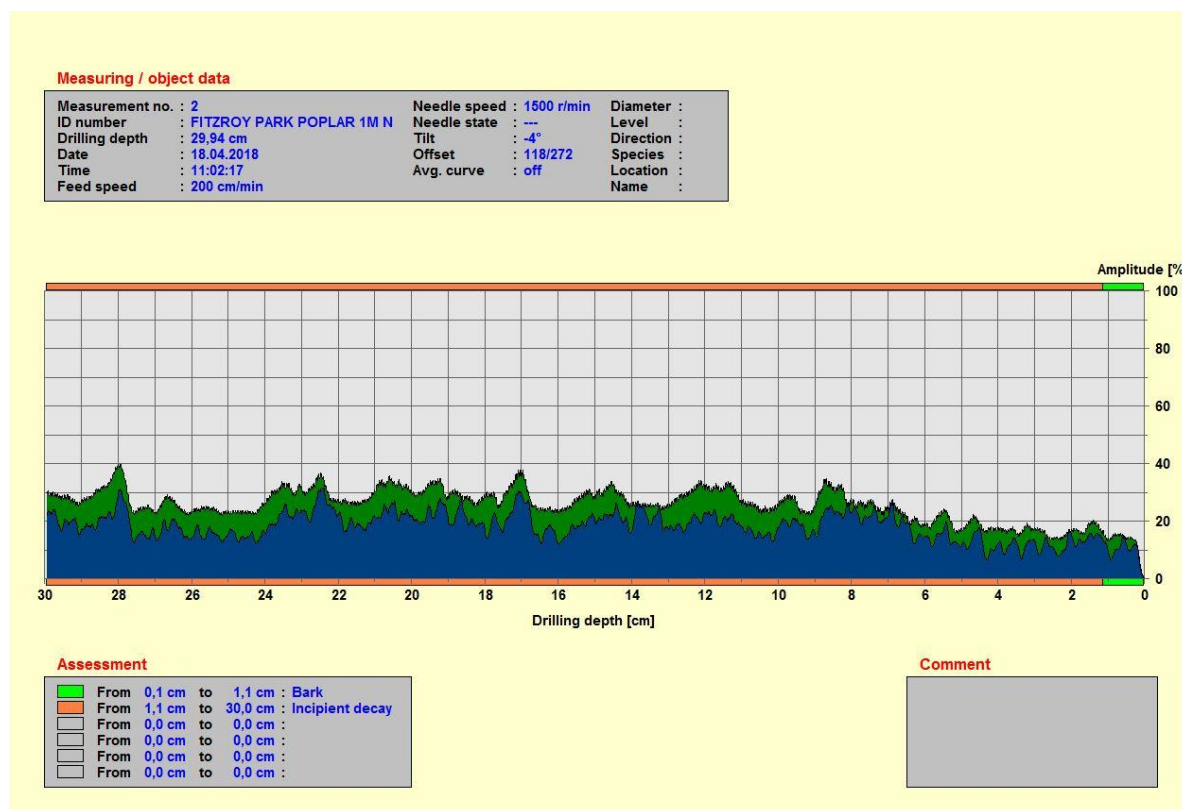
RESI PD Drill trace (read from right to left) at approximately 1m above ground level to the north, showing incipient decay from 2cm to 30cm

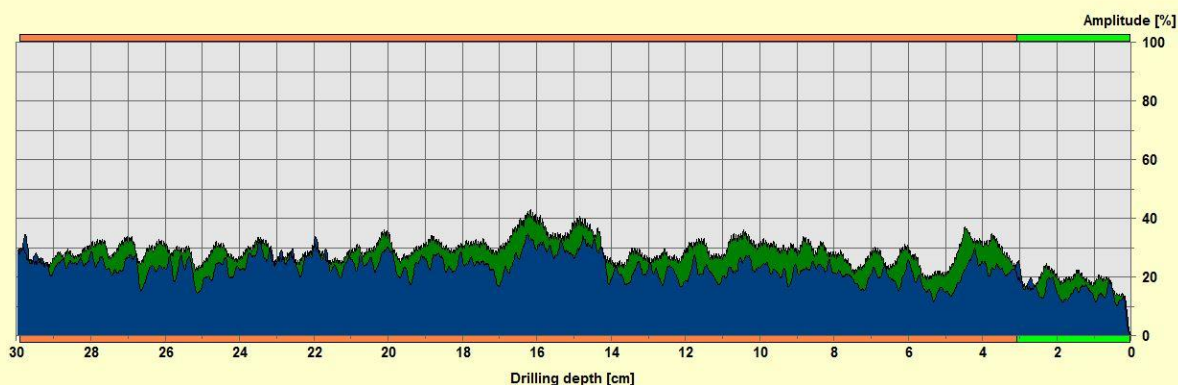
█	From 0,0 cm to 3,1 cm : Bark
█	From 3,1 cm to 29,9 cm : Incipient decay
█	From 0,0 cm to 0,0 cm :
█	From 0,0 cm to 0,0 cm :
█	From 0,0 cm to 0,0 cm :

RESI PD Drill trace (read from right to left) at approximately 1m above ground level to the west, showing incipient decay from 2cm to 30cm

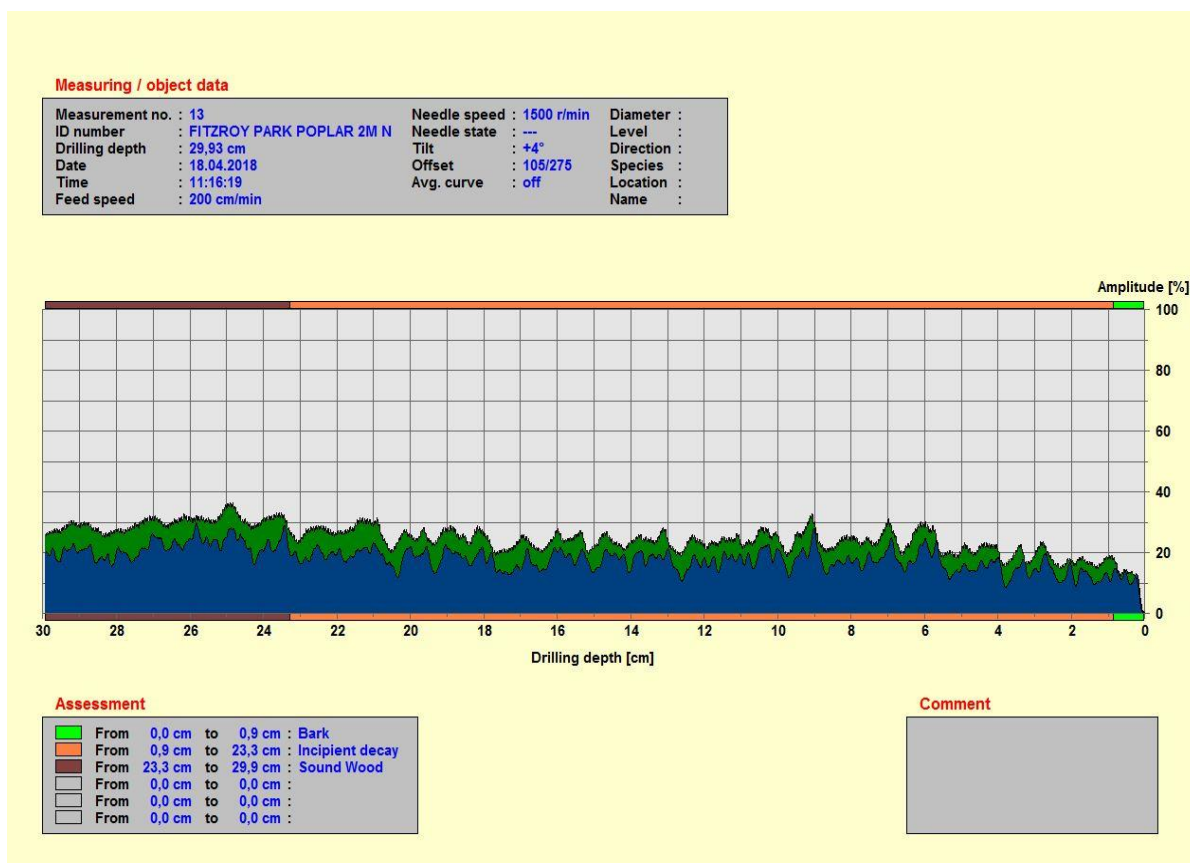
RESI PD Drill trace (read from right to left) at approximately 2m above ground level showing incipient decay between 1cm and 23cm where sound wood continues to 30cm
