**DEFECTS REPORT**

**16 BUCKLAND CRESCENT  
LONDON  
NW3 5DX**

**BUTA LIMITED  
57a BELSIZE PARK GARDENS  
LONDON  
NW3 4JN**

DATE OF SURVEY: 8<sup>TH</sup> FEBRUARY 2018  
DOC REF: 18.044.DR REV B  
WEATHER: COLD

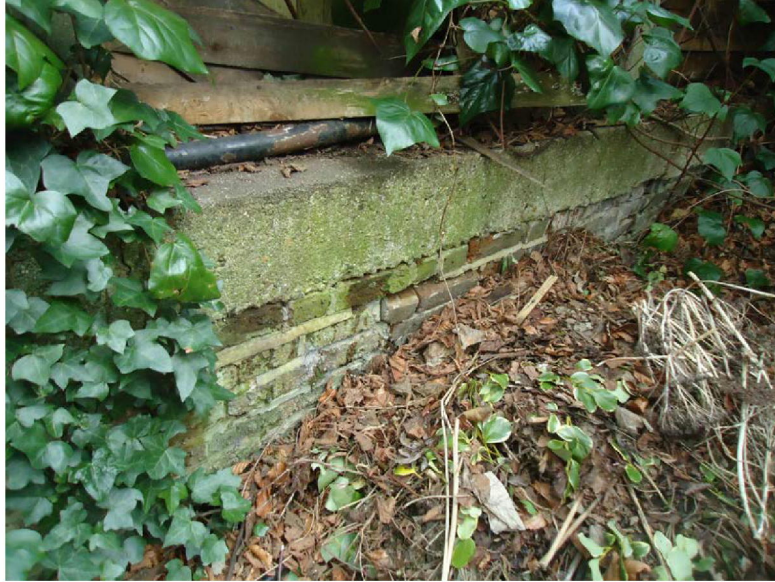
- 2.1.3 Generally the concrete posts are intact although the base has been pushed forwards slightly due to its age and movement from surrounding trees. There is significant vegetation growing from the rear adjoining gardens which has caused damage to the fence panels but we suspect the fence panels have deteriorated due to age.

Photo 1 – Party fence wall to the rear

- 2.1.4 We do not envisage wholesale reconstruction of the rear elevation boundary fence and wall is required at this time, however, we would recommend the fence panels are replaced in a like for like featheredged panels simply slotted into the existing concrete fence posts. This will require negotiation with the adjoining owners for the removal of vegetation from the rear elevation properties.

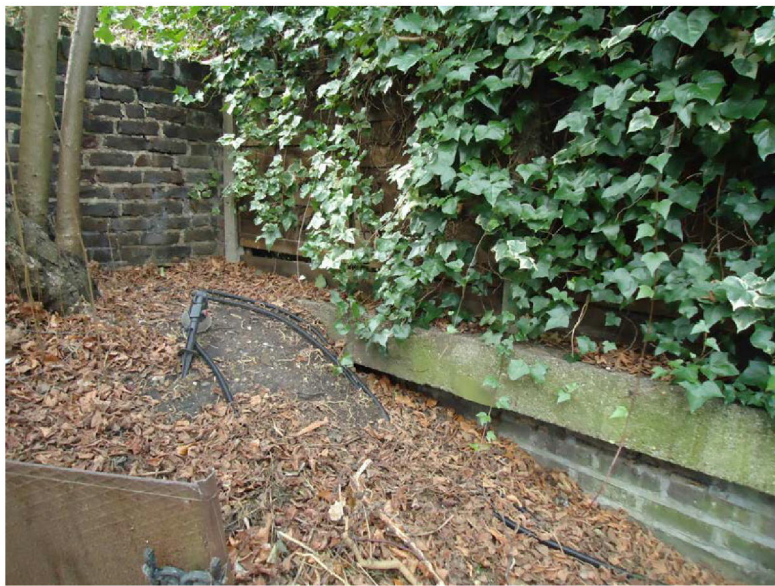
- 2.1.2 The rear elevation wall appears to have been taken down in the past and a concrete capping applied over the original wall with a concrete fence post installed. The works all appear to have been undertaken from the BUTA side of the wall. The rear fence serving No.16 runs along two properties to the rear elevation and the design and construction does not change.

Photo 2 – Concrete plinth on the original wall to the rear elevation

- 2.1.5 We did note areas of brickwork at low level which have been repaired in the past and we would recommend the wall is due an overhaul with any missing pointing or damaged brickwork is cut out and repaired as part of the works.

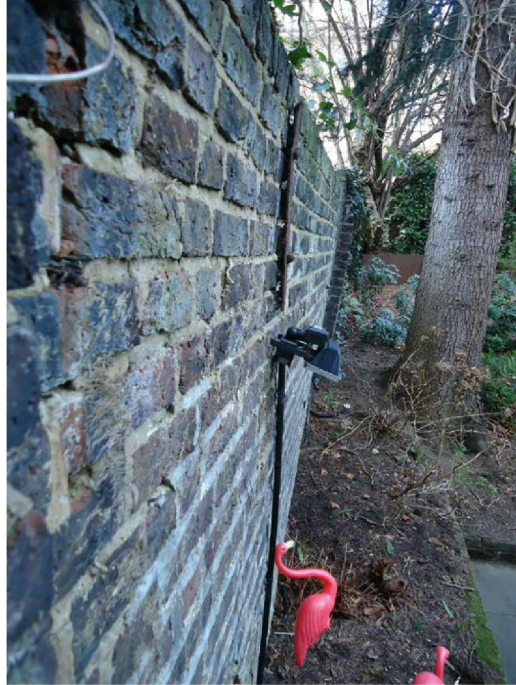
- 2.2.1 The boundary wall with No.18 is again the original wall probably constructed in a stepped footing on no foundations. The wall has a lean into No16 close to a large tree within the garden. We suspect the movement is due to the foundations being undermined by the trees and shrubs and lack of maintenance. Further down the garden towards the rear elevation there is a section of the wall that has a lean and is loose.

Photo 3 – Lean to the boundary wall with No.18

- 2.2.3 The large tree close to the boundary wall is undermining the structural stability of the wall and causing the wall to move. We would recommend that the tree is removed and where there is a large belly in the wall and where the wall is loose close to the tree that section is taken down and is reconstructed on the existing footings but with expansion ties and joints constructed in the wall. We suspect the brickwork can be retained and reused and you may well salvage up to 40% of the current bricks.

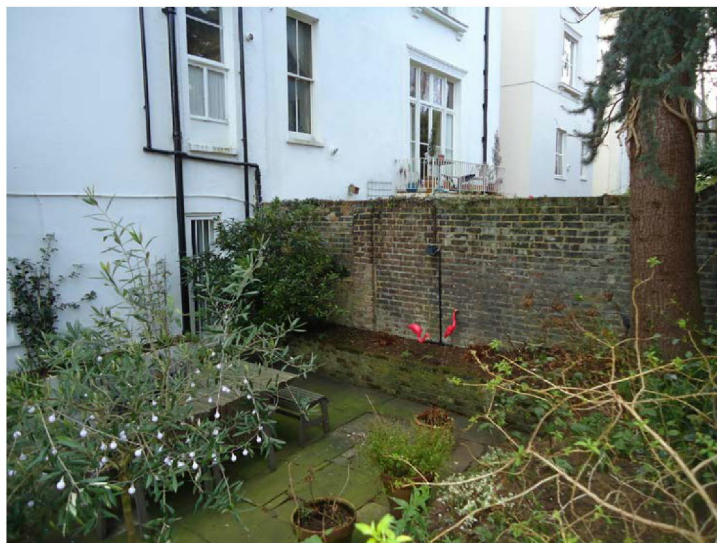
- 2.2.2 With reference to ownership of the wall, we would advise the boundary wall is a party fence wall which is located on or at the dividing line between 16 and 18, and used, intended to be used, or available to be used by both properties. The party fence wall stands half on the land of each owner and is maintained at mutual cost. Each owner of adjoining lands on which a boundary wall (party fence wall) stands owns the part of the wall that stands on the owner's land and has an easement, or right of use and obligation to maintain the wall. However, based on the large tree within No.16 causing the damage it may well fall to BUTA to repair the boundary wall.

Photo 4 – Party fence wall with No.18

- 2.2.4 The rear elevation section would benefit from removal of any loose and defective brickwork and reconstruction although we do not envisage much more than 2 sq m to the rear which requires rebuilding to the rear of the garden at high level.
