Our reference: J39
25th April 2018

Inspection of willow tree at 14 Windmill Hill

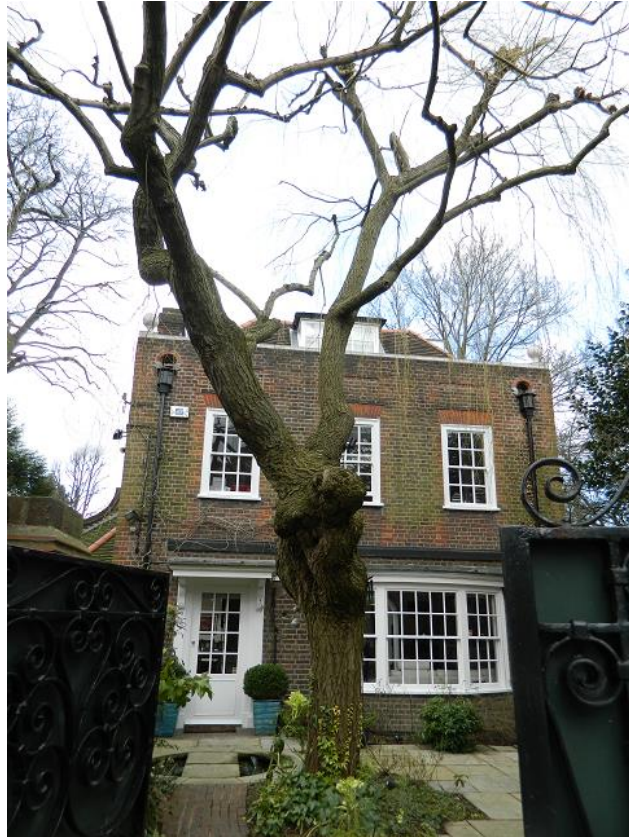
I carried out an inspection of the tree on 16th March 2018 (Figure 1). It had a trunk diameter of 480 mm and was pollarded at 9 m with about 1 m of regrowth from the pollard points. The diameter crown spread was about 9 m. No fungal fruiting bodies were present on the trunk. I tapped around the base of the trunk with a sounding mallet in order to detect the presence of dead bark or internal decay. All soundings were normal with no indications of the influence of fungal pathogens. In order to confirm my diagnosis that the stem was sound I took an increment core to a depth of 240 mm and it revealed intact undecayed wood to the centre of the trunk. I can therefore confirm that the rocking motion reported is not due to weakness in the trunk but is more likely due to problems with root anchorage. I had no facilities to inspect roots and therefore cannot say whether they are likely to be decayed or not, but removal of a small section of bark revealed that the cambium at the base of the tree was live and there were no signs of infection with honey fungus.

I was emailed a copy of a video recorded by Modern Arb Services on 12th April 2018 which showed the tree being 'wobbled' and indeed the trunk was moving in the ground. Whilst I can identify no direct cause for this I consider that the tree cannot be regarded as safe due to its close proximity to the house, boundary wall and road.

Figure 1. Photograph of willow tree in front garden.

The options available to make the tree safe are to further reduce the branches by pruning or to fell it. The pruning would have to be substantial and would need to be well below the existing pollard

points at 9 m. This would significantly disfigure the tree and is therefore not an option that I would recommend. In my opinion removal of the tree and replacement with one more suited to the setting would be appropriate.
