## SITE INVESTIGATION

25 FROGNAL

LONDON

**Insured:** [REDACTED]  
**Client's Ref:** 6635888  
**Auger's Ref:** 75715.1.2.USI  
**Visit Date:** 17.Jan.2018  
**Report Date:** 18.Jan.2018  
**Author:** SM  
**Checked By:** MM

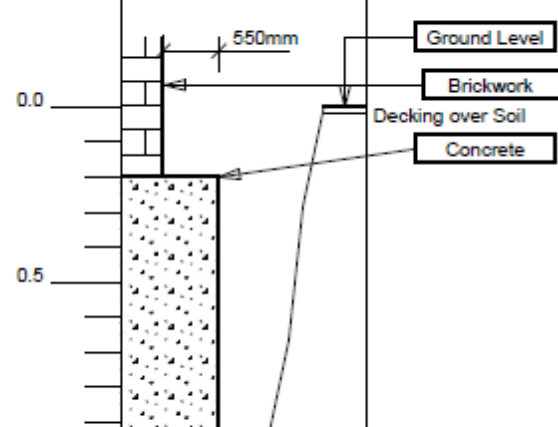
Trial Hole Log No. 2	Location : REAR LH CORNER OF X2 EXT
Moist = Normal wetting condition of subsoil. MP = Mackintosh Probe (Blows per 100mm). SV() = Shear Vane (19mm or 33mm)

Ground Level Brickwork Decking over Soil Concrete					
0.5							
1.0			SV(19)	64kpa	Soil @ 1m	Root @ 1m	
1.5		Brown fine gravelly silty CLAY	SV(19)	150+kpa	Soil @ 1.5m	Root @ 1.5m	
2.0			SV(19)	150+kpa	Soil @ 2m		
2.5		Brown clayey SILT	SV(19)	150+kpa	Soil @ 2.5m		
3.0		TRIAL HOLE TERMINATED

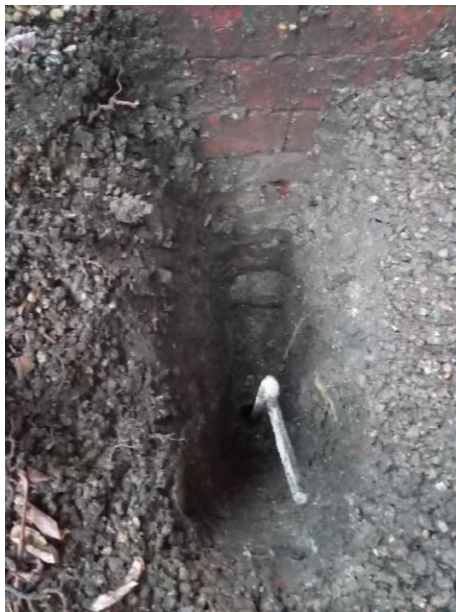
*Fig 1.1 – TH1.*

<b>Brief:</b>	Auger were commissioned by <b>Cunningham, Lindsey</b> to undertake a site investigation as instructed by the Loss Adjuster.
<b>Findings:</b>	<b><u>Visual Inspection</u></b> <ul style="list-style-type: none"><li>• TH1 was terminated at 1.9m due to hitting very hard ground, unable to auger further because of this. Furthermore, please note that due to depth, the footings are not necessarily exposed and footing depth and profile has been assumed by probing techniques.</li></ul>
