SUMMARY OF PROPOSED WORKS

CLIENT Venoru Ltd	
PROJECT 49 Marchmont Street, WC1N 2AN	
DRAWING PROPOSED FOURTH FLOOR (ATTIC) PLAN FOR PLANNING PURPOSES ONLY NOT FOR CONSTRUCTION	
DRG. No 14	REVISION C
SCALE 1:50 @ A3 PAPER	DATE 4 April 2018

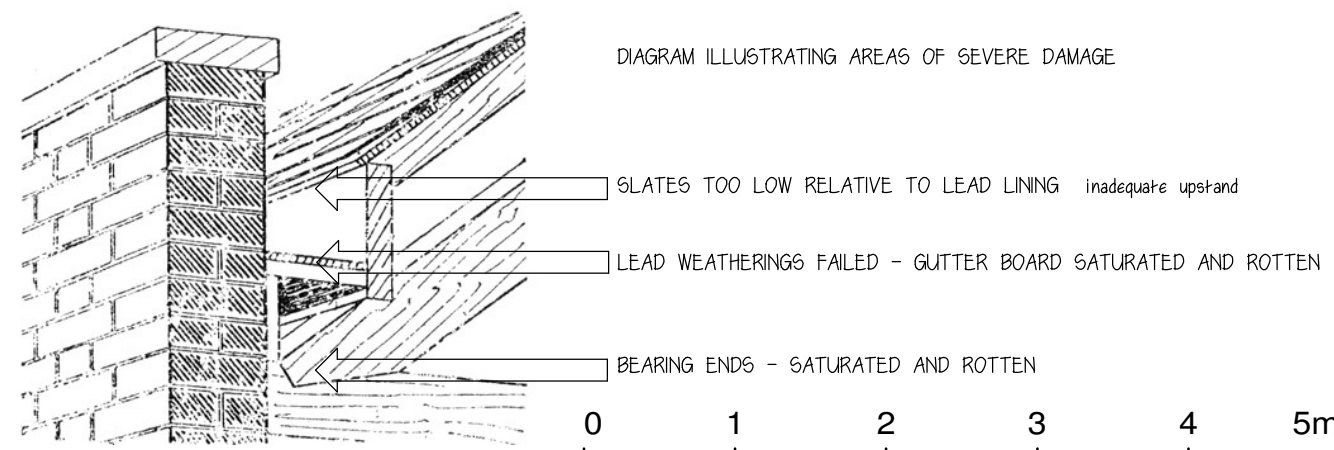
DIAGRAM ILLUSTRATING AREAS OF SEVERE DAMAGE

1. Intermediate ceiling joists
 Many of these are rotten and lack integrity especially at the eastern end where collapse has occurred
 these are to be repaired where possible using scarf joints or methods outlined to the right or new ceiling rafters to be placed alongside existing
2. Main trusses - see section also
 The bearing ends especially adjacent to the failed parapet gutter on the east elevation are rotten and defective
 The ends are to be carefully propped and new ends scarfed in - see diagrams adjacent to illustrate the typical approach
3. Rafters - have been inspected for rot and damage - whilst some may be beyond repair the intention is to retain as many original timbers as possible. They are to be left in situ
 However, long-term neglect, water ingress and continuous saturation have left many rotten at the bearing ends - of which many in a critical condition

GUTTER BOARD AT PARAPET
 (NB - Access not possible to west (rear) elevation because of window collapse)
 The gutter board has entirely failed and will need to be replaced entirely

The adjacent rafters will need to be temporarily propped, defective timbers cut away and replaced
 It is not clear if this can be done unless the roof is stripped and all defective timber cut out - when the rafters and trusses are being repaired too
