TO: Bloomsbury Leisure Group  
Bedford Way  
London, WC1H 9EU  
F.A.O: Jon Dalton  
CC: John Wiseman  
Dexterdesigns  
REF: Guildford Place, wall tile repairs

Following your recent instruction and my visit to site on 6<sup>th</sup> February 2017 I am pleased to submit my recommendations and costs to carry out the proposed wall tile repairs to the Ladies and Gents Toilets at Guildford Place, London.

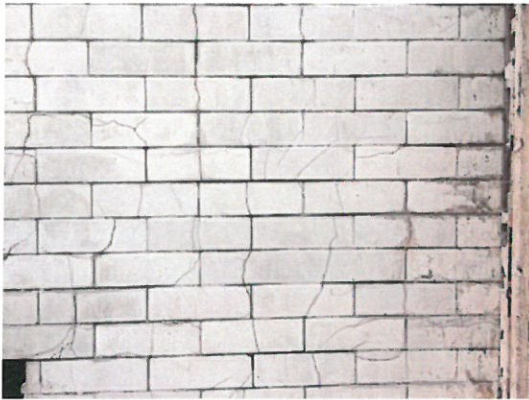
Before

While on site we carried out a small cleaning trail approximately 1 meter square in the Gents Toilets (see images before & after attached). As expected, the surface dirt and grime was easily removed, but unfortunately the ingrained dirt and surface cracking remained. I was surprised at the extent of surface cracking and this needs careful consideration. If the areas of the building are to be re-commissioned, I fear there may be hygiene issues if the structural movement is on going with cracks and fissures being almost impossible to keep clean.

Cleaning trial to Gent Toilet wall, drawing A107b

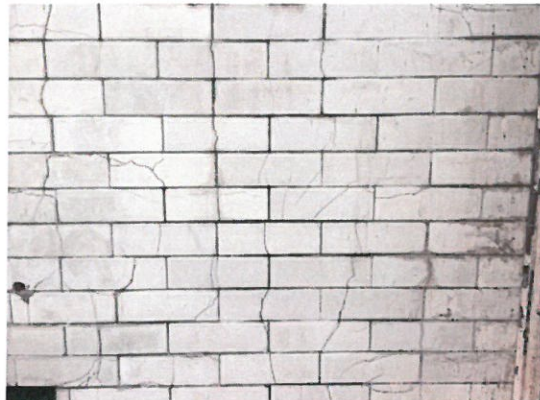
After, very little improvement

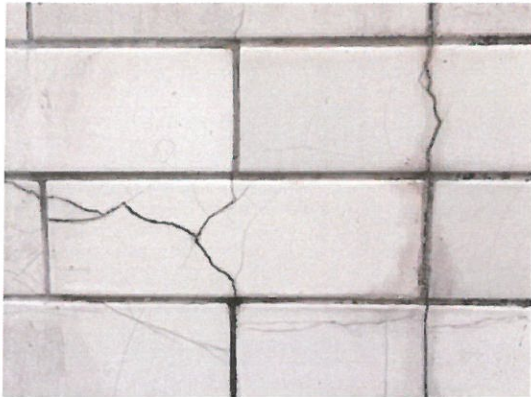
The glazed tile face is typically thin and not very forgiving in this type of environment. As a result of the movement most of the tiles, especially in the Gents Toilets have many cracks or fissures, and or ingrained staining. This staining has ingressed the tile surface and cannot be removed successfully by chemical or poultice cleaning methods.

Movement cracks causing surface cracks / fissure

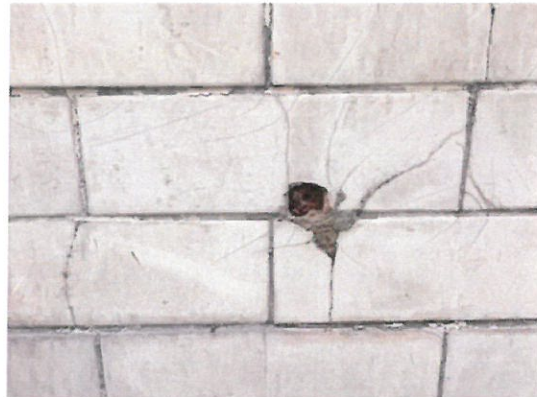
Impact damage, previous wall fixing damage

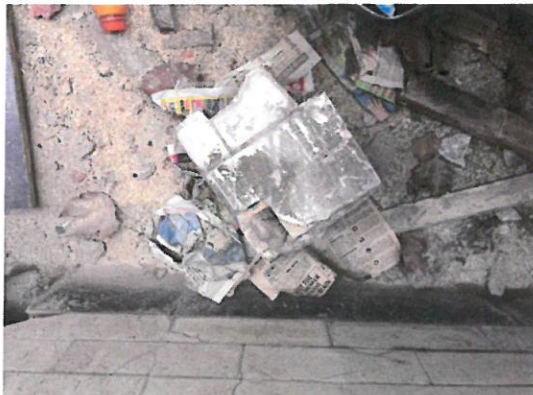
Detached sections from vulnerable areas at high level

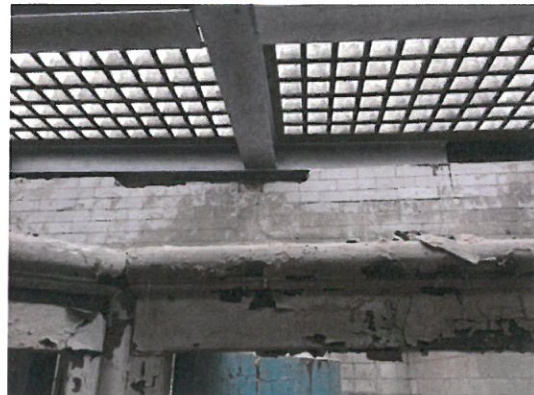
Missing and damaged tiles at high level following reinstatement of new roof light

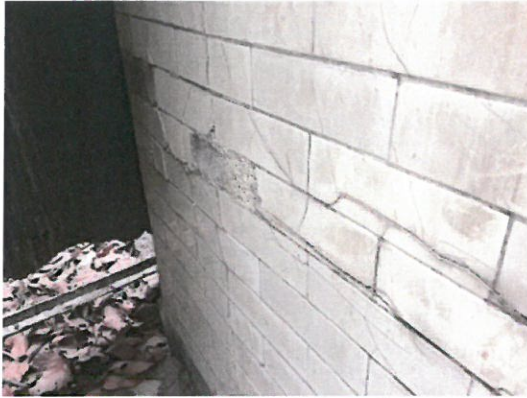
Structural failure, horizontal crack

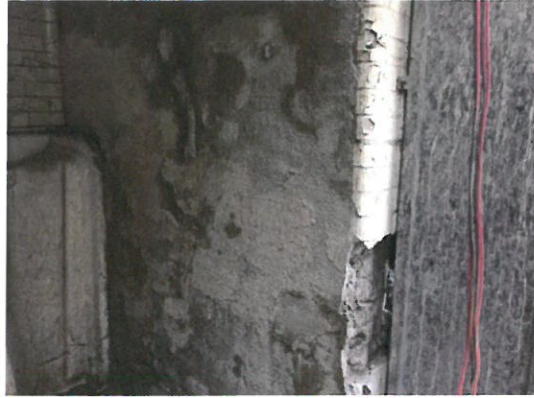
Large rendered section, missing tiles

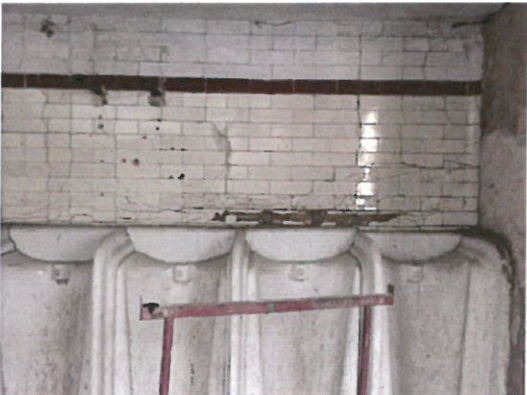
Delaminated tiles above urinals

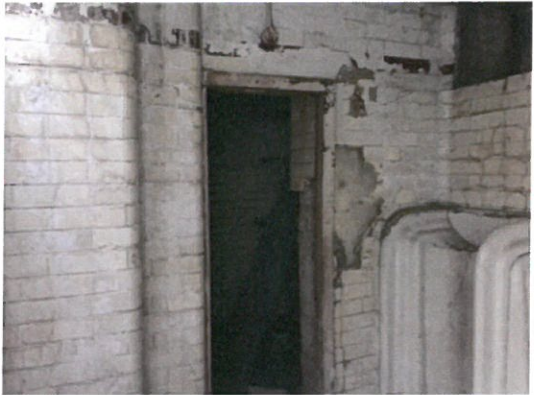
Paint in tiles surface, numerous missing sections

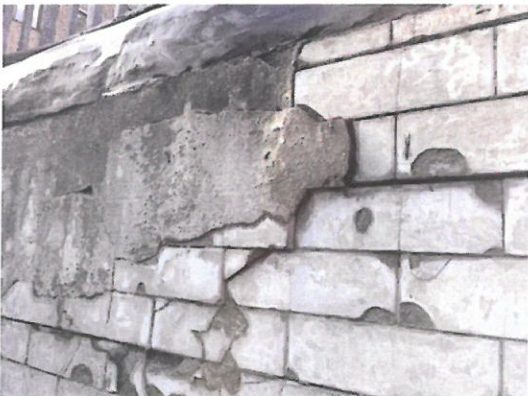
Exterior wall, previous unsympathetic repairs, indicating historic structural failure

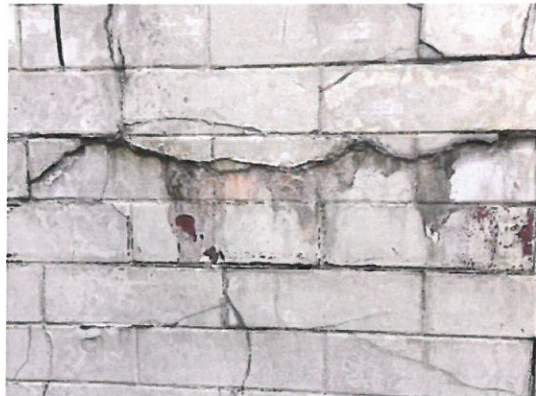
Exterior wall, severe movement and moisture ingress

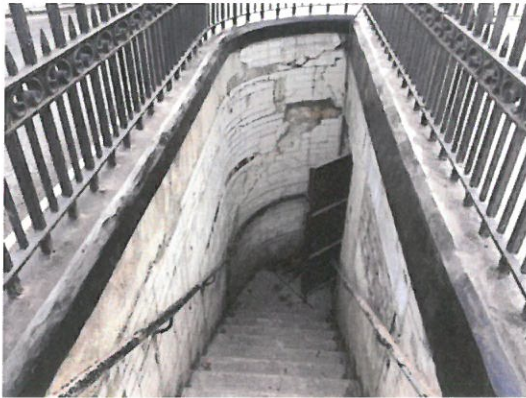
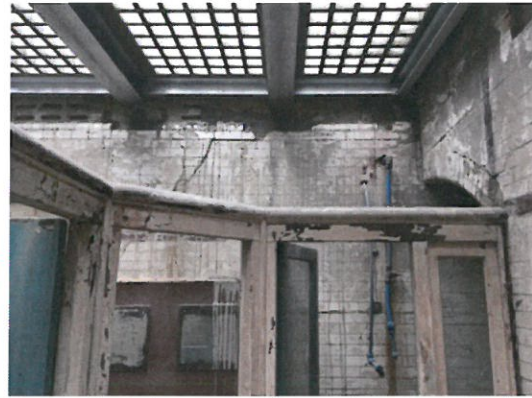
Generally in better condition than Gents Toilet,  
Repairs required at high level

1. I suggest the best example of the existing tile decoration be repaired, ideally an internal wall in the Ladies toilet where structural failure and moisture ingress are not present. This wall could be restored to illustrate how the original Toilets were decorated, using handmade replacement Craven Dunnill tiles where necessary.

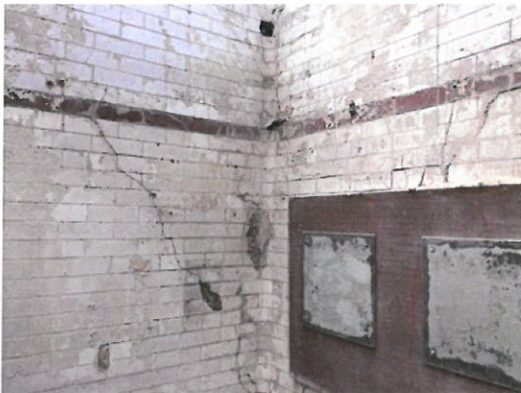
Severe structural crack, wall paint on tiles

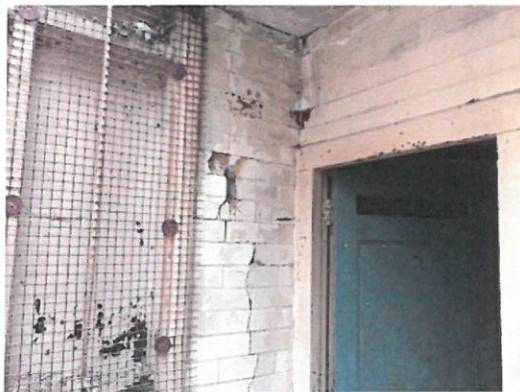
Severe cracking either side of entrance door, structural as well as cosmetic repairs required
