Apartment 2.02 St Pancras Chambers - Room 2

Apartment 2.02 St Pancras Chambers - Flooring details

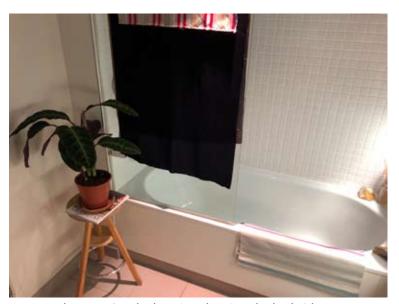
Bathroom - Detail showing the access panel for the plumbing and electrical services.

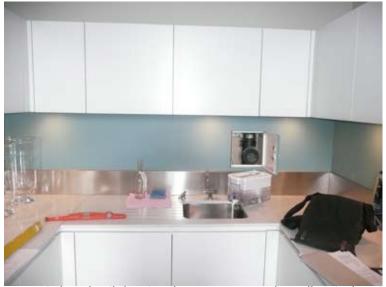
Room 3 - North elevation showing the side sub-walls to house the kitchen services

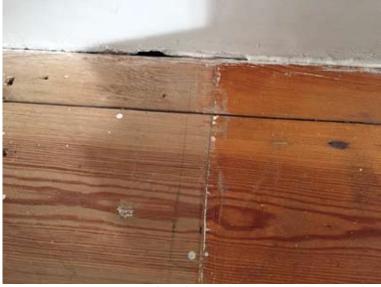
Room 3 - Plaster skirting detail .

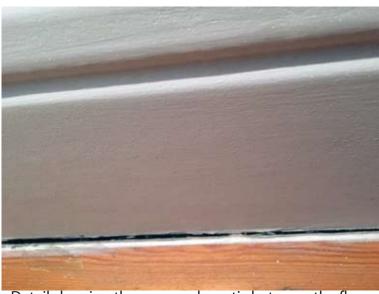
Detail showing the mastic used around the board covering the fireplace in Room 2
