# Claim Assessment Report

**Our Reference:** IFS-LBG-SUB-17-0073223

**Risk Address:** 8 Brookfield Park, London, NW5 1ER

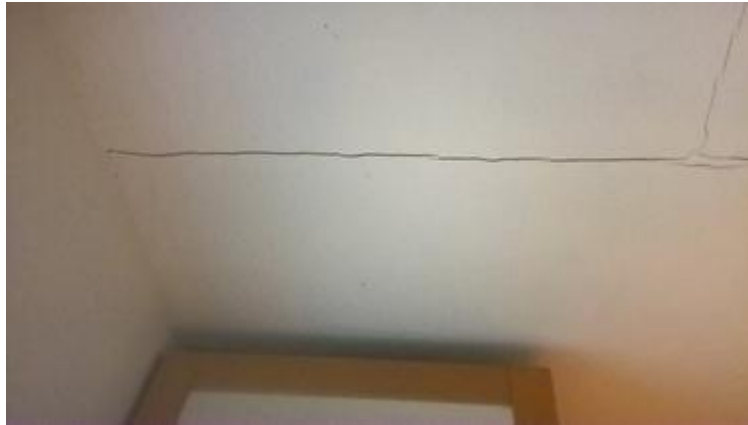
FIGURE 03 Kitchen Ceiling

The internal damage to the kitchen includes ceiling and wall cracks as well as some floor distortion. The crack patterns are typical for foundation related movement. Cracks have developed across the window and door opening in the right flank wall of the extension. The cracks are wider at the top and diagonal implying foundation movement.

Generally cracks 1mm wide or less will be filled (internal) or re-pointed (external). Internally, where the cracks are wider than 1mm, but less than 5mm the underlying brickwork or blockwork will be exposed and prior to making good the plaster finishes the cracking will be covered with expanded metal lathe. Where cracks are 5mm across or wider, some form of bed joint reinforcement will be introduced.

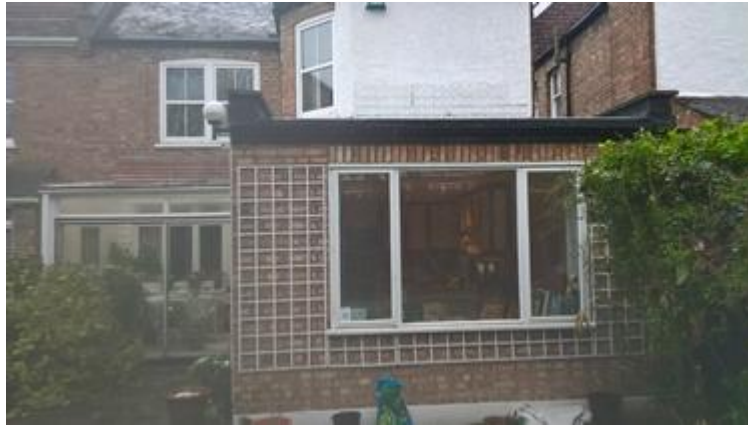
FIGURE 06 Rear Elevation

Externally, cracks have developed in the flank wall of the extension, within the adjacent conservatory. There is also some distortion to the paving directly to the rear of the extension.

Foundation movement to the right corner of the extension in relation to vegetation in the rear garden results in the crack damage and distortion now evident.
