Arboricultural Consultancy for Lloyds Bank

Insured	Mrs Inger Freeman	Address	8 Brookfield Park, London, NW5 1ER		
Client	Subsidence Management Services	Contact	Kevin Dean	Claim No.	IFS-LBG-SUB-17-0073223
ES Ref	SA-240141	Consultant	Giles Mercer	Contact No.	0330 380 1036
Report Date	23/01/2018

2. Property and Damage Description

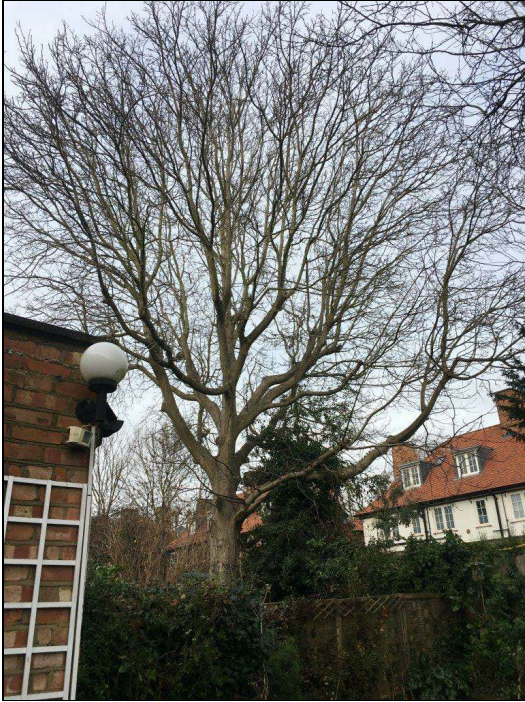
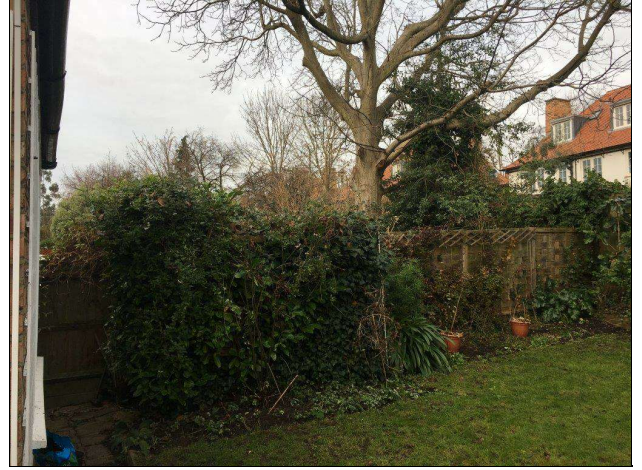
S1 & T1

Please note that the footing of the insured property fall within the anticipated rooting distance of additional vegetation which we believe presents a foreseeable risk of future damage and accordingly we have made recommendations in respect of this.

Tree No.	Species	Age Cat	Approx. Height (m)	Distance to Building (m) *	Ownership	Action	Requirement
S1	Laurel	1	2	1.1	C - Insured	Action to avoid future risk	Do not allow to exceed current dimensions by way of regular pruning.
T1	Walnut	2	22	10.6	A - Third Party 10 Brookfield Park London NW5 1ER	Action to avoid future risk	Crown reduce by 3m – 4m all around and maintain at reduced dimensions by way of regular re-pruning (3-year max).
T3	Yew	1	8.2	11.3	D - Unknown	No action	No works.
T4	Ash	1	18.5	14.8	D - Unknown	Action to avoid future risk	Crown reduce by 3m – 4m all around and maintain at reduced dimensions by way of regular re-pruning (3-year max).

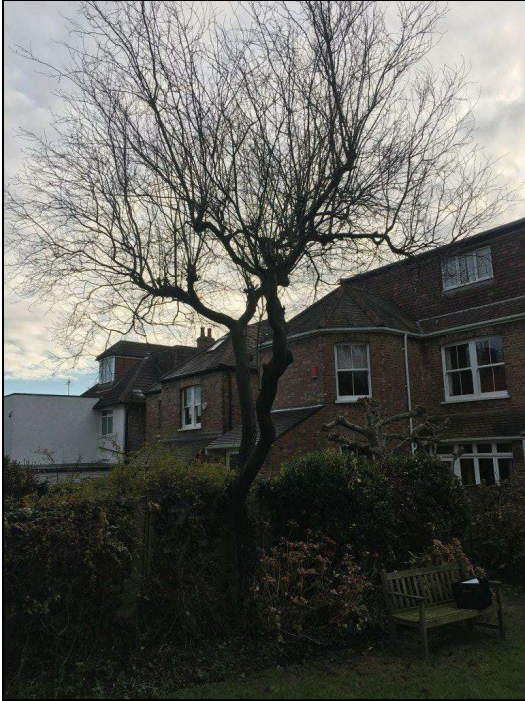
In terms of species profile, size and proximity to the damaged structure the *Prunus* (T2) is, in our opinion the dominant vegetation proximate to the area of damage, the source of the roots recovered and accordingly we have identified it as the principal cause of the observed damage.

Removal of T2 and T5 will offer the most certain and reliable arboricultural solution likely to restore long-term stability.

It seems inevitable that the owner will require sufficient time to fully assess the efficacy of the recent works and as such we would advise that T2 is removed promptly and the property is monitored.

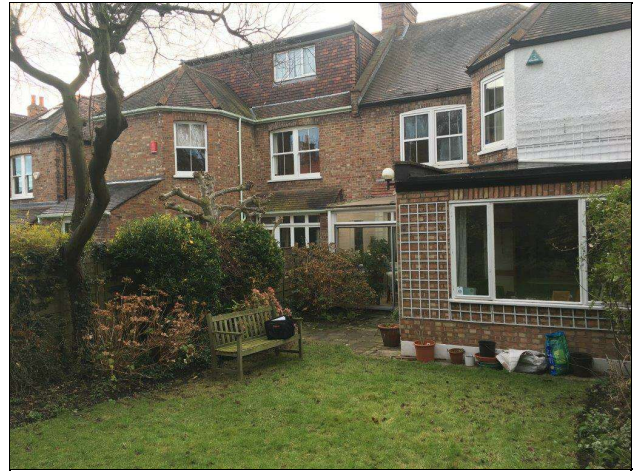
T2 & T5

However, whilst not positively implicated, T5 (Fig) cannot be discounted as contributing to the overall level of soil drying proximate to the area of damage and is therefore also considered to retain a contributory influence, albeit in a secondary capacity when compared to T2.

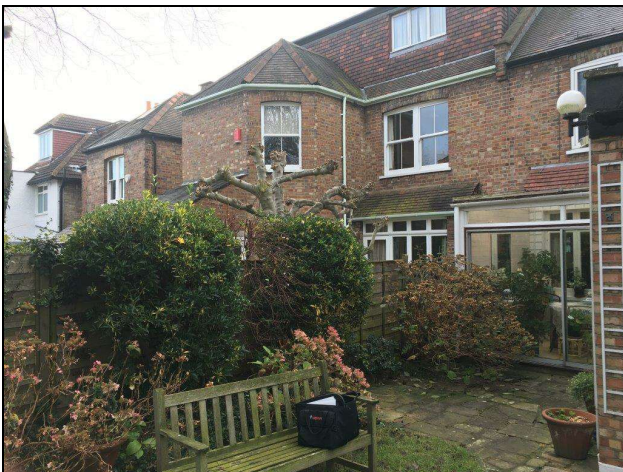
T5 (Fig) is therefore also judged to be a significant, albeit secondary factor in the current movement/damage,

Please note; T5 has very recently been subject to robust crown reduction works; the extent of this work is likely to accord with the parameters recommended by published research and consequently a meaningful reduction in soil drying should be expected.
