Fire Risk Assessment (V.3)

5 Great James Street, Bloomsbury, London

Date of Site Visit: 19/01/2018

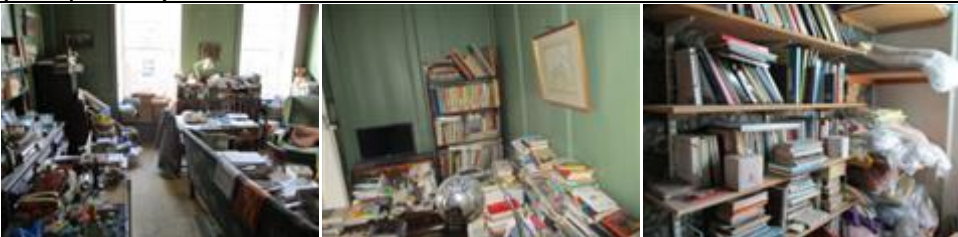
Sources of Ignition	2.7) Are adaptors and extension leads being used in a safe manner			
Observed Condition:	Unsatisfactory			
Risk Measurement	Severity: 3	Likelihood: 2	Risk Score: 6	Risk Weighting: 2
Recommended Action	The electrical socket provision and use of extension leads in Flat 2 could not be ascertained so investigate the situation further and upgrade the sockets as required. Also check that there is a suitable provision of sockets in Flats 1 and 3 and upgrade accordingly.			
Action Notes	Extension cables and connections should not be overloaded or used in sequence ("daisy chain") due to the elevated risk of electrocution or fire.			
Action Images

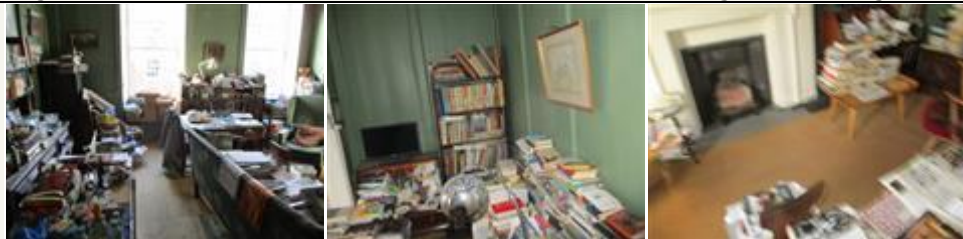
Sources of Fuel and Oxygen	3.10) Are all other fuel/oxygen issues, not covered elsewhere in the report, satisfactory			
Observed Condition:	Unsatisfactory			
Risk Measurement	Severity: 3	Likelihood: 2	Risk Score: 6	Risk Weighting: 2
Recommended Action	Provide a fire guard to the gas fire.			
Action Notes	In Flat 2 Mrs King has an unguarded open gas fire in the lounge which also has a large amount of combustible material in fact the flat has a high fire loading.			
Action Images

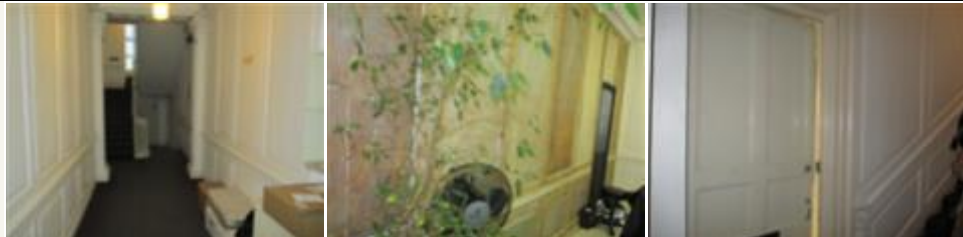
Fire and Smoke Containment	4.2) Are all walls, doors, ceilings, glazing etc. to the required level of fire resistance			
Observed Condition:	Unsatisfactory			
Risk Measurement	Severity: 3	Likelihood: 2	Risk Score: 6	Risk Weighting: 2
Recommended Action	The walls on the left between the offices and the means of escape corridor from the commercial premises should be upgraded to 60 minutes fire resistance. This can be achieved by encapsulating the internal office walls with plasterboard with the joints to be taped and the whole skimmed with plaster. A fire rated paint or varnish cannot be used as the original boards are too thin for this type of application.			
Action Notes	The walls between the offices and the means of escape corridor from the commercial premises are constructed of the original 1721 wood panels and are not to 60 minutes fire resistant. Flats should be separated from other occupancies in mixed-use buildings by walls and floors affording a minimum fire resistance of 60 minutes. It is equally important that the common means of escape from flats is suitably protected from the effects of a fire in other occupancies. The common means of escape routes, including corridors, lobbies and stairways, should be separated from other occupancies by fire-resisting construction to ensure the escape routes remain safe to use at all times.

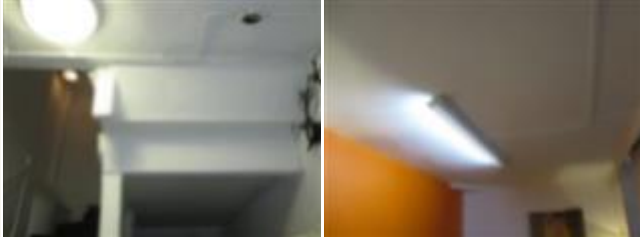
Fire and Smoke Containment	4.2) Are all walls, doors, ceilings, glazing etc. to the required level of fire resistance			
Observed Condition:	Unsatisfactory			
Risk Measurement	Severity: 3	Likelihood: 2	Risk Score: 6	Risk Weighting: 2
Recommended Action	The fire separation between the basement ceilings and the ground floor (including the staircase soffit and spandrel) is believed to be lathe and plaster which is not in good condition and only providing a notional 30 minutes fire resistance, this needs to be made up to 60 minutes fire resisting preferably by encapsulating in additional plaster board to add a further 30 minutes fire resistance with the joints to be taped and the whole skimmed with plaster.			
Action Notes	The basement fire separation from the ground floor due to the lathe and plaster ceilings and walls is only a notional 30 minutes.			
Action Images

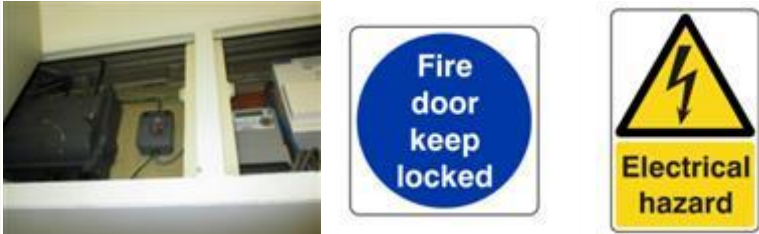
Fire and Smoke Containment	4.2) Are all walls, doors, ceilings, glazing etc. to the required level of fire resistance			
Observed Condition:	Unsatisfactory			
Risk Measurement	Severity: 3	Likelihood: 2	Risk Score: 6	Risk Weighting: 2
Recommended Action	The electric intake equipment in the basement offices in the means of escape to the front external fire exit should be enclosed in a 30 minute fire resistant cupboard. The new doors should be signed "Fire door keep locked" and an electrical warning sign fitted.			
Action Notes	The electric intake equipment in the basement offices in the means of escape to the front external fire exit is not enclosed in 30 minute fire resistant materials.			
Action Images

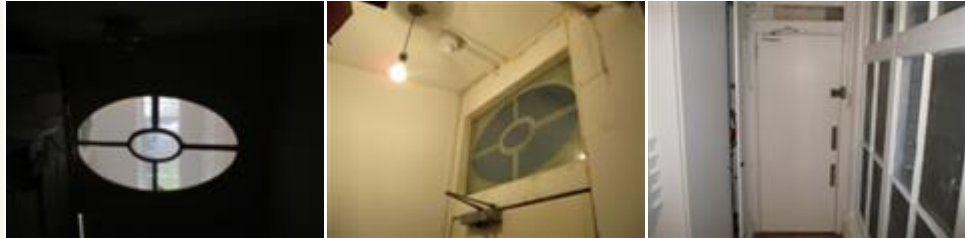
Fire and Smoke Containment	4.2) Are all walls, doors, ceilings, glazing etc. to the required level of fire resistance			
Observed Condition:	Unsatisfactory			
Risk Measurement	Severity: 3	Likelihood: 2	Risk Score: 6	Risk Weighting: 2
Recommended Action	Ensure that the glazing at the top of Flats 1 and 3 doors is upgraded to provide a minimum of 30 minutes fire resistance. This can be achieved by installing a fire resistant sheet of glass on the back of the existing glazing as per Flat 2. The glazing above the door to the Londonist on the ground floor should be encapsulated with plasterboard to 60 minutes fire resistance or replaced with 60 minute fire resistant glazing.			
Action Notes	The glazing above Flats 1 and 3 doors have no indication of fire resistance.			
Action Images

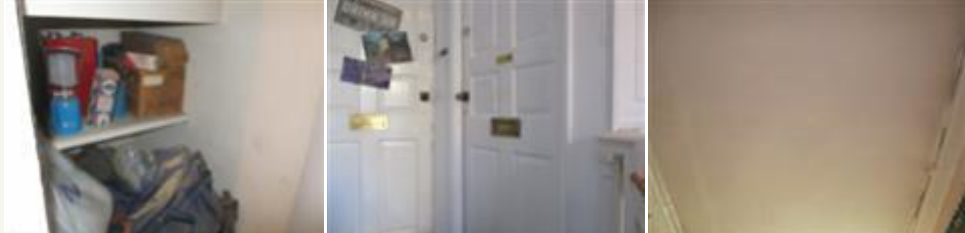
Fire and Smoke Containment	4.2) Are all walls, doors, ceilings, glazing etc. to the required level of fire resistance			
Observed Condition:	Unsatisfactory			
Risk Measurement	Severity: 3	Likelihood: 2	Risk Score: 6	Risk Weighting: 2
Recommended Action	The fire separation in Flat 2 in the cupboard under the stairs for Flat 3 should be upgraded to ensure at least 30 minutes fire resistance. This may be achieved by encapsulating the internal walls with plasterboard. The partition walls between Flat 2 and the common staircase should be upgraded to 30 minutes fire resistance by encapsulating the internal walls with plasterboard. The ceilings in Flat 2 are lathe and plaster and are in very poor condition and it is doubted if this will provide a notional 30 minutes fire resistance especially with the high fire loading in this flat, it would be preferable if they were encapsulated in new plasterboard to provide 30 minutes fire resistance but as the building is Grade 11* listed this is probably not possible therefore they should be painted with a fire retardant paint to provide 30 minutes fire resistance, advice from a specialist paint supplier should be sought prior to any application.

Action Notes	There is a cupboard in Flat 2 under the stairs for Flat 3 which is not to 30 minutes fire resistance.			
Action Images

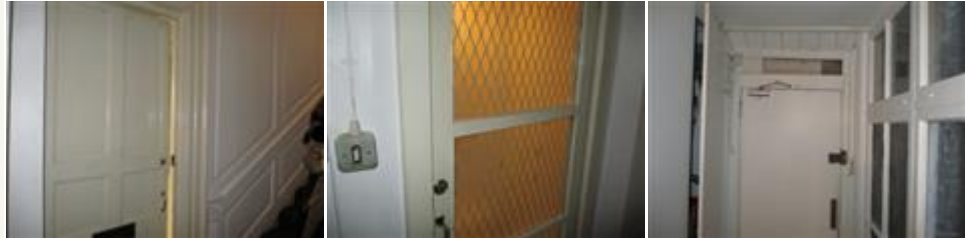
Fire and Smoke Containment	4.2) Are all walls, doors, ceilings, glazing etc. to the required level of fire resistance			
Observed Condition:	Unsatisfactory			
Risk Measurement	Severity: 3	Likelihood: 2	Risk Score: 6	Risk Weighting: 2
Recommended Action	The entrance door to Ambigram Architects should be upgraded to 60 FDS standard and fitted with new door furniture including a self-closer. The doors to Stack Hut and Londonist should be replaced with 60FDS fire doors to match the Ambigram Architects door. The glazing above the door to the Londonist on the ground floor should be encapsulated with plasterboard to 60 minutes fire resistance or replaced with 60 minute fire resistant glazing.			
Action Notes	The entrance doors to the commercial tenants are not 60 minutes fire resisting.			
Action Images

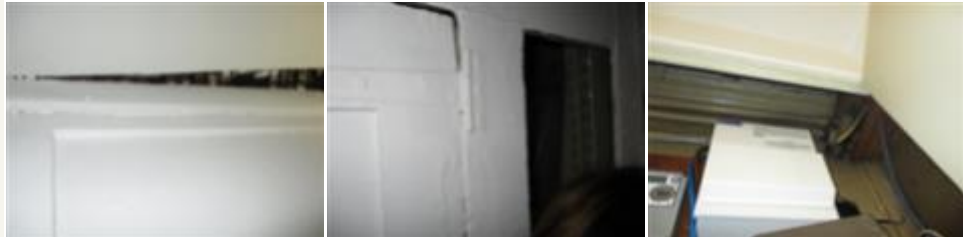
Fire and Smoke Containment	4.4) Are all gaps in fire resisting walls or floors effectively sealed			
Observed Condition:	Unsatisfactory			
Risk Measurement	Severity: 3	Likelihood: 2	Risk Score: 6	Risk Weighting: 2
Recommended Action	All of the penetrations in the basement office by ducting or building services should be fire stopped using approved materials installed by a competent contractor to provide a minimum of 60 minutes fire resistance. On the ground floor entrance corridors the penetrations in the walls should be fire stopped to provide a minimum of 60 minutes fire resistance. On the staircase by Flat 2 the wall needs to be fire stopped to provide a minimum of 30 minutes fire resistance. Any sealants used should comply with BS476-22. See additional photographs.			
Action Notes	To ensure effective protection against fire, walls and floors providing fire separation must form a complete barrier. Any openings such as pipe or cable penetrations through which fire and smoke may spread should be rectified by suitable fire stopping with an equivalent level of fire resistance.

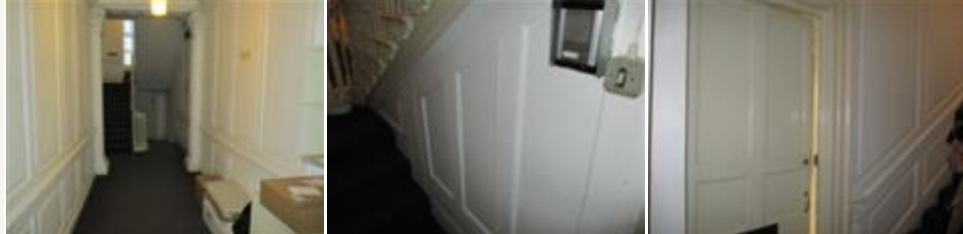
Fire and Smoke Containment	4.6) Do wall linings restrict the spread of fire			
Observed Condition:	Unsatisfactory			
Risk Measurement	Severity: 3	Likelihood: 2	Risk Score: 6	Risk Weighting: 2
Recommended Action	The surface finish / lining of the walls in the means of escape corridor and staircase appear to be combustible and should be upgraded to Class O. This may be achieved by using a fire rated paint to achieve Class O and advice from a specialist fire retardant paint supplier should be sought prior to any application.			
Action Notes	Flammable materials should not cover the surface areas of walls in escape routes. The walls on the right in the means of escape corridor and staircase abut the party wall and are constructed of the original 1721 wood panels and it is believed that due to the number of paint finishes these are not to a standard classification not lower than 'Class O' (as prescribed in the Building Regulations Approved Document B).

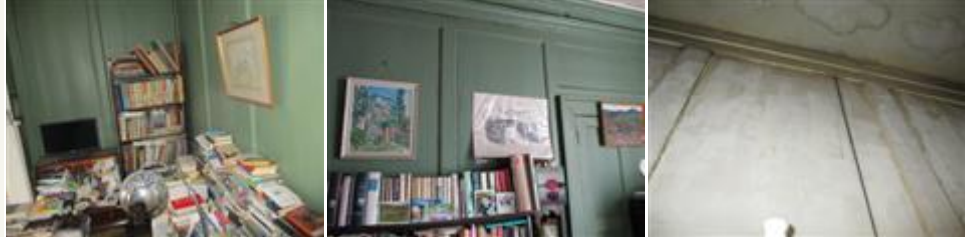
Fire and Smoke Containment	4.6) Do wall linings restrict the spread of fire			
Observed Condition:	Unsatisfactory			
Risk Measurement	Severity: 3	Likelihood: 2	Risk Score: 6	Risk Weighting: 2
Recommended Action	The wall linings in Flat 2 are the original 1721 wood panels and these should be treated with a suitable fire retardant to bring them up to Class 1.			
Action Notes	The wall linings in Flat 2 are the original 1721 wood panels and these are not to Class 1 for surface spread of flame.			
Action Images

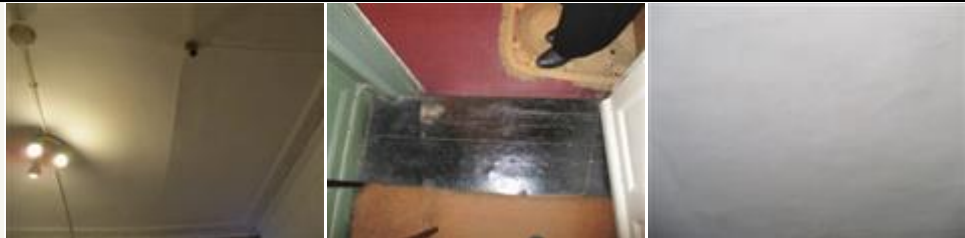
Fire and Smoke Containment	4.7) Is the fire rating of floors satisfactory			
Observed Condition:	Unsatisfactory			
Risk Measurement	Severity: 3	Likelihood: 2	Risk Score: 6	Risk Weighting: 2
Recommended Action	The ceiling from Flat 1 or the floor in flat 2 should be upgraded to 30 minutes fire resistance to provide better protection against the spread of fire. This may be achieved by either encapsulating the internal ceilings with plasterboard or by using a fire rated paint to 30 minutes fire resistance on the internal ceiling. The floor boards in Flat 2 should be painted with a fire resistant varnish to 30 minutes fire resistance. Advice from a specialist fire retardant paint supplier should be sought prior to any application.			
Action Notes	The ceiling in Flat 1 is not to 30 minutes fire resistance. In Flat 2 the floor boards are original from 1721 and have many layers of paint or varnish on them. The ceiling in Flat 2 is the original lathe and plaster and is not to 30 minutes fire resistance. Construction of floors should not allow fire spread to the compartment above before the building has been safely evacuated.

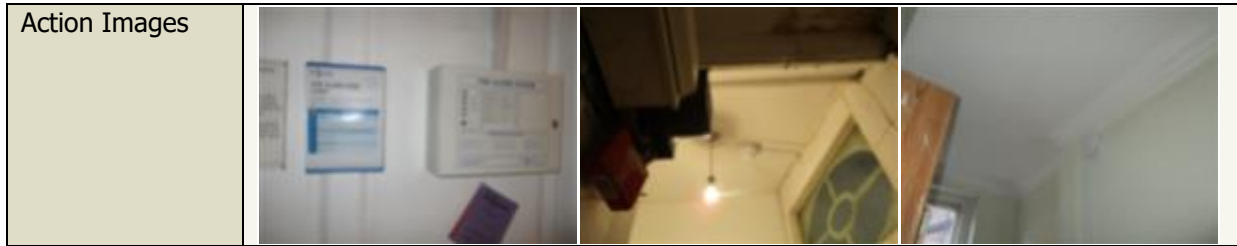
Fire Detection and Warning Systems	5.2) Is the fire detection and alarm system adequate for the layout and use of the building			
Observed Condition:	Unsatisfactory			
Risk Measurement	Severity: 3	Likelihood: 2	Risk Score: 6	Risk Weighting: 2
Recommended Action	<p>The fire alarm system should be upgraded and there are several options available. Option 1: The premises should be fitted with a new Grade A LD2 BS 5839 pt 6 system in the flats with AFD (Automatic Fire Detection) installed in all of the risk rooms including lounges, access rooms and kitchens, it should also be fitted in bedrooms to achieve 75dBa at the bedhead and be interfaced with the Landlords system. Because of the poor compartmentation (even with the recommended works there are still hidden voids which will allow fire spread) and inner room situations (risk rooms) it is recommended that the Landlords fire alarm is extended into the commercial tenants demised areas to cover all rooms and that smoke detection is fitted to each staircase landing to L2 BS5839 pt 1 standard as this would cover risk rooms i.e. inner/access rooms. The Landlords L3 BS5839 pt 1 system currently has an AFD head in each of the flats and these should remain but should be changed to smoke detectors rather than heat detectors as their location is protected by a lobby and there would need to be a very serious fire for it to activate. Option 2: It could be argued that as the Landlords L3 BS5839 pt 1 system already has an AFD head in each flat and commercial demise it would avoid confusion if there was just one fire alarm system for the whole premises with a Landlords L2 BS5839 pt 1 system providing smoke detection to each staircase landing in and each room of both the residential and office areas. The provision of multi-sensor AFD heads could be used to keep false alarms to a minimum. See the Hochiki White Paper Scenarios 1, 2 and 3 for a part 1 system for further information (Uploaded to Meridian). It is advised to discuss this option with the Fire Alarm engineers and London Fire Brigade. Fire alarm requirements: A diagrammatic fire alarm zone plan is required. AFD installations may be achieved by using wireless technology which would not require invasive chasing of walls or surface mounted cables. A new Fire Alarm Control panel to the current EN 54 pt 2-4 standard will be required. To avoid confusion any redundant fire alarm equipment should be removed. See additional photographs. All works are to comply with Camden Councils Historic impact Assessment and Design and Access Statement.</p>

Action Notes	<p>There are a variety of fire alarm systems on site and there seems to be a new system and a redundant system and it is difficult to know the cause and effect of all of the equipment on site, i.e. is the AFD in the basement office still live or is only the new AFD head active. There seems to be a mixed system within the flats having various degrees of coverage including an AFD head just inside their front entrance doors from the Landlords main building fire alarm system linked back to the fire alarm panel in reception. One of the commercial tenants Ambigram Architects has only a domestic smoke detector. With the exception of the Londonist all of the residential and office tenants have inner room situations, in fact Flat 2 has inner, inner, inner room situations with the bedroom access room not protected by AFD or vision panels etc. The flats seem to have a Grade D LD3 BS 5839 pt 6 system and the HMO a Grade D LD2 system but no AFD in the access room. The Landlords new system seems to be to L3 BS 5839 pt 1. It is not known if the AFD in the offices is still live or if it's linked to the Landlords panel. The zone chart just shows 1 zone per tenant but this is just for the Landlords AFD head and it is expected that the other AFD heads in the tenant's demised areas are not linked to the Landlords panel.</p>

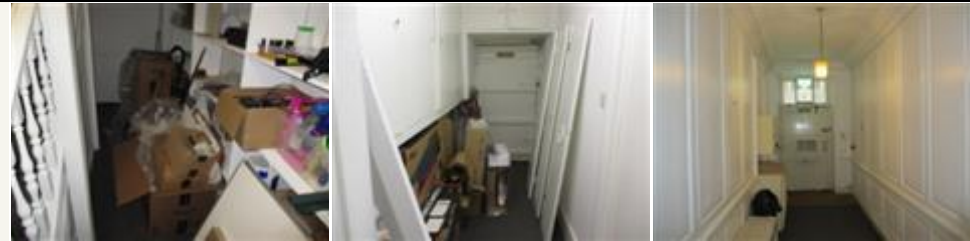
Escape Routes	7.7) Is every escape route free of items which could cause slips, trips or cause an obstruction and/or pose a fire hazard			
Observed Condition:	Unsatisfactory			
Risk Measurement	Severity: 3	Likelihood: 2	Risk Score: 6	Risk Weighting: 2
Recommended Action	Ensure that the escape routes in the following areas are unobstructed: Basement offices means of escape. These routes should be kept clear at all times and on no account should combustible material be left adjacent to or underneath the electrical cupboards. Also on the ground floor inside the entrance door and corridor.			
Action Notes	Items which pose a potential fire hazard or those that could cause an obstruction should not be located on escape routes. Tenants should be reminded that escape routes and exits should be available for use and kept clear of obstruction at all times.			
Action Images

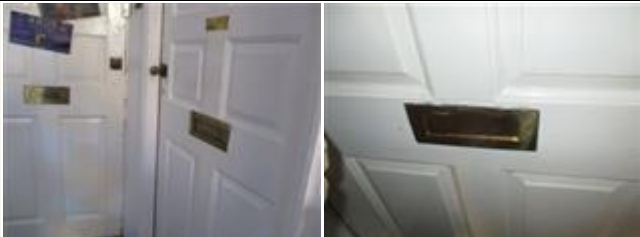
Residential	11.13) Is the fire door furniture suitably fire resisting?			
Observed Condition:	Unsatisfactory			
Risk Measurement	Severity: 3	Likelihood: 2	Risk Score: 6	Risk Weighting: 2
Recommended Action	The letter boxes in the following flats should be replaced by a fire resisting letter box: Flats 1-3.			
Action Notes	Letter plates should ideally be positioned in the lower part of the door and should conform to BS EN 13724: Letter plates.			
Action Images

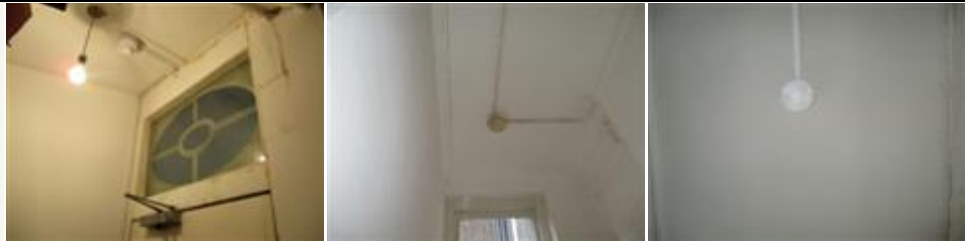
People at Risk	1.3) Can sleeping occupants be adequately warned of fire			
Observed Condition:	Unsatisfactory			
Risk Measurement	Severity: 2	Likelihood: 2	Risk Score: 4	Risk Weighting: 3
Recommended Action	Instruct the fire alarm engineers to conduct an audibility test throughout the building including the systems in the offices and residential flats. Ensure that the fire alarm sound levels are sufficient to wake anyone who may be sleeping i.e. sound level of 75dBA should be achieved at the bed head. See following for recommendations re the installation of additional AFD heads.			
Action Notes	The L3 system AFD and sounders are installed just inside the flat entrance doors so the decibel level at the bed head is unknown and some of the rooms in the residential flats have no AFD. In sleeping areas, to ensure that people are woken, a sufficient sound level should be achieved at the head of the bed (i.e. 75dBA). This will usually mean the fitting of a sounder device in each bedroom.

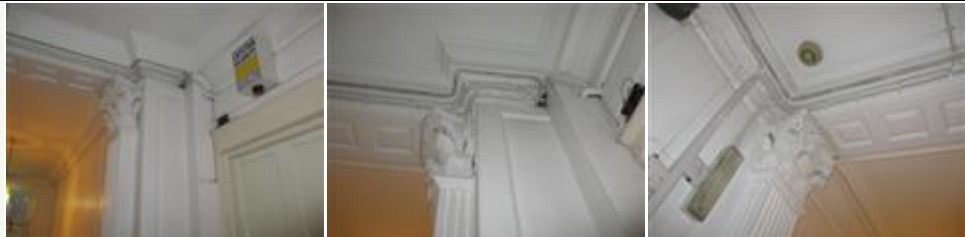
Sources of Fuel and Oxygen	3.10) Are all other fuel/oxygen issues, not covered elsewhere in the report, satisfactory			
Observed Condition:	Unsatisfactory			
Risk Measurement	Severity: 2	Likelihood: 2	Risk Score: 4	Risk Weighting: 3
Recommended Action	The surface mounted cables should be painted with a fire retardant paint to stop fire spread.			
Action Notes	There are a lot of surface mounted cables in the entrance corridor and staircase which have been painted over many times, this presents a fire spread hazard.			
Action Images

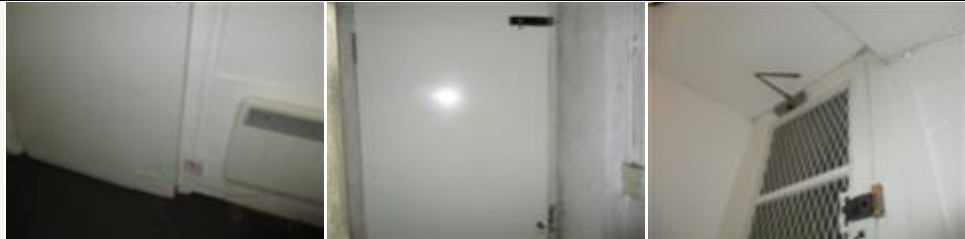
Fire and Smoke Containment	4.8) Are fire doors satisfactory; in good condition and state of repair			
Observed Condition:	Unsatisfactory			
Risk Measurement	Severity: 2	Likelihood: 2	Risk Score: 4	Risk Weighting: 3
Recommended Action	<p>Replace or upgrade the internal fire door to the basement office front fire exit to 30 minutes FDS and fit intumescent strips, cold smoke seals and a self-closer. The other door to the front escape route from the basement should have the lock removed and the door made up to 30 minutes fire resistance with intumescent strips, cold smoke seals and a self-closer. The fire door from the basement discharging under the buildings single escape staircase needs to be changed and upgraded to a 60 FDS fire resisting door with a self-closer with intumescent strips and cold smoke seals should be fitted at the head of the basement stairs. In the meantime the self-closer should be repaired and tenants instructed in writing not to disable self-closers. In the Londonist fit a self-closer to the fire door on the ground floor adjacent to the staircase. If this door needs to be held open it should be fitted with either a Doorgard or Agrippa sonic electro-magnetic door holder which will close on operation of the fire alarm.</p>

Action Notes	<p>The current door to the basement office front fire exit is not constructed to provide a minimum 30 minutes fire resistance. The other door to the front escape route from the basement is fitted with a mortice lock with a key. The fire door from the basement discharges under the buildings single escape staircase but is only a notional 30 minute fire door.</p>			
Action Images

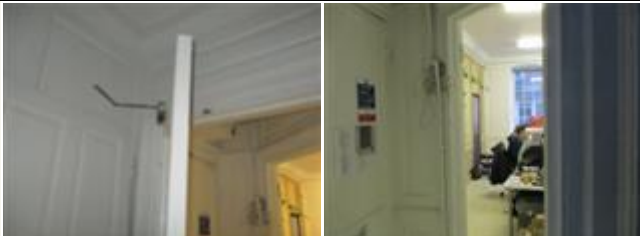
Fire and Smoke Containment	4.8) Are fire doors satisfactory; in good condition and state of repair			
Observed Condition:	Unsatisfactory			
Risk Measurement	Severity: 2	Likelihood: 2	Risk Score: 4	Risk Weighting: 3
Recommended Action	<p>Repair the self-closer to the internal door from the rear offices in Ambigram Architects. The door to the front office needs to be reinstated. If these doors need to be held open then it should be fitted with an Agrippa or Doorgard electro-magnetic hold open device which will close the door on operation of the fire alarm. Write to the tenants and inform them that they must not disconnect the self-closers or remove internal doors.</p>			
Action Notes	<p>The self-closer on the door from the rear offices in Ambigram Architects has been disconnected and the door to the front office has been removed allowing rapid fire spread through the ground floor and offering no protection to the inner room.</p>

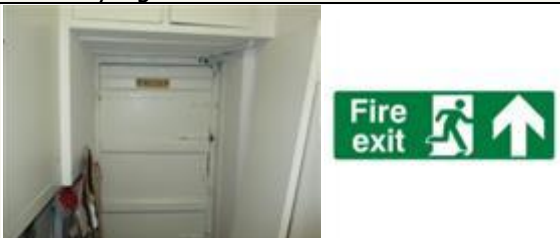
Signs and Notices	6.2) Are fire exit doors suitably marked			
Observed Condition:	Unsatisfactory			
Risk Measurement	Severity: 2	Likelihood: 2	Risk Score: 4	Risk Weighting: 3
Recommended Action	Remove the text only sign and install a fire exit direction sign "arrow up" on the door from the basemen front means of escape to the external staircase. All signs should comply to BS ISO 7010 2011 and have text, a pictogram and arrow.			
Action Notes	Text only sign in use.			
Action Images

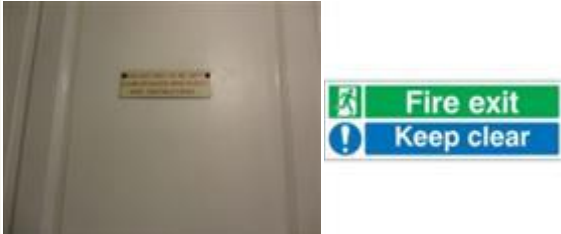
Signs and Notices	6.9) Are other signage issues, not covered elsewhere in the report, satisfactory			
Observed Condition:	Unsatisfactory			
Risk Measurement	Severity: 2	Likelihood: 2	Risk Score: 4	Risk Weighting: 3
Recommended Action	The old red letter text "Fire escape keep clear" sign in the means of escape corridor should be replaced with a current standard sign.			
Action Notes				
Action Images

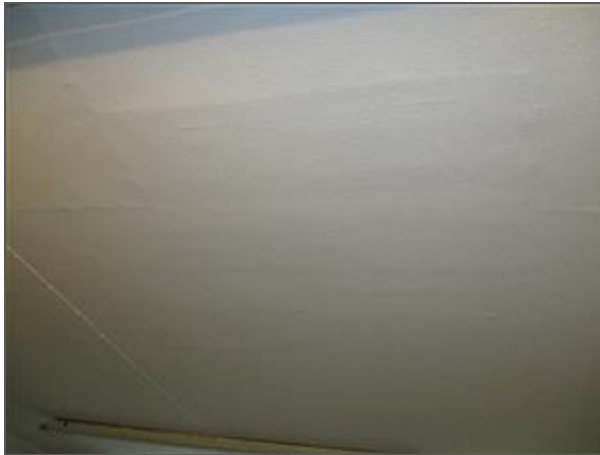
The fire separation between the basement and the ground floor is believed to be lathe and plaster which is not in good condition and only providing a notional 30 minutes fire resistance, this needs to be made up to 60 minutes fire resisting preferably by encapsulating in additional plaster board with the joints to be taped and the whole skimmed with plaster.

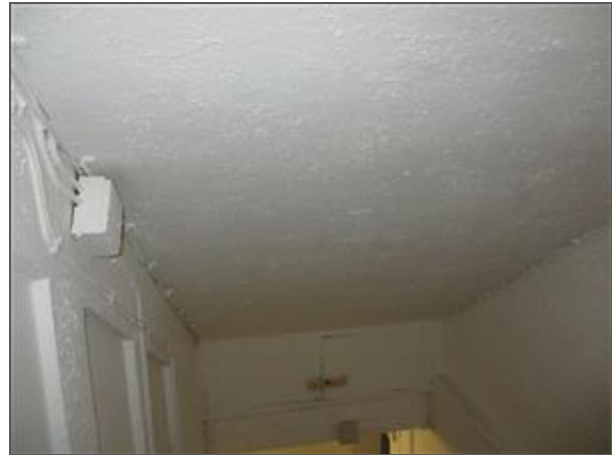
The fire separation between the basement and the ground floor is believed to be lathe and plaster which is not in good condition and only providing a notional 30 minutes fire resistance, this needs to be made up to 60 minutes fire resisting preferably by encapsulating in additional plaster board with the joints to be taped and the whole skimmed with plaster.

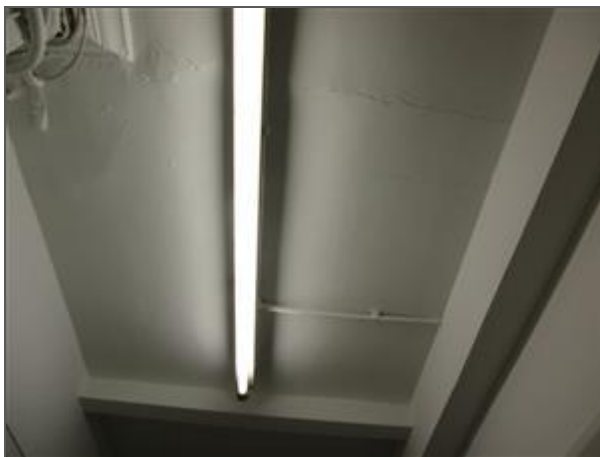
The fire separation between the basement and the ground floor is believed to be lathe and plaster which is not in good condition and only providing a notional 30 minutes fire resistance, this needs to be made up to 60 minutes fire resisting preferably by encapsulating in additional plaster board with the joints to be taped and the whole skimmed with plaster.

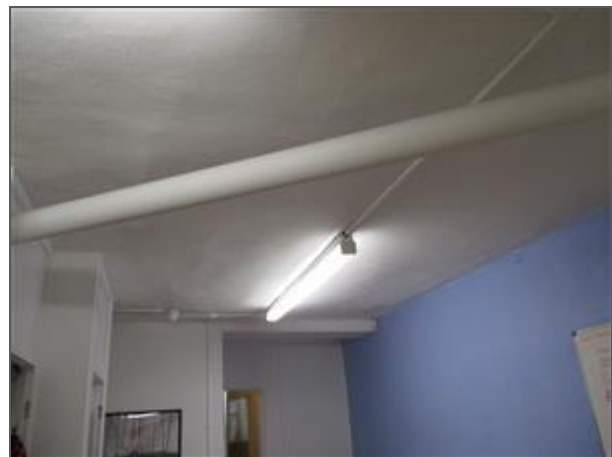
The fire separation between the basement and the ground floor is believed to be lathe and plaster which is not in good condition and only providing a notional 30 minutes fire resistance, this needs to be made up to 60 minutes fire resisting preferably by encapsulating in additional plaster board with the joints to be taped and the whole skimmed with plaster.

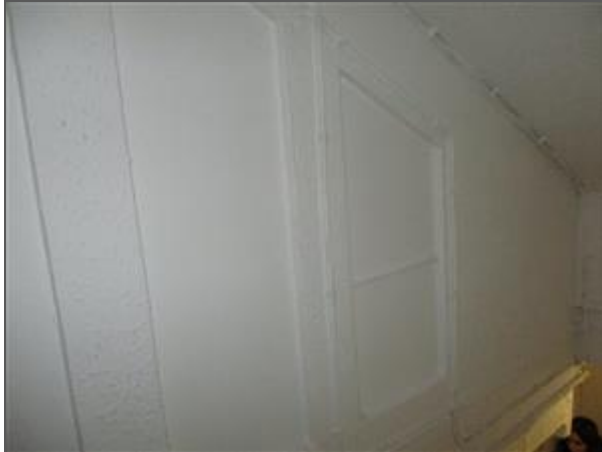
The fire separation between the basement and the ground floor including the panelling to the staircase is believed to be lathe and plaster which is not in good condition and only providing a notional 30 minutes fire resistance, this needs to be made up to 60 minutes fire resisting preferably by encapsulating in additional plaster board with the joints to be taped and the whole skimmed with plaster.

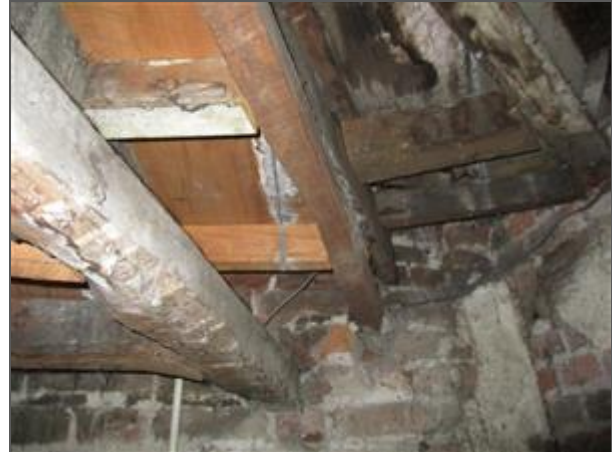
In th basement The unprotected wood that cannot be encapsulated should be treated with a fire retardant paint or varnish to provide 60 minutes fire resistance.

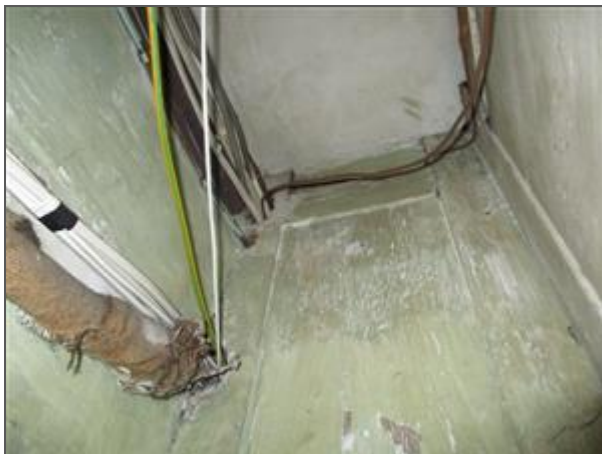
The penetrations in the basement cupboards adjacent to the basement means of escape to the front of the building by ducting or building services should be fire stopped using approved materials installed by a competent contractor to provide a minimum of 30 minutes fire resistance.

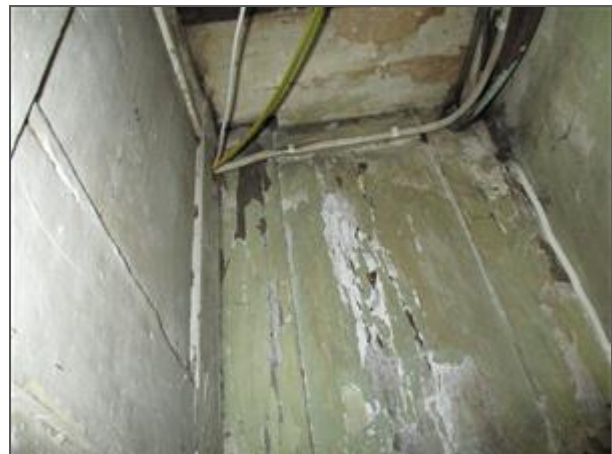
The penetrations in the basement cupboards adjacent to the basement means of escape to the front of the building by ducting or building services should be fire stopped using approved materials installed by a competent contractor to provide a minimum of 30 minutes fire resistance.

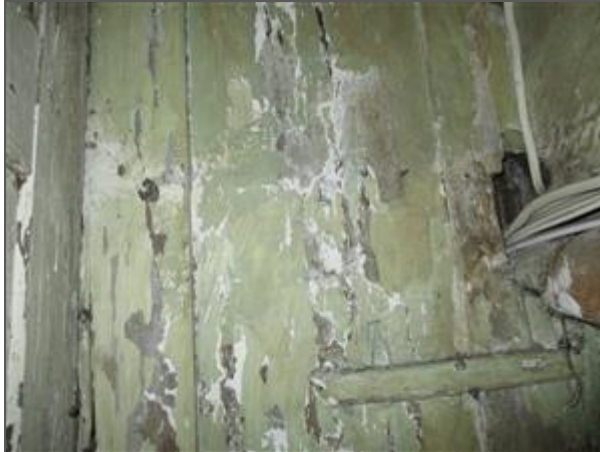
The unprotected wood in the cupboards adjacent to the basement means of escape to the front of the building that cannot be encapsulated should be treated with a fire retardant paint or varnish to provide 30 minutes fire resistance.

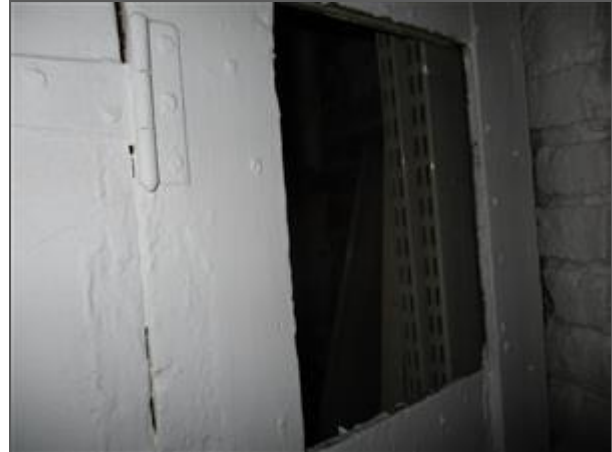
The openings in the basement office walls adjacent to the basement means of escape to the front of the building by ducting or building services should be fire stopped using approved materials installed by a competent contractor to provide a minimum of 30 minutes fire resistance.

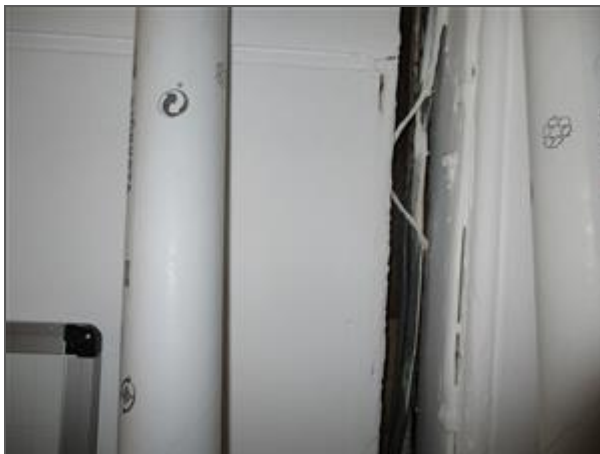
The openings in the basement office walls adjacent to the basement means of escape to the front of the building by ducting or building services should be fire stopped using approved materials installed by a competent contractor to provide a minimum of 30 minutes fire resistance.

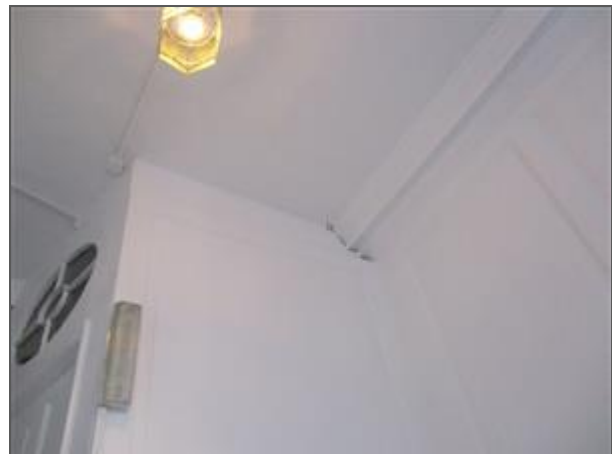
On the staircase by Flat 2 the wall needs to be fire stopped to provide a minimum of 30 minutes fire resistance.

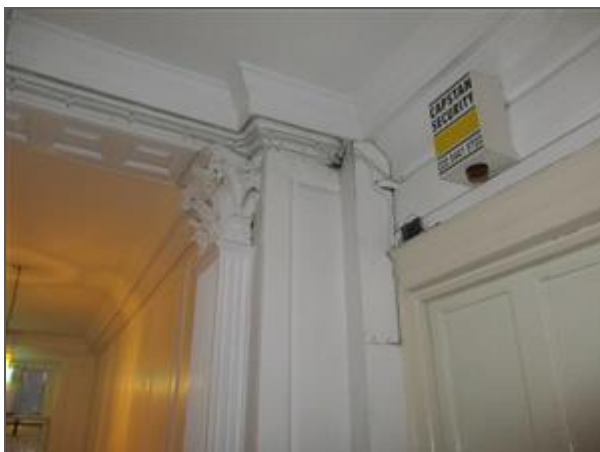
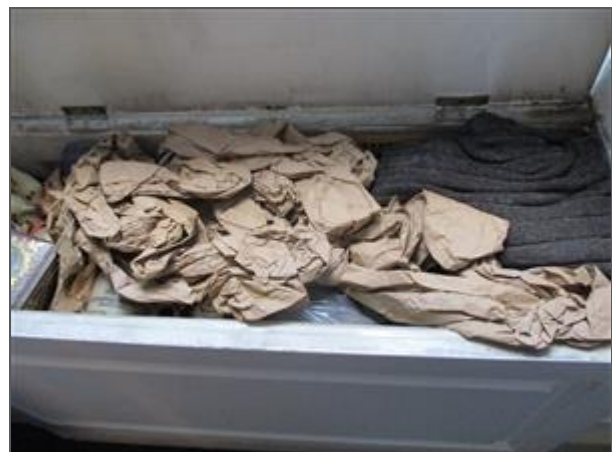
The wall above the door to Ambigram Architects on the ground floor needs to be fire stopped to provide a minimum of 60 minutes fire resistance.

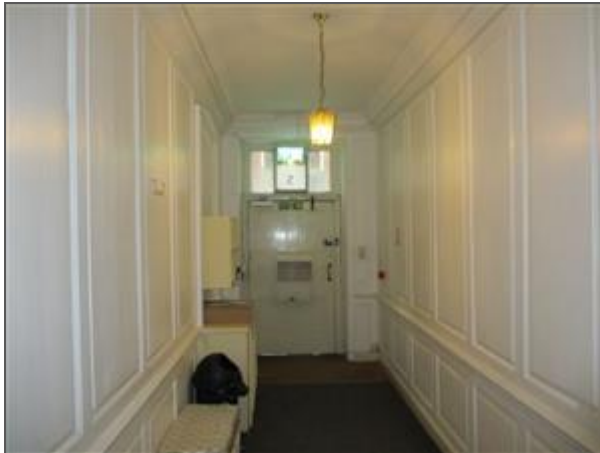
Ensure that the escape routes in the following areas are unobstructed and free from combustible material: Ground floor inside the entrance door and corridor. These routes should be kept clear at all times.

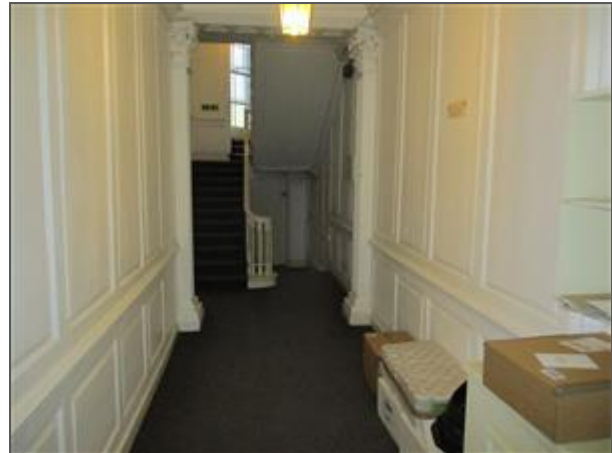
Ensure that the escape routes in the following areas are unobstructed and free from combustible material: Ground floor inside the entrance door and corridor. These routes should be kept clear at all times.

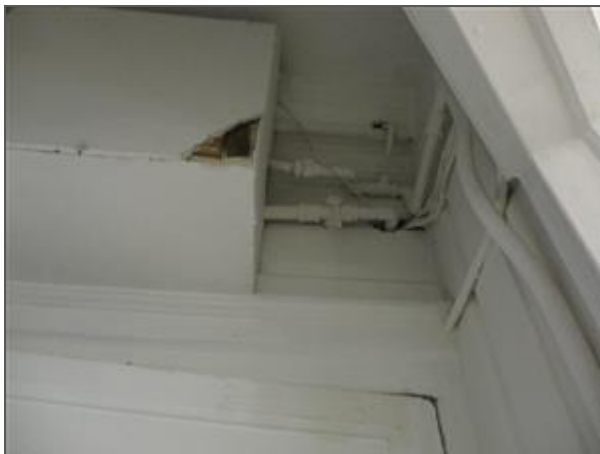
The wall on the ground floor entrance corridor needs to be fire stopped to provide a minimum of 60 minutes fire resistance.

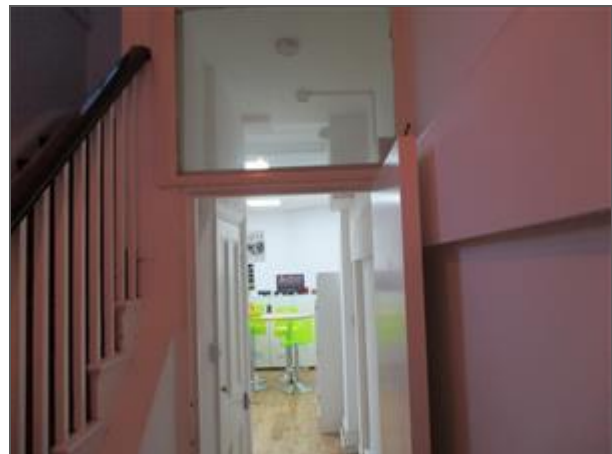
In the Londonist fit a self-closer to the fire door on the ground floor adjacent to the staircase. If this door needs to be held open it should be fitted with either a Doorgard or Agrippa sonic electromagnetic door holder which will close on operation of the fire alarm. This door should be fitted with either a 'Fire Door Keep Closed' sign or an Automatic Fire Door Keep Clear' sign.

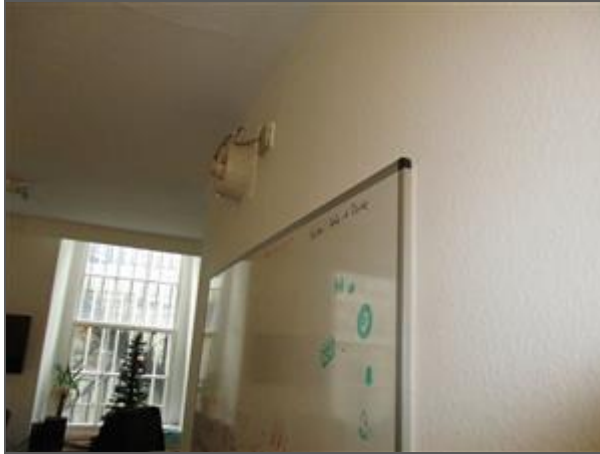
Hidden void in the basement.

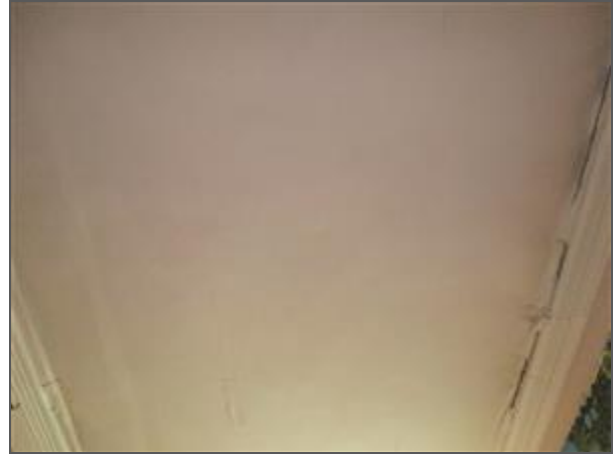
No AFD in access rooms.

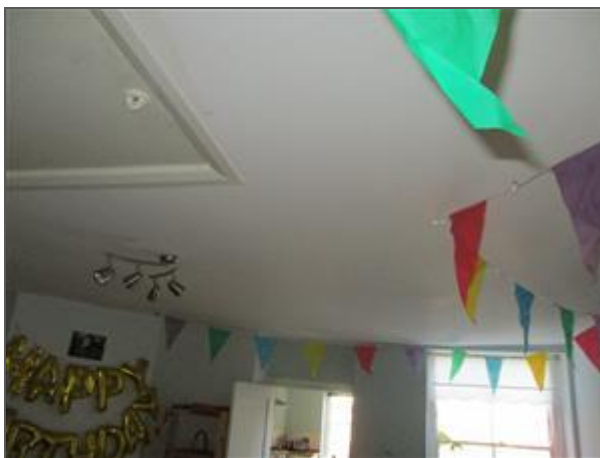
No AFD in access rooms.

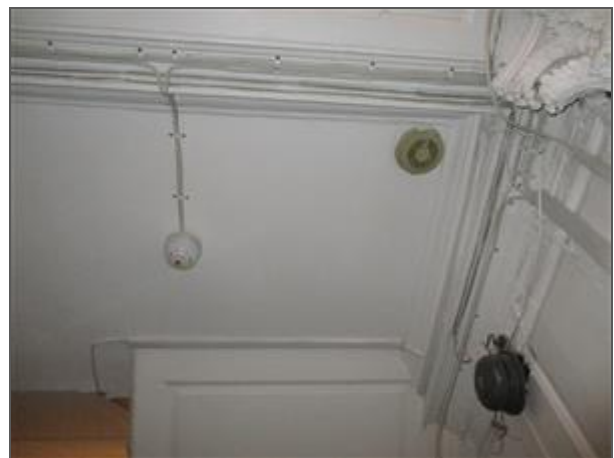
Redundant fire alarm should be removed.

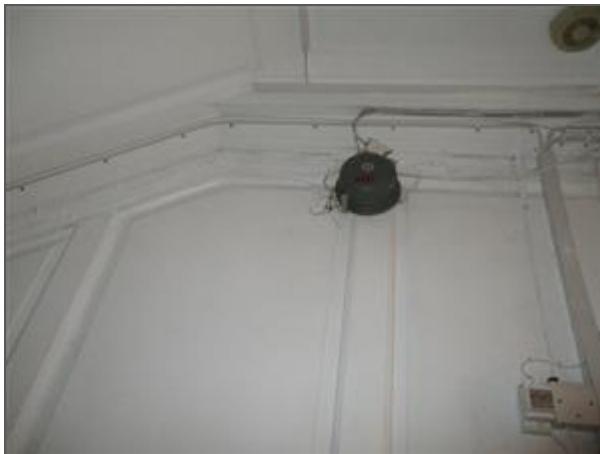
Redundant fire alarm should be removed.

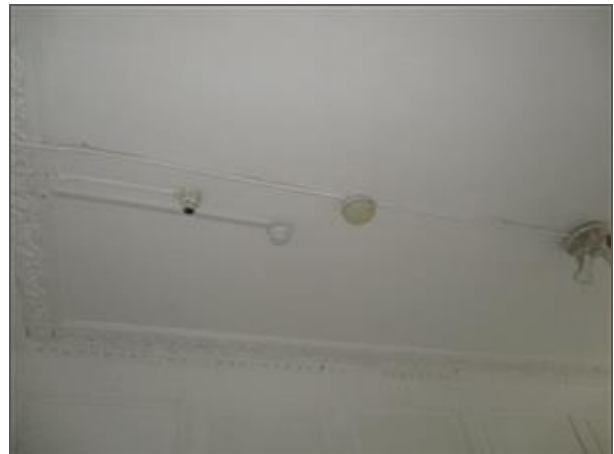
Two fire alarm systems in the flats.

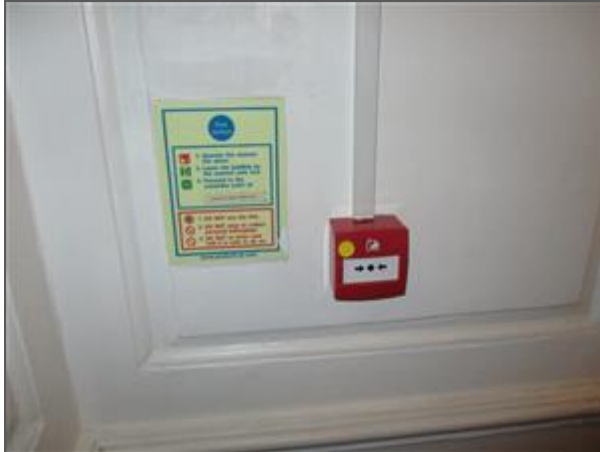
Fire action notice adjacent to the break glass call point.

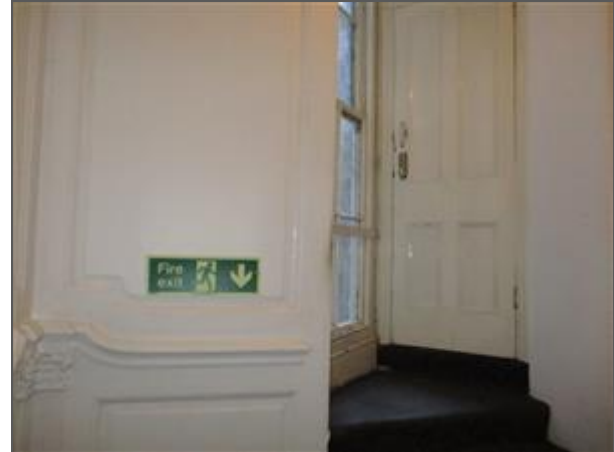
The toilet door off of the staircase does not need to be upgraded to a fire door.
