**ARBORICULTURAL IMPACT ASSESSMENT REPORT FOR:**

94 Agamemnon Road  
London  
NW6 1EH

**Ref:** NJA/94AGM/AIA/01

**Date:** 17<sup>th</sup> December 2017

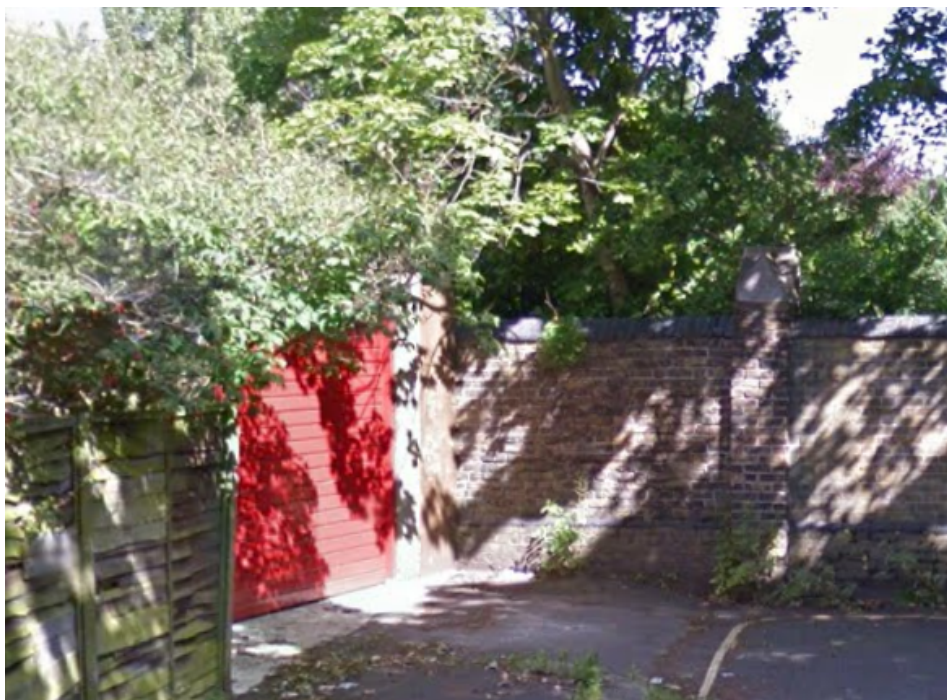
- 4.1.3 In BS5837, paragraph 4.6.2 states that RPA's should reflect the morphology and disposition of the roots; where pre-existing site conditions or other factors indicate that rooting has occurred asymmetrically, a polygon of equivalent area should be produced. Modifications to the shape of the RPA should reflect a soundly based arboricultural assessment of likely root distribution.
- 4.1.4 **In this instance, a *priori* modifications have been made in order to reflect the inhibition of root development into the application site by the substantial brick wall (see Photograph 2) between it and T1, though further investigations are recommended, where the proposals encroach / come near RPA and their modification could have a bearing on the impact assessment.**

Photograph 2: Brick wall separating T1 from application site (Source: Google Maps)

| 4.1.6 | At paragraph 5.1.1. BS5837: 2012 notes that “Care should be exercised over misplaced tree preservation; attempts to retain too many or unsuitable trees on a site are liable to result in excessive pressure on the trees during demolition or construction work, or post-completion demands on their removal.” |
- 
| 4.1.8 | In this instance, there are no internal site trees and significant impediments to root growth into the site and therefore only limited primary constraints upon development. |

4.2.4 Assuming that they will be retained, the orientation of the off-site tree will ensure that shading constraints are minimal, with leaf deposition and honey-dew likely to be as it is today. It will also be noted that the tree is growing in an unsuitable long-term position, abutting the boundary wall.

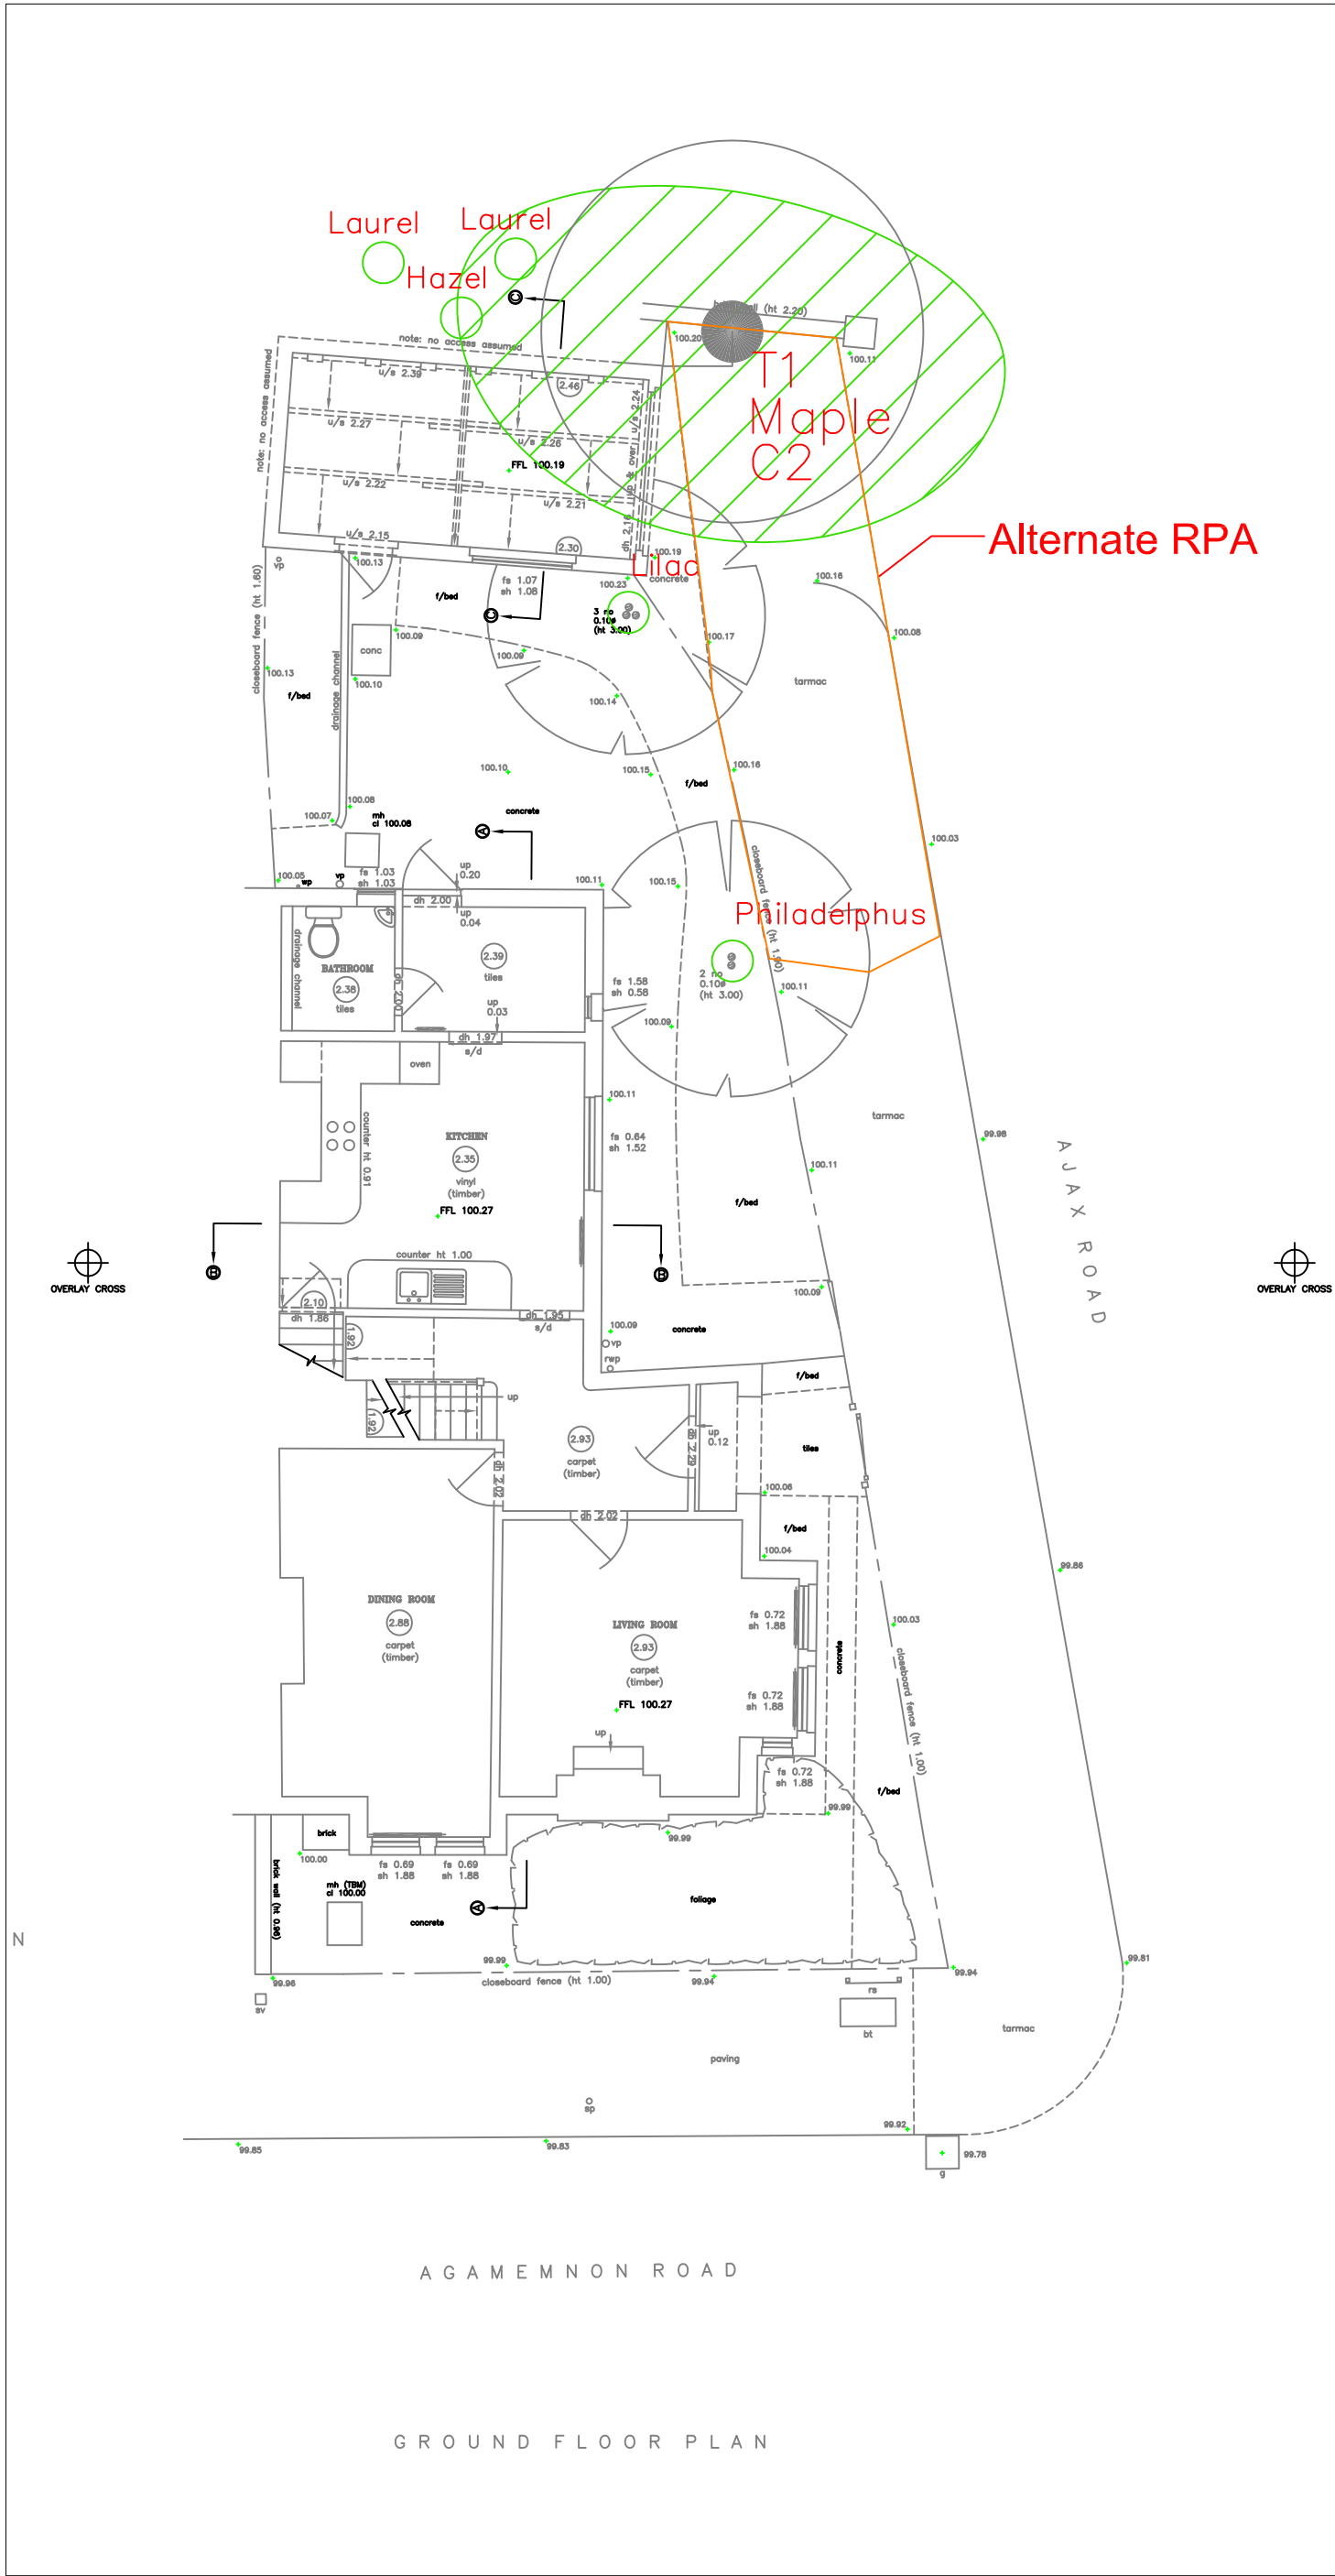
**TREE CONSTRAINTS PLAN**

3.2.1 Only 1 tree on or adjacent to the site comprises a planning constraint, the C category \*(Low Quality), semi-mature Norway maple located beyond a Victorian brick wall.

| Tree No. | English Name | B.S. Cat | Height | Ground Clearance | Crown Spread | Recommended Works | Comments/ Reasons |
|---|---|---|---|---|---|---|---|
| 1 | Maple, Norway | C | 11 | 3.5 | 2344 | DWD | Long low lateral branches<br>Small deadwood hung up in crown<br>Unsuitable species for position next to boundary wall<br>Recommended husbandry 3 |

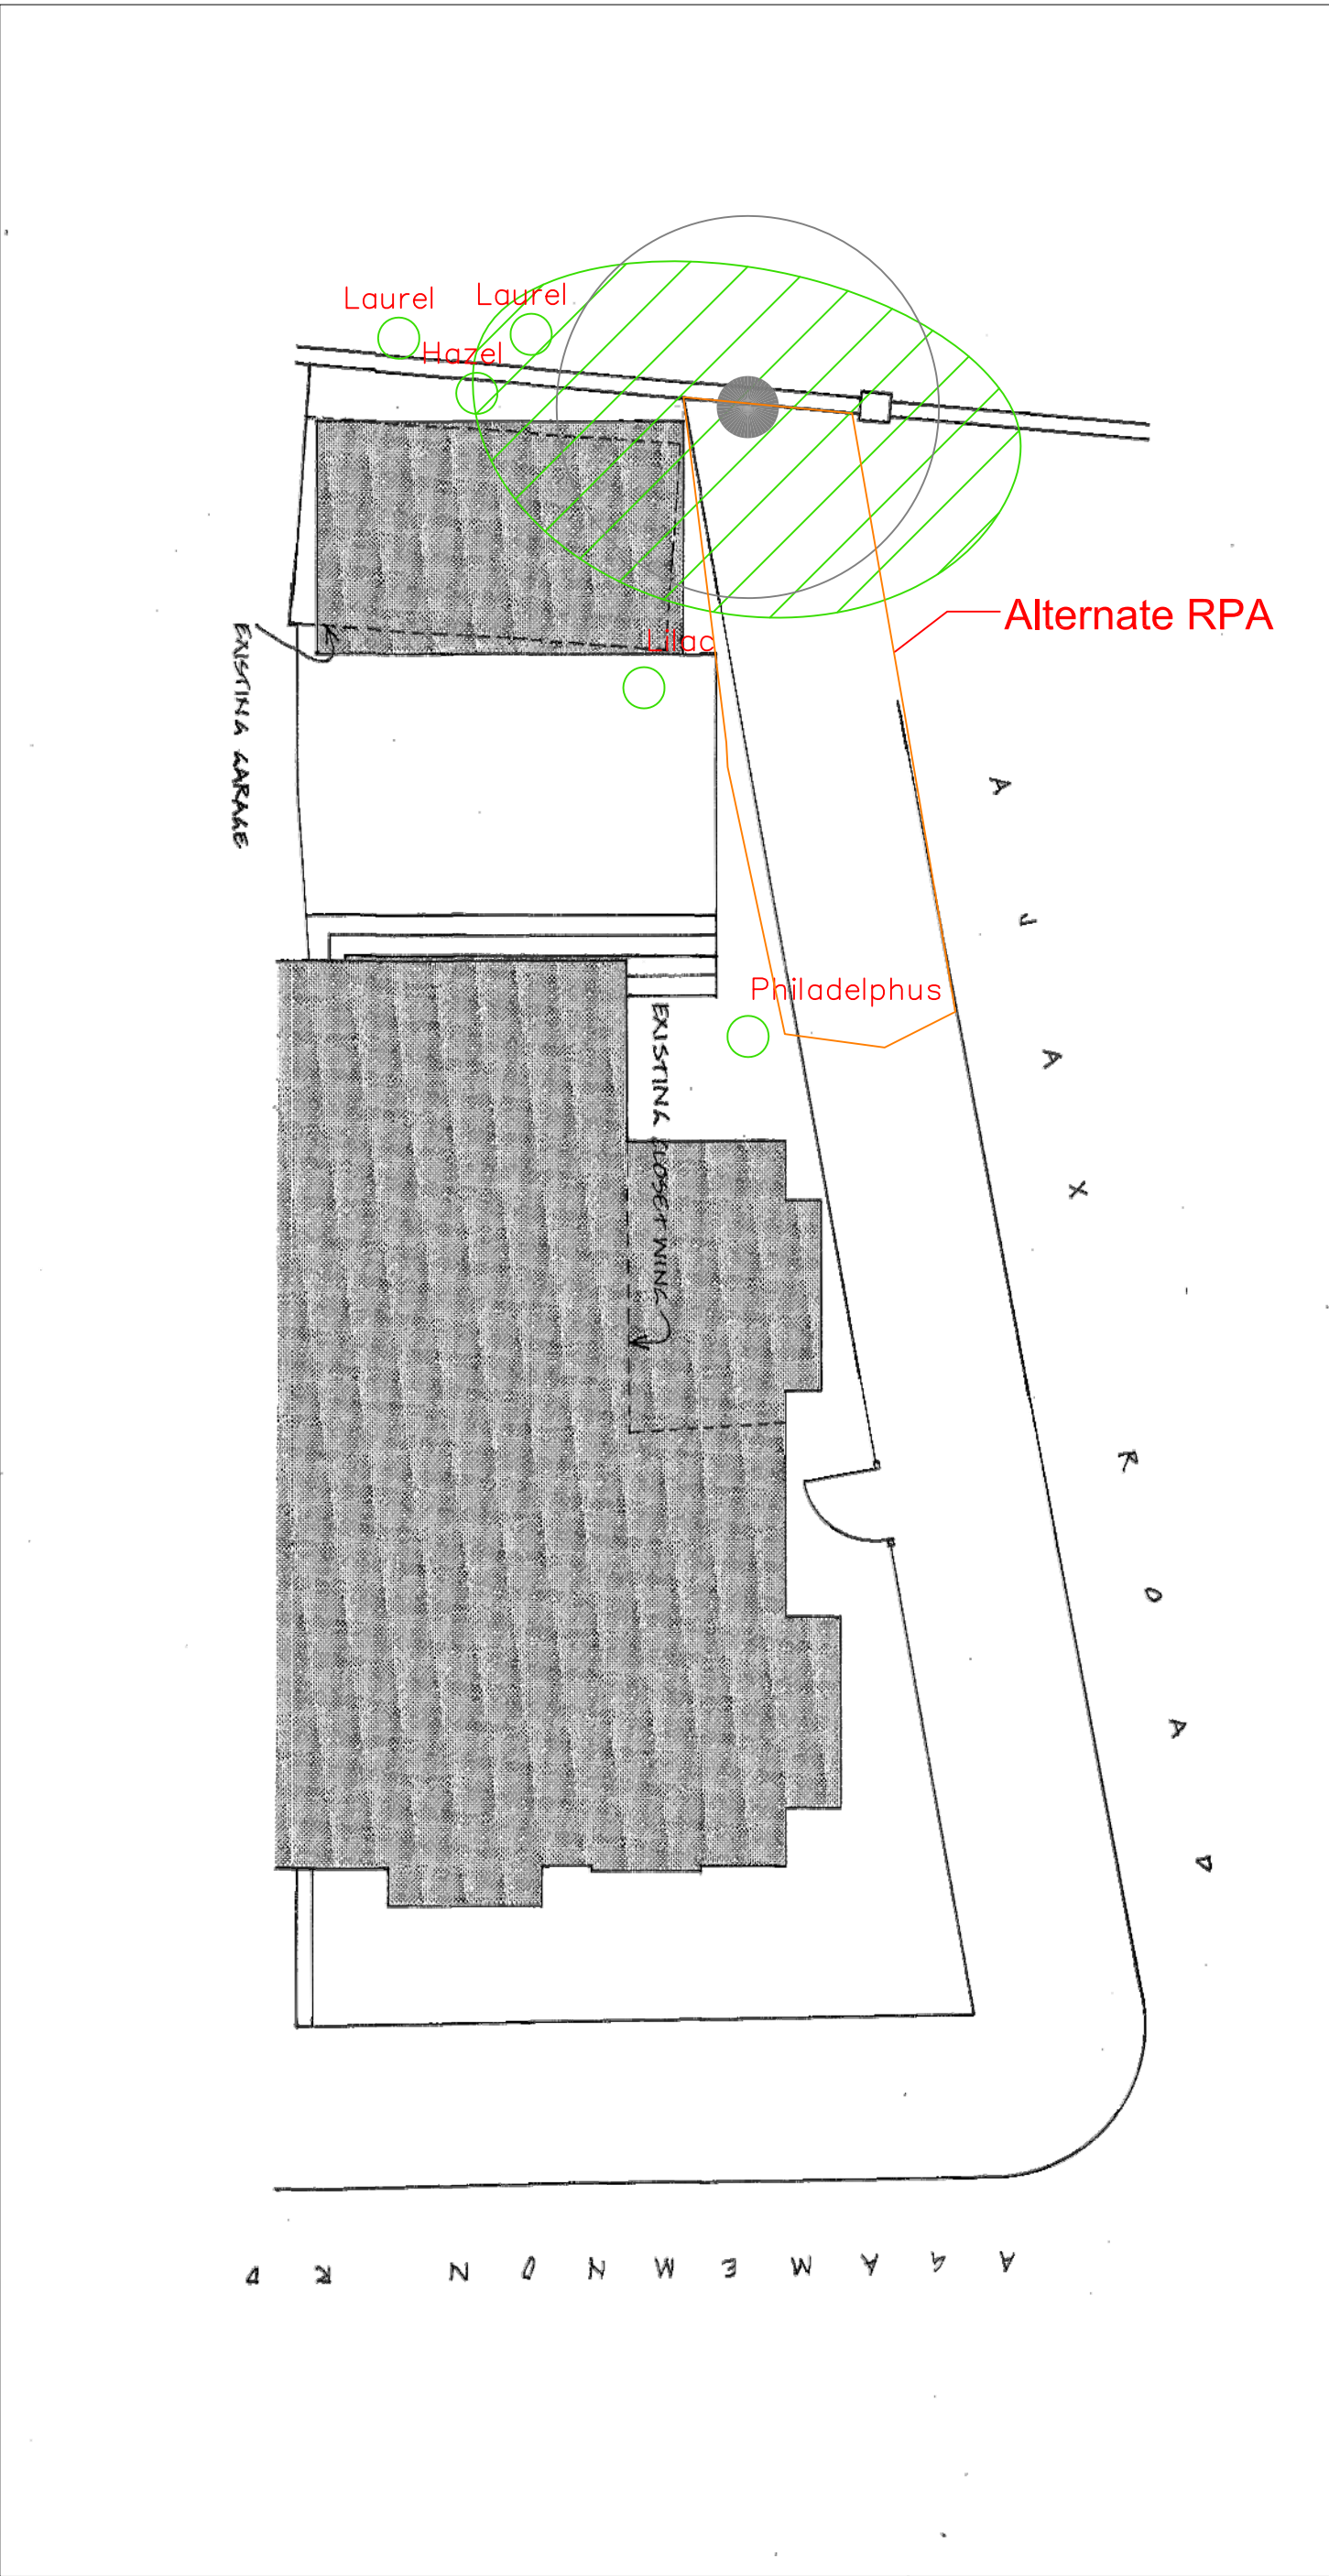
**ARBORICULTURAL IMPACT ASSESSMENT PLAN (S)**

- 6.1.1 Following the modification of the RPA of T1 as per paragraph 4.6.2 of the British Standard, there is no encroachment by the proposals and thus only theoretical impacts to the tree. Trial pits can of course be provided to confirm this hypothesis, but given the low quality of the tree and likely influence of the existing structures, we suggest instead manual excavation of the first 700mm of the nearest corner footing at the time of construction.
- 6.1.2 The lowering of the floor level of the new garage significantly lessens the need to crown raise / cut back the canopy of T1, any minor facilitation pruning will be of negligible impact provided it is carried out in accordance with good arboricultural practice.

- 7.1 The potential impacts of development are very low, there is no encroachment of the modified RPA of the only tree to form a planning constraint and no tree removal is necessary to facilitate the proposals.

6.3.2 The path of foundations through the conventional RPA will be manually excavated to 750mm depth under arboricultural supervision; any roots encountered within the trenches / pits will be cleanly pruned back to an appropriate junction with a sharp pruning saw or secateurs back to a junction. Roots larger than 25mm diameter may only be cut in consultation with an arboriculturalist.

| 8.1.2 | Excavation and construction impacts within the RPA's of the tree identified in Table 1 above, will need to be controlled by method statements specifying mitigation methods suggested in para 6.3 above and by consultant supervision as necessary. These method statements can be provided as part of the discharge of conditions. |
