18-22 Haverstock Hill – BS5837 Tree Survey and

Arboricultural Impact Assessment

Issue/Revision:	Draft	Final
Date:	April 2018	April 2018
Comments:		
Prepared by:	James Rawlinson	James Rawlinson
Signature:	Jacque	Jacque
Authorised by:	Mitch Cooke	Mitch Cooke
Signature:	MDZe.	MDZe.
File Reference:	551027jrMarch18D01_BS5837	551027jrMar18FV01_BS5387.docx

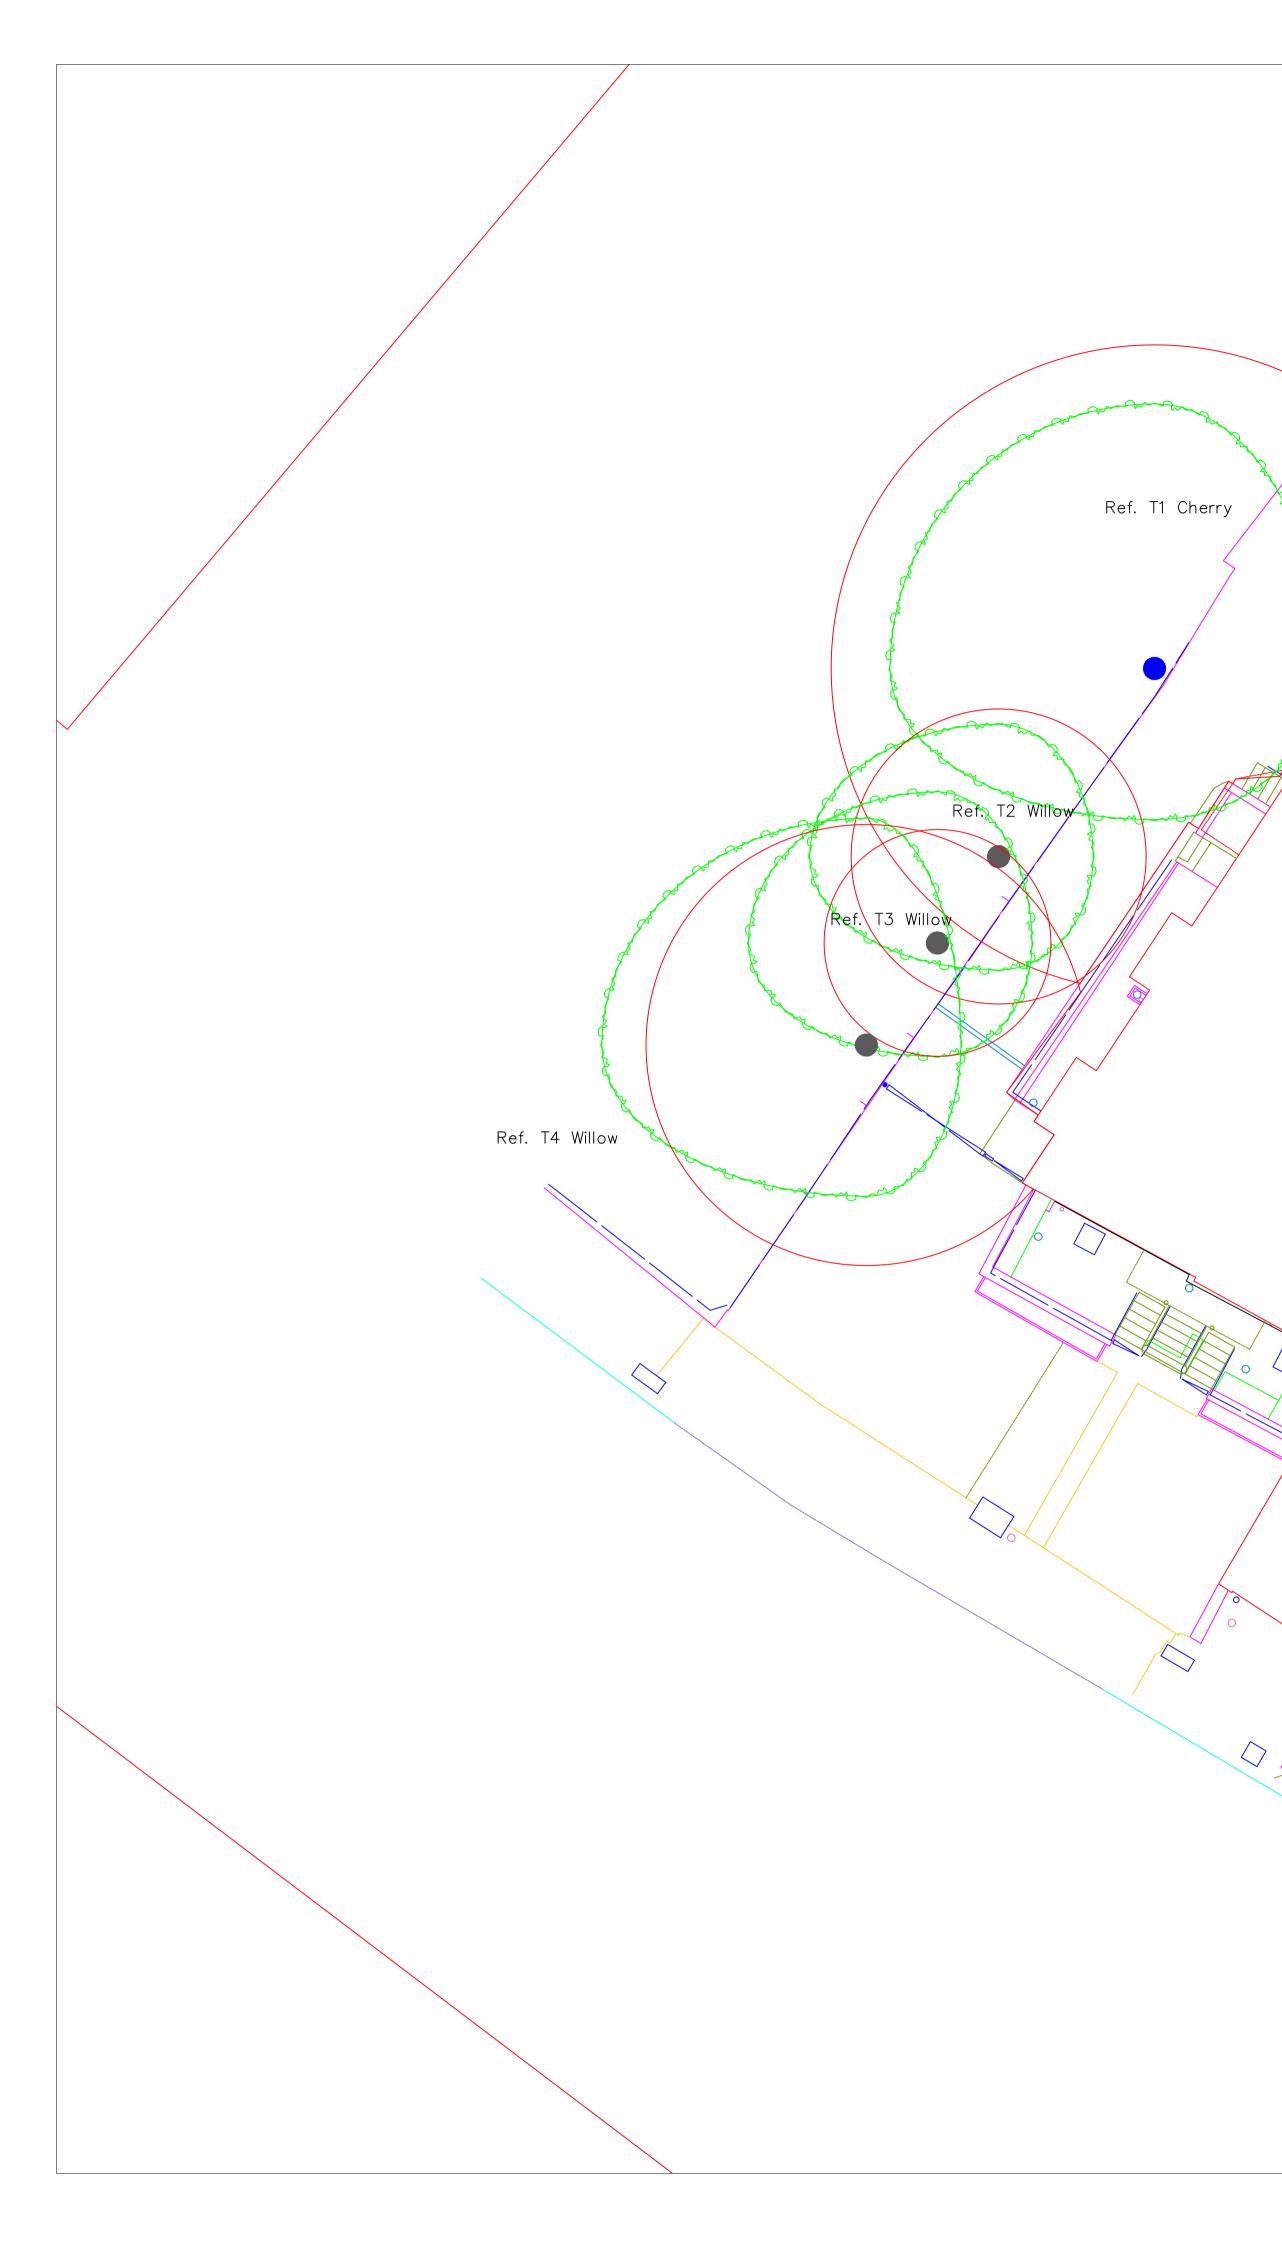
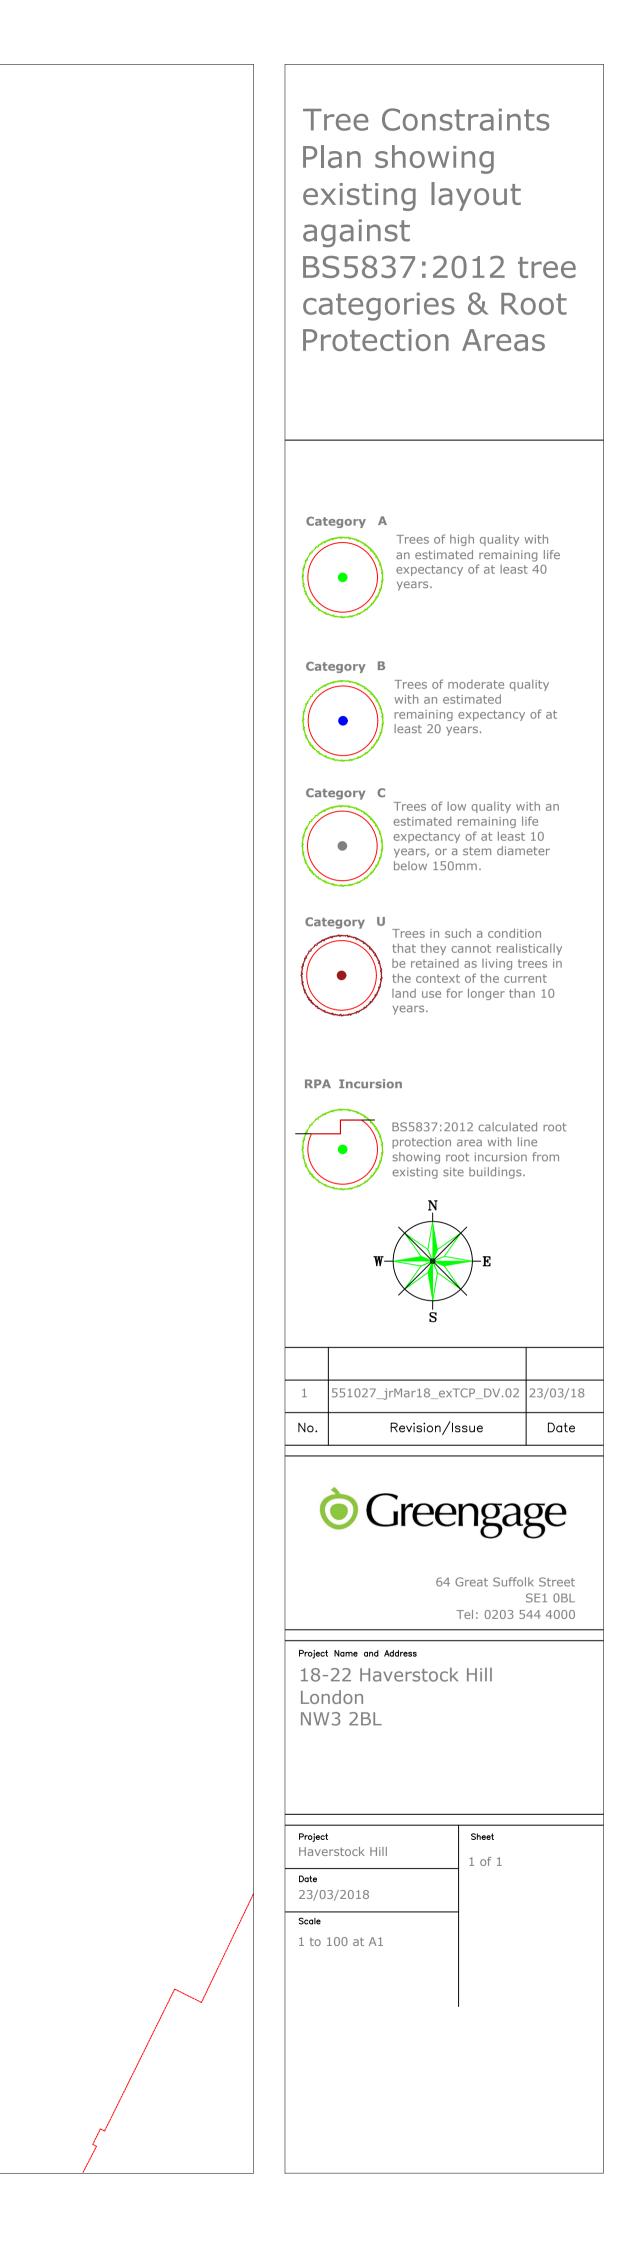
APPENDIX 2.0: TREE CONSTRAINTS PLAN

Note: the RPA's of all surveyed trees are as calculated via the BS5837 methodology (12 x stem diameter at 1.5 m), which is an estimate of root growth within a free growing environment. Factors that are likely to influence root spread from T1—T6, on to the proposed development site include:

-the retaining wall (subterranean depth); -level changes between the two sites; and -any underground constructions from previous site/land use.

Without these details and prior to any on site investigations (trial digs), the RPA's are therefore shown as described. It is though anticipated that the observed level change and retaining wall will have impeded root spread to a greater extent than that shown on this Tree Constraints Plan.

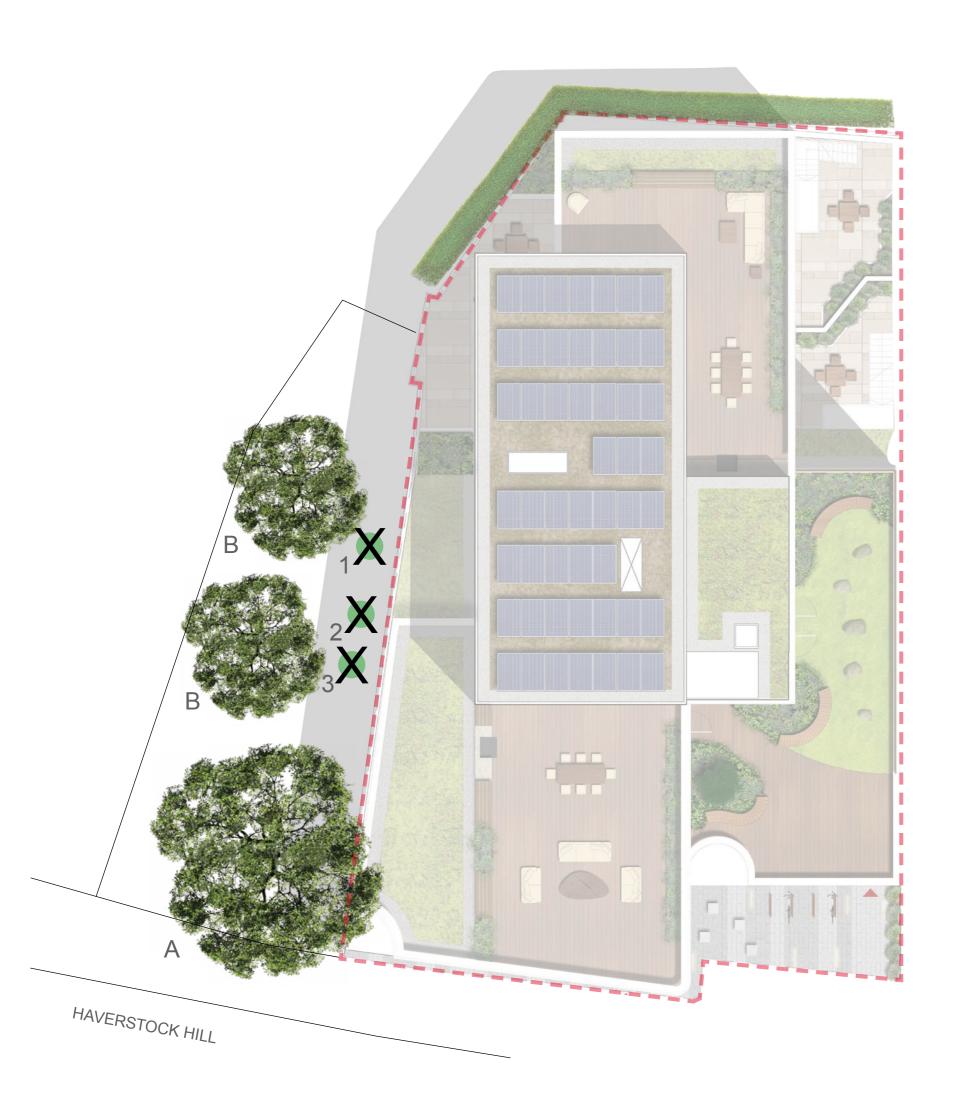
3.17 Arboricultural implication plan

Three existing trees on the adjacent property to the West could be removed due to impacts on existing retaining wall, ongoing maintenance, and tree health concerns. Small immature trees could also be removed to allow new mature tree growth. Replacement trees were selected with discussions with local authority tree officers, maintenance, and seasonal interest. A new prominent semi-mature deciduous tree could enhance the public realm environment. Additional Carpinus could help screen the development from the school boundary.
