Structural Appraisal Report for 90 Leverton Street, London. NW5 2NY

Ref: 180345/H Hawker Approved By: NN 17 Apr 2018 Version final

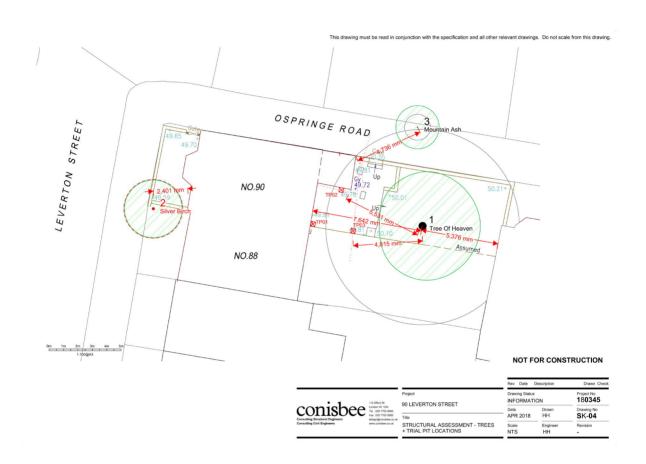
- 3.5 The party wall appears to be original Victorian structure, with a corbelled footing to approx 700mm deep, which seems relatively deep for a garden wall, was possibly, was an outhouse or reflects soft ground present at that time.(TP02)

- 3.6 The trail pits along the party wall both have several roots within them, as described above and there was a larger root, some 30mm dia, in TP03.

- 5.1 A trail pit towards the end of the higher portion of party wall (also wall to neighbours extension, although the wall appears to be original) highlighted a drain running under this wall, presumably across the gardens, manholes to the rear of no.90 and then into Ospringe Road.
