# **Building Survey Report**

**Rose Cottage  
Vale of Health  
London  
NW3 1AX**

**Date of Inspection**

**21<sup>st</sup> December 2016**

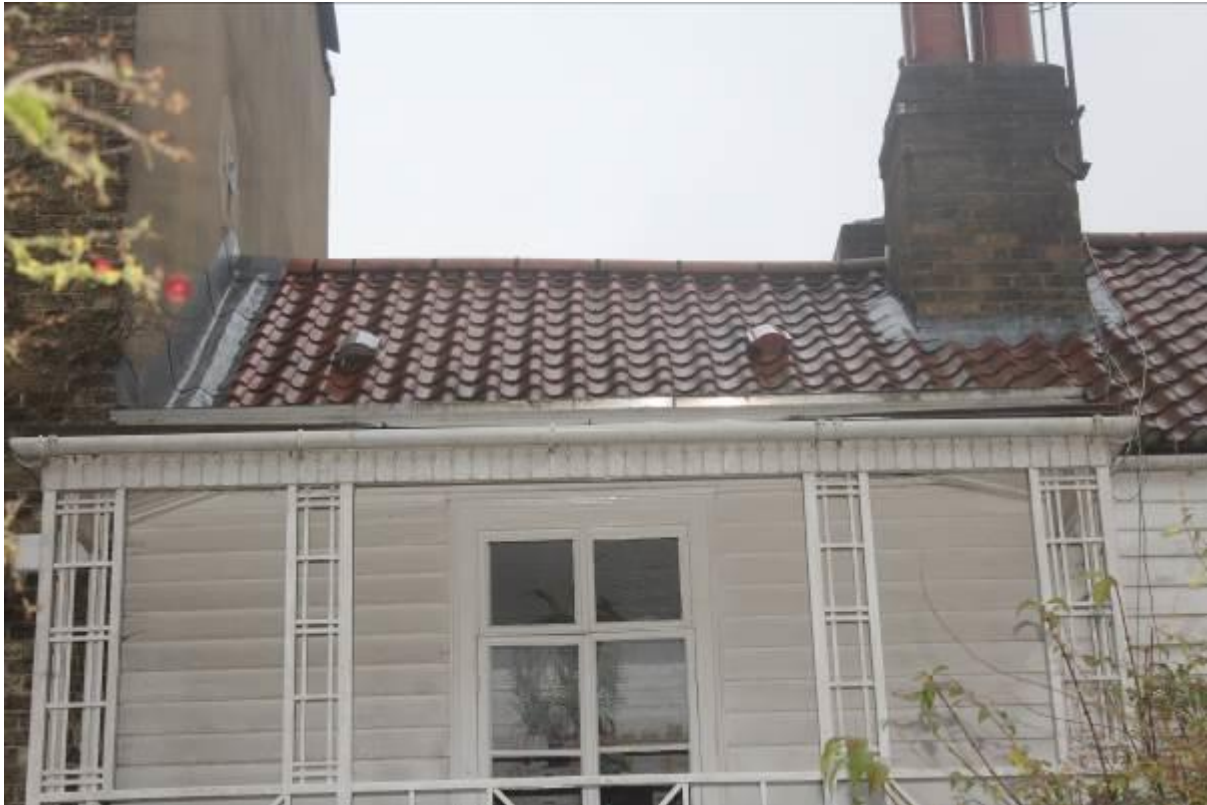
1. Inspect what appears to be a zinc roof to the balcony.

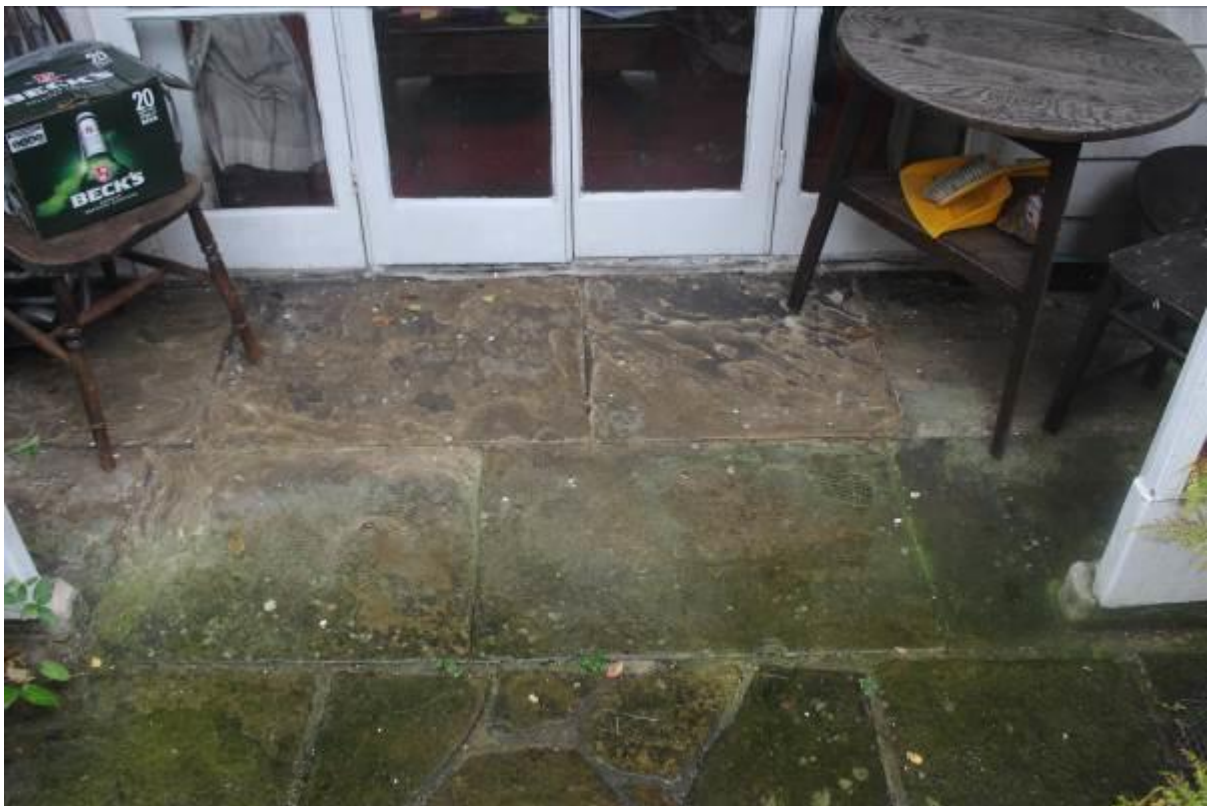
The new stone slabs that have been built up to the external timber framed wall to the front, west facing elevation will have breached any damp proof course and part of the cill will be below ground level although protected to a degree by the balcony structure from the weathering elements it would however be better if the slabs were removed, any timber underneath ground level was checked and repaired and then a gap provided between the French door cill and the external stone slabs to prevent lateral moisture transferal between the timber structure and the damp ground. Further investigation is recommended.

No damp proof course was observable, if a damp proof course exists then it should in theory be underneath the door cill and underneath the timber framing but this has been bridged by the stone slabs and as previously stated a small gap should be provided between the slabs and the structure to allow the structure to breathe adequately and preventing moisture ingress into the external timber low level structure, re-detailing is recommended to this elevation.

2. Sub floor ventilation required and a gap between door sill and external surfaces, also inspection of the condition of the timber sill, currently under ground level.

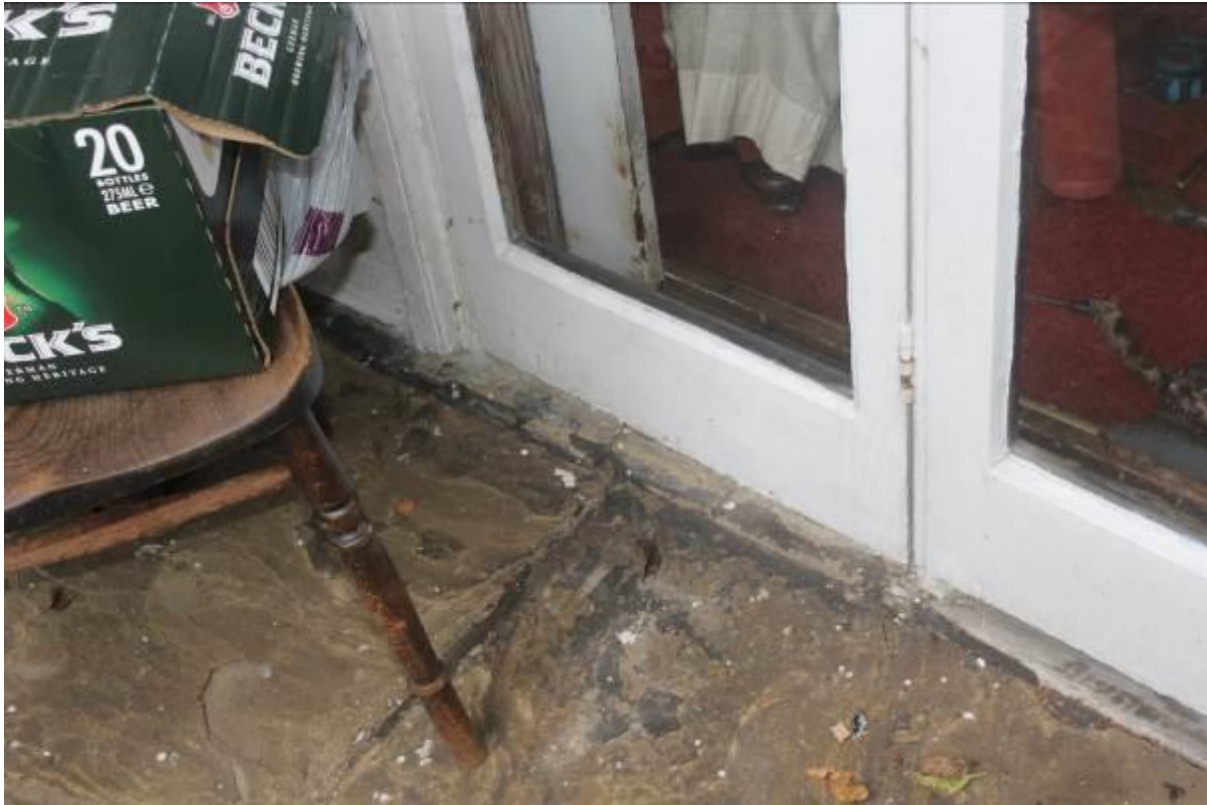
3. As above.

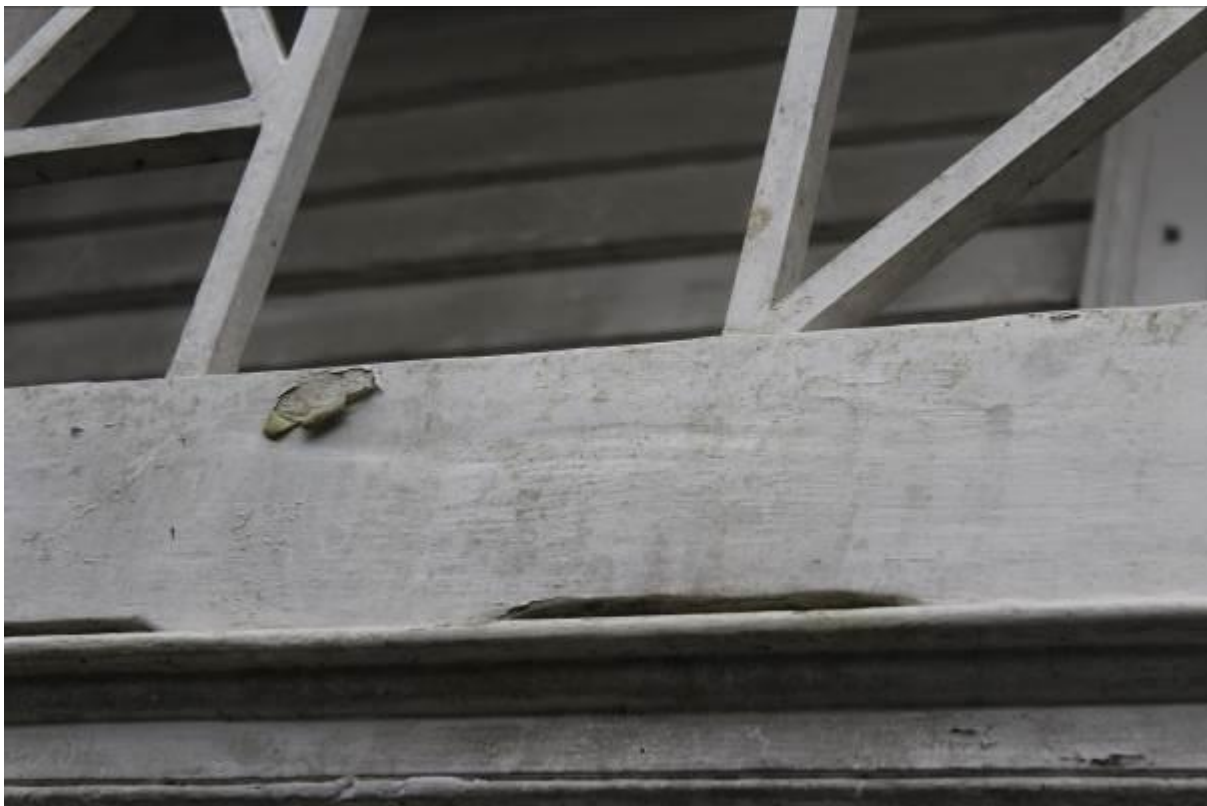
There is also a balcony structure to the west, which is of timber construction. Technically of course this is listed and any alteration to this would need listed building consent. I am not convinced that it is original in any way, the detailing suggests that it is of the 1920's design. Some pockets of timber decay were noted in various areas within this structure and repair is required.

4. Timber decay evident to balcony structure.

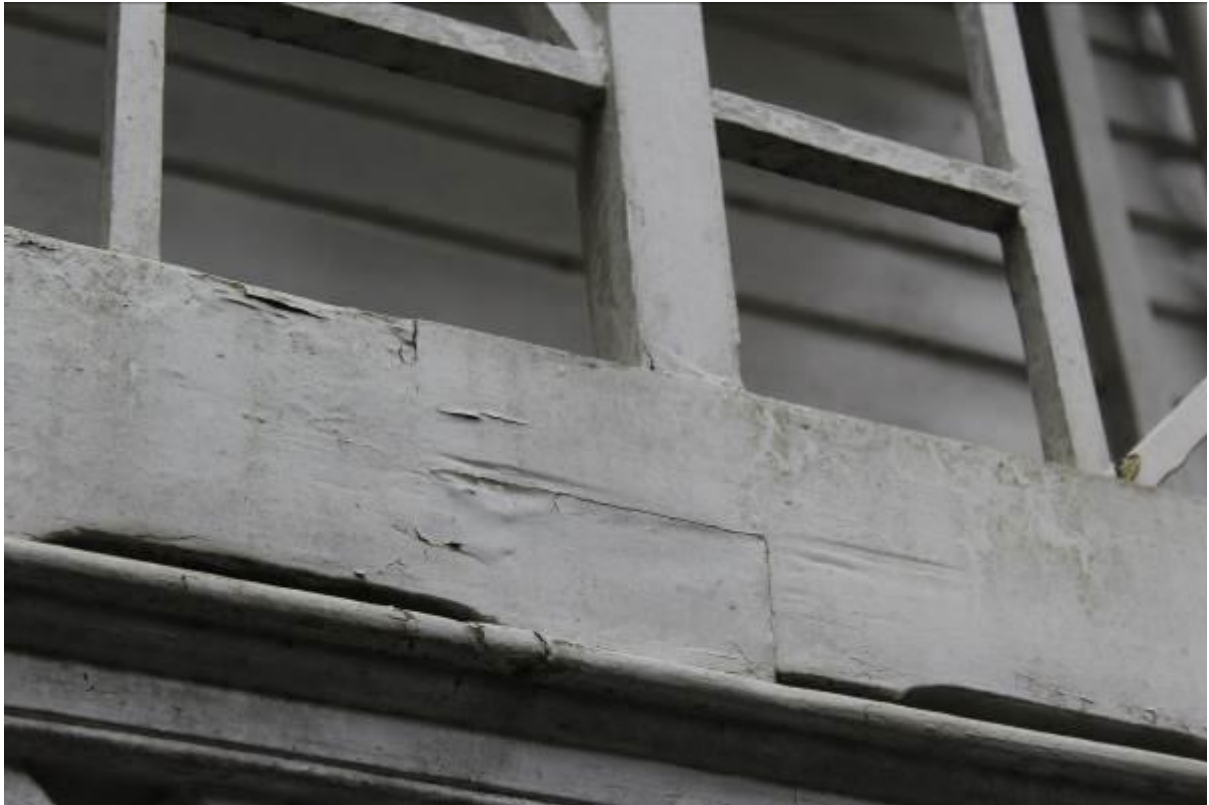
**5. As above.**

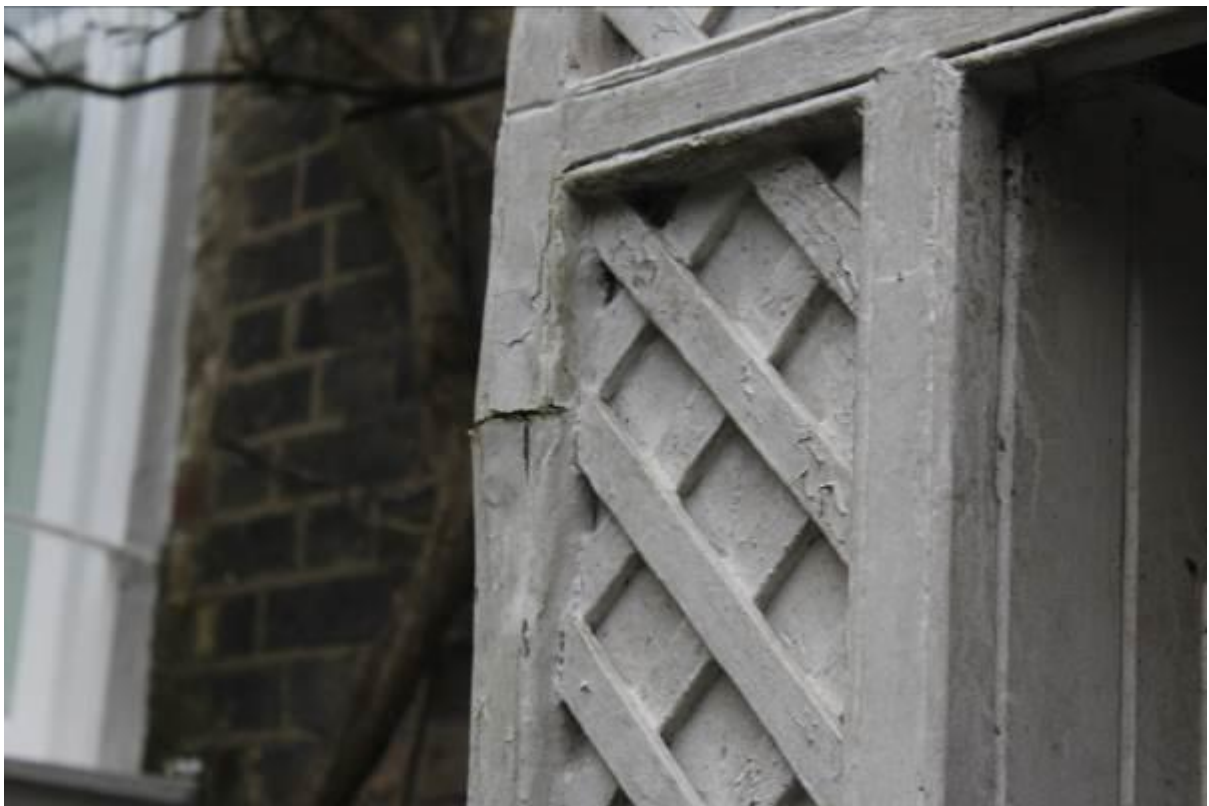
**6. Window care repair required.**

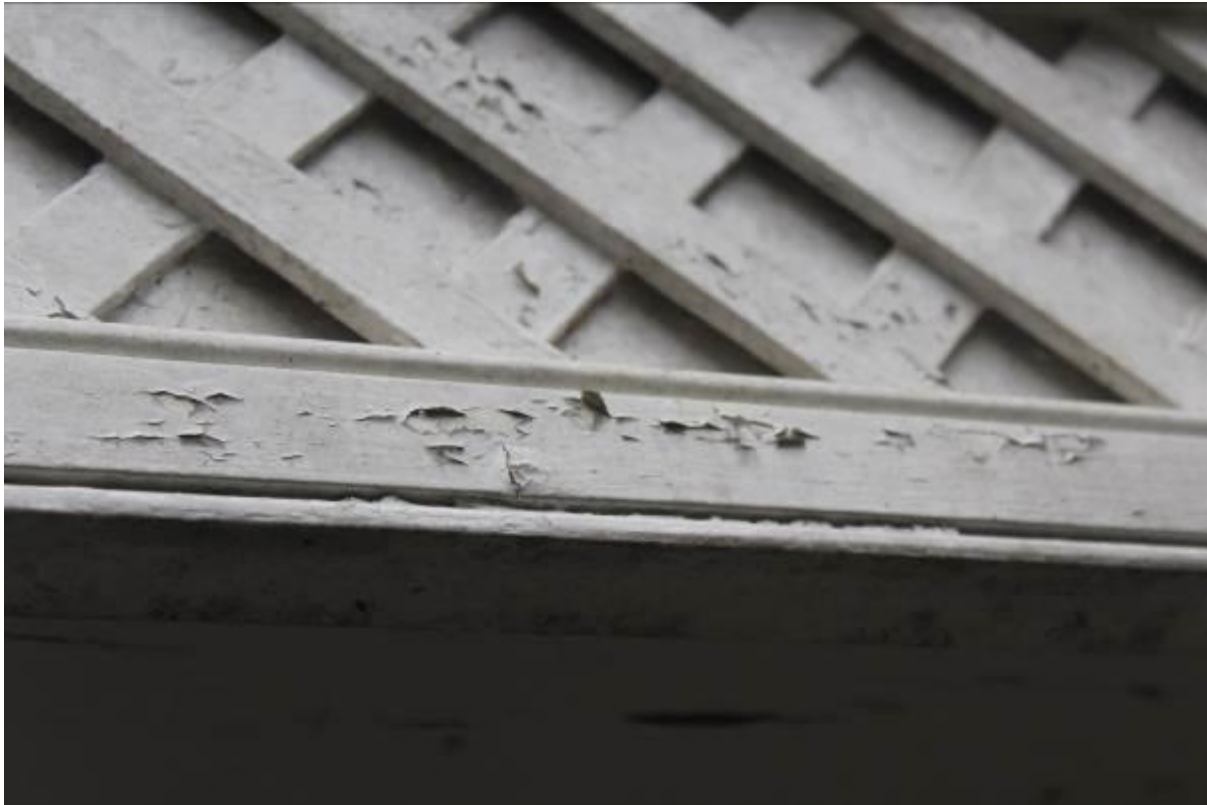
**7. Paint coatings require redecoration.**

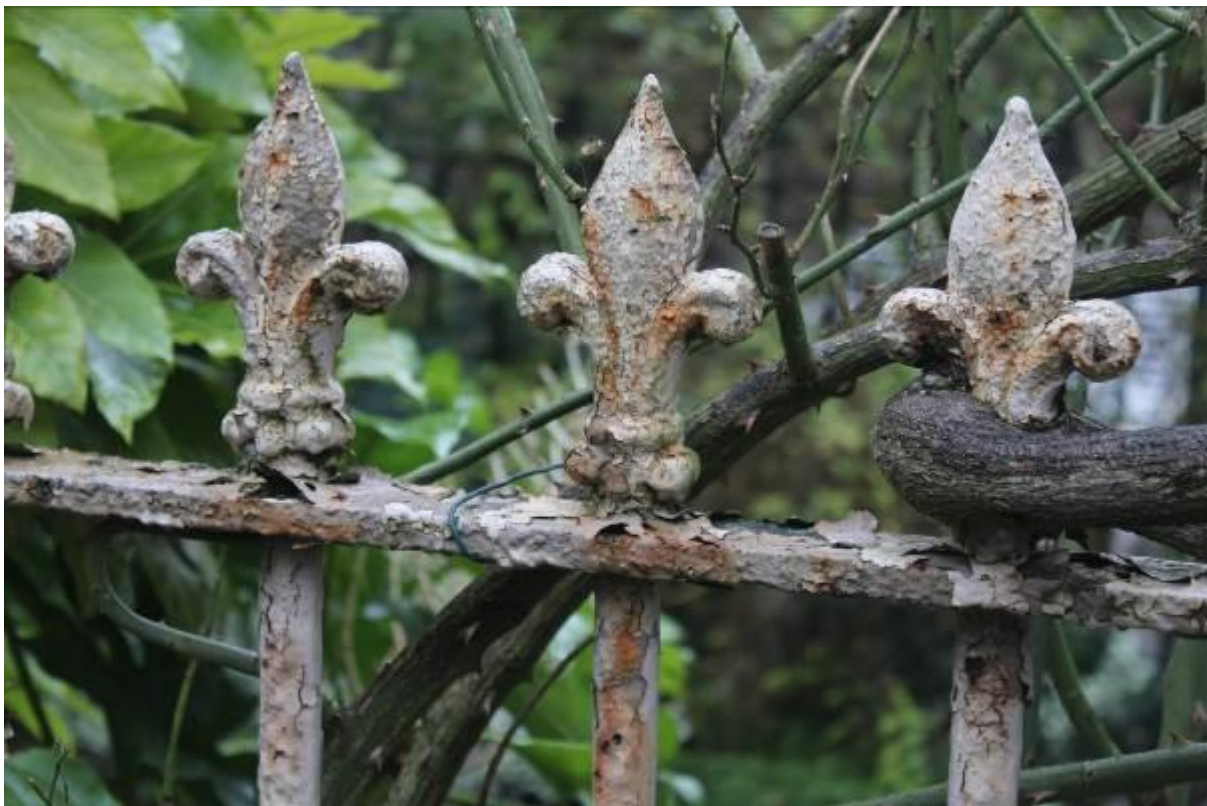
**8. Redecoration required in conjunction with careful removal of corrosion to boundary railings.**

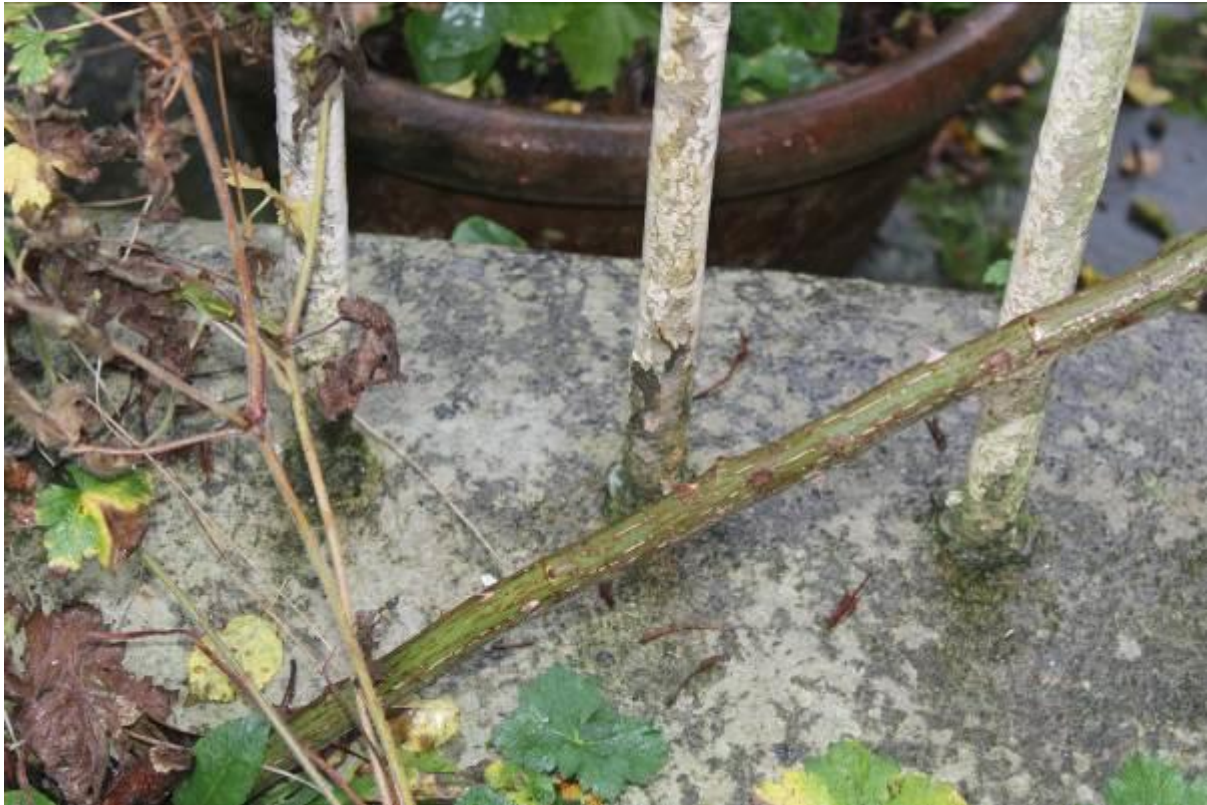
**9. As above.**

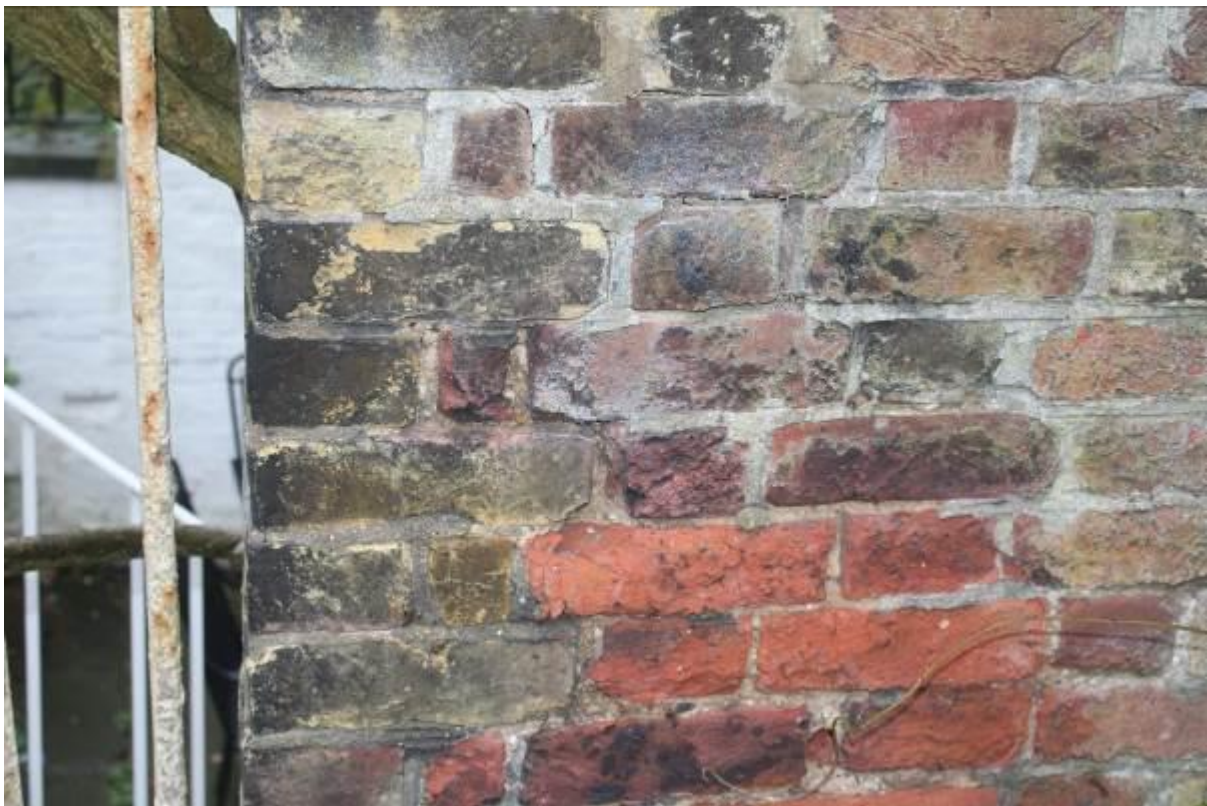
**10. Some minor brick boundary repairs also required.**

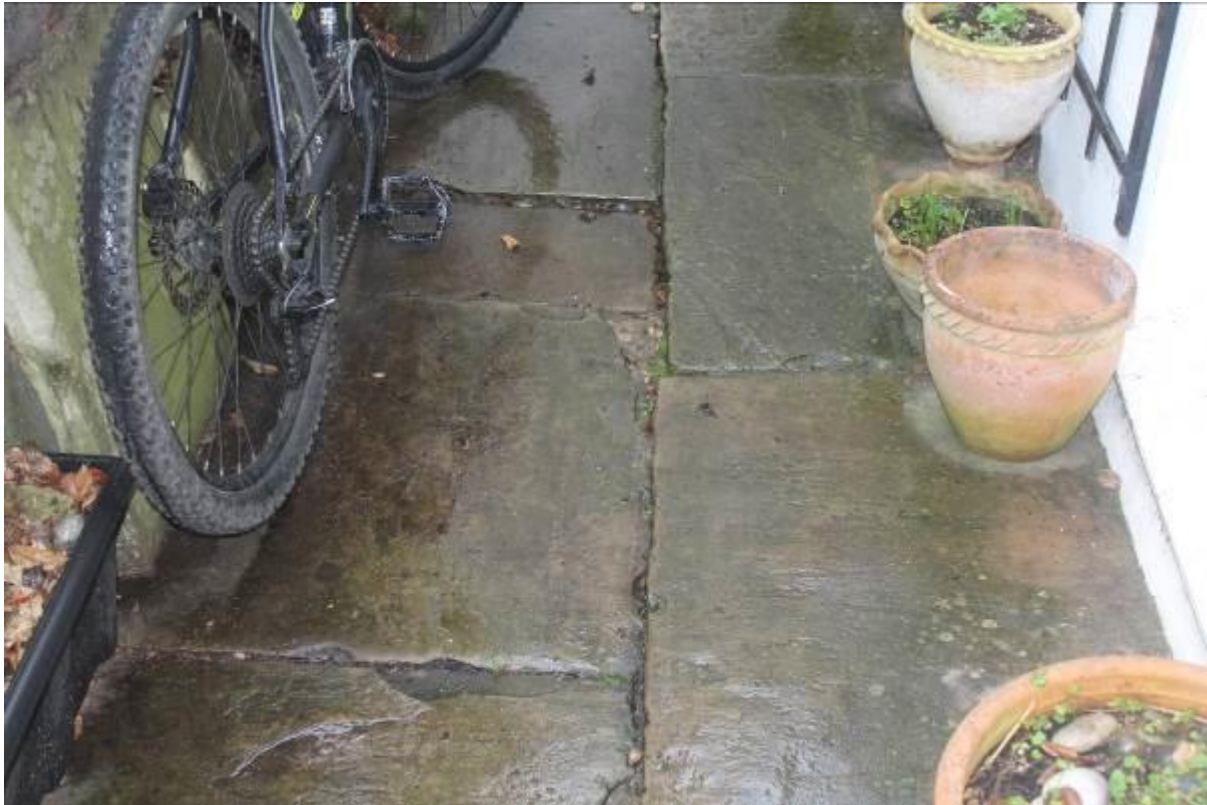
When you observe the condition of the York stone flagstones to the side yard it is apparent that they undulate and they have no sealed joints and some of the slabs, particularly adjacent to the brick buttress, have dropped more significantly, so much so that a trip hazard has formed between adjacent slabs, this indicates that water has washed away the particles of soil from underneath these slabs so if this event has occurred to the slabs then it would have happened to the adjacent foundations as well.

- 13. Rainwater percolates through the paving gaps causing them to settle unevenly and contributes to the movement to the flank wall, this is why we recommend a damp membrane is located under these slabs.**

The simple solution would be to lift up the paving slabs create a waterproof barrier preventing rainwater from passing through the slabs and washing away the fine particles of soil from underneath the existing foundations of the side wall of the rear addition, creating a gully for the rainwater goods to the rear elevation of the main building and then running that into the inspection chamber located at the very front end towards the end boundary of the main building. There may be some very minor movement between now and in the next twelve months but this is likely to be extremely minor in nature and once this has been carried out we would not expect any more settlement type movement of this rear addition.

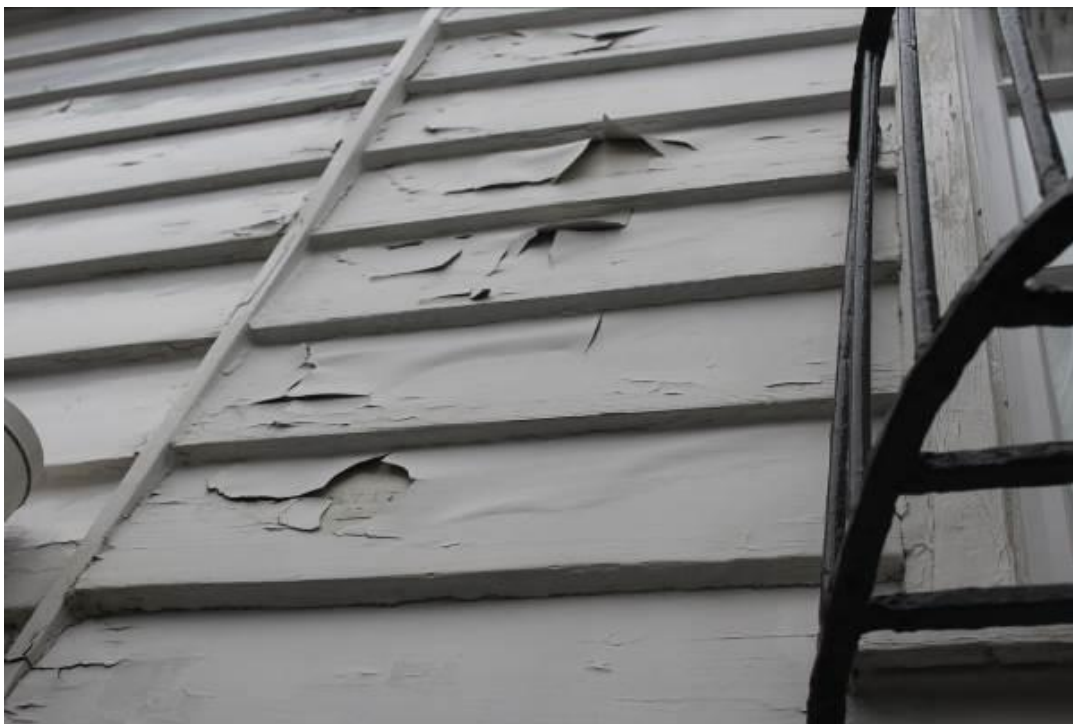
- 14. Redecoration required.**

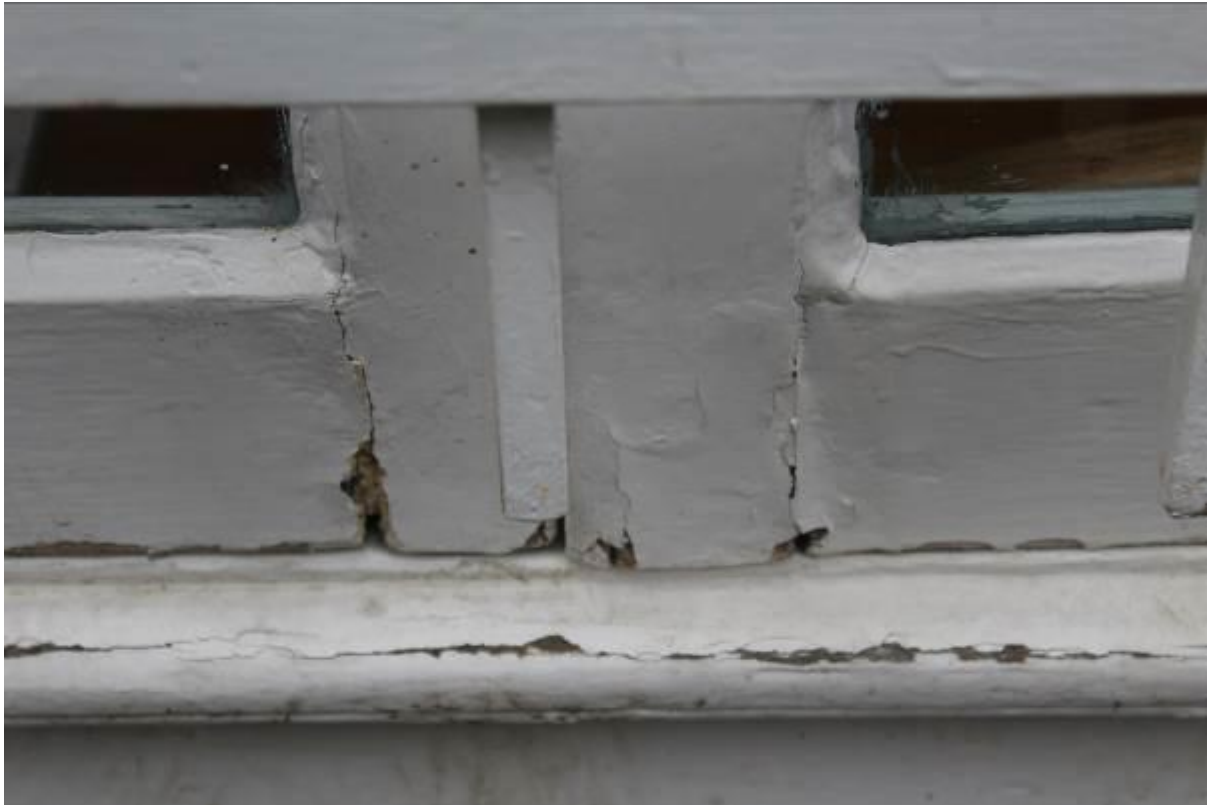
Further along the flank rear addition elevation a window has been located over what was originally appears to be a door opening. Window care repairs to timber decay are required to the bottom rails of this window, which are not obvious unless you push the timber which is a little spongy and clearly there is decay in these locations.

**15. Joinery window care repairs required to some rear addition windows.**

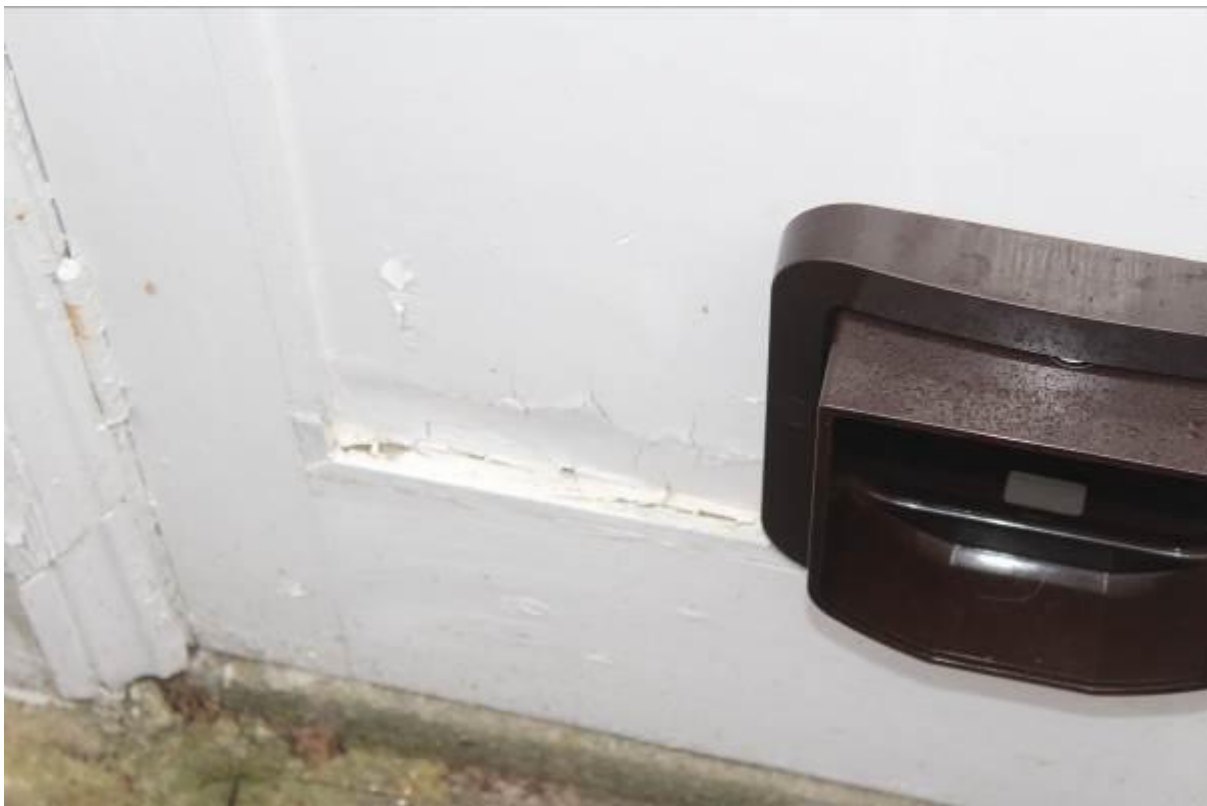
**16. As above.**

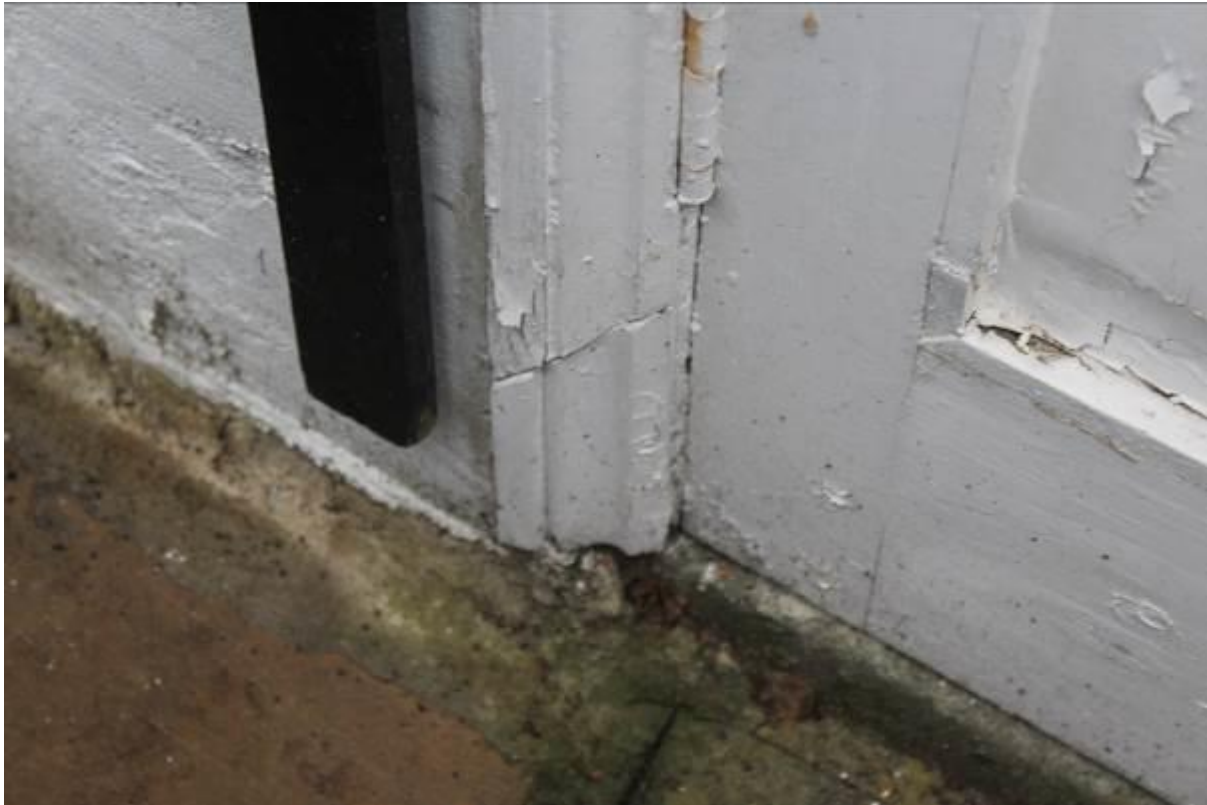
Repair has been carried out at low level to the left hand architrave this will only fail again in the relatively near future because the timber is not treated or of external quality and cracks have already developed in the paint finish and water penetration will occur into this and decay will occur this is inevitable as a result we would recommend the door is replaced in its entirety and completely redetailed.

**17. Poor internal quality architrave timber used, this should all be redtailed.**

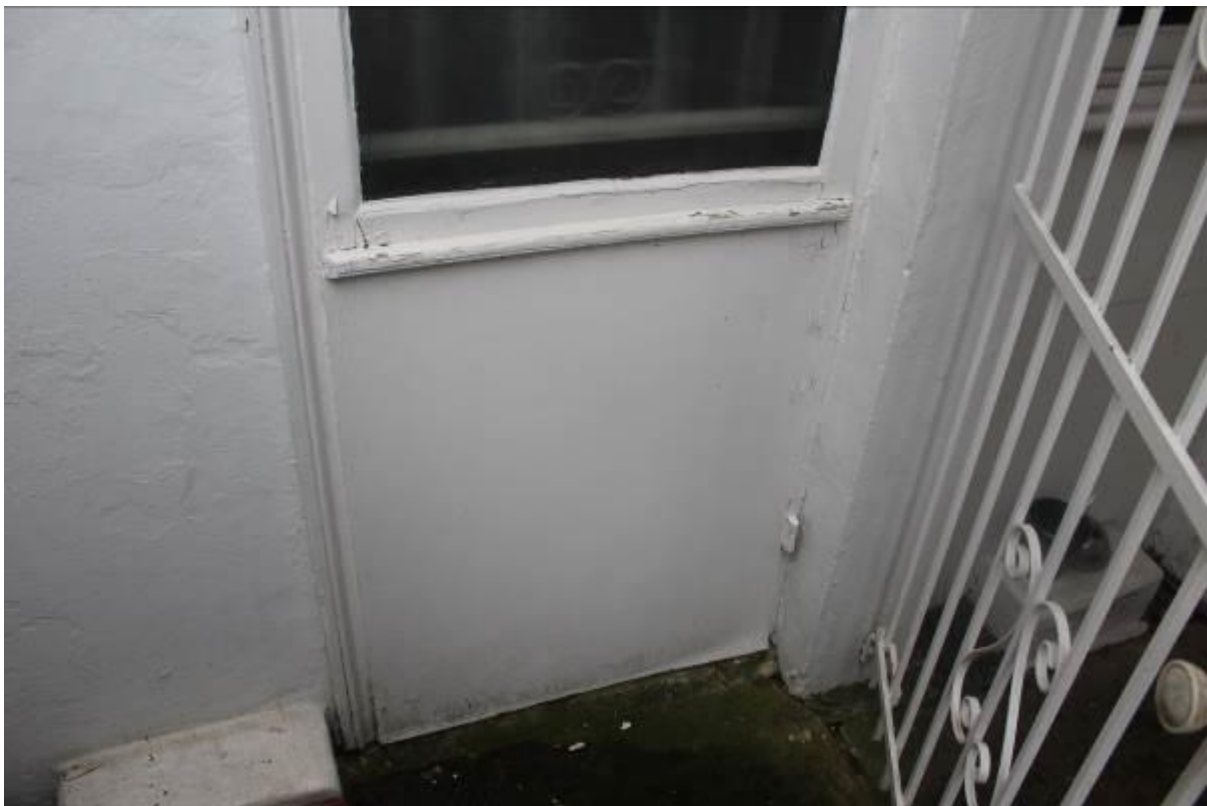
There is a door in the rear addition, adjacent to the previously mentioned one, which has been painted shut. This is a significantly older door with an elongated cill, again listed building consent will be required in order to change this but we recommend that it is changed or retained as a window it has no insulative qualities, either way joinery repairs and redecoration will be necessary to this.

**18. Rear reception room door fixed shut.**

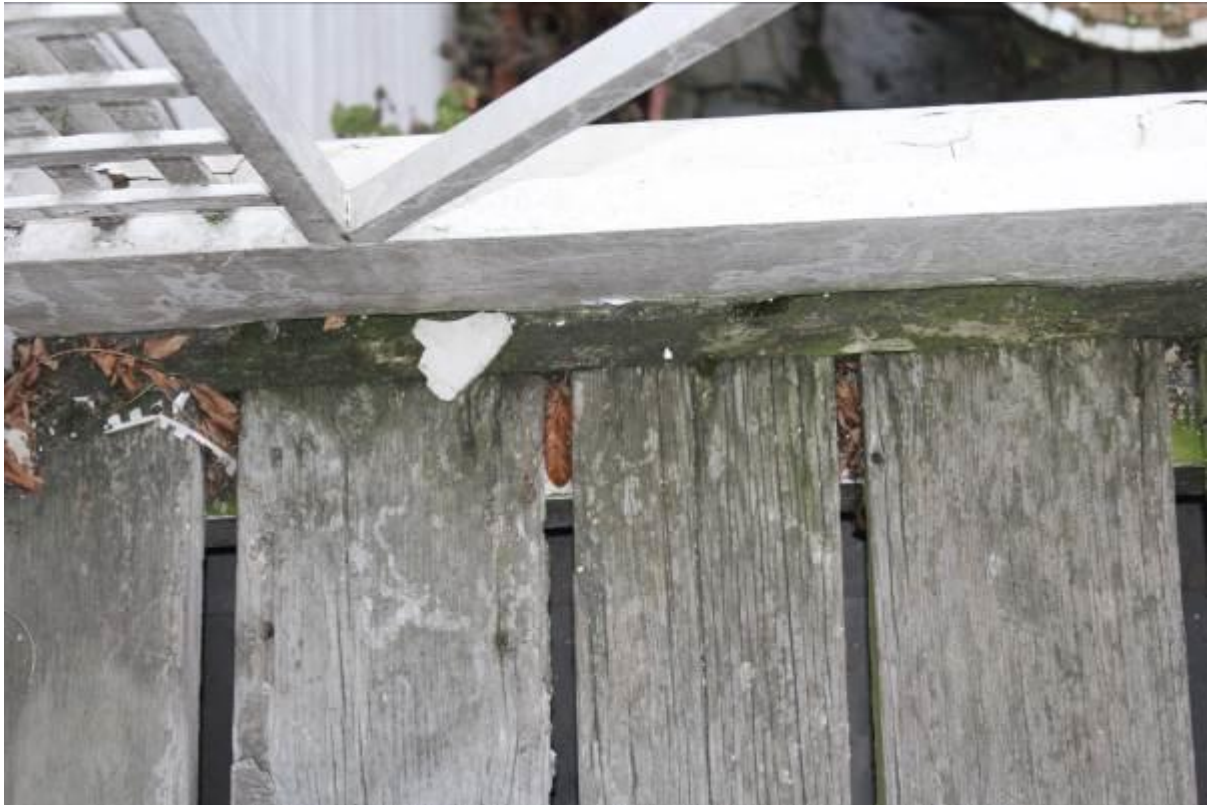
**19. Ends of balcony decking showing signs of decay.**

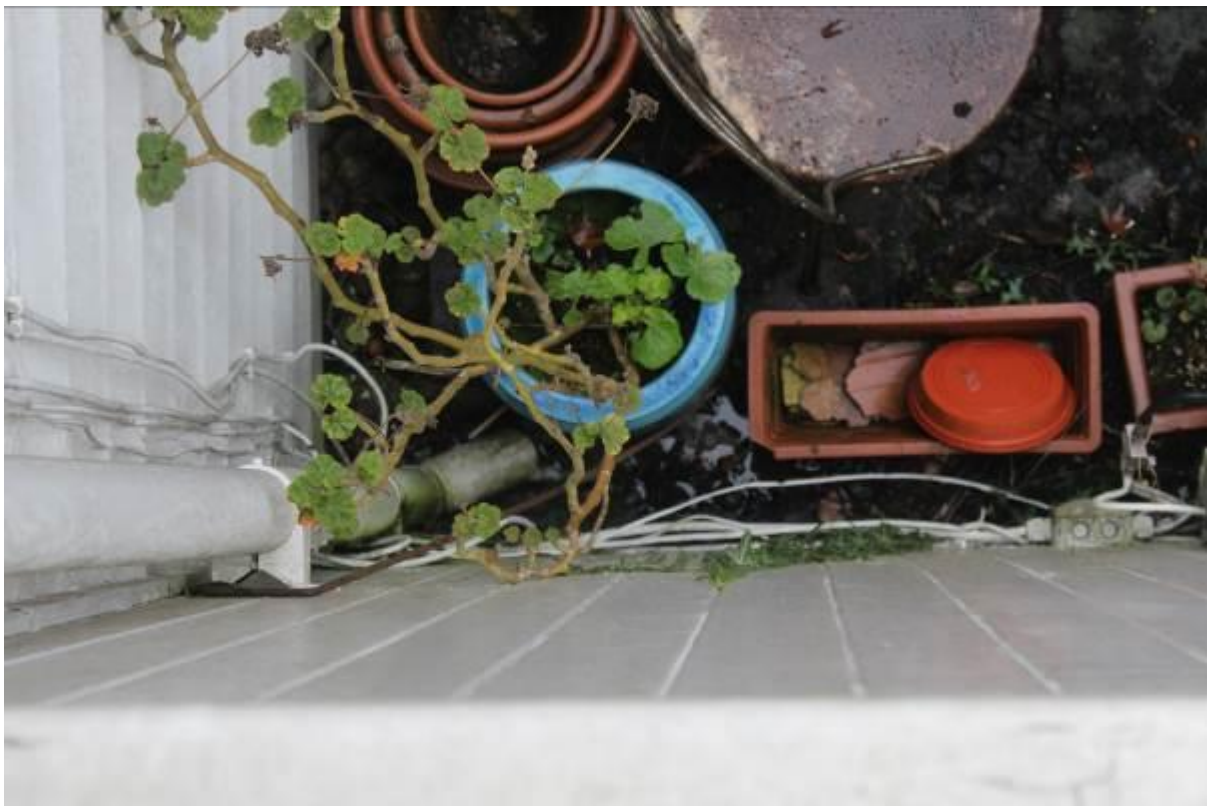
**20. Rainwater build up noted in adjoining property to downpipe serving west elevation roof. Further investigation and repair/unblocking is required.**

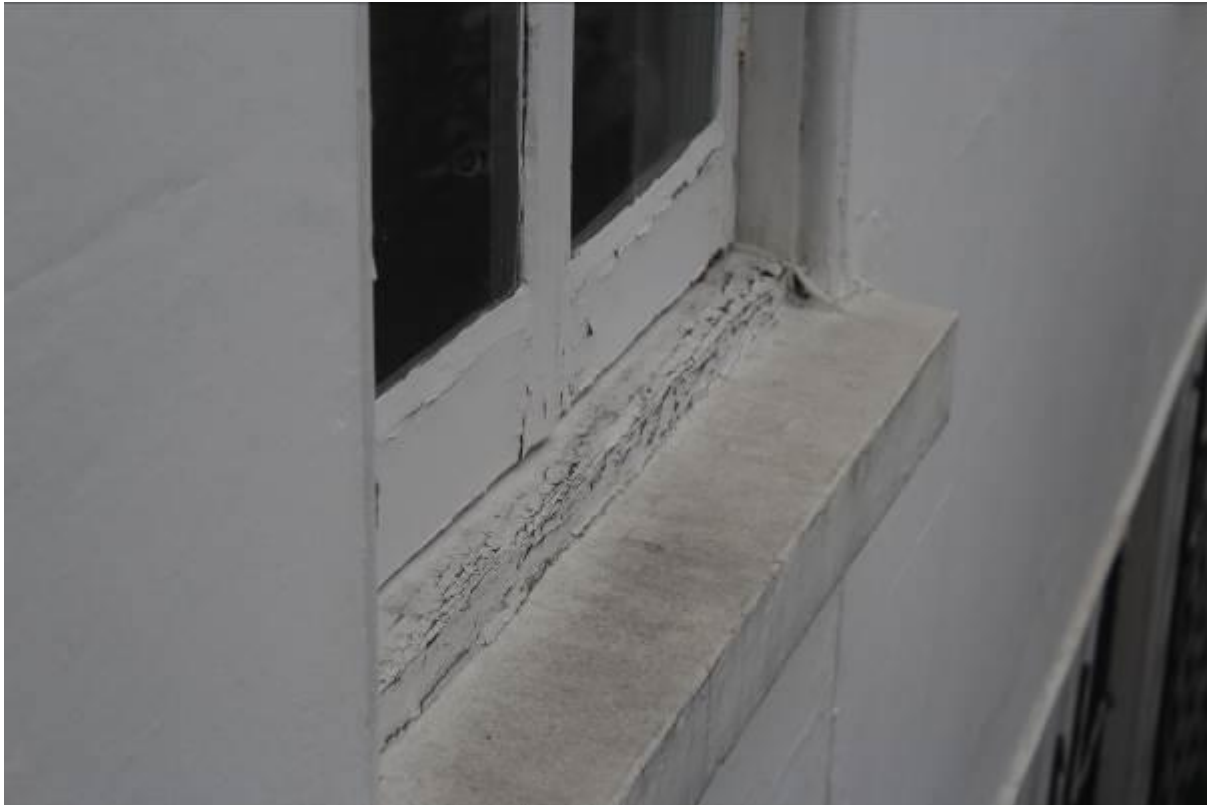
**21. Redecoration and repair required to external joinery to rear addition.**

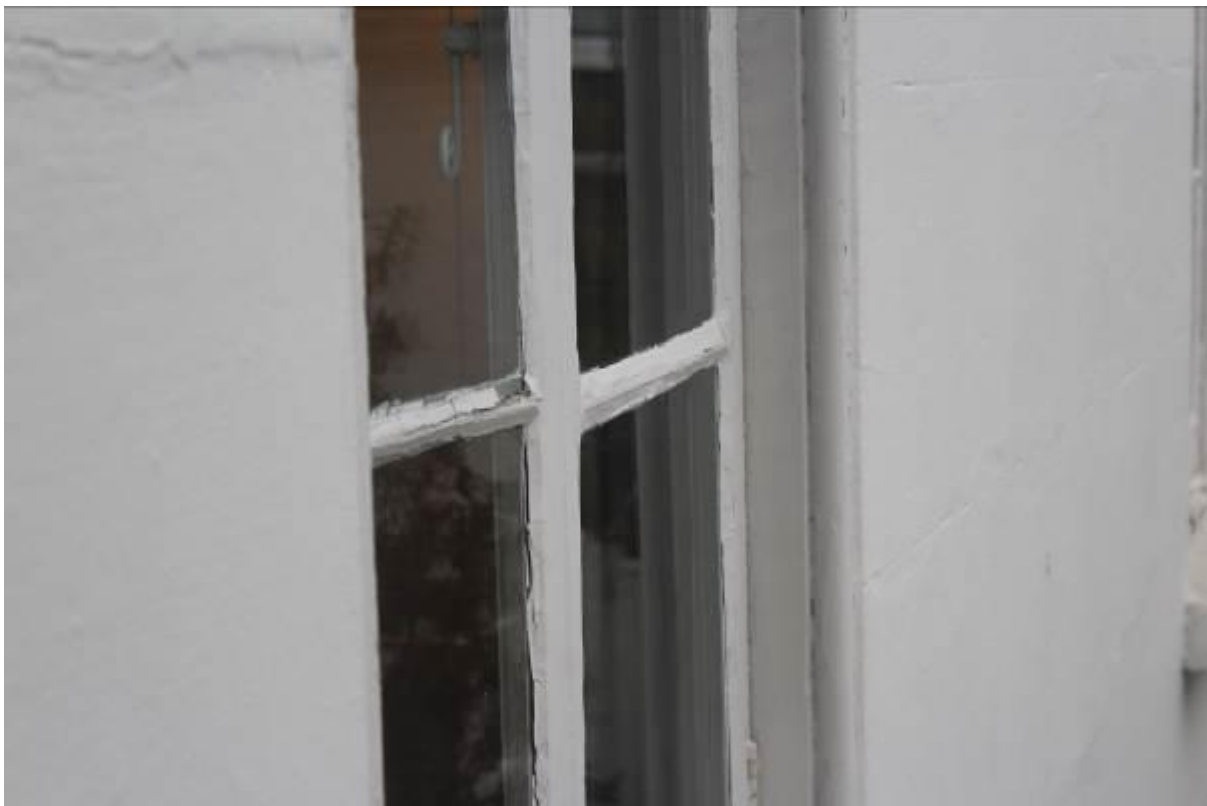
**22. As above.**

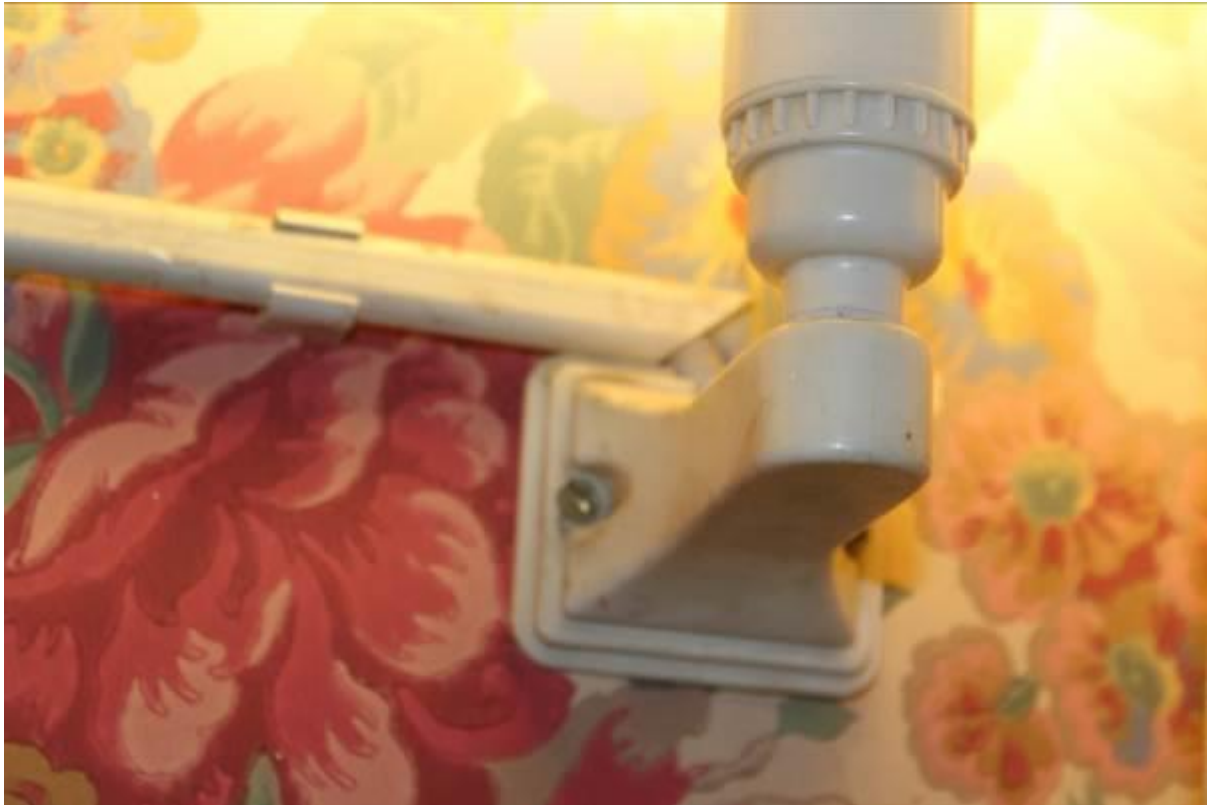
**23. Poorly formed surface run conduit.**

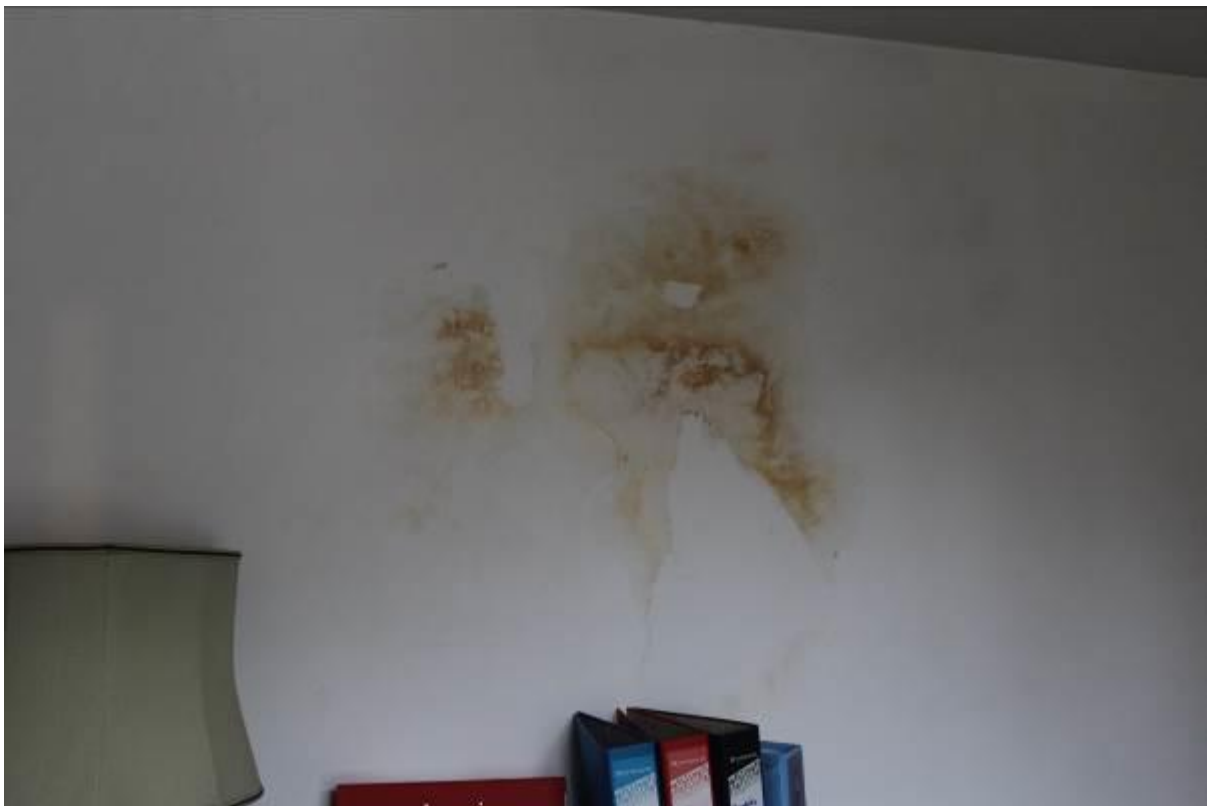
**24. Plaster repairs required to first floor bedroom where water damage has occurred.**
