# **Building Survey Report**

**Rose Cottage  
Vale of Health  
London  
NW3 1AX**

**Date of Inspection**

**21<sup>st</sup> December 2016**

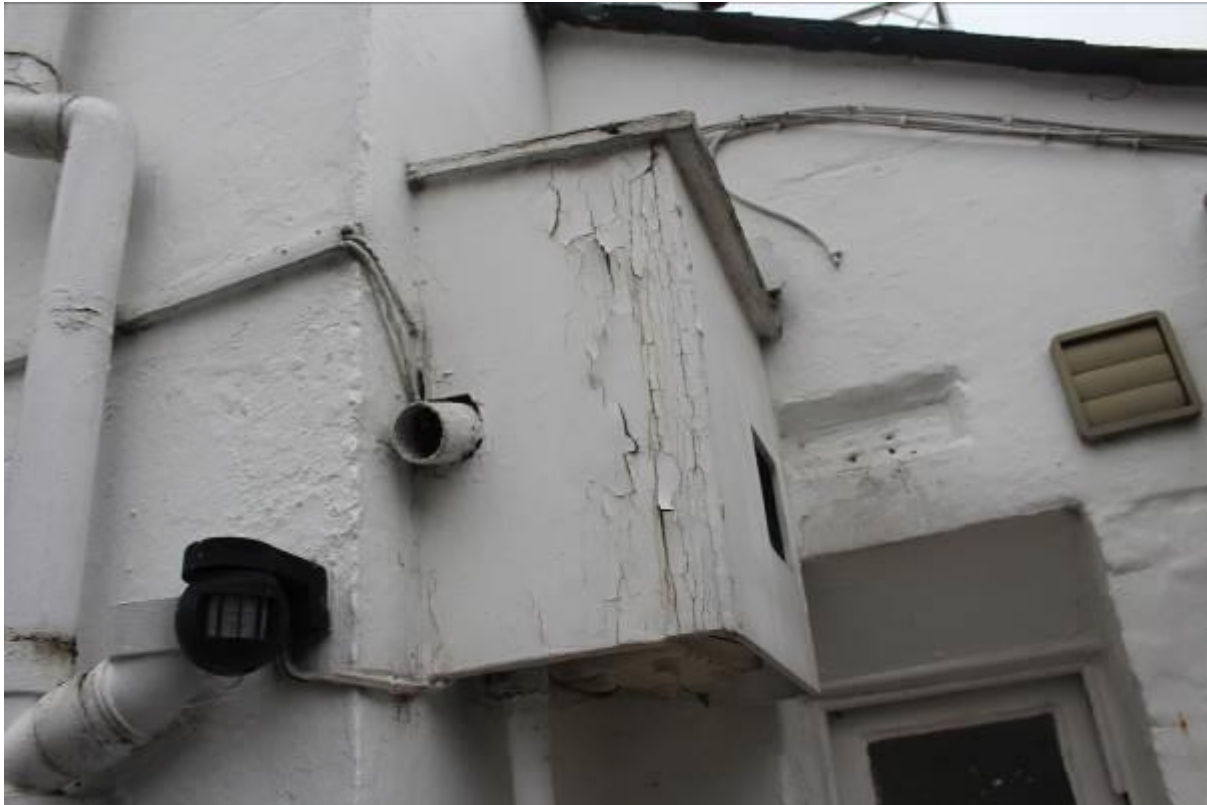
An external gas meter box is provided adjacent to the east entrance gate, this would benefit from redecoration and repair.

**26. Repair and redecoration of gas meter box is required.**

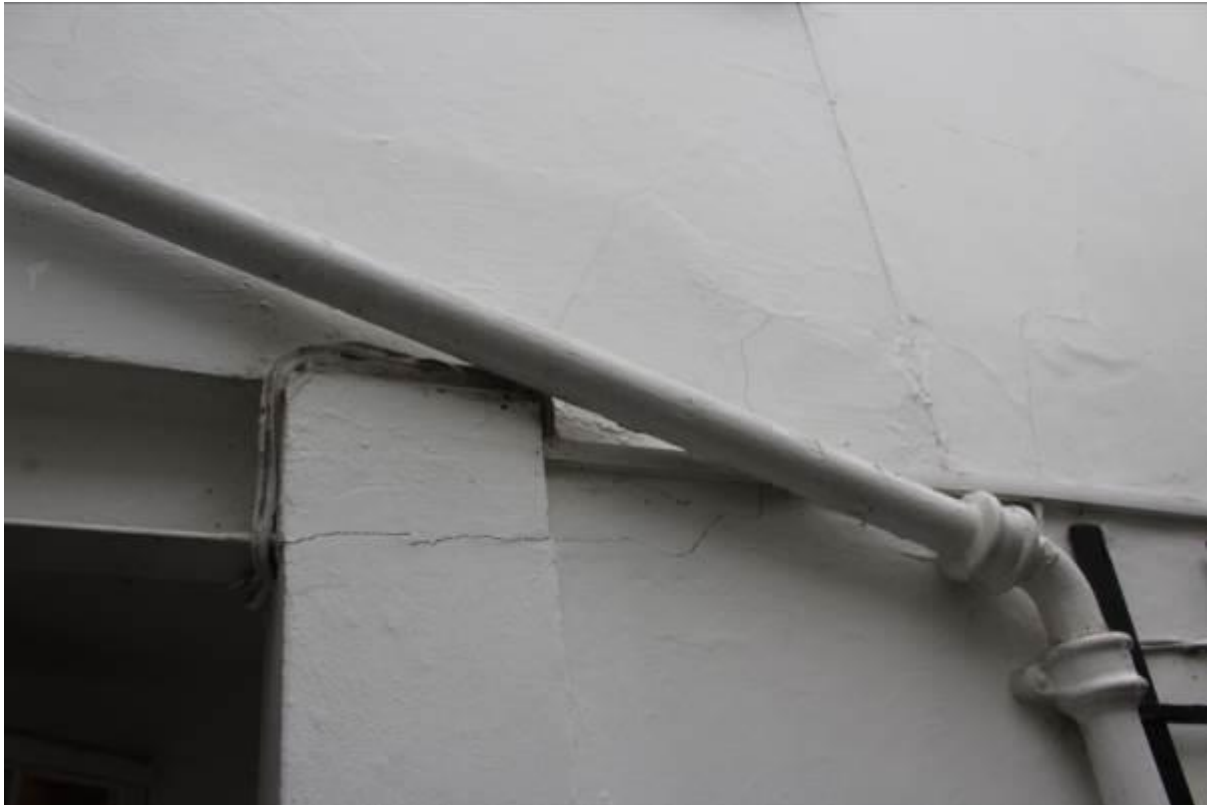
Whilst this hairline cracking as can be seen in the attached photograph it illustrates that movement is minimal but possibly ongoing.

**28. Some cracking observed to rear addition masonry indicating the movement is slowly ongoing.**

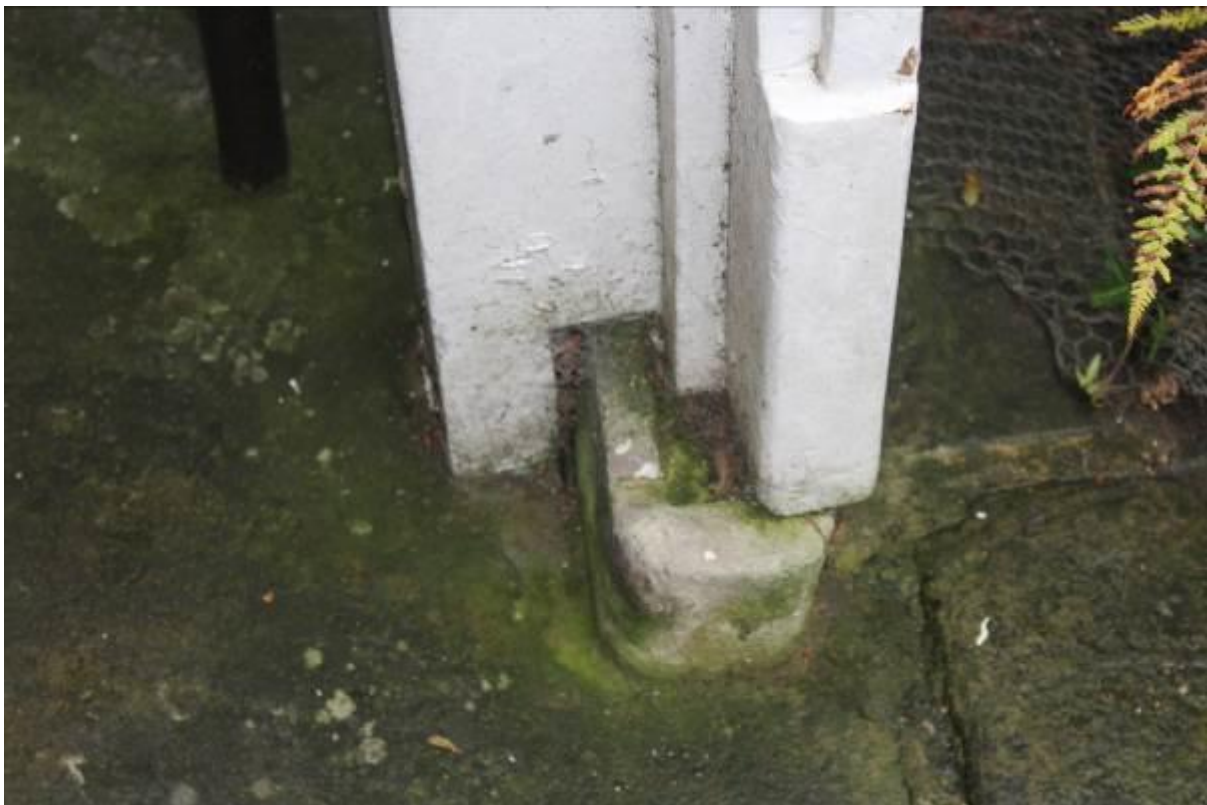
In addition, the base to the two main front posts comprises a stone, which appears to be just resting on a flagstone and the timber frame has begun to move away from these supporting structural support "stones" and as a result we recommend that the structure is temporarily propped and a new support base is provided for the timber structure. It may be possible to retain the existing stone blocks but this does need to be readjusted because eccentric loading on these blocks is likely to cause them to fail at some stage in the future. (See attached photographs)

**29. Front balcony support base now out of alignment and in need of re-seating.**

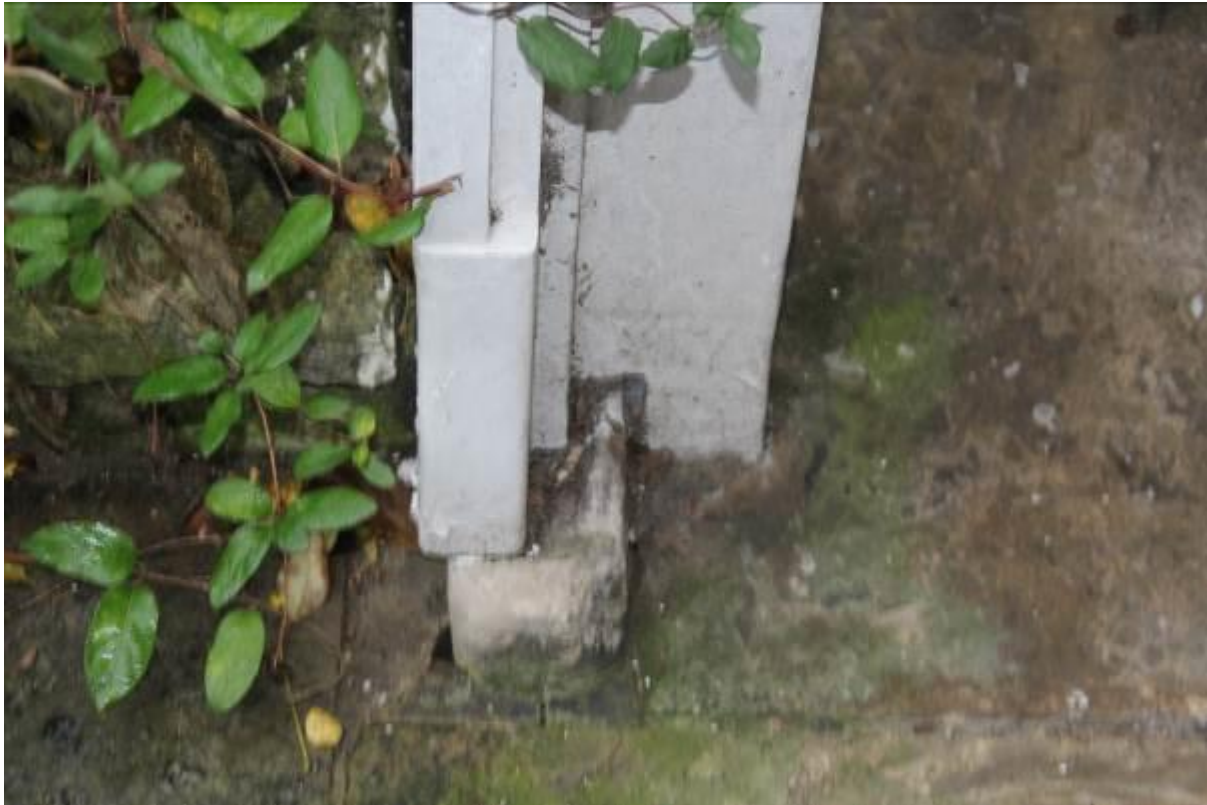
**30. As above.**

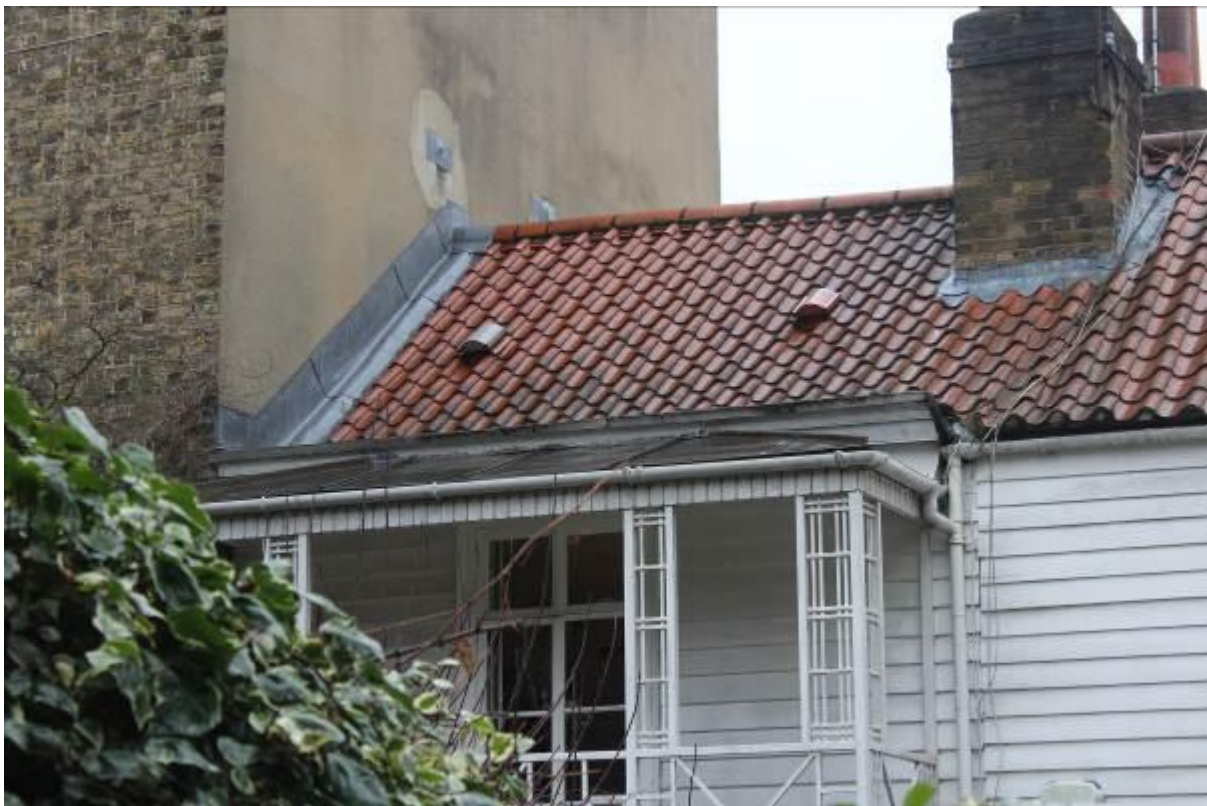
**31. The balcony roof can be seen here to be zinc or lead, further investigation recommended.**

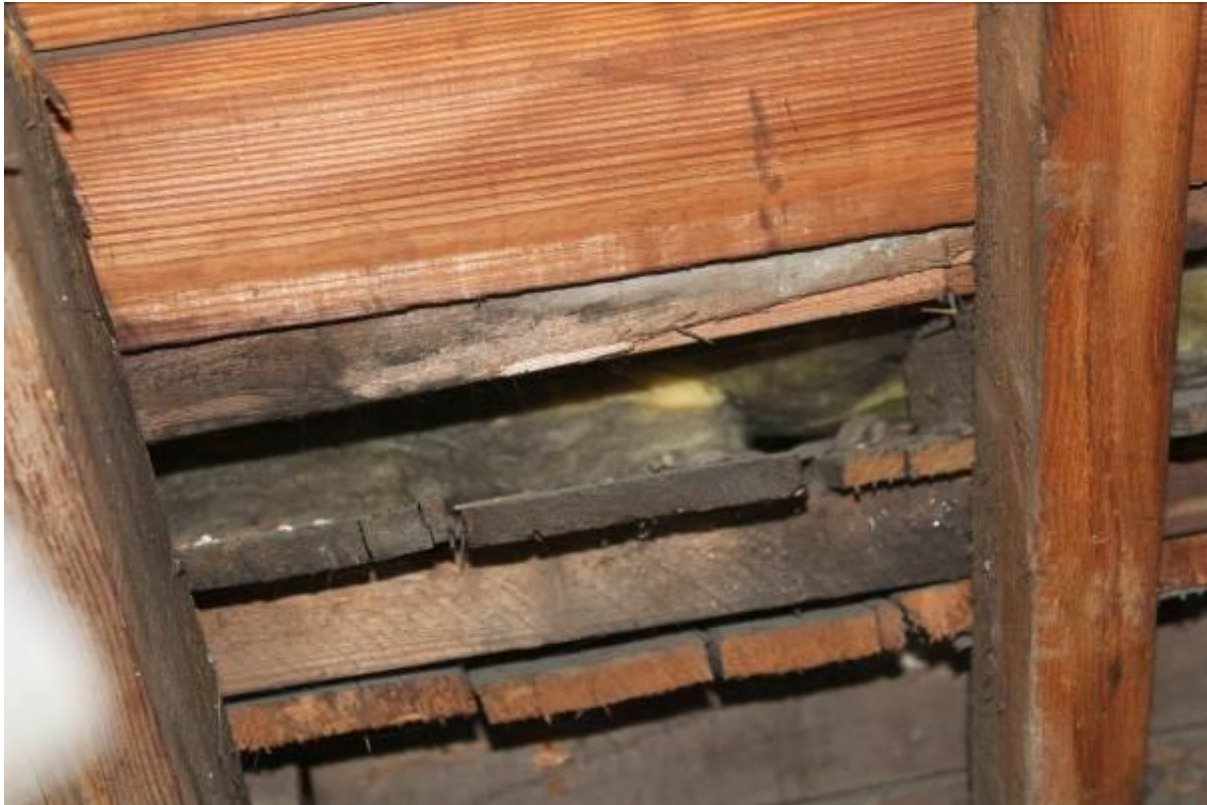
Evidence of insulation in the rear addition roof was apparent although no visual inspection of this area was possible as there is no roof access hatch, ideally one should be installed. Overall we consider the roof space to be in good condition, there are no significant issues or concerns that we have in relation to this area.

**32. Evidence of some insulation in back addition roof space as viewed from the front roof space. An access hatch in this roof space is recommended.**

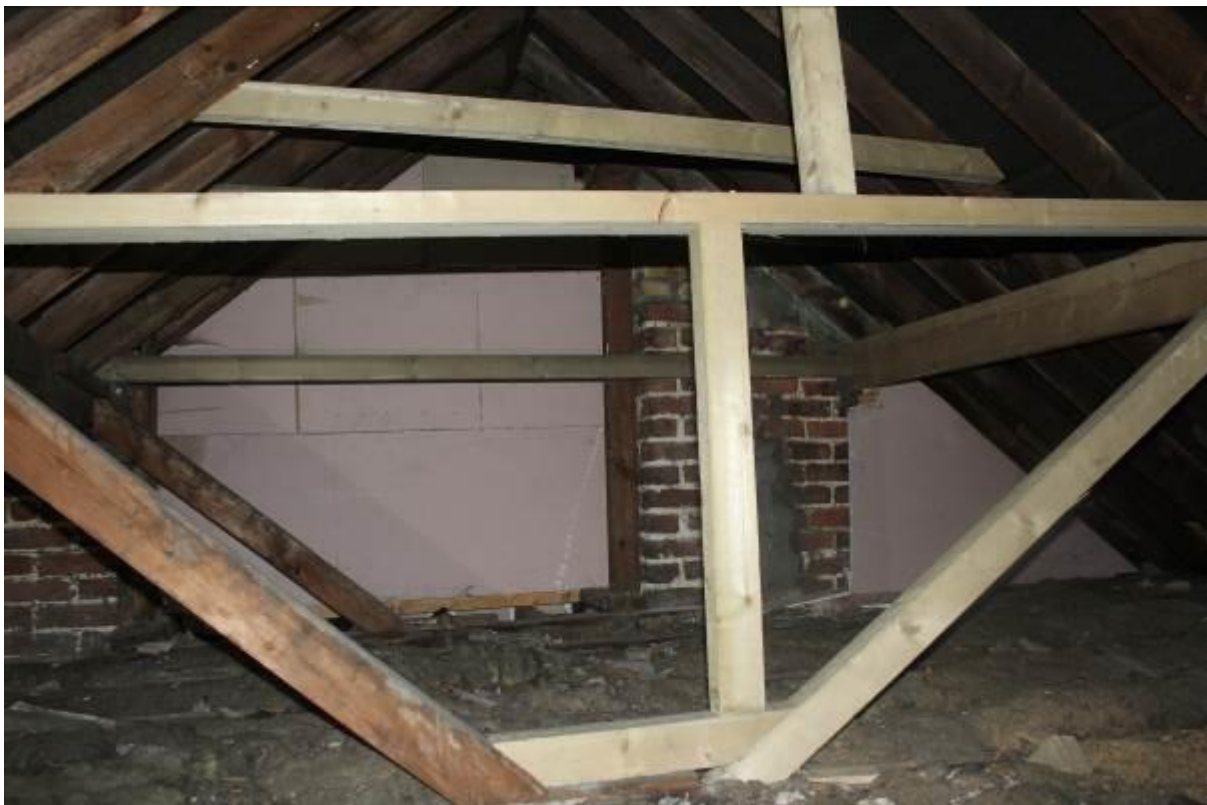
**33. Additional roof supports and fireproofing of party wall to main roof space.**

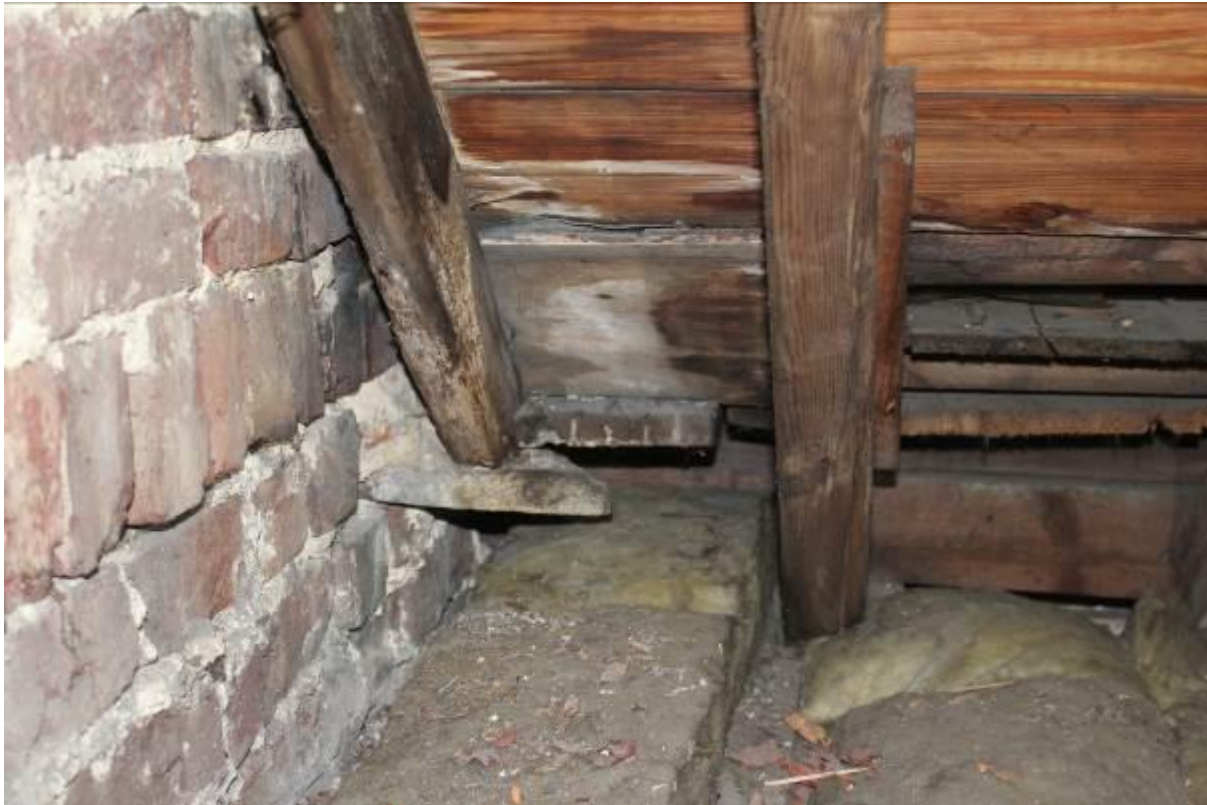
- 34. Support to base of rafter not ideal but currently satisfactory, this needs to be monitored or strengthened in some way.**

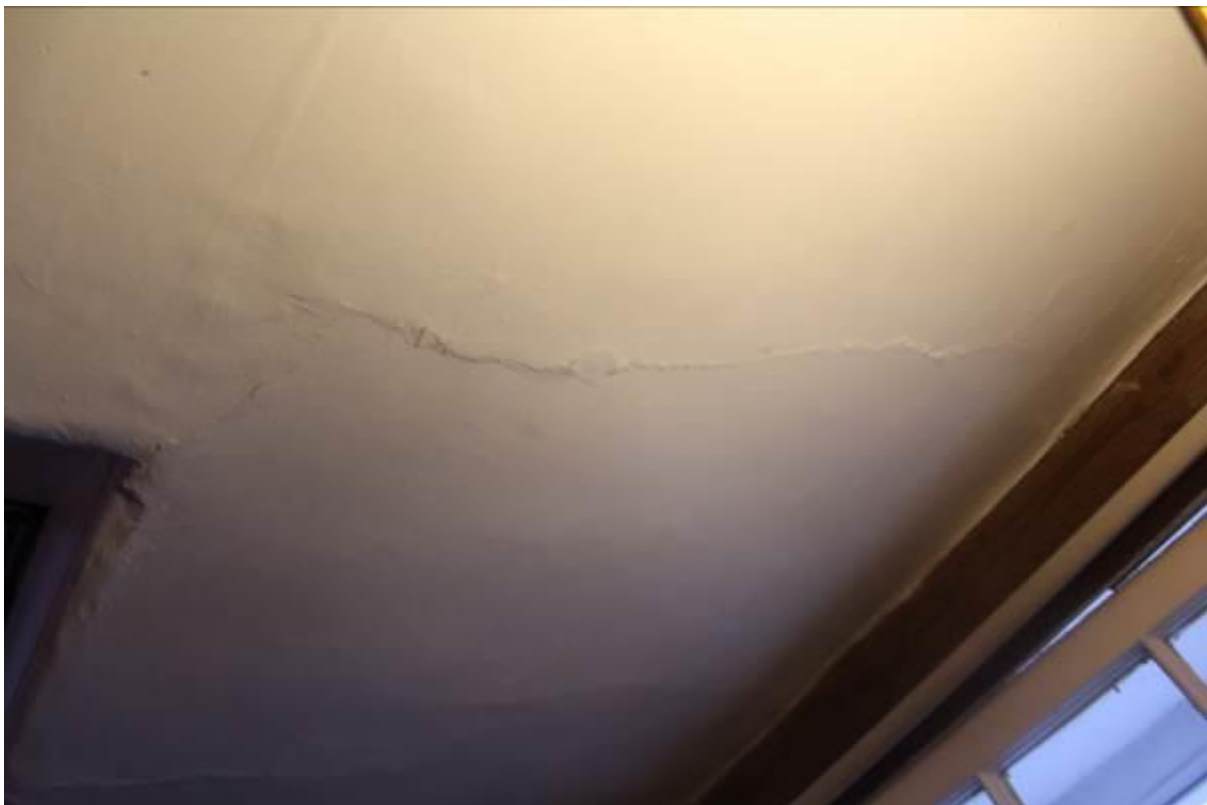
- 35. Ceilings would benefit from overboarding.**

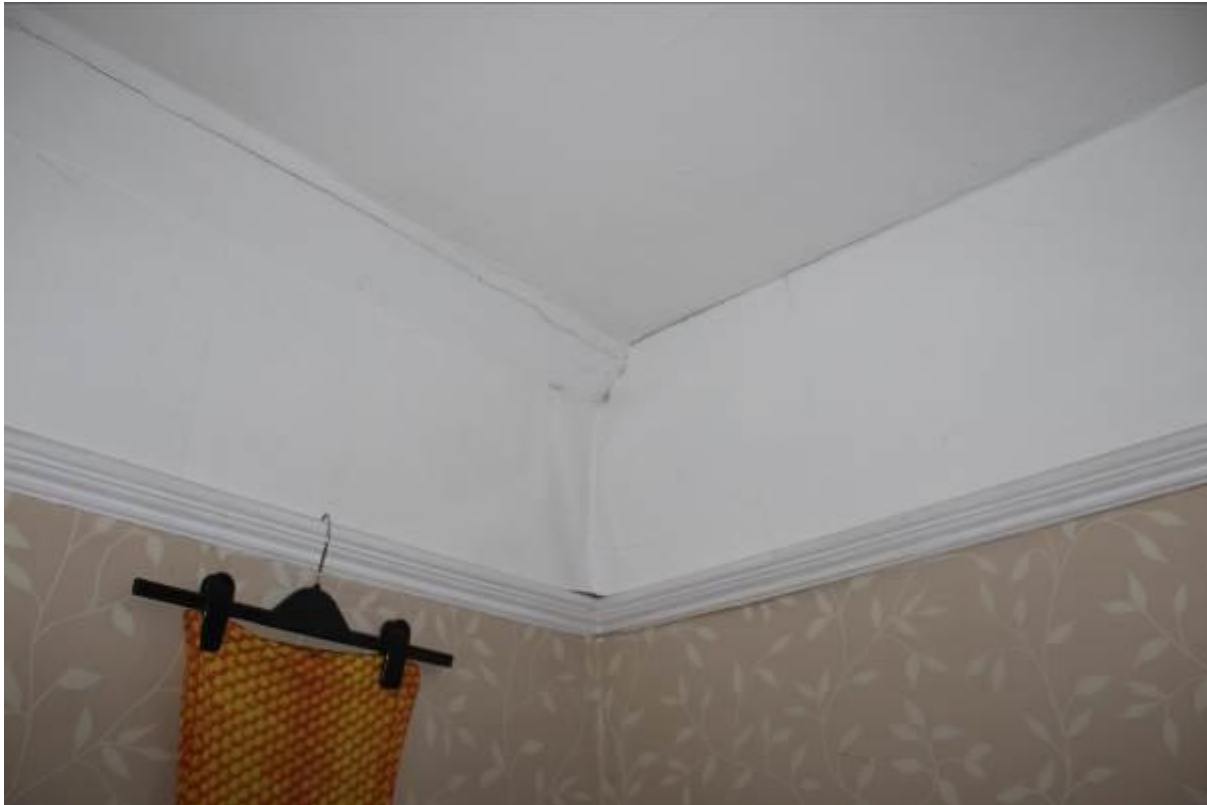
**36. Some minor movement evident in first floor bedroom.**

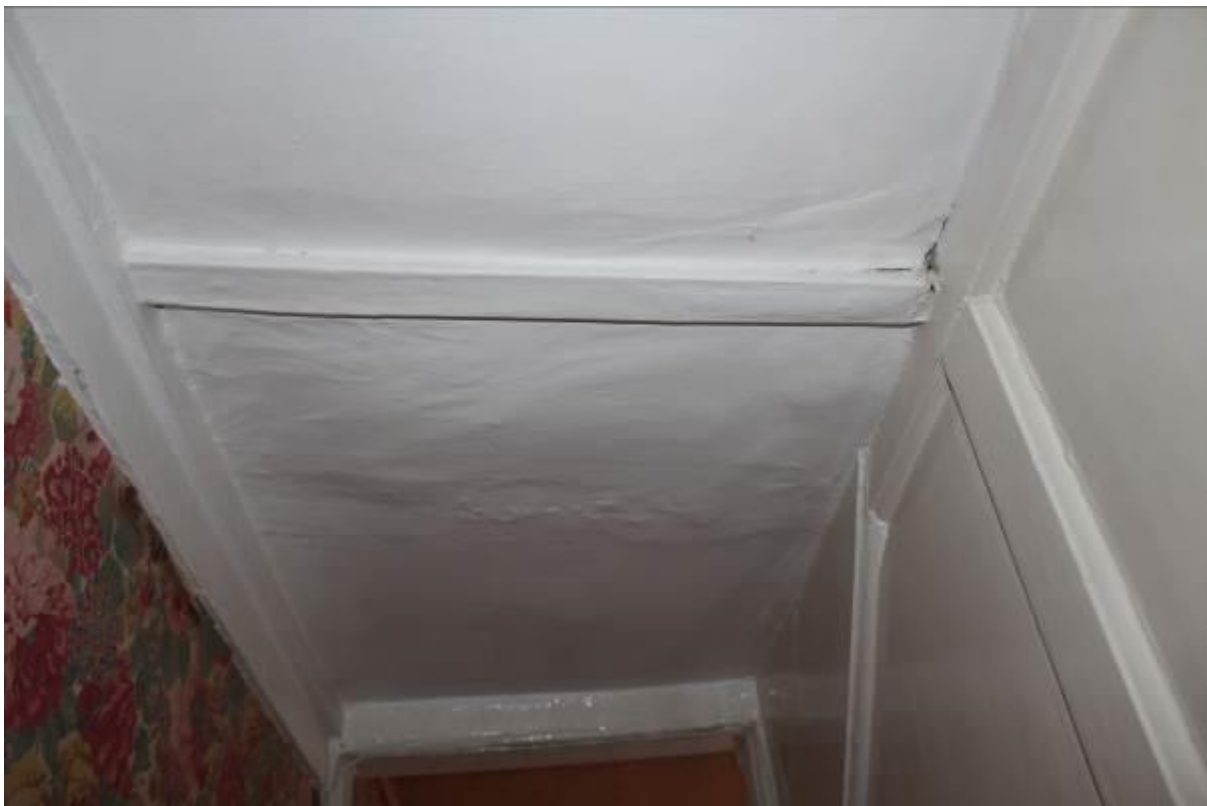
**37. Overboarding recommended to first floor ceilings**

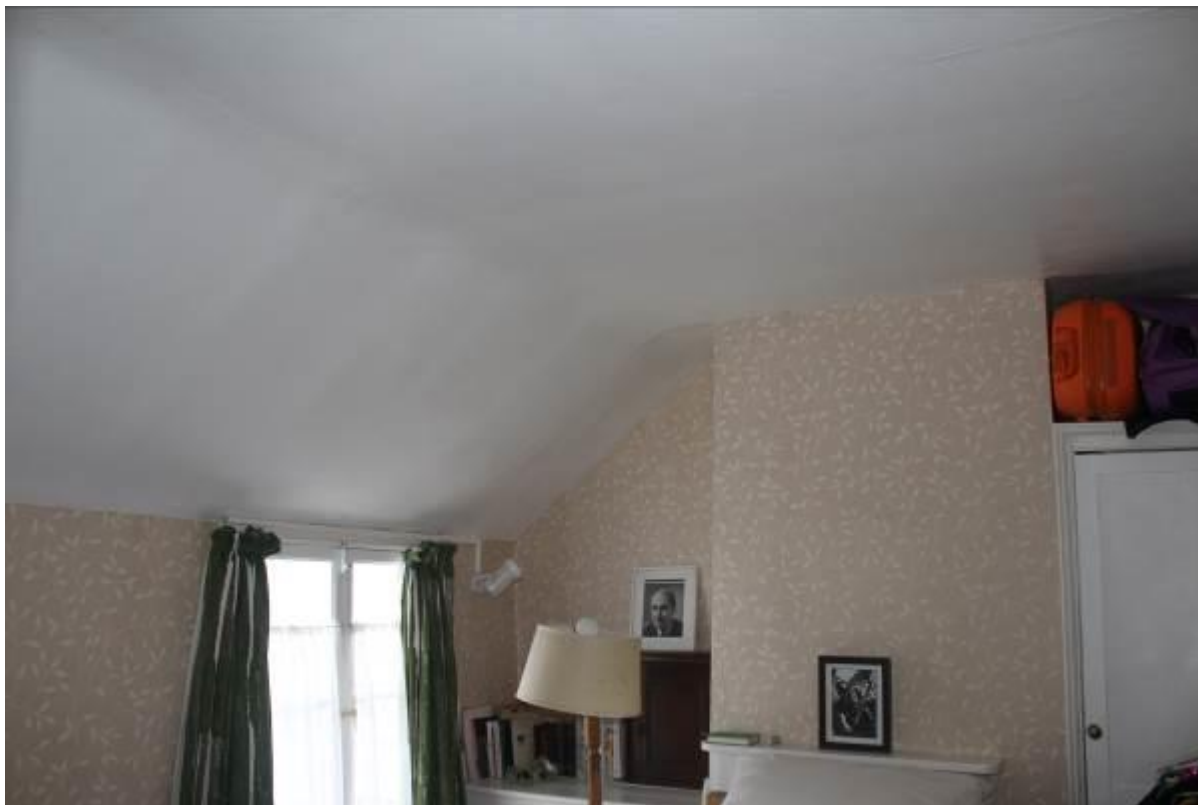
**38. The roof construction has caused the rear wall to spread as demonstrated in photograph 12, but there is no significant evidence of this being ongoing.**

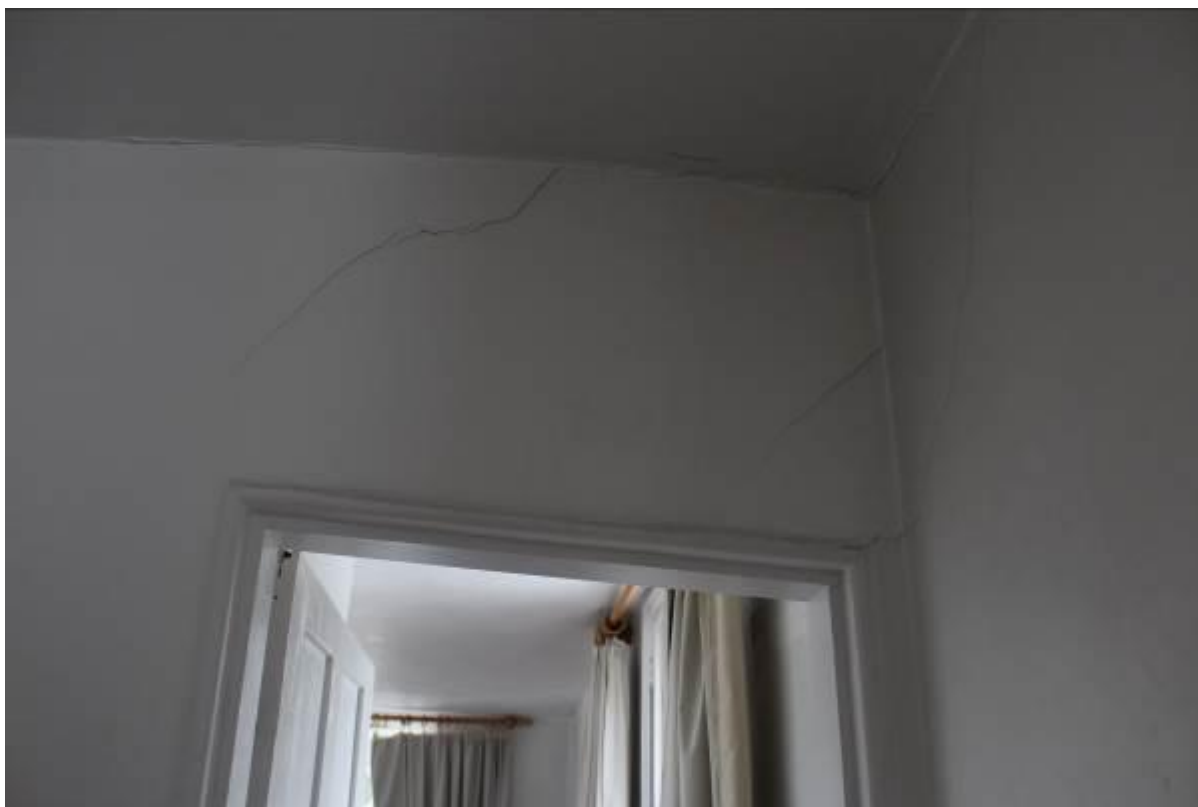
**39. Slight cracking above first floor door opening indicating movement is ongoing.**

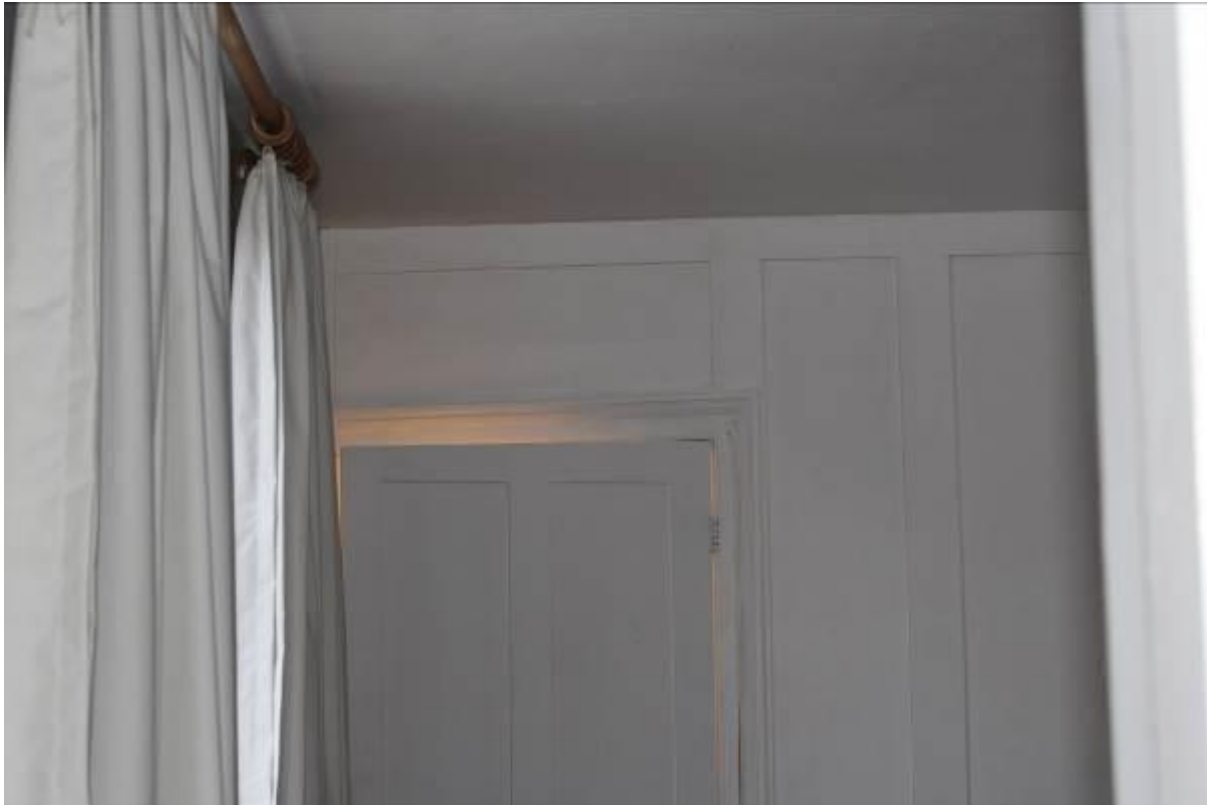
The heads to the internal door openings along the side of the rear addition, particularly at ground floor level are observed to be deflecting and there is an indication that significant movement has occurred over a long period of time slowly in a vertical plane to this side wall. This movement is generally in a downward direction caused by settlement but this does appear mainly to be historic.

**40. Door openings to the rear addition are out of alignment.**

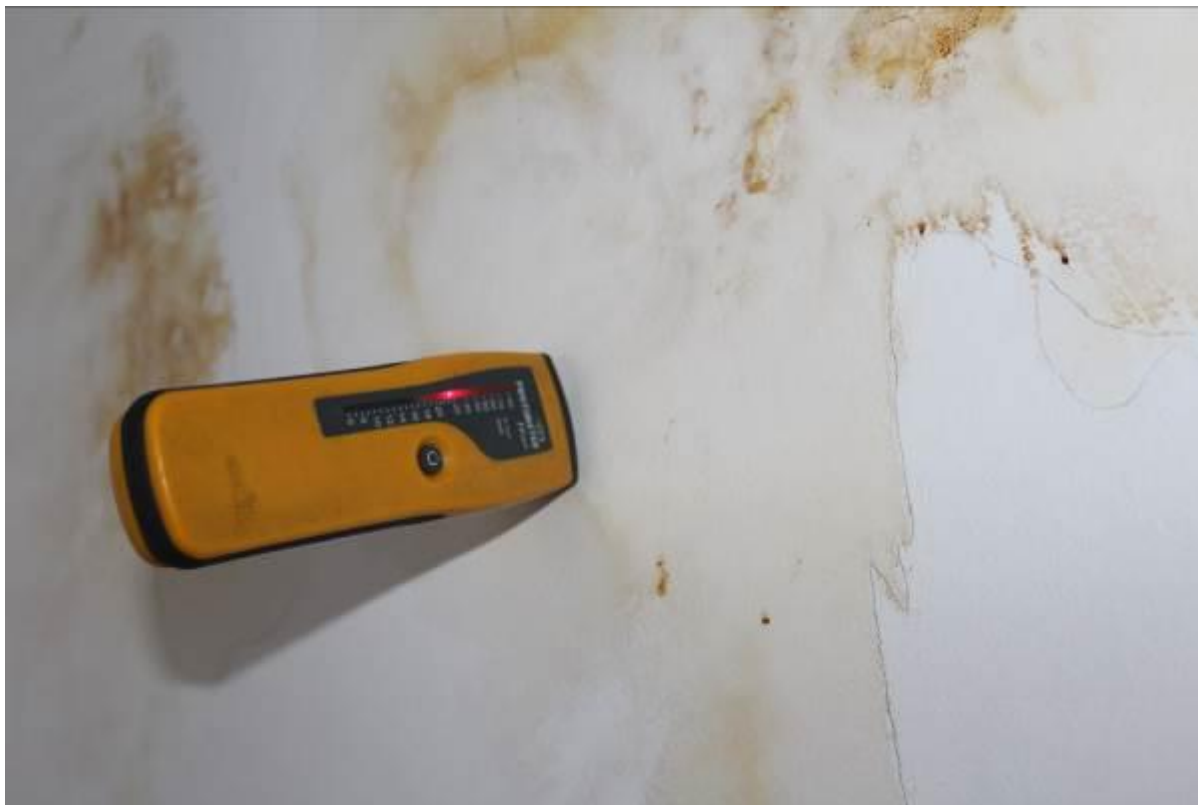
- 42. High reading noted in first floor bedroom, this could be caused by salt contamination, replastering required and further investigate by inspecting roof above.**

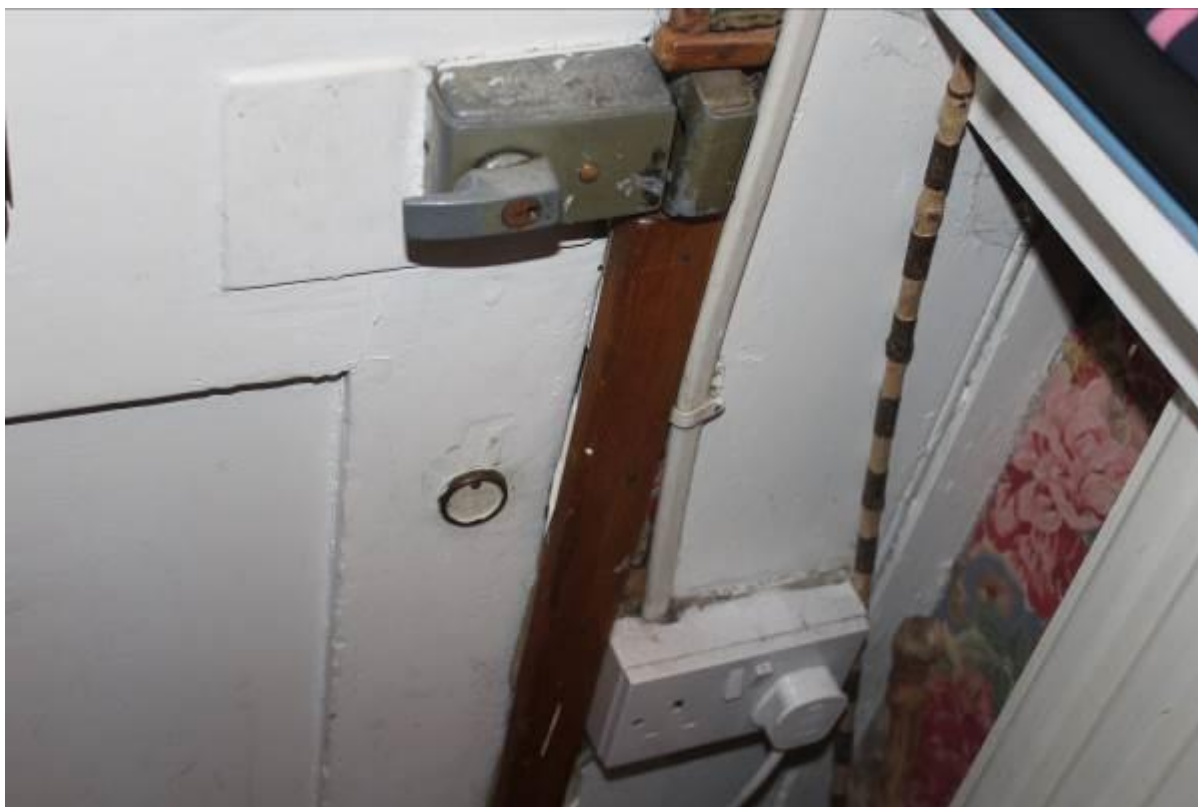
- 43. Air gap between door and frame.**

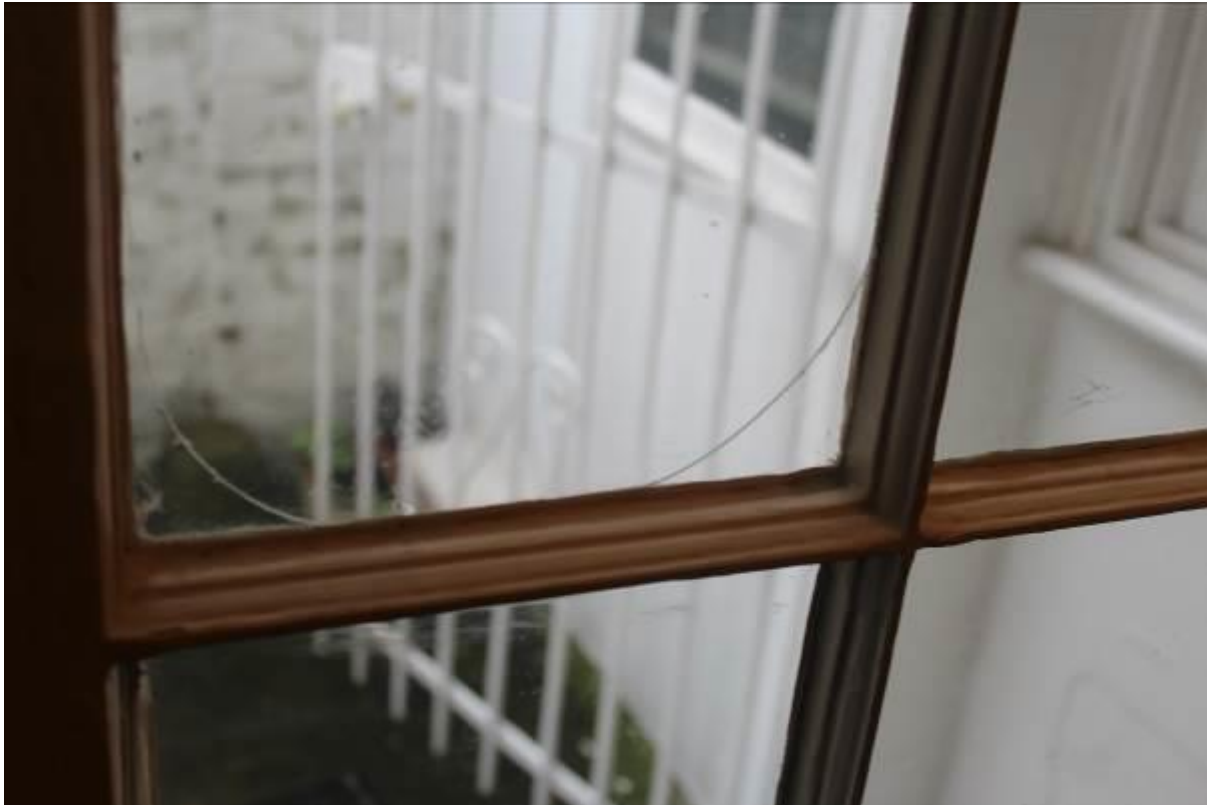
**44. Replace broken glass pane.**

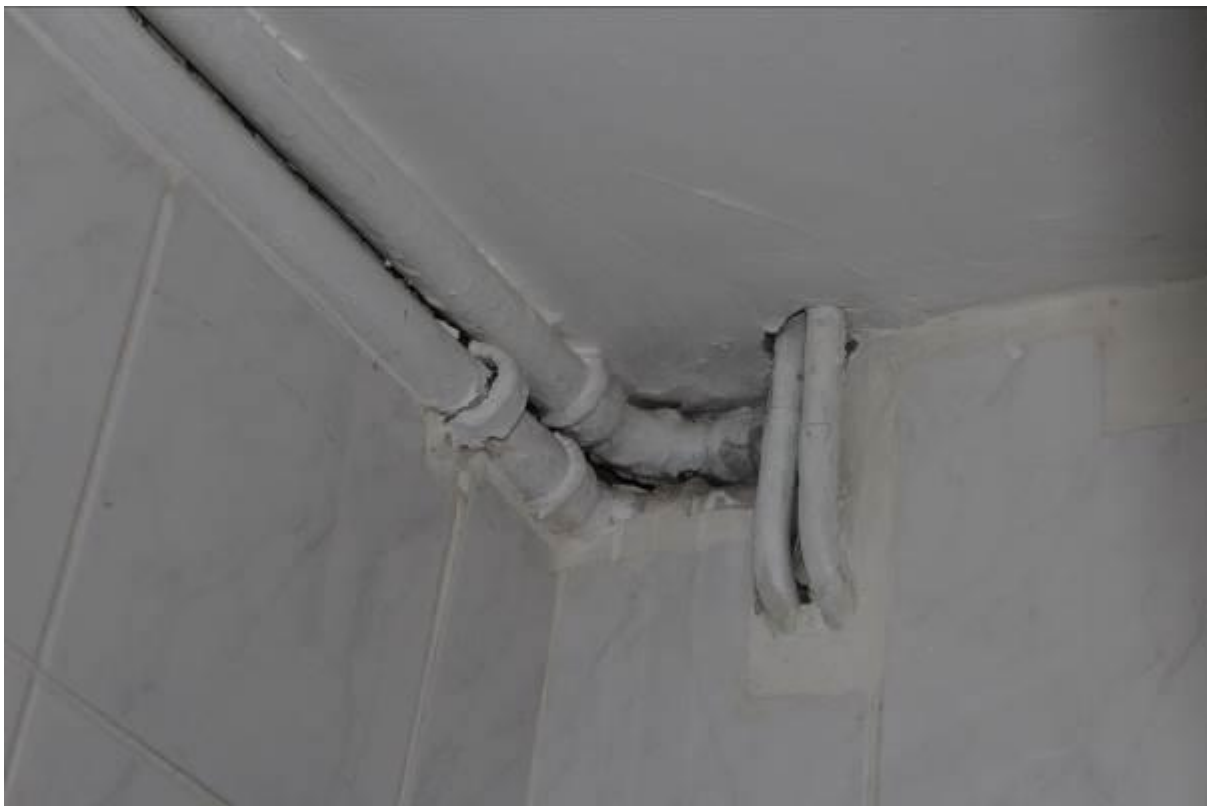
**45. Surface run ground floor pipework, unsightly, recommend concealment if not redundant.**

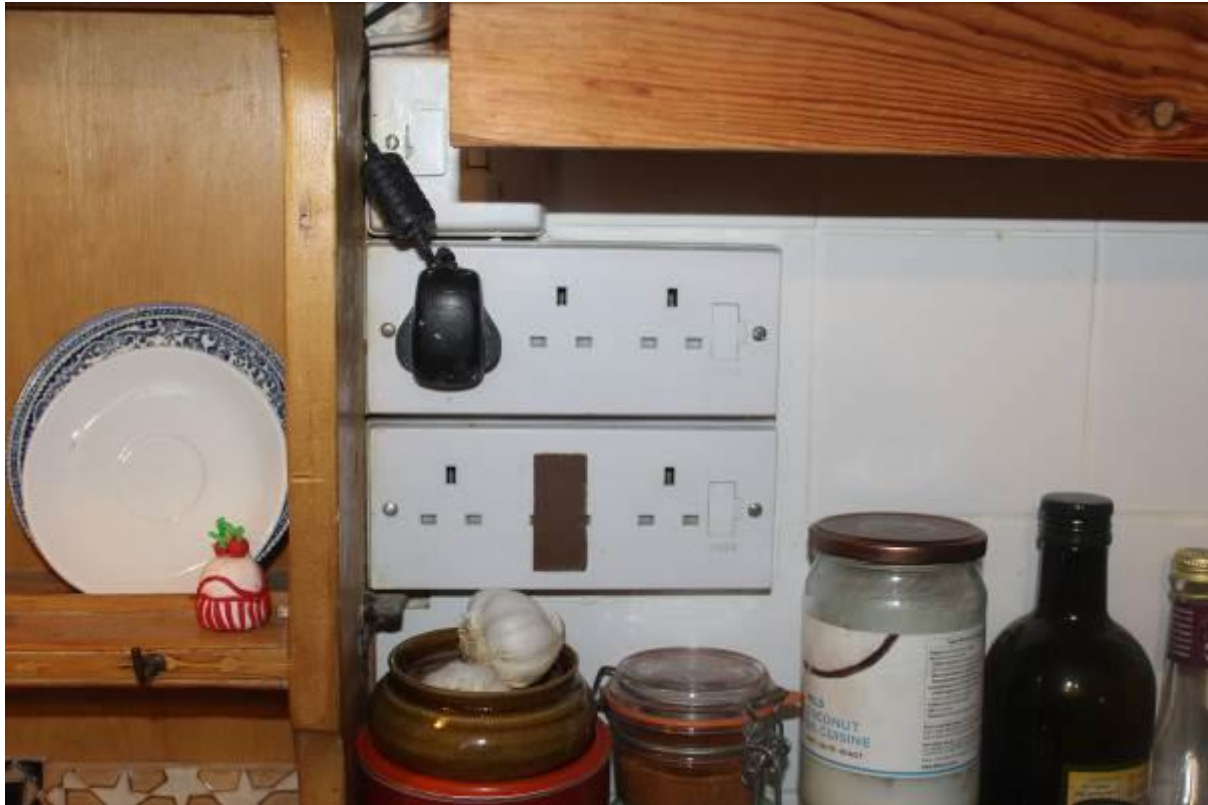
**46. Poorly designed electrical socket facilities, also note one of the positions has been blanked off with tape. Further investigation or rewiring required.**

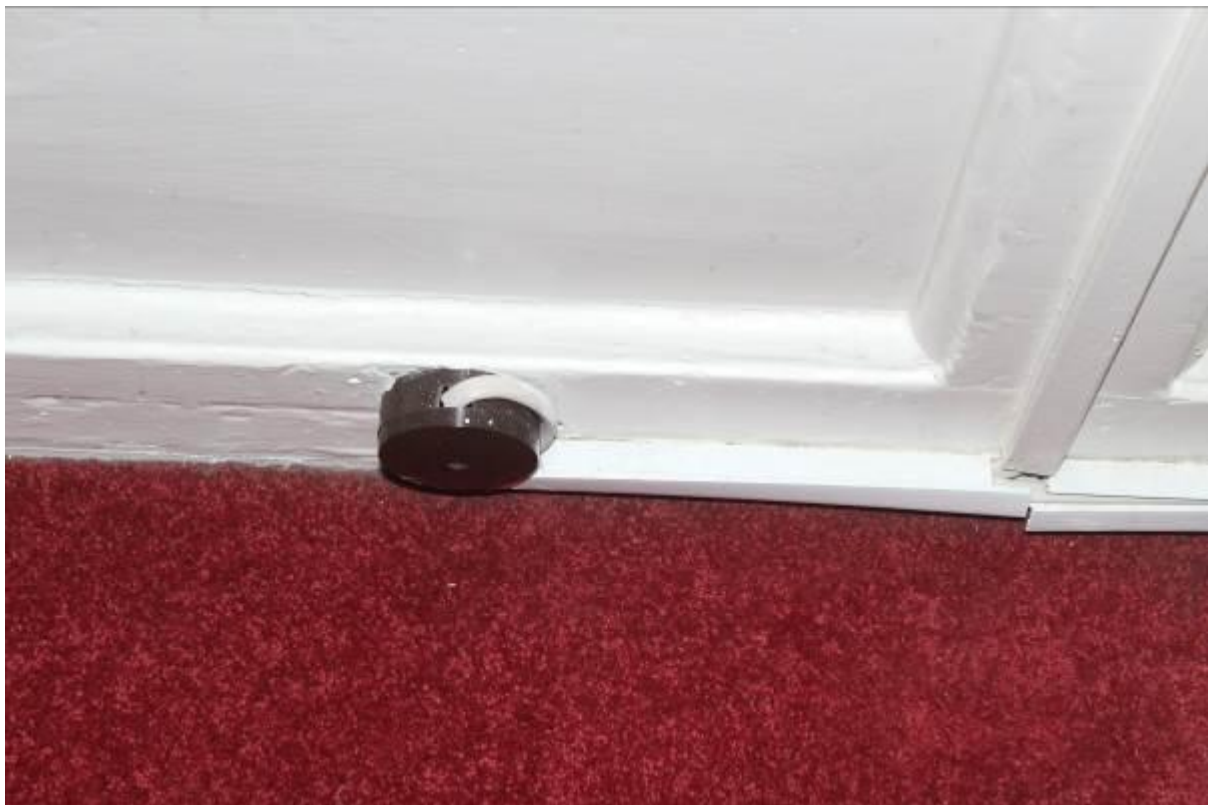
**47. Poor electrical detailing.**

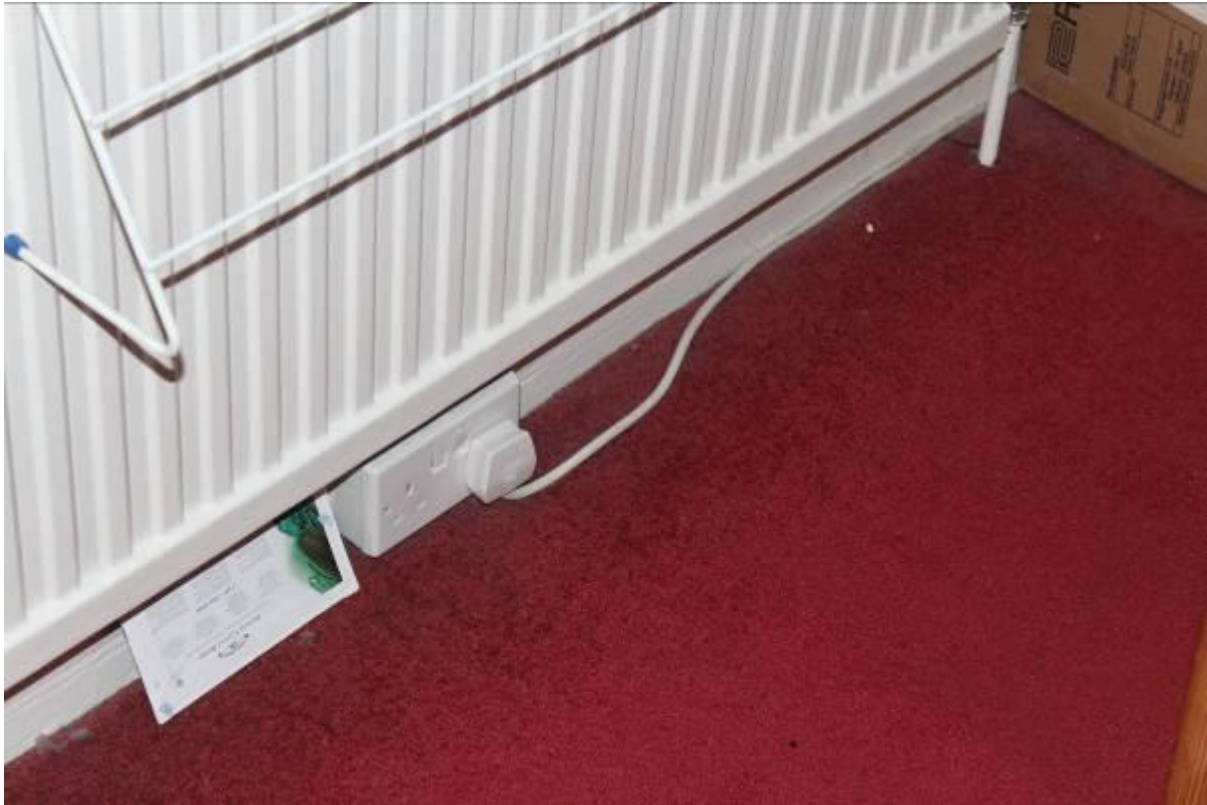
**48. As above.**

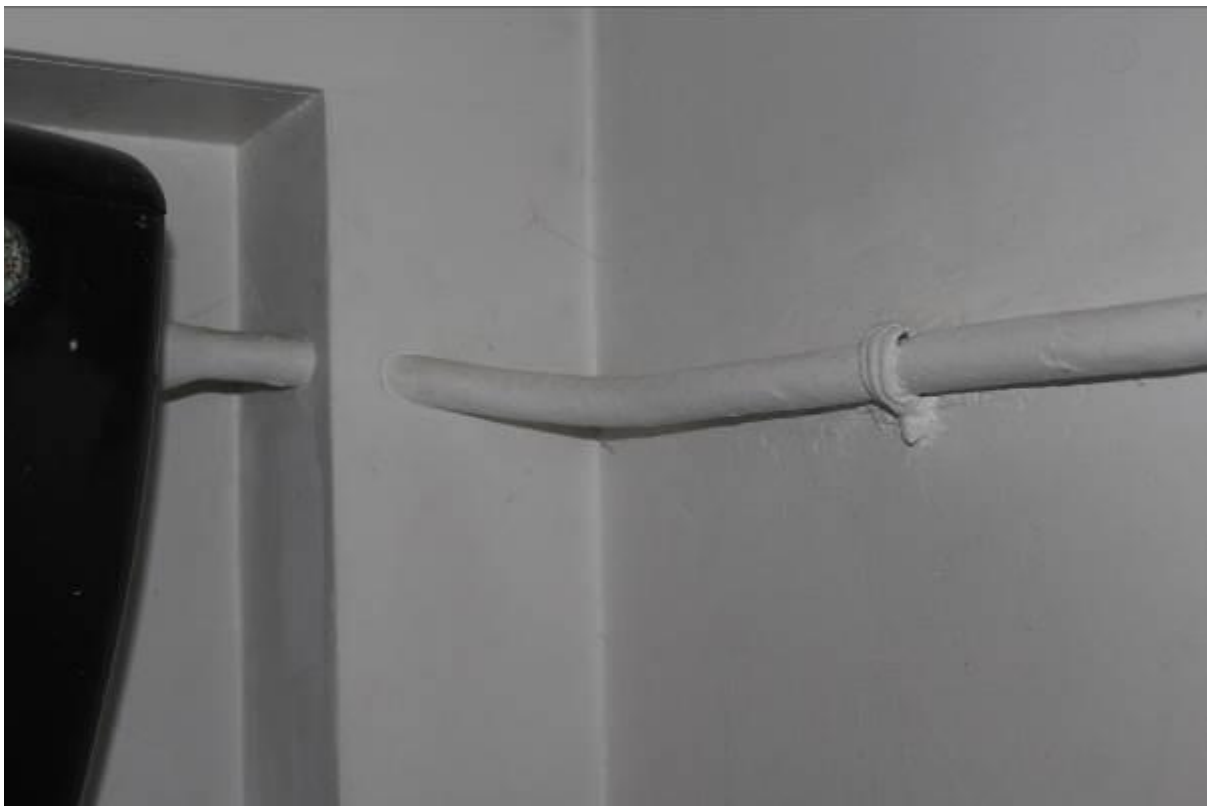
**49. Lead main cold water pipework.**
