COOKE
FAWCETT
ARCHITECTS

Rose Cottage, Vale of Health, NW3 1AX
Opening up - revision B
30.04.2018

180430_135_REP_OpeningUp_RevB

1. Plan describing agreed areas of opening up
2. Schedule
3. Photographic record and notes
4. Additional opening up of rear outrigger chimney

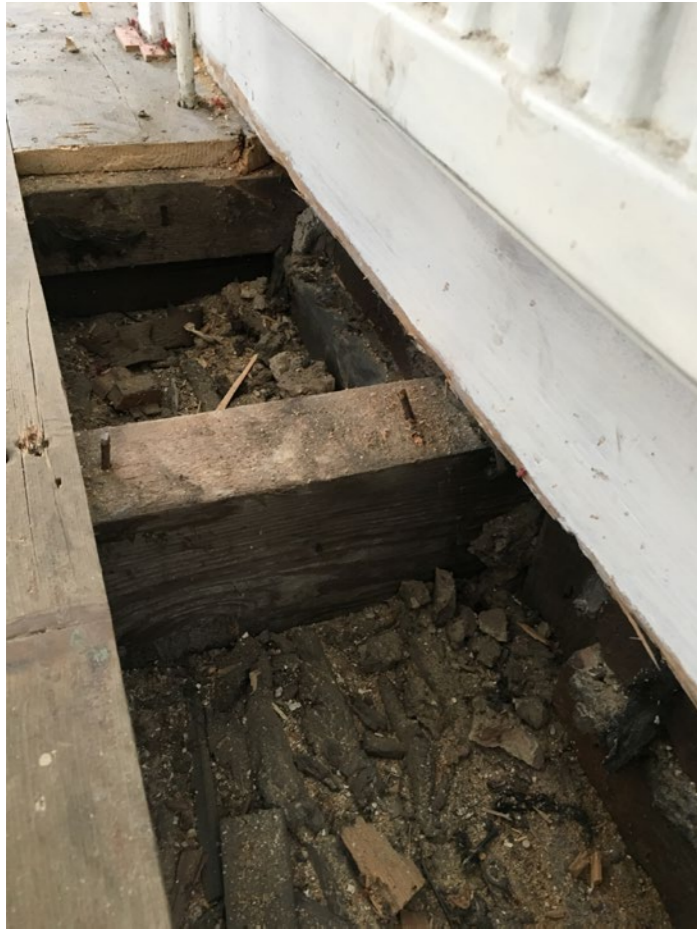
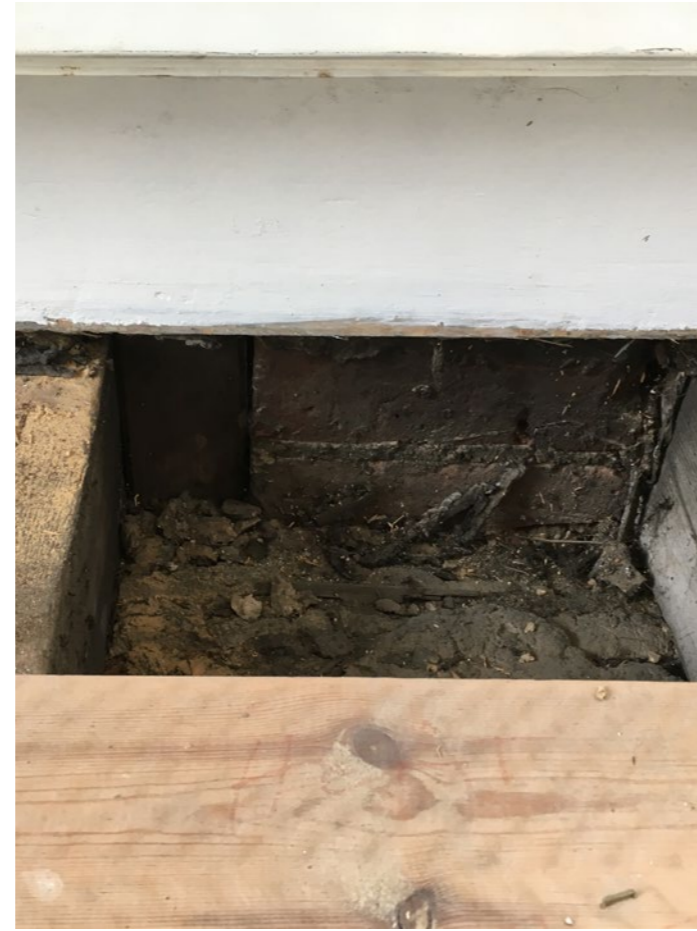
TP - 01
floor in outrigger at 1st floor

- Joists in reasonable condition
- Joist sockets in reasonable condition
- Discovery of vertical timber studs in wall buildup
- Conclusion is that wall has dropped but that joist socket connection remains in reasonable condition

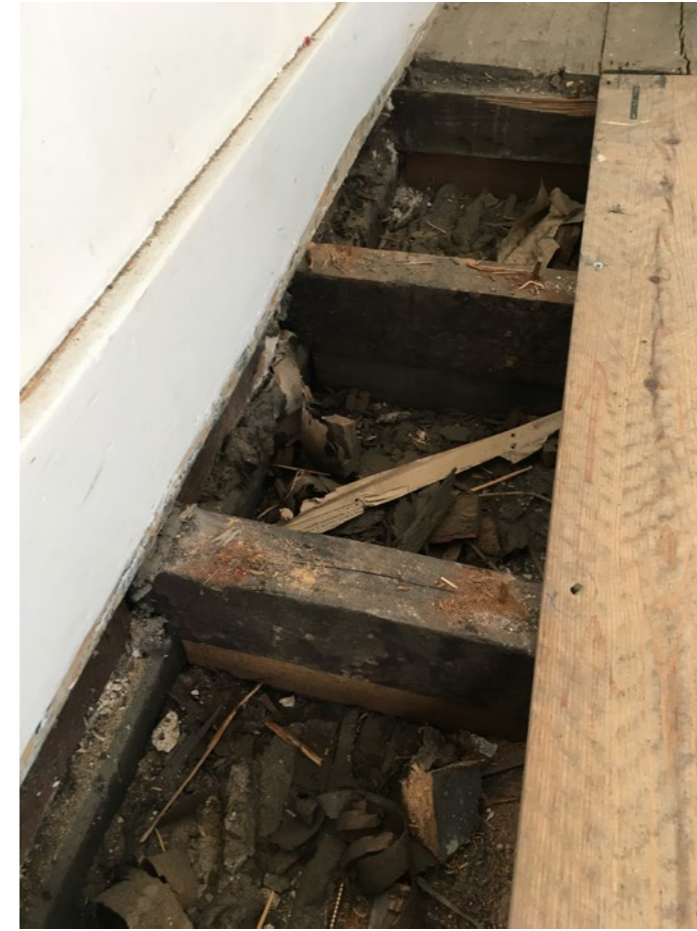
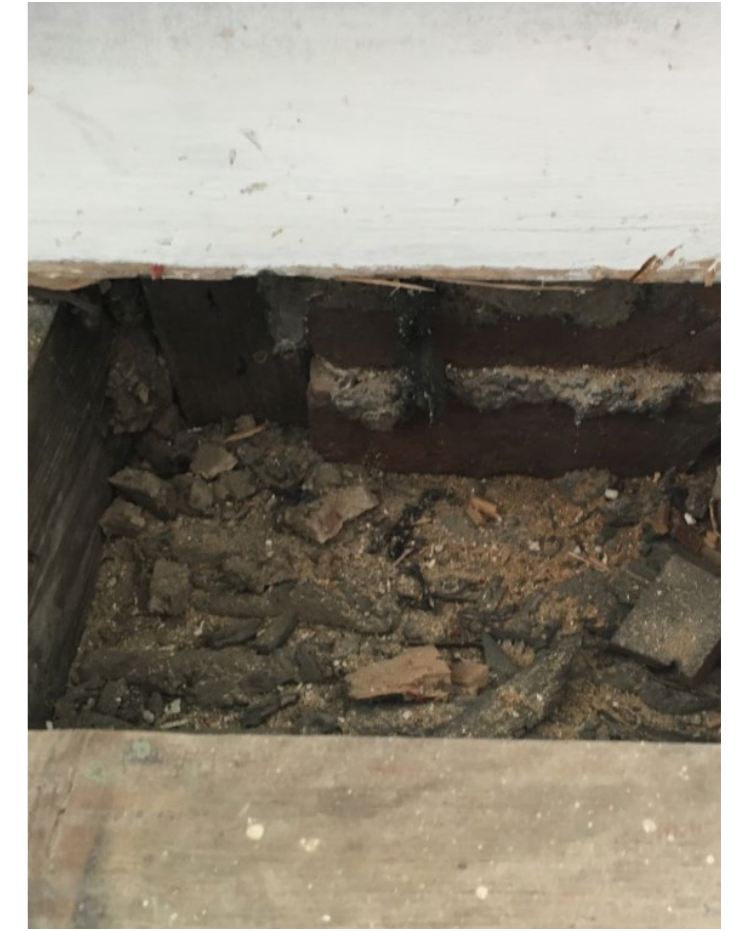
TP - 02
floor in outrigger at 1st floor

- As per TP-01

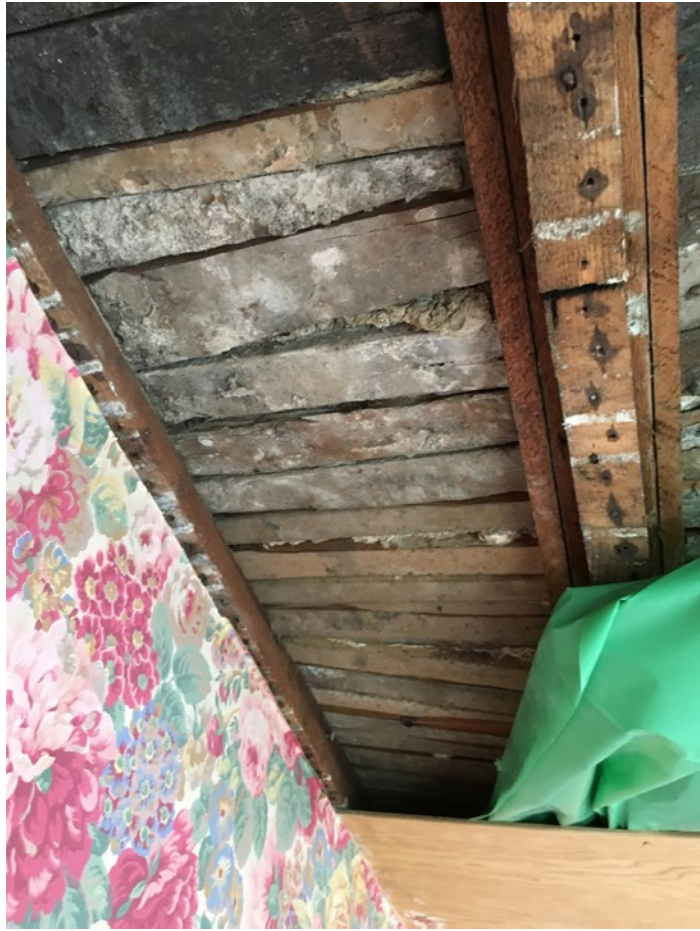
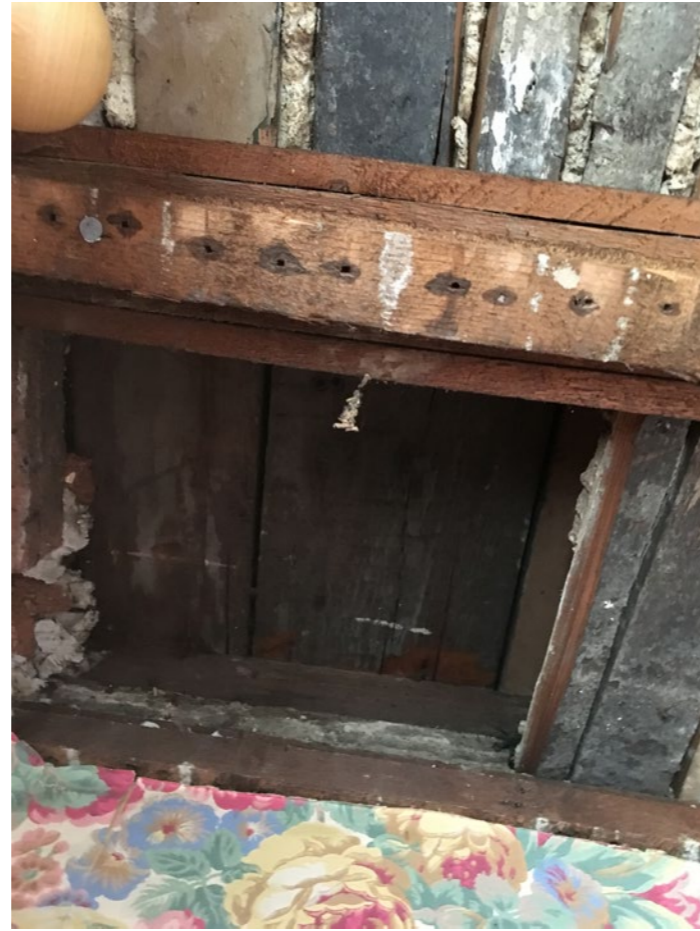
TP - 03
Ceiling above staircase, 1st floor outrigger

- Original lathe and plaster ceiling has been previously removed
- Layer of boarding above joists suggests that this may have previously been a roof level

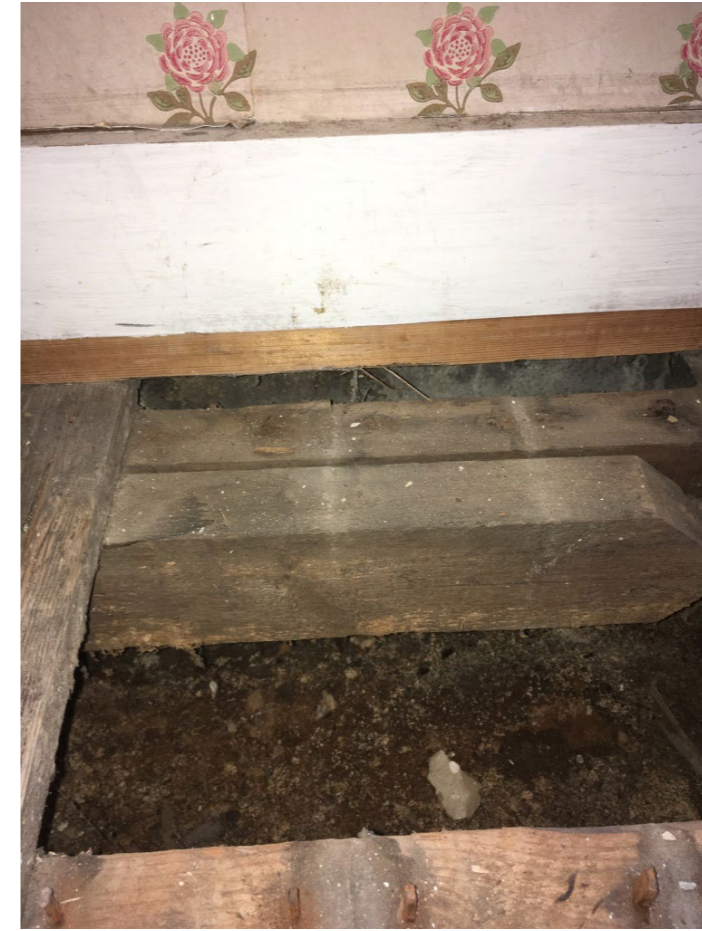
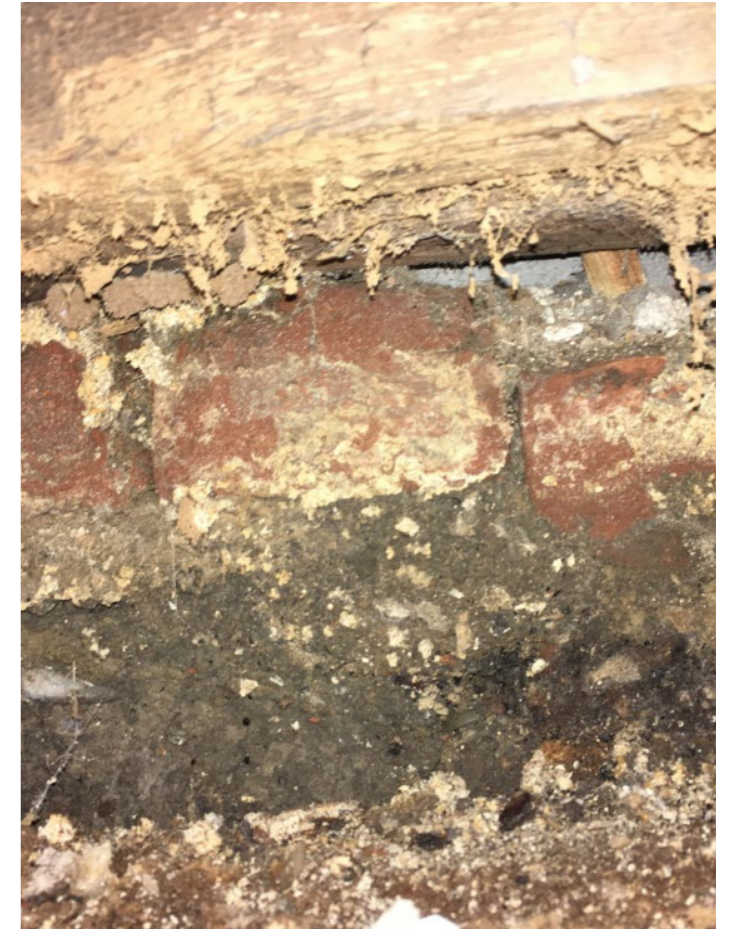
TP - 04
Floor between chimney and facade, ground floor outrigger

- Evidence of damp and decay
- Several areas of rot in existing timber

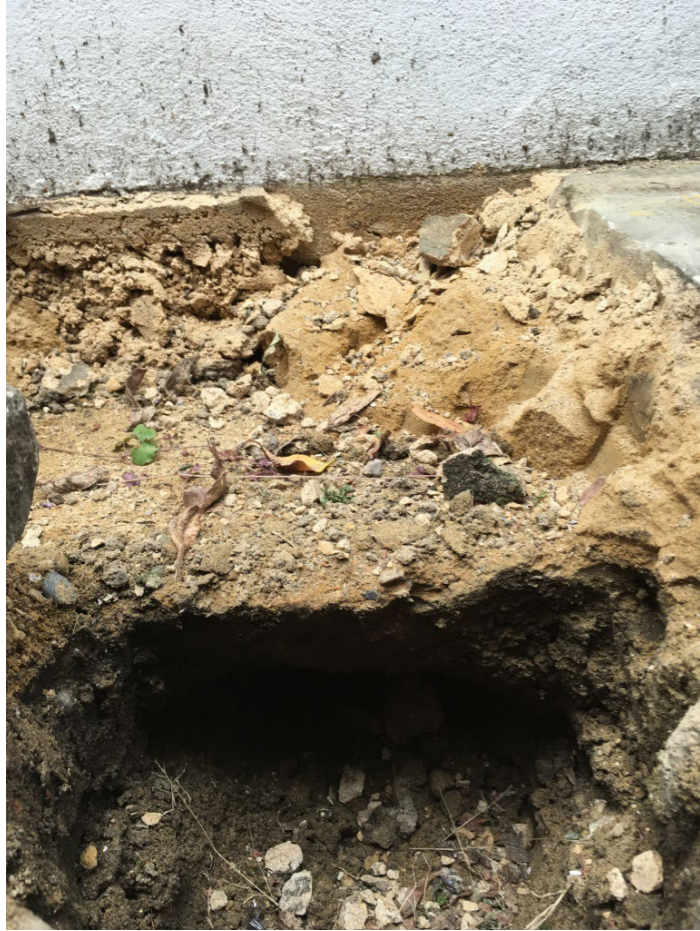
TP - 05
Exterior paving

- No foundations
- Non-original concrete haunch cast against facade
- Soil erosion beneath wall

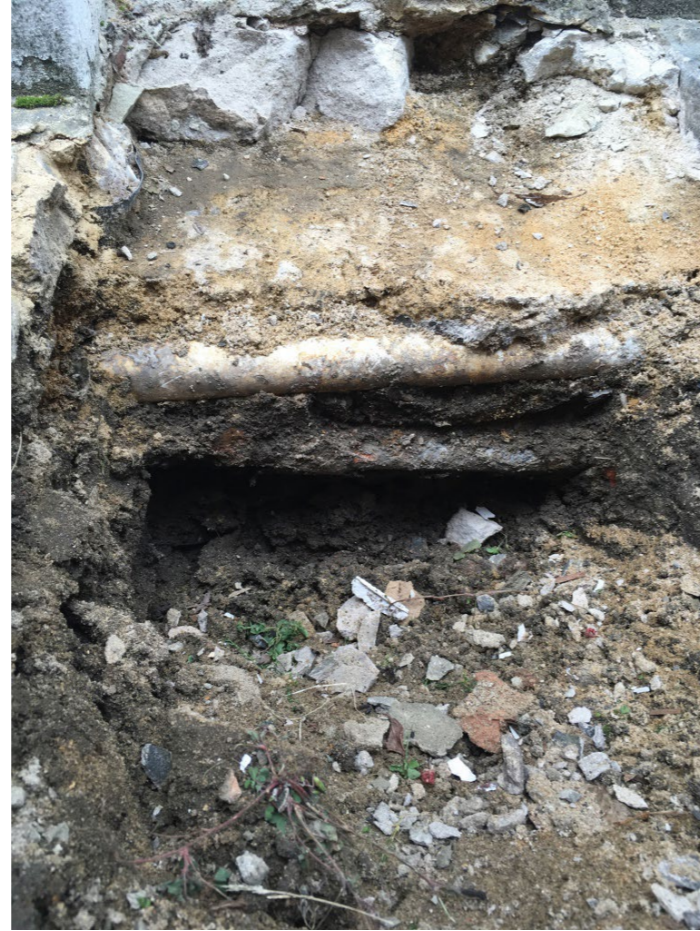
TP - 06
Exterior paving

- As per TP-05
- Evidence of some servicing (potentially redundant) cast into concrete haunch

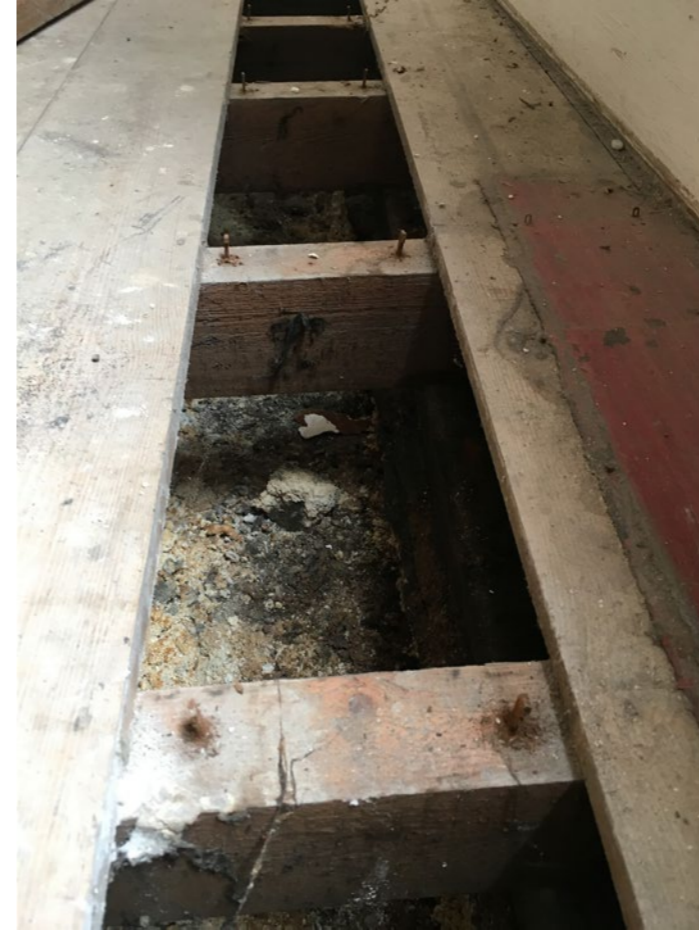
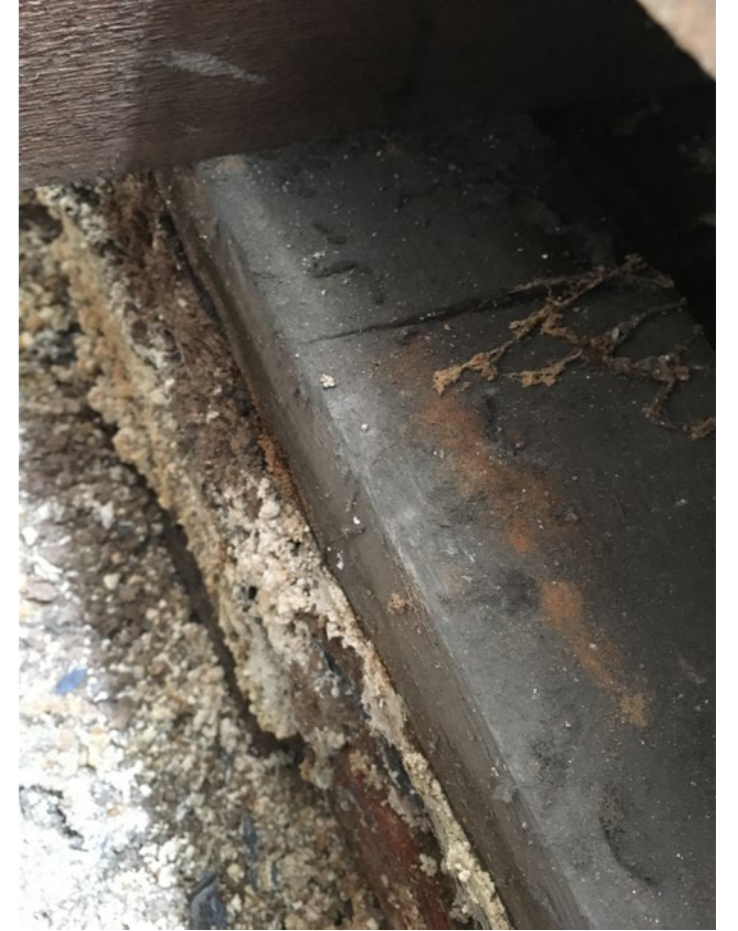
TP - 07
Flooring at ground floor adjacent to facade

- Evidence of damp and water ingress
- No discernible DPC or DPM
- Wall plate is rotten and wet
- Damage to joists through decay
- Evidence of mould - spores on earth and timbers

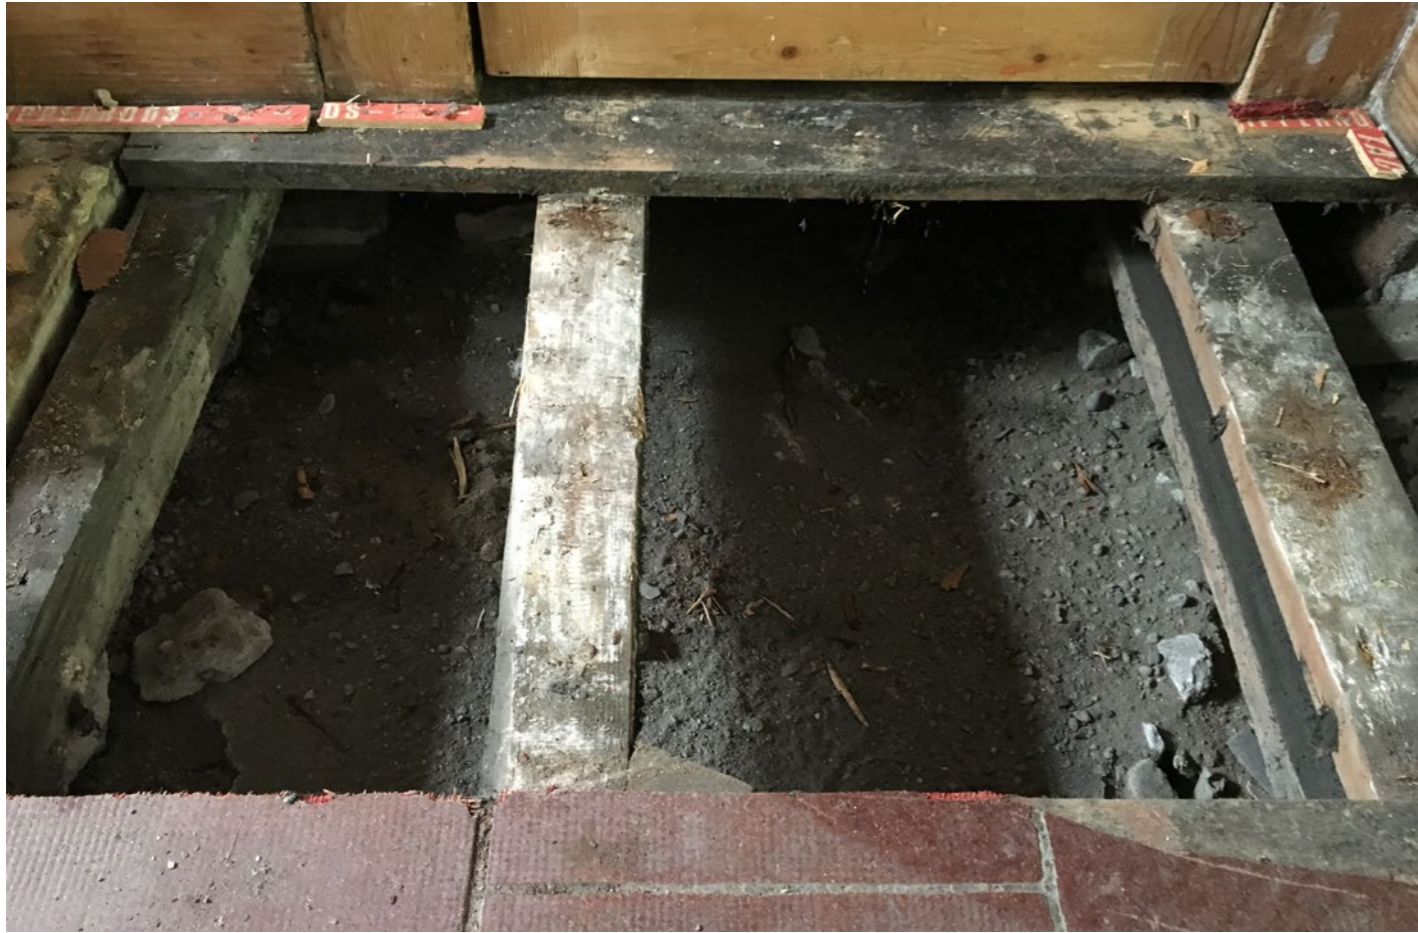
TP - 08
Flooring by hearth in main reception room

- No insulation
- Existing joists are bearing onto patchy arrangement of dwarf walls and existing piers
- Mounds of soil limit space for air circulation
- Floorboards and joists in reasonable condition

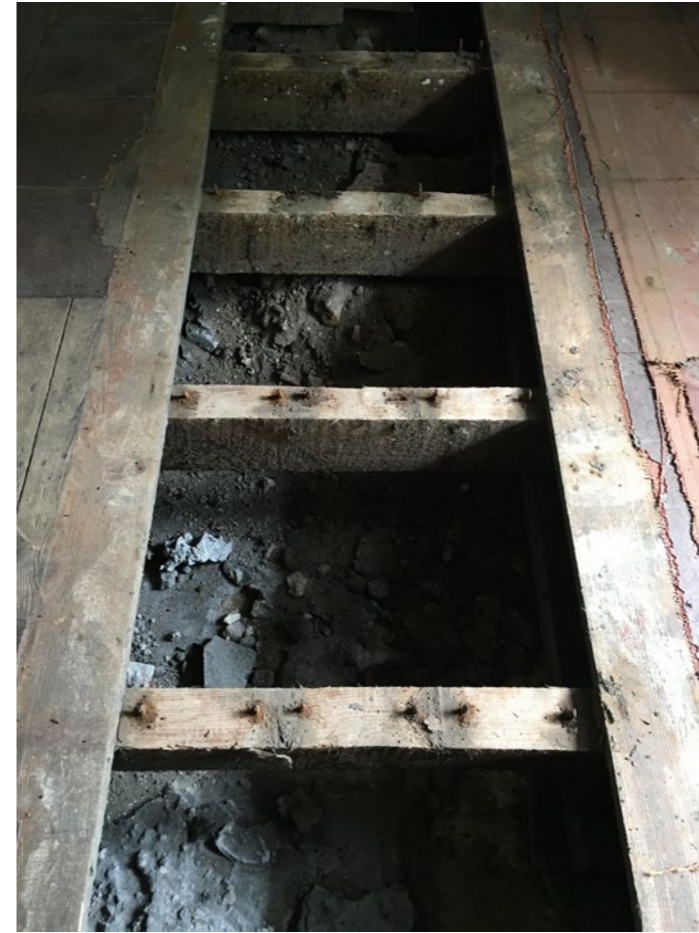
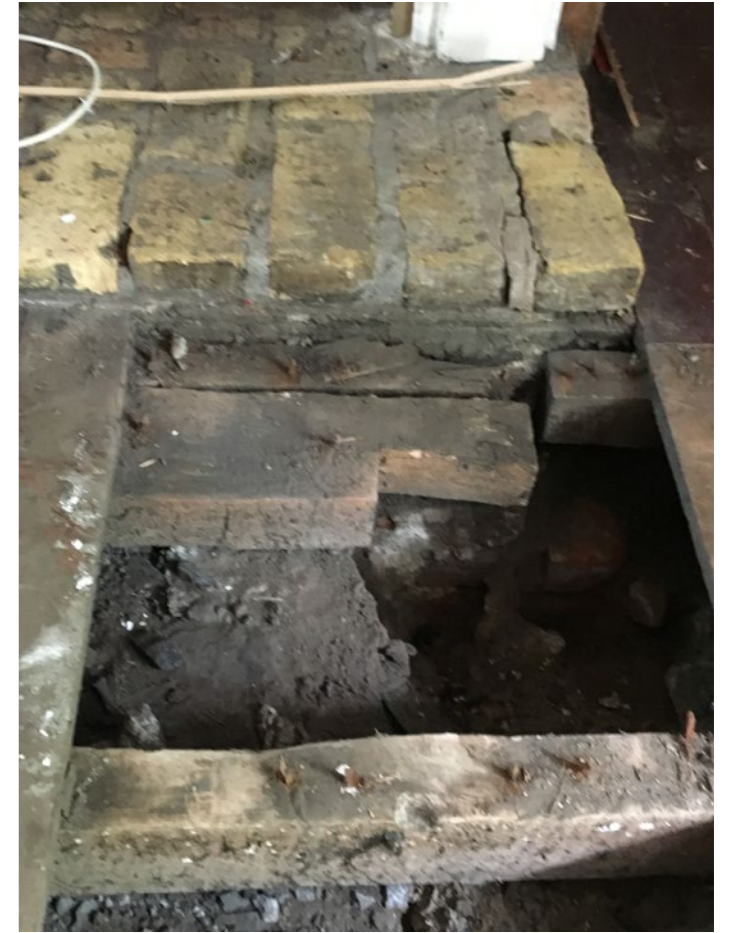
TP - 09
Flooring in body of main reception room

- As per TP-08

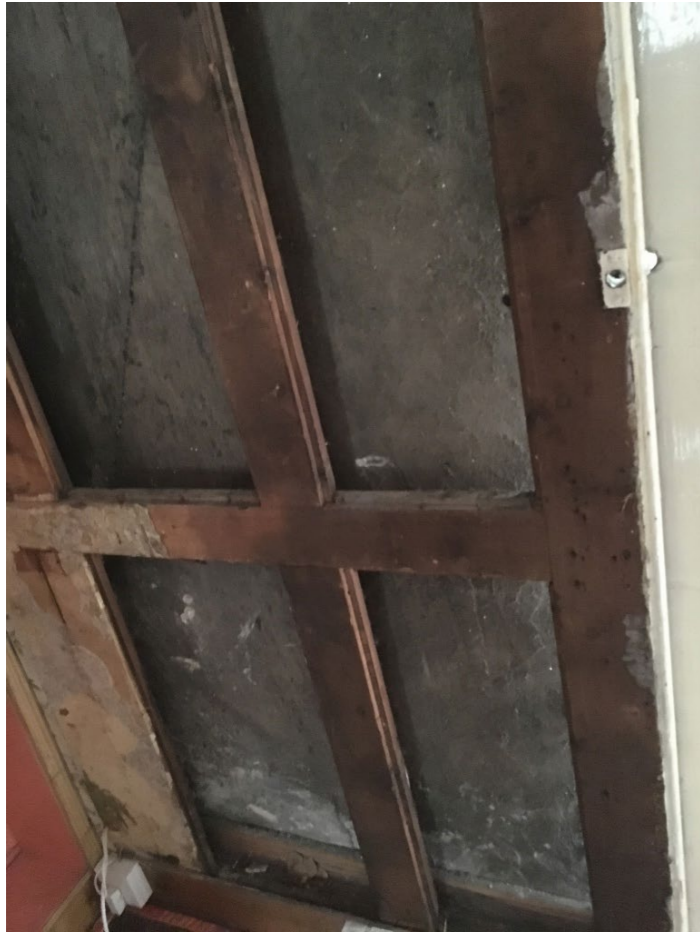
TP - 10
Finishes concealing sliding shutters

- No insulation
- Sliding mechanism is accessible and can be restored

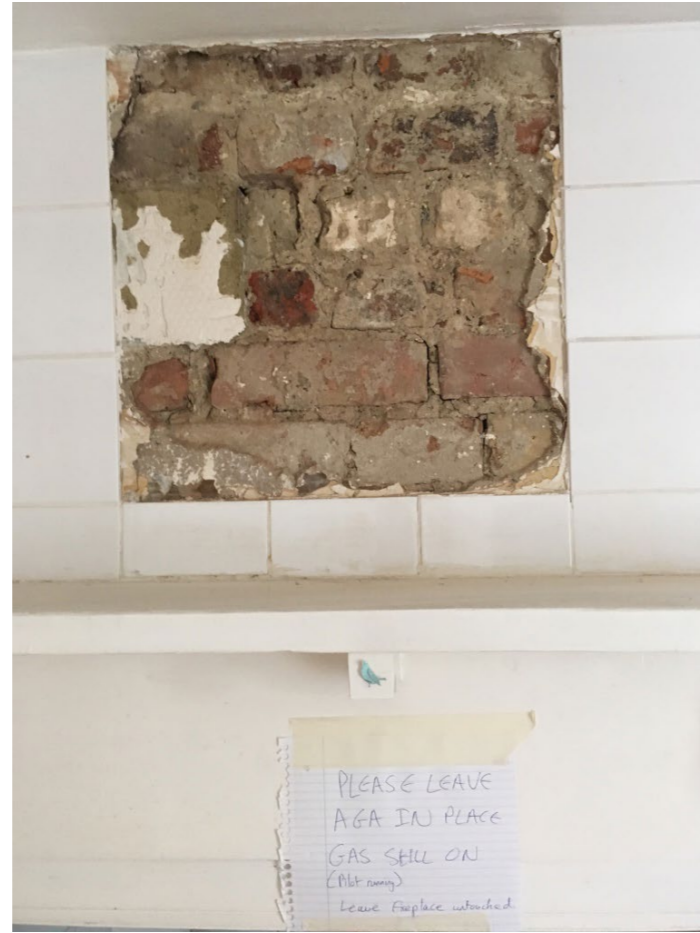
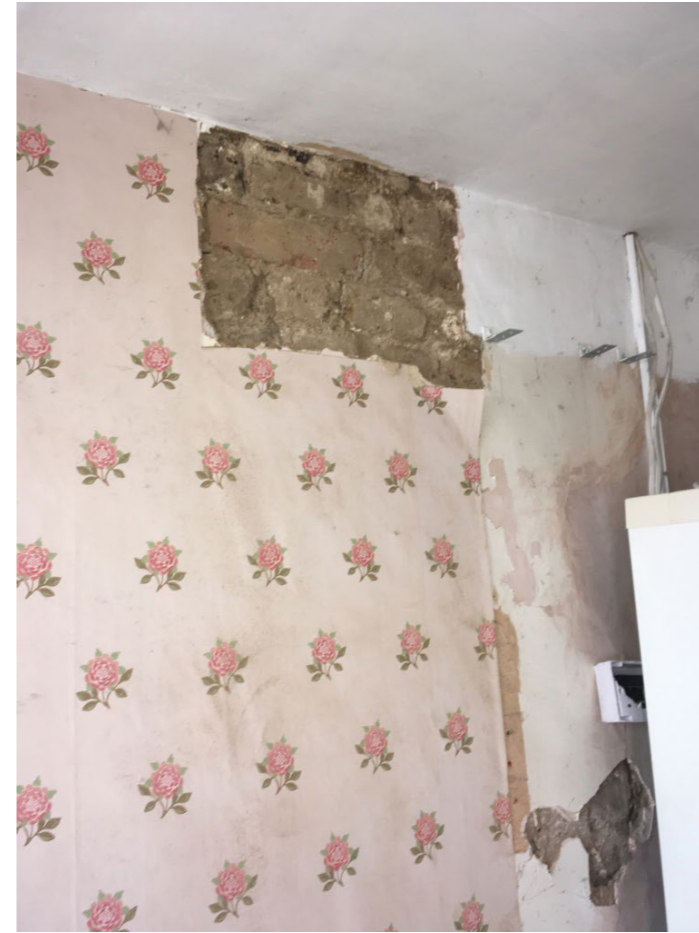
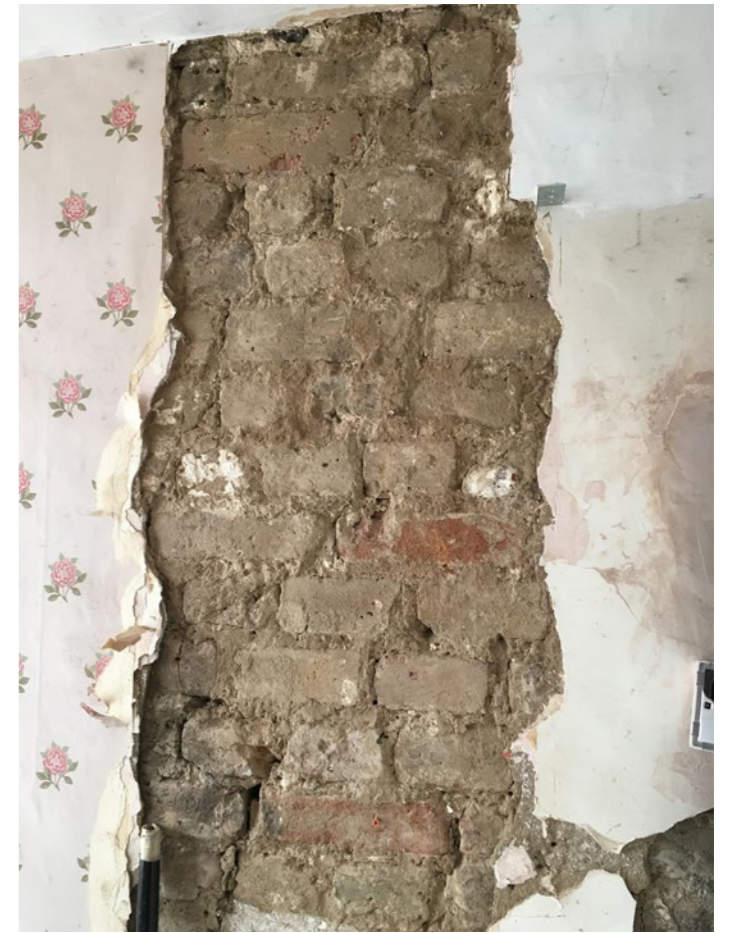
TP - 11
Finishes to existing chimney

- Unremarkable brickwork
- Some evidence of local cracking

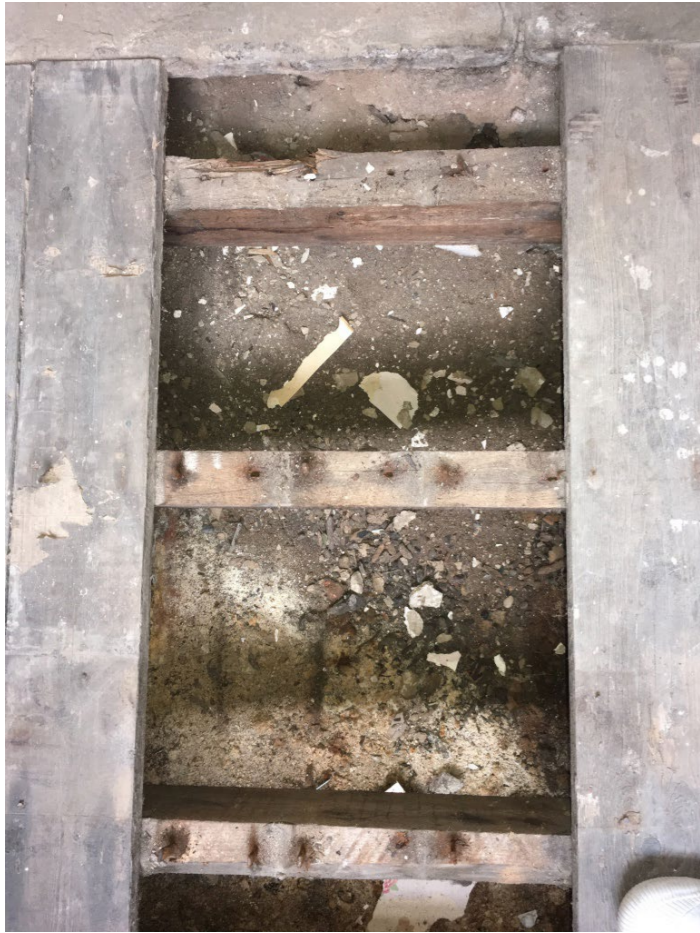
TP - 12
Floor adjacent to kitchen chimney

- No insulation
- Evidence of mould and timber decay
- Damp floor substrate

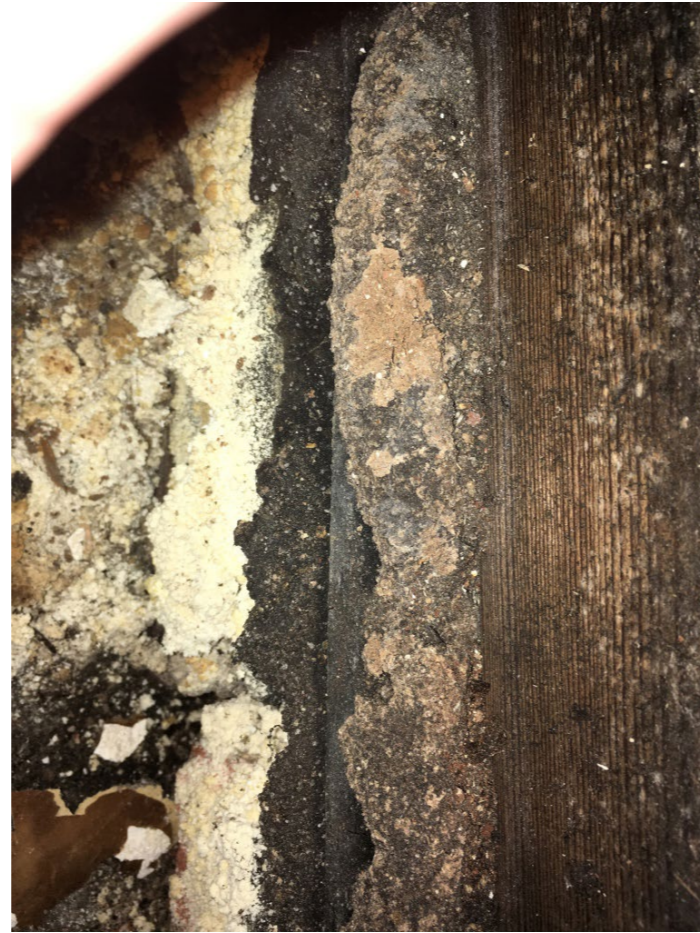
TP - 13
Footing for balcony

- Timber post sits on interesting stone element with carved drainage channels
- Stone footing then sits on brick and clay tile footing sitting on compacted earth

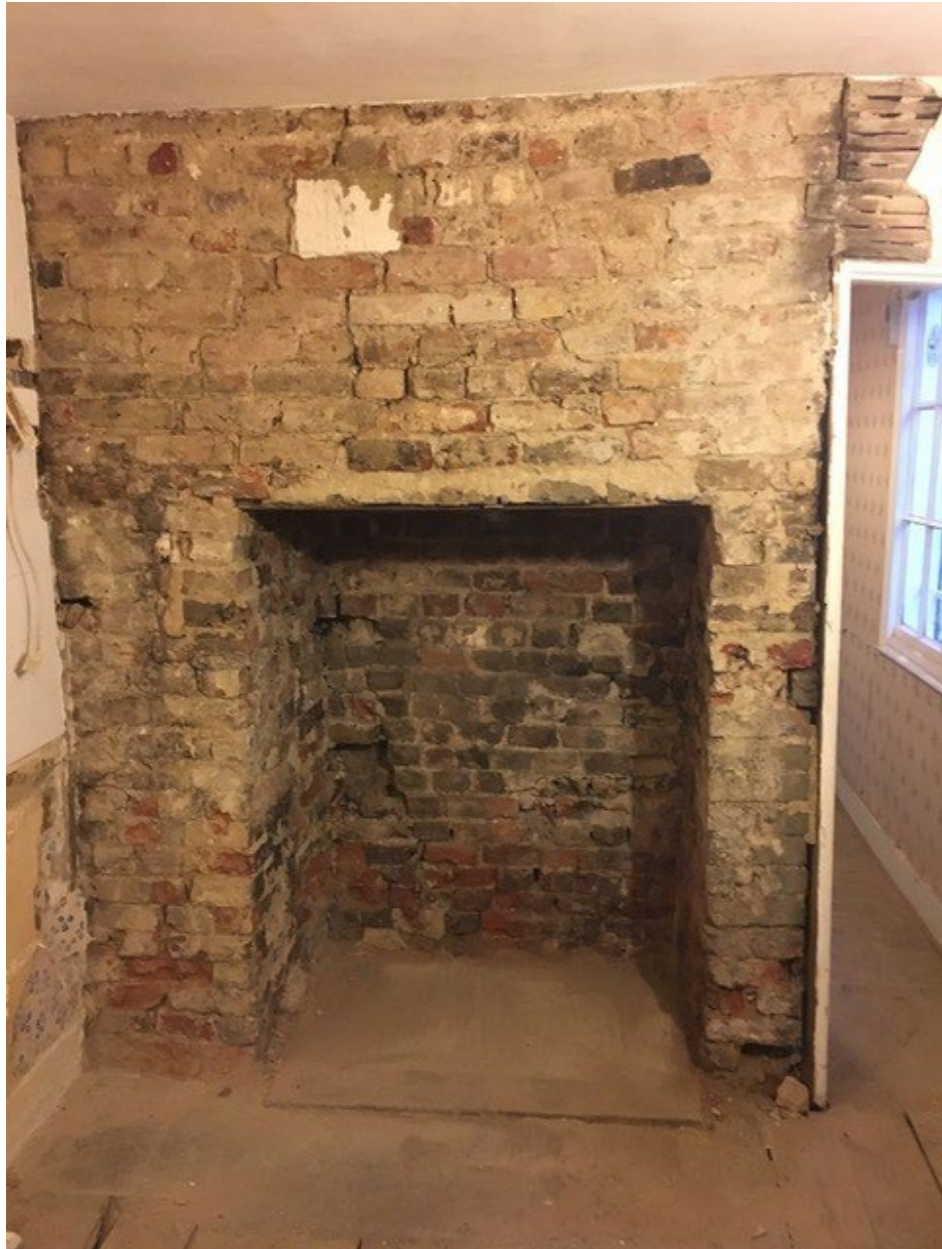
Chimney following opening up: Existing hearth at ground floor (kitchen)

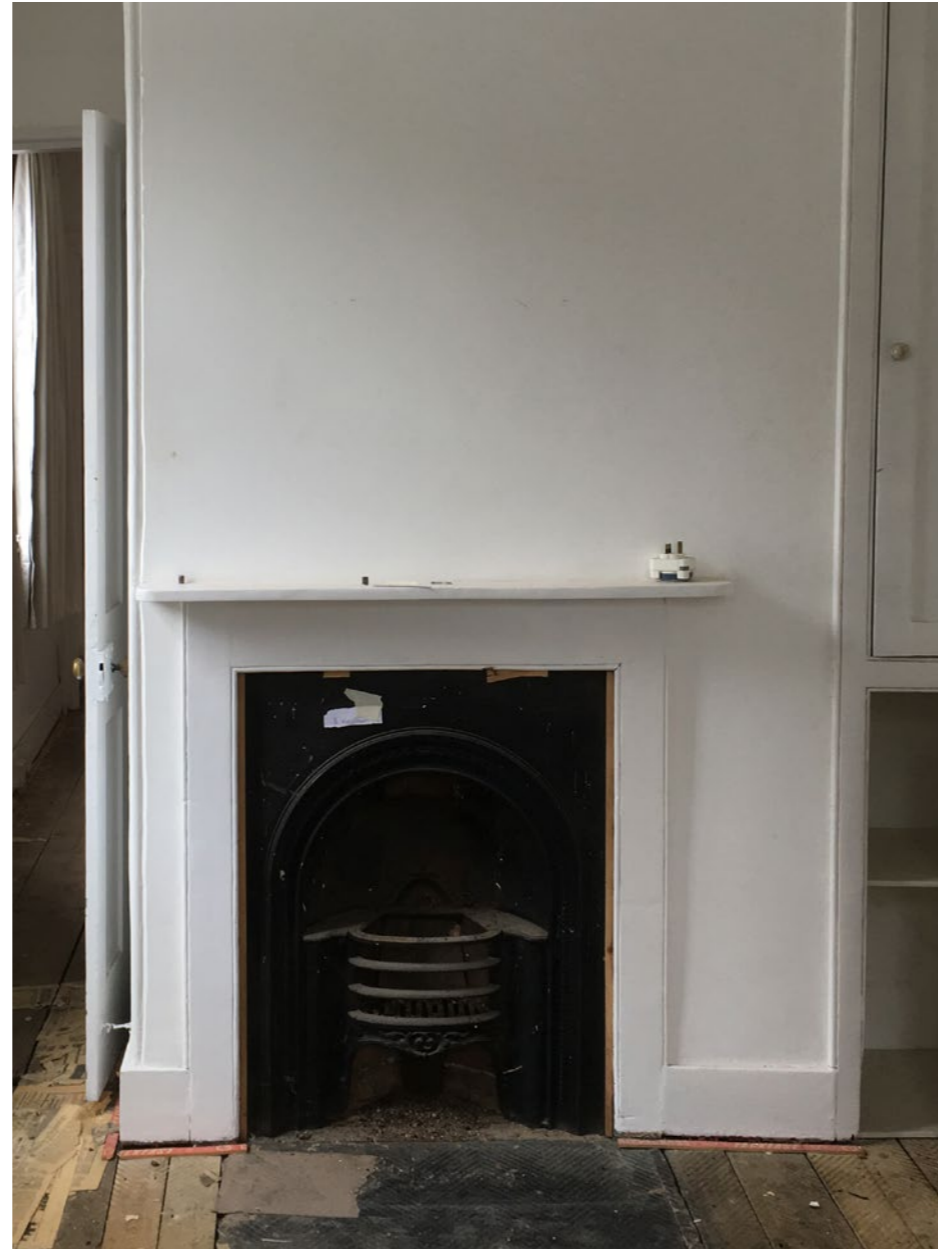
Existing fireplace in back bedroom at 1st floor (Victorian)

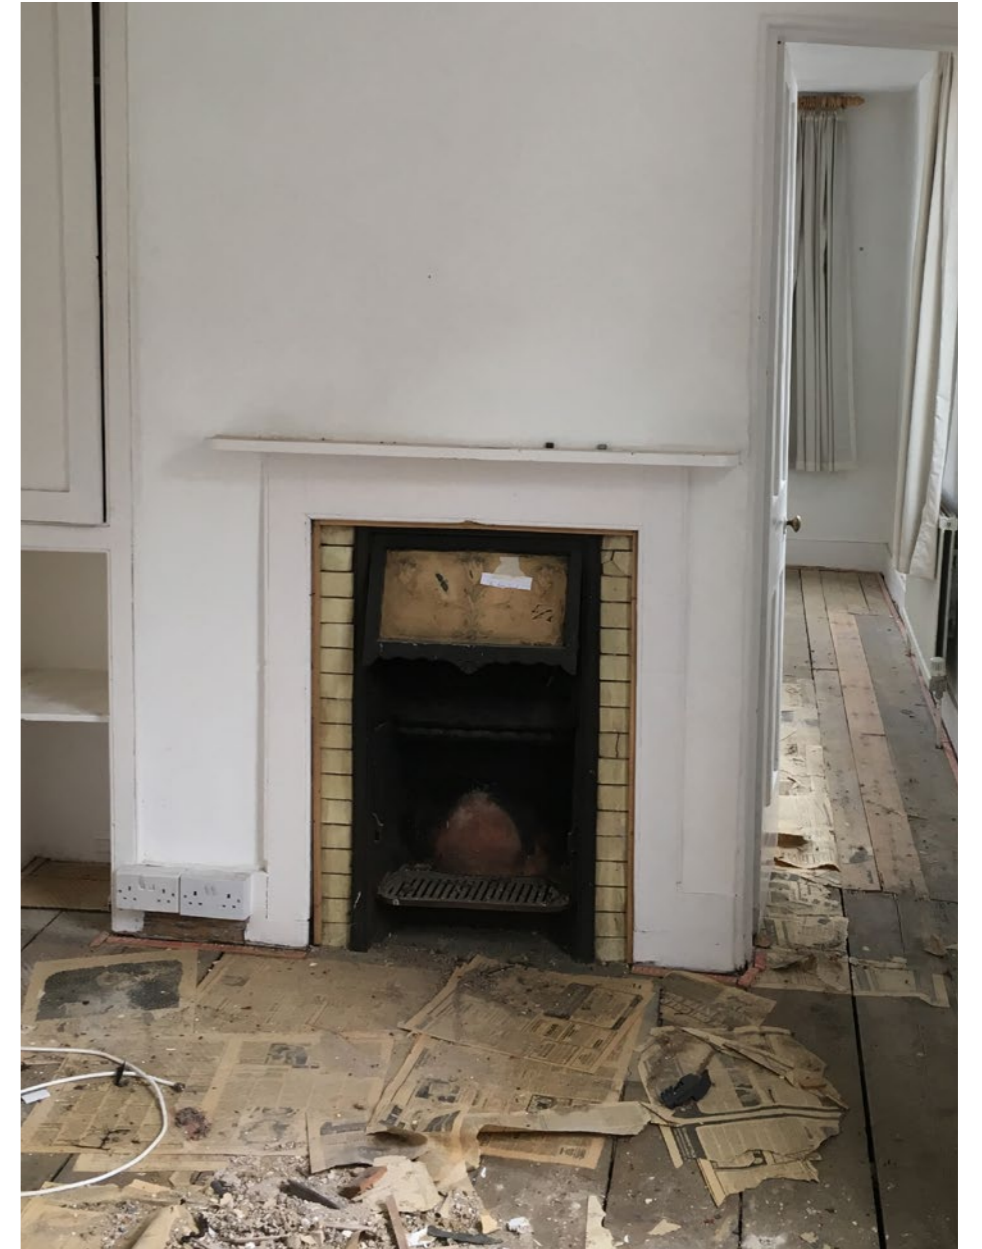
Existing fireplace in middle room at 1st floor (likely Edwardian)

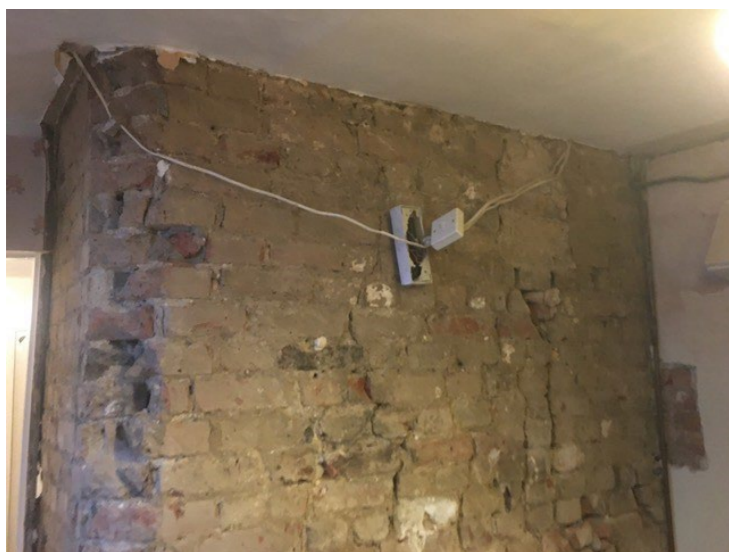
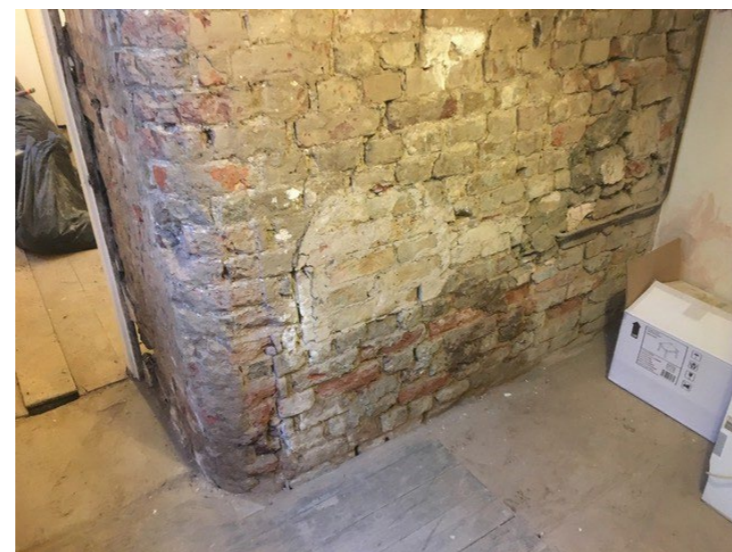
Rear of ground floor chimney breast showing poor quality brickwork, areas of non-original brick patching and cracks.

- Since the original version of this report was issued subsequent opening up of the existing chimney has been agreed. This has revealed the following:
- Existing chimney is made up of poor quality, somewhat cracked unremarkable brickwork.
- Evidence of previous work (patching)
- Fireplaces at 1st floor level fairly ordinary - one likely Edwardian, the other Victorian
