# ARBORICULTURAL ASSESSMENT REPORT

<b>For:</b>	<b>Client:</b>	Oriel Services Limited
	<b>Insurer:</b>	Legal and General Insurers Limited
<b>Site:</b>	<b>Policyholder:</b>	██████████
	<b>Risk Address:</b>	25 Frognal, London, NW3 6AR
<b>Refs:</b>	<b>OCA Ref:</b>	70790
	<b>Client Ref:</b>	6724684
	<b>Insurer Ref:</b>	D140903640

<b>Arborist Name:</b>	Thomas Peppiatt	<b>Date:</b>	27/02/2018
-----------------------	-----------------	--------------	------------

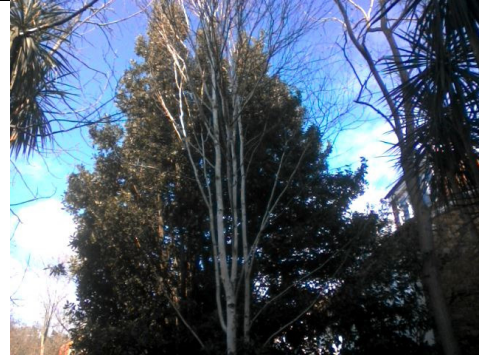
TG3 - Bay Laurel

Although no rooting evidence has been found to implicate TG3, S1 and S2, we feel that, due to their size, location and species characteristics, this tree is considered to be rooting below foundation depth and should be removed as a current claim requirement.

Tree No:	Species	Works Required
T1	False Acacia	Fell and treat stump
T2	False Acacia	Fell and treat stump
S1	Buddleia	Fell and treat stump
C1	Vine	Fell and treat stump
T4	Lime	Fell and treat stump
S2	Buddleia	Fell and treat stump
TG3	Bay Laurel	Fell and treat stumps

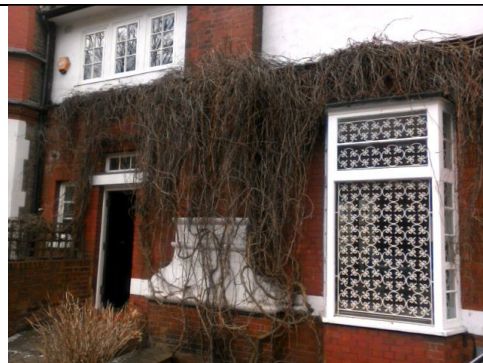
C1 - Vine

TH1 1600mm depth	Prunus spp and Tilia spp.
TH1 1800mm depth	Vitaceae spp and Tilia spp.
TH2 1000mm to 1500mmdepth	Leguminoseae spp.

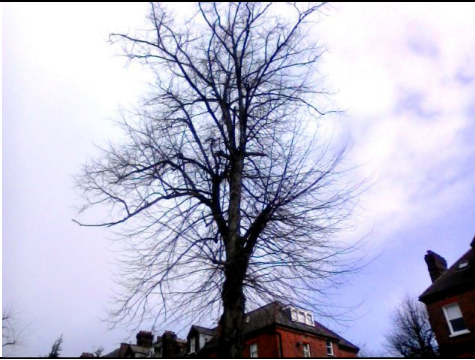
T4 - Lime

The London Borough of Camden has confirmed that the implicated Lime tree T4 is subject to a Tree Preservation Order. They have also confirmed that the properties are within a Conservation Area as well.
