Findings of the Arboricultural Assessment - Tree Survey

Vernon House

5-8, St Mark's Square, London

March 2018

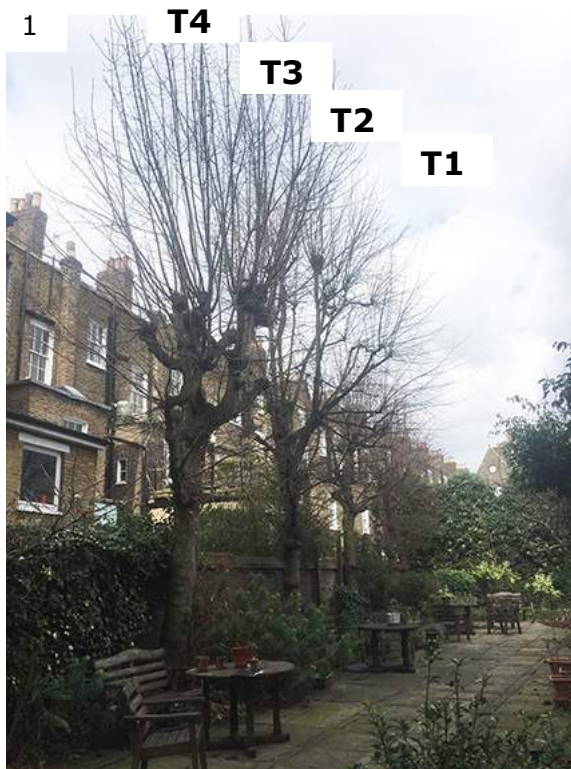
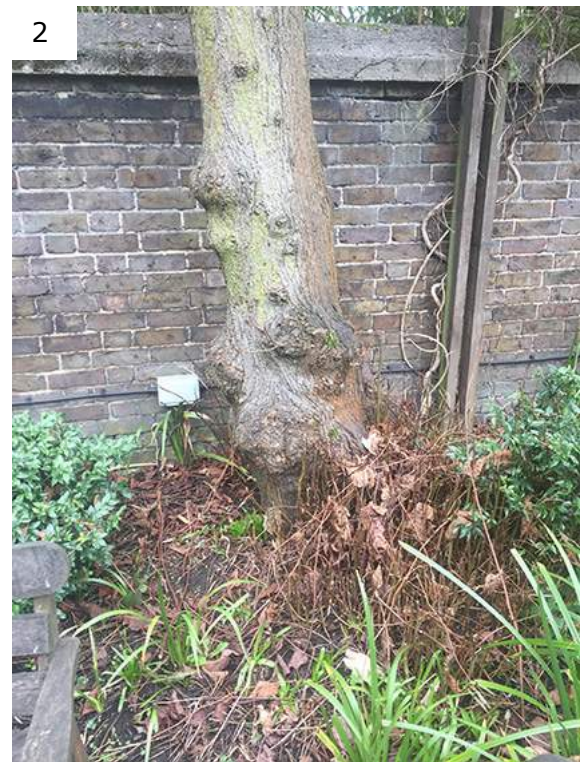
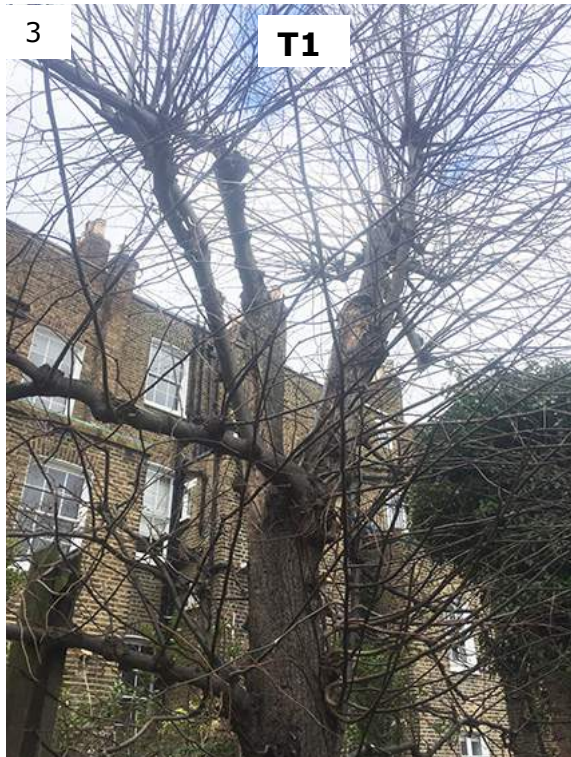
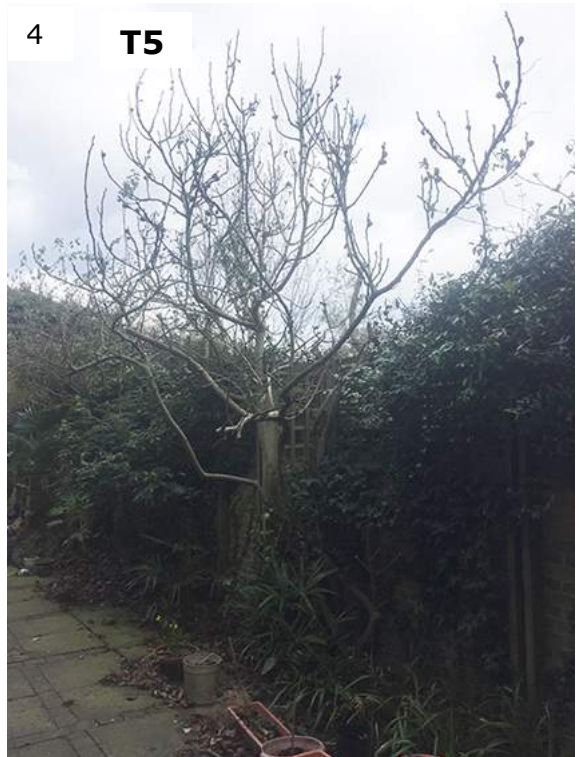
(1) T1 – T3 are limes and T4 is a sycamore, all pollarded and adjacent to the western boundary wall of the site. (2) Regrowth/suckers on T2. (3) Damage to T1 from limb breakage. (4) T5 (multistemmed) against the eastern boundary wall, attached to trellis/posts to support the limbs.

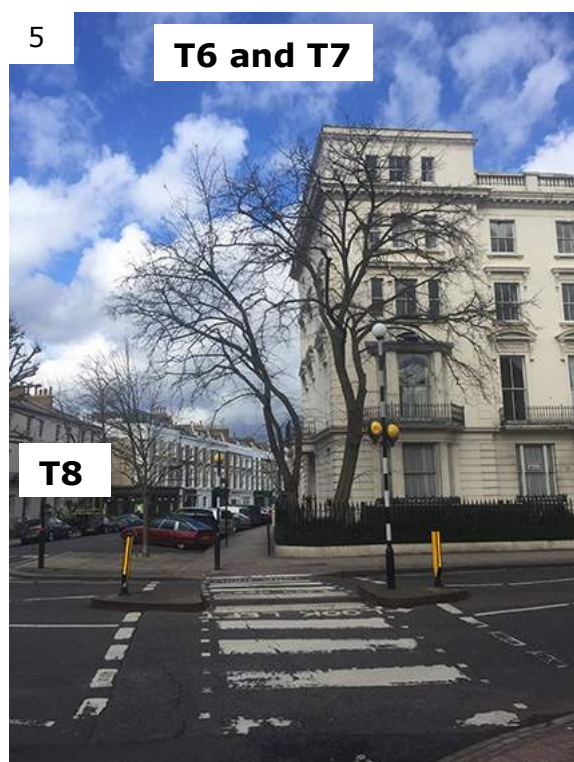
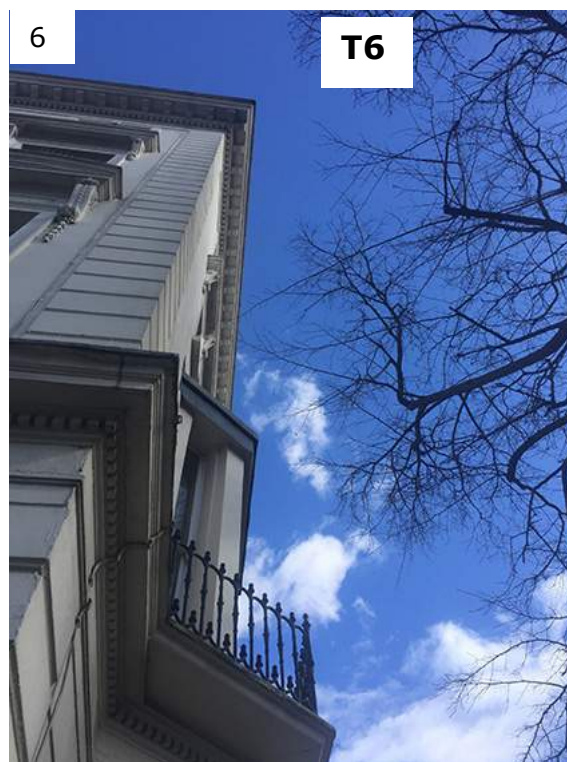
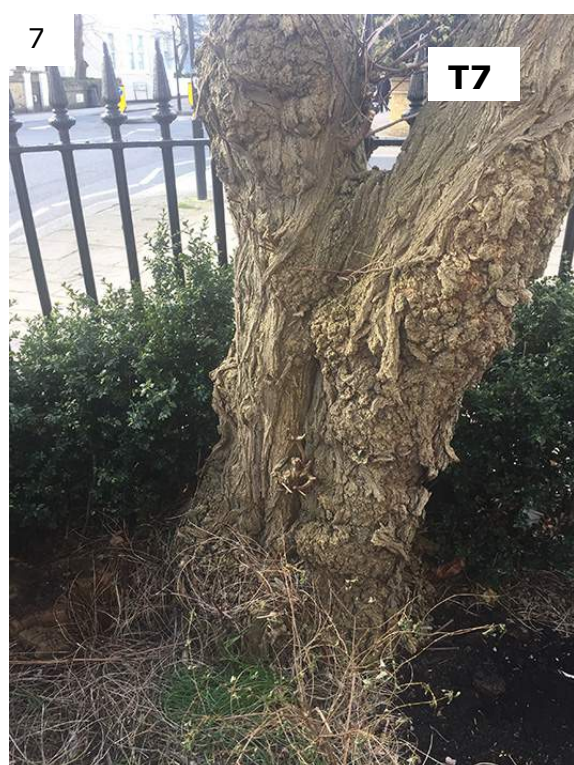
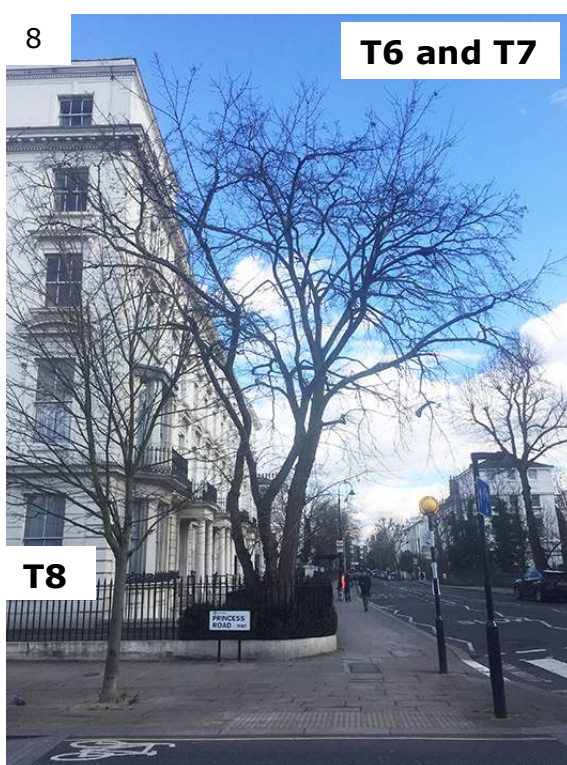
(5) T6 and T7 combine to give good landscape amenity value. (6) The canopy of T6 within 1m of the building. (7) T7 forked with possible included bark and weak union. (8) T6 and T7 viewed looking east along Regents Park Road. T8 (off-site) is semi mature located within the pavement of Princess Road.

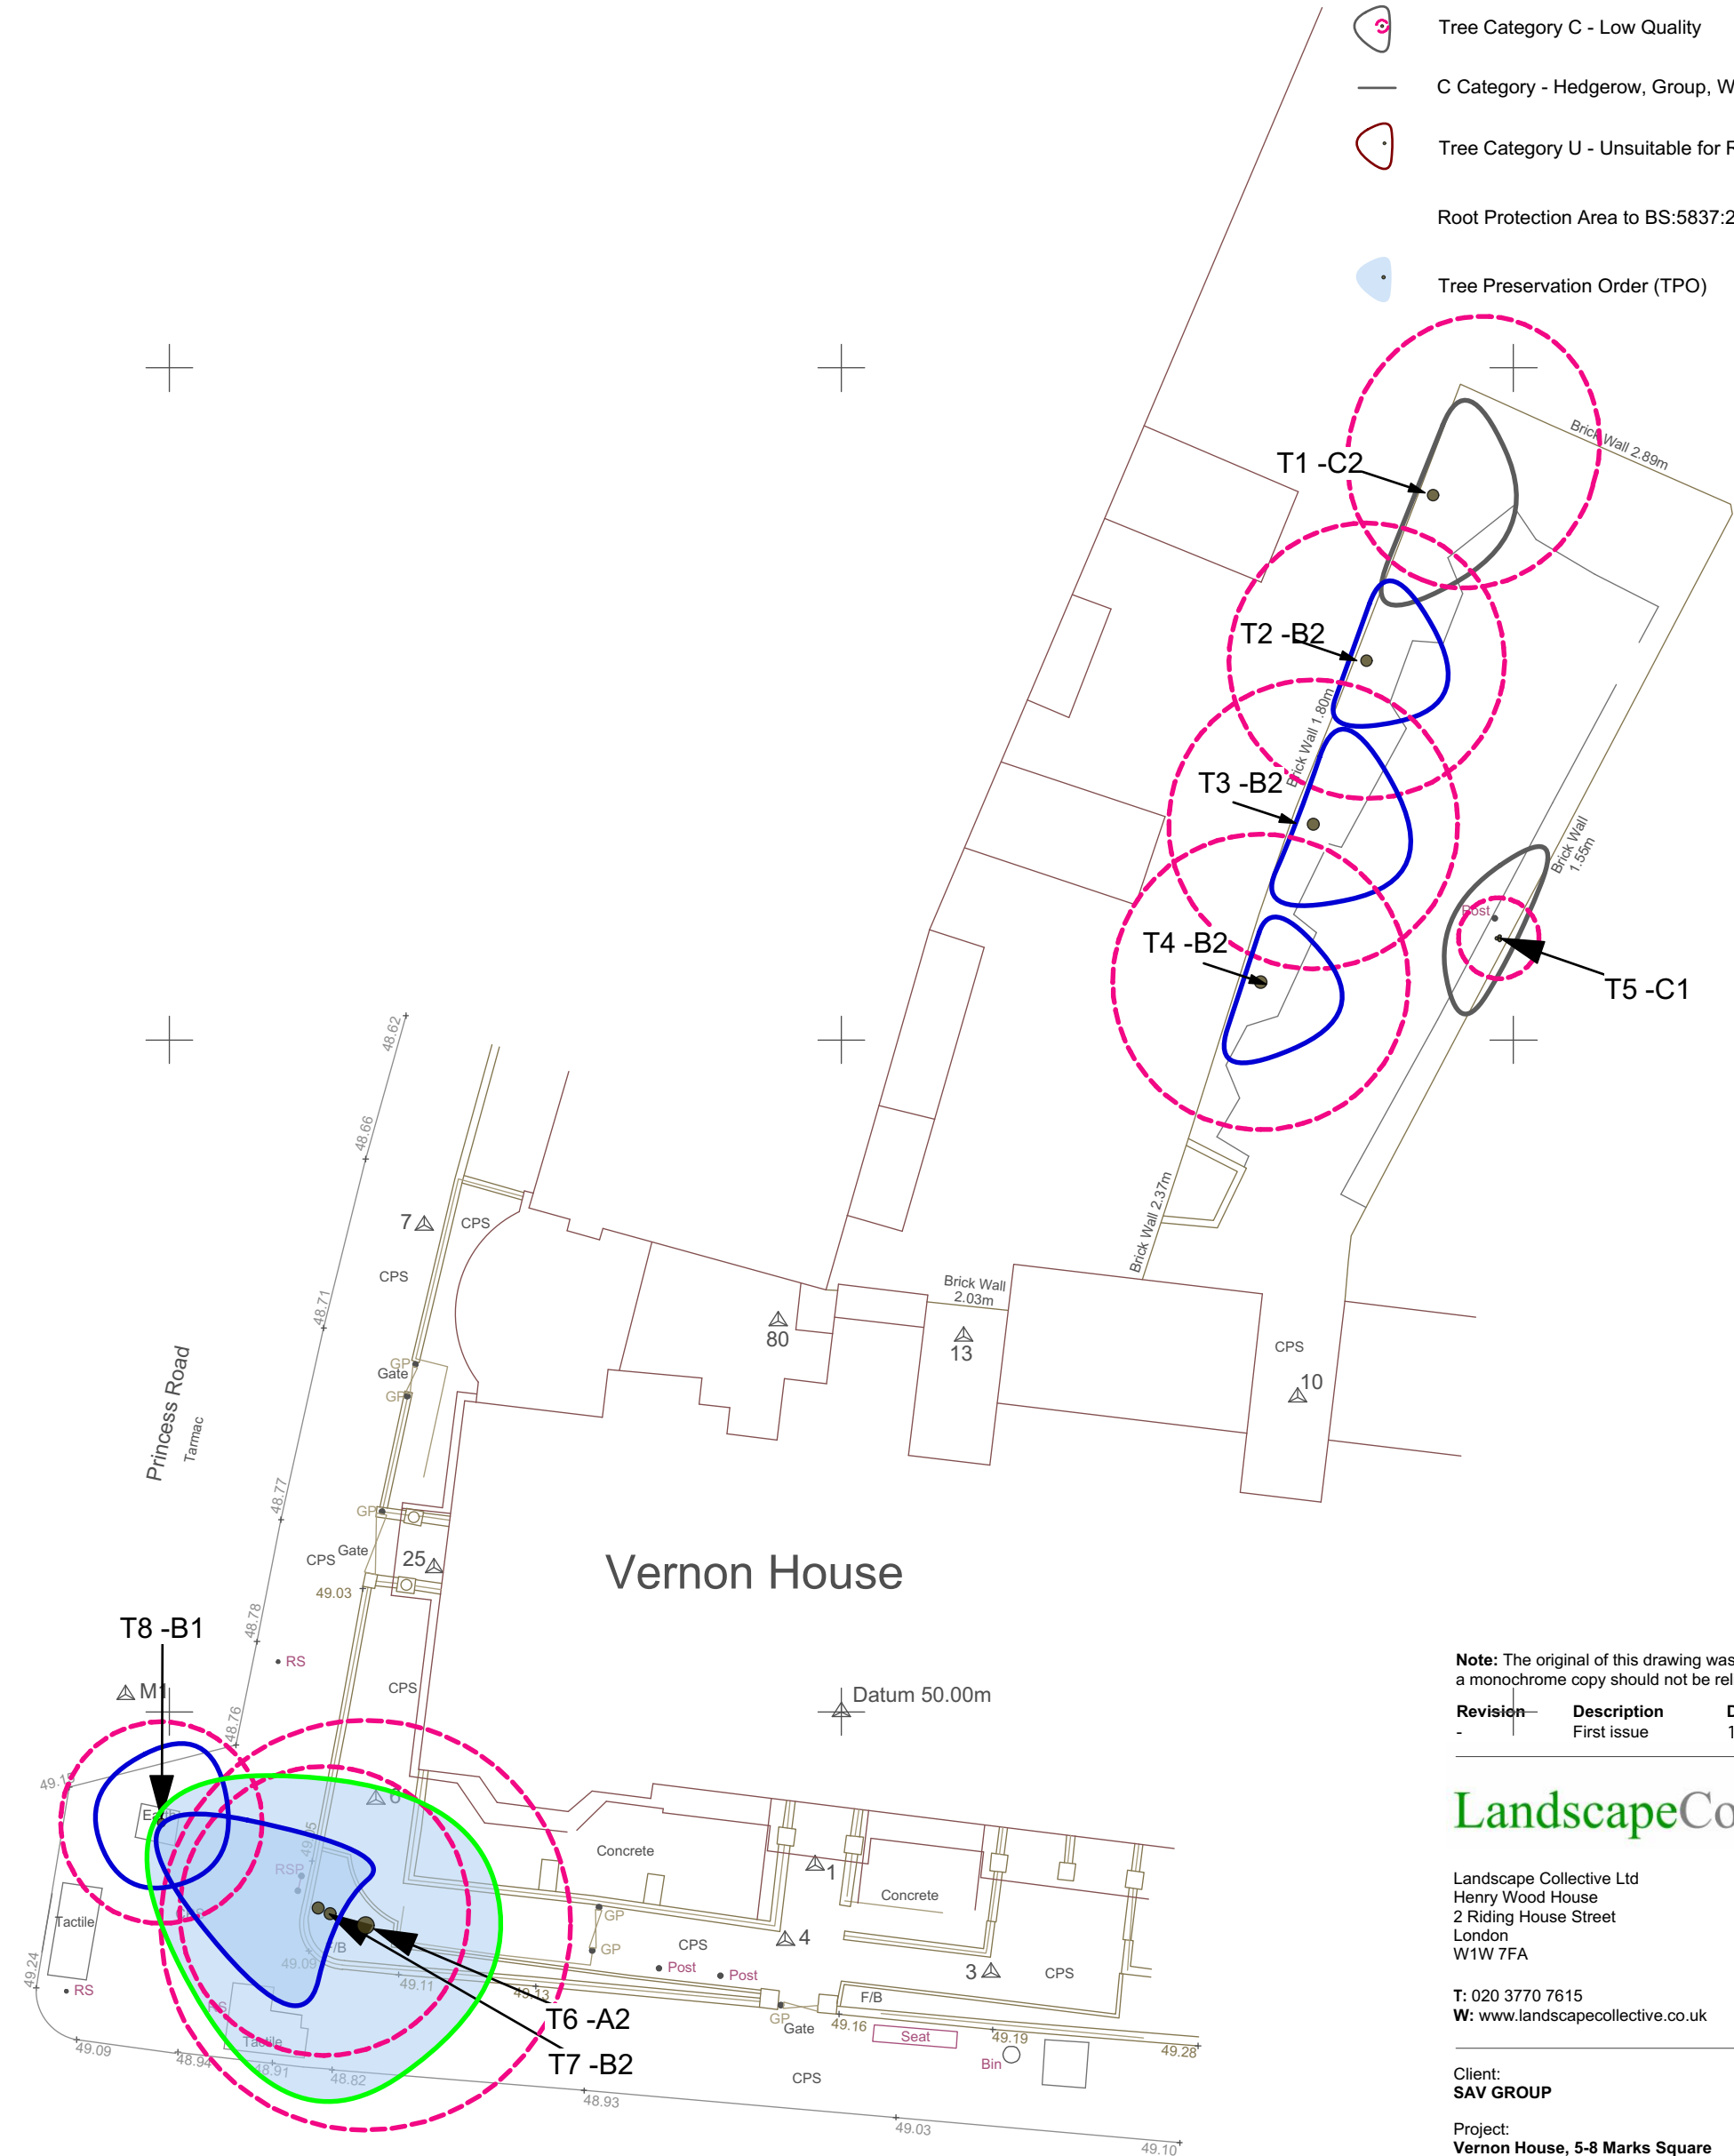
- 2.10 The root protection areas (rpa) as shown on drawing LC 00256_01 show that part of the site is covered by the rpa of the trees. However the coverage is likely to be more, as the roots to the trees along the western boundary will have probably extended into the site , rather than under the brick boundary wall. However the regular pollarding of the trees would most likely have restricted their growth.

- 2.11 The rpa for T6 and T7 are unlikely to extend into the area within the footprint of the building, because of hard landscaping and construction restrictions (voids created by stairwell to basement) around the base of the trees. Similarly T8 is within Princess Road paved area and the rpa is well outside the site building footprint.
