Findings of the Arboricultural Assessment
- Arboricultural Impact Assessment

Vernon House

5-8, St Mark's Square, London

May 2018

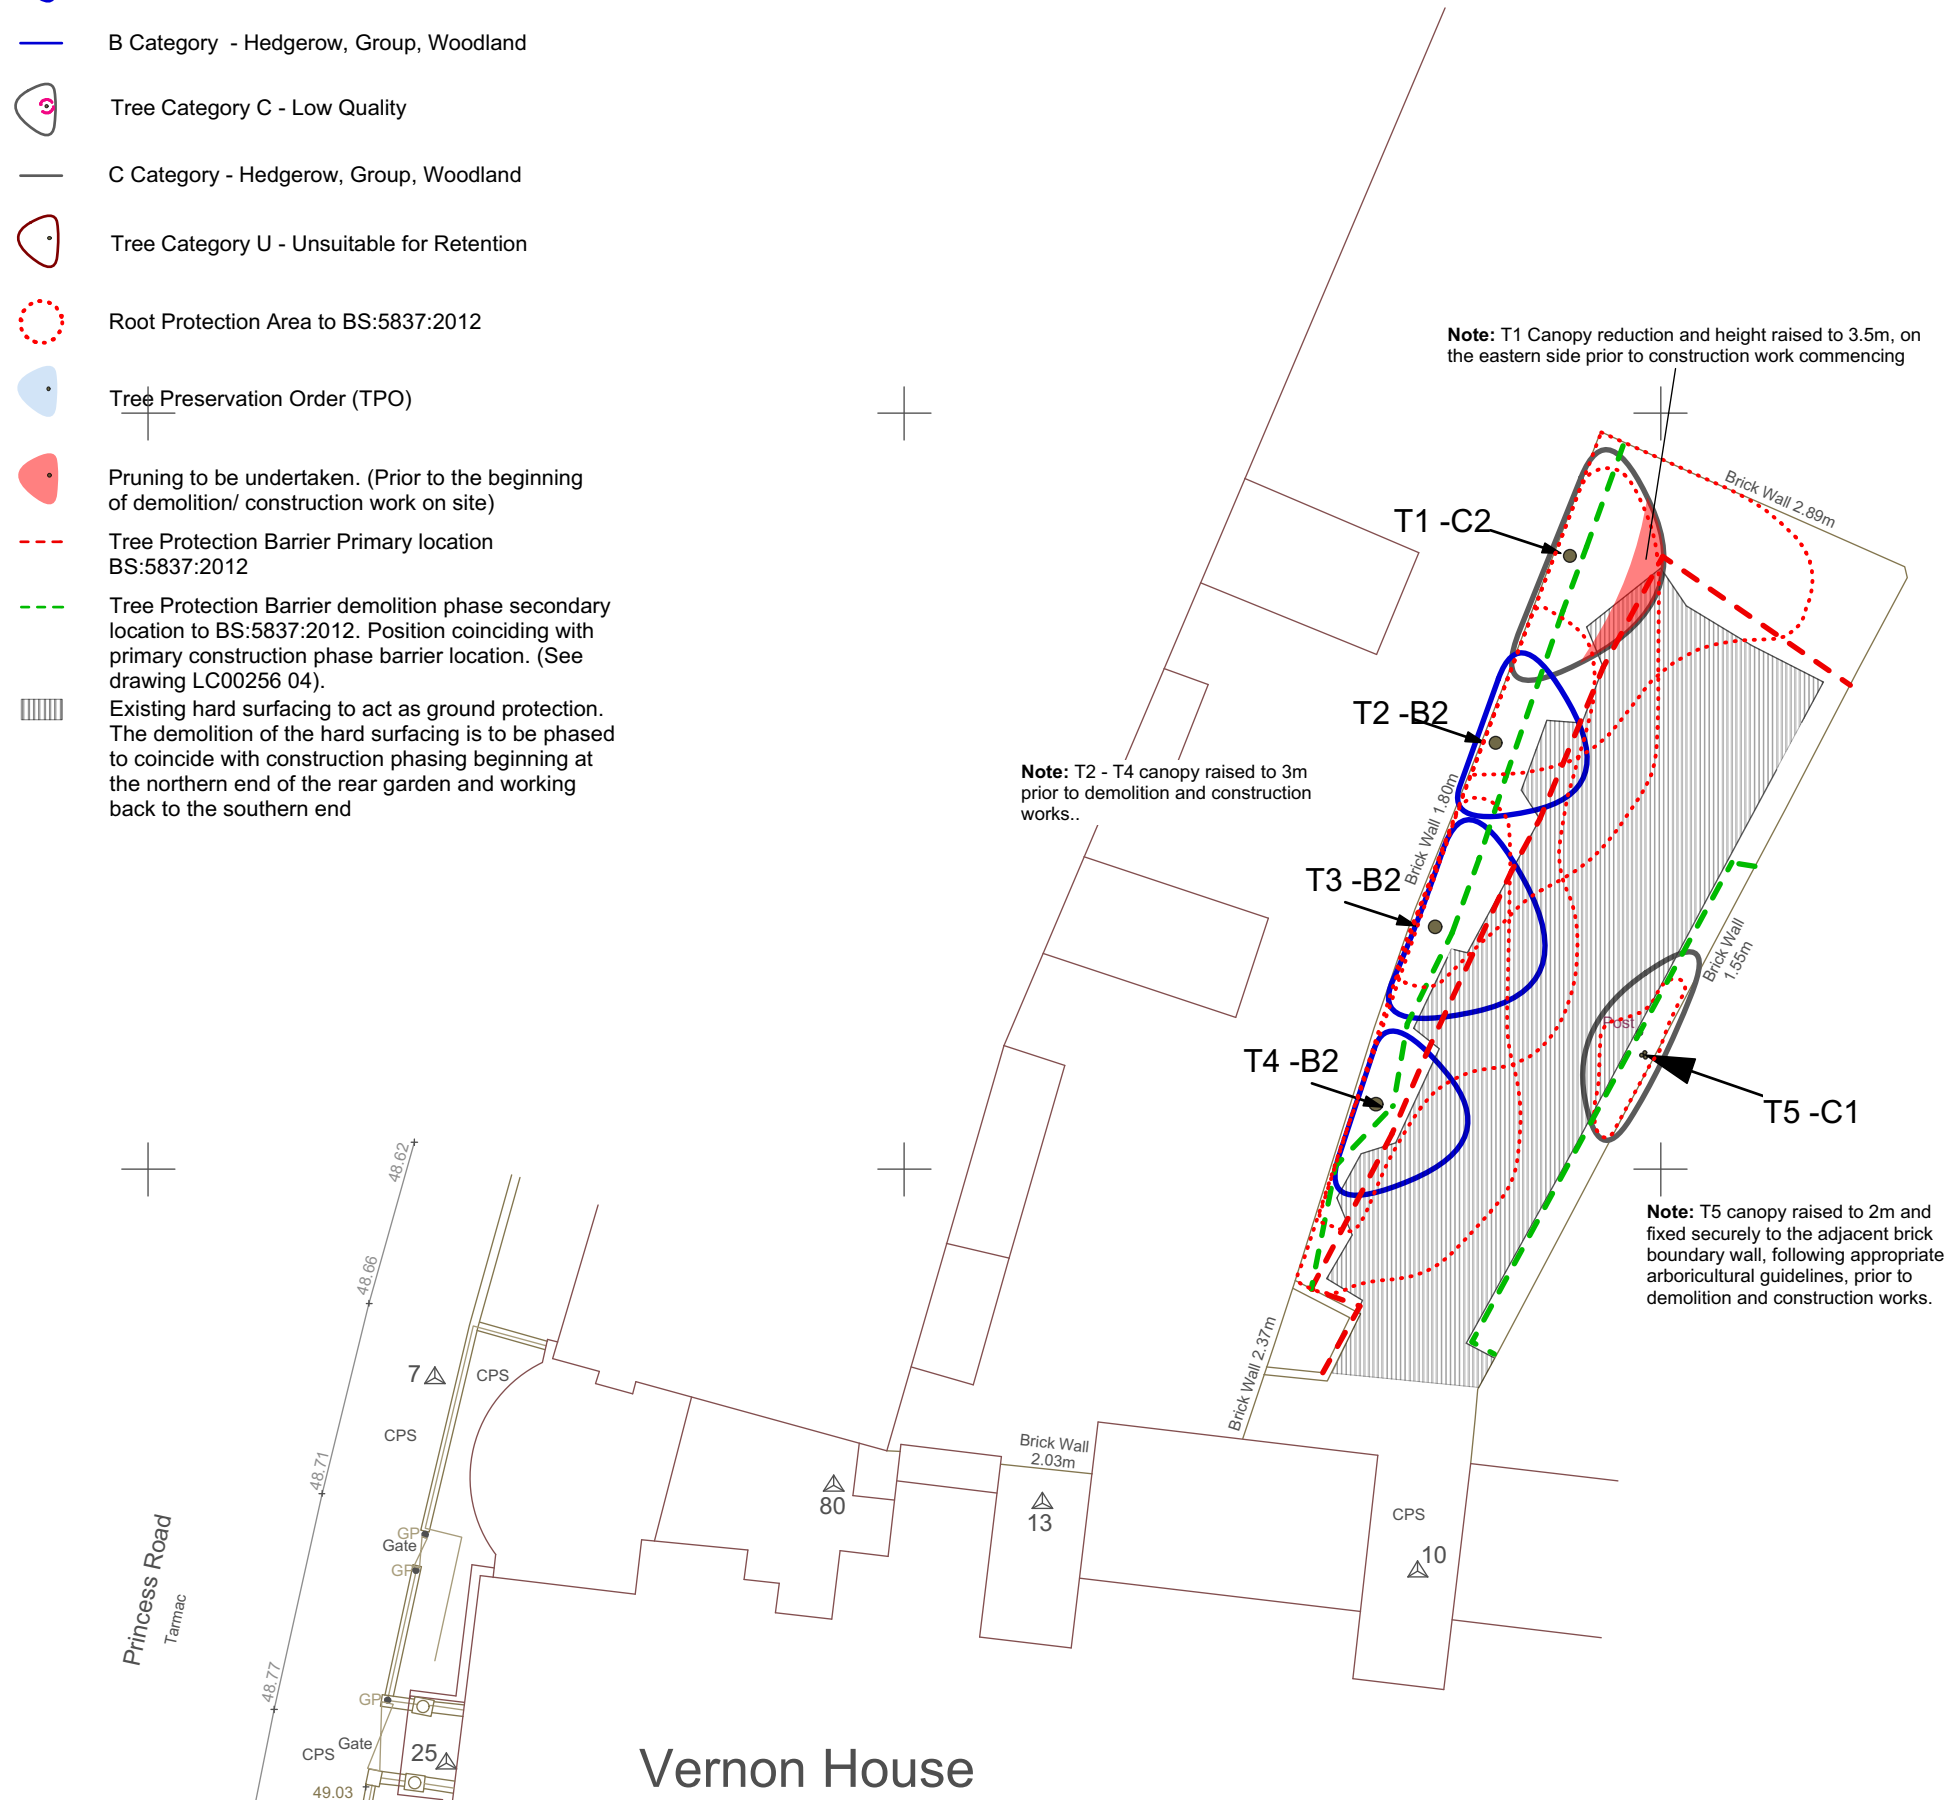
Existing hard surfacing to act as ground protection. The demolition of the hard surfacing is to be phased to coincide with construction phasing beginning at the northern end of the rear garden and working back to the southern end

- 3.13 Therefore it is recommended that tree protection fencing be used, until construction activities are required within rpa. At which time, the tree protection fencing is to be moved to the secondary location shown in appendix 4.

- 3.14 With the tree protection fencing in the secondary position, existing hard surfacing will be retained and only removed after construction of the communal garden room is complete. The existing hard surfacing will remain in place to facilitate access for construction. Groundworks will begin at the northern end of the rear garden and work back towards the southern end. Removal of hard surfacing, creation of levels and proposed hard surfacing works will work systematically back from north to south, using the existing paving as ground protection until such time as the immediate area will have replacement hard surfacing.
