## 2018/1696/P Representations – Annex

### **Staircase – State of Completion/Poor Standard**

## Cycle Store – Unfinished and Unsafe

## Refuse Store Capacity

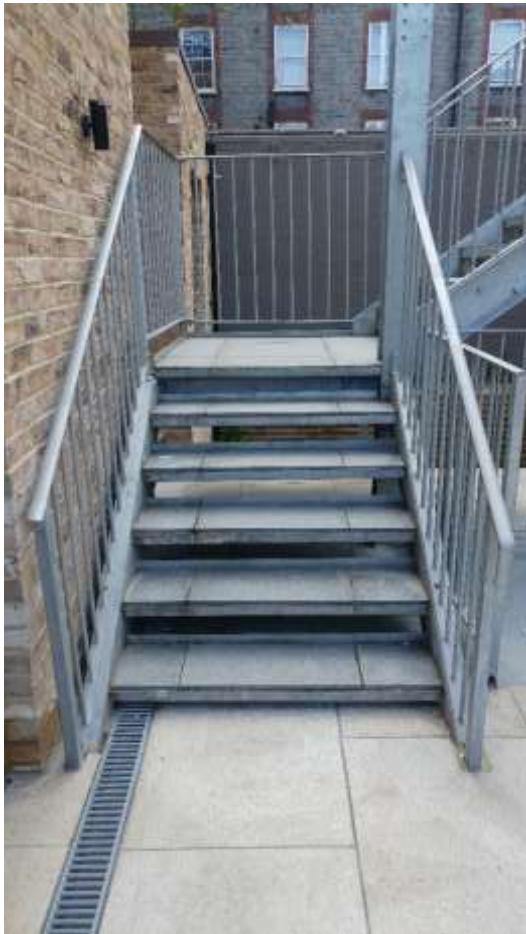
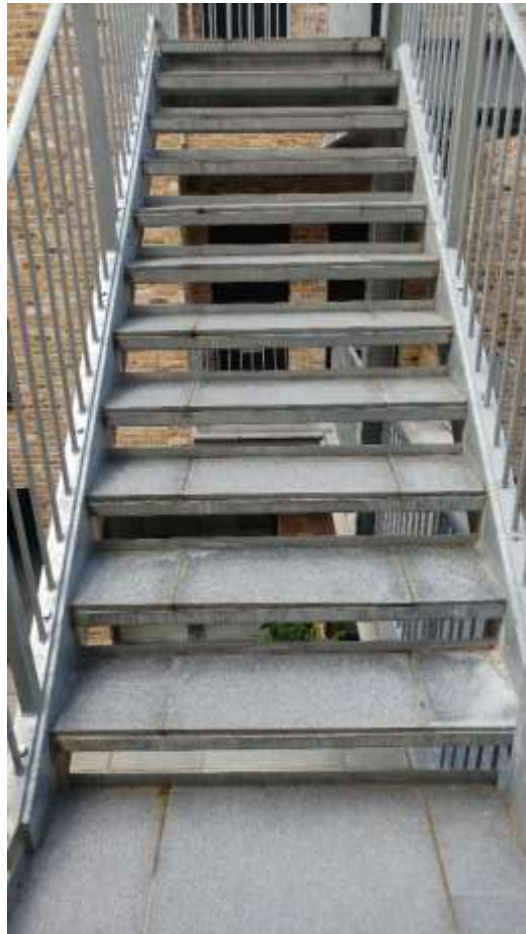
The built staircase.

The two flights are 6 and 11 steps instead of 9 and 9. The finish is uncoated galvanised steel. Safety rods not in evidence.

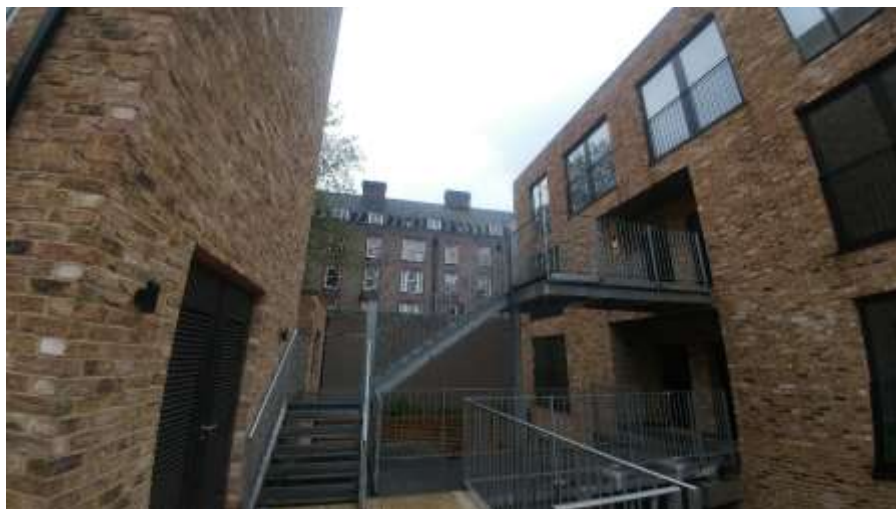
Illustrating the degree to which the staircase, when extended, will dominate the view from the maisonettes.

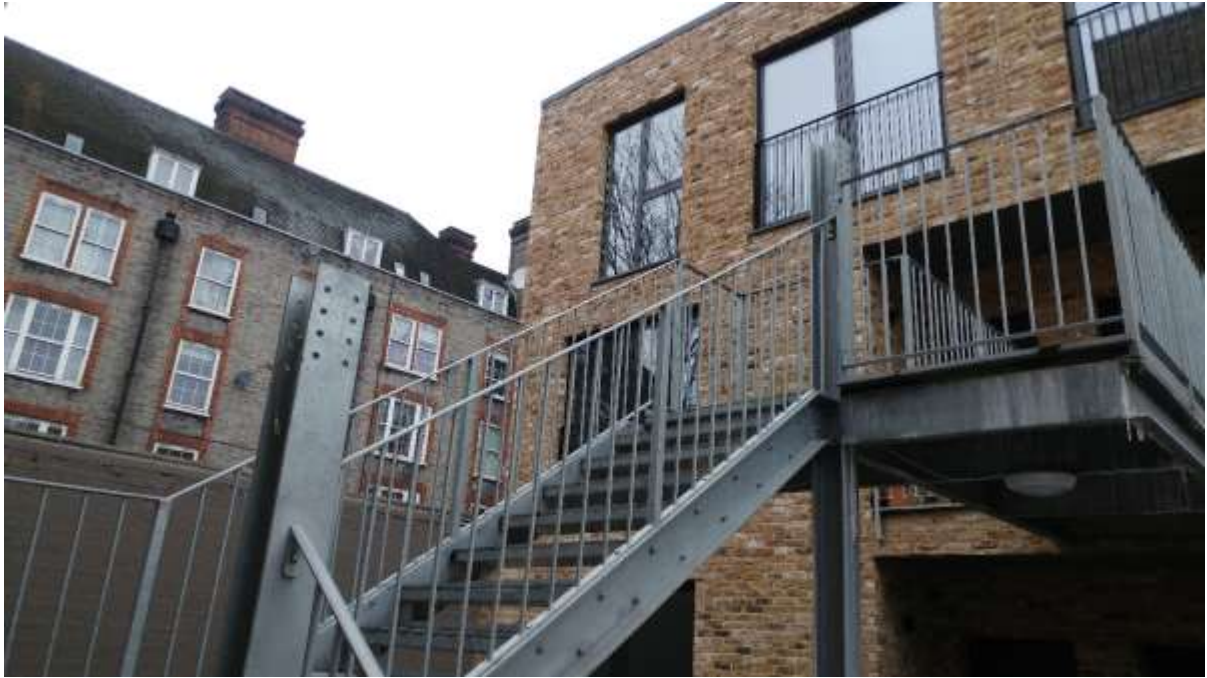
“Industrial” finish (or unfinished?)

Does anyone really want another four flights plus a landing that looks like this??

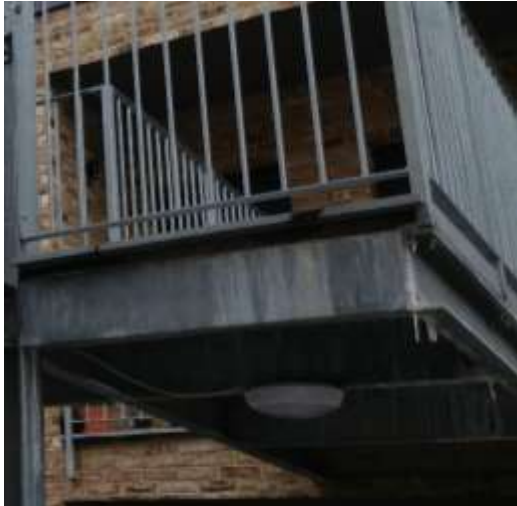
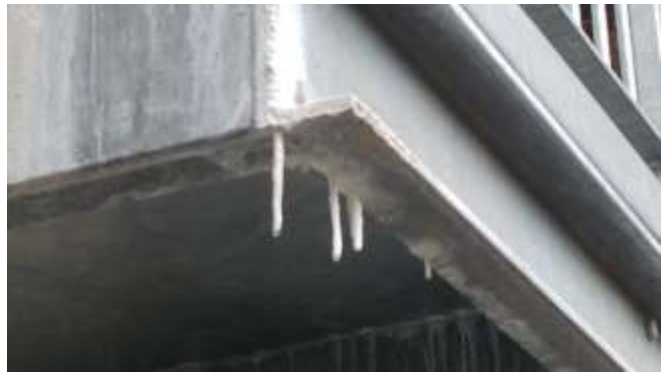
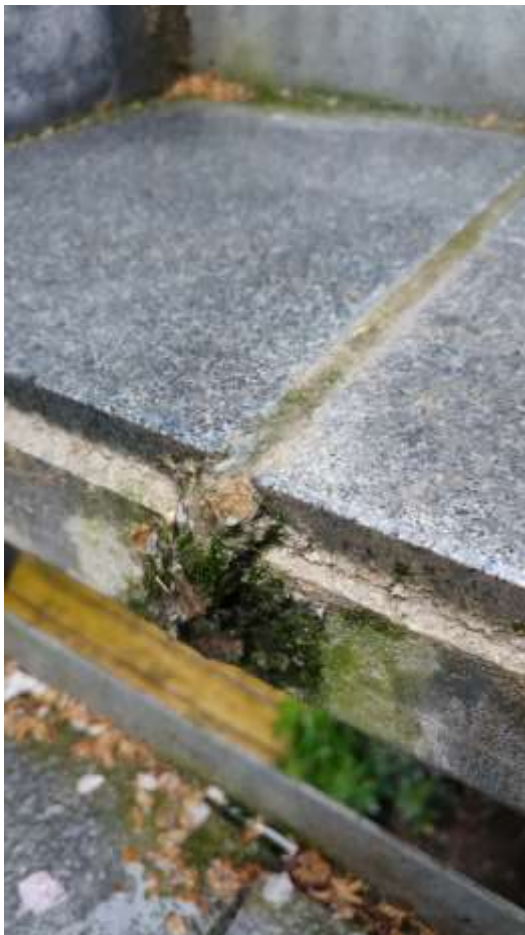
Streaking and stalactites caused by leaching.

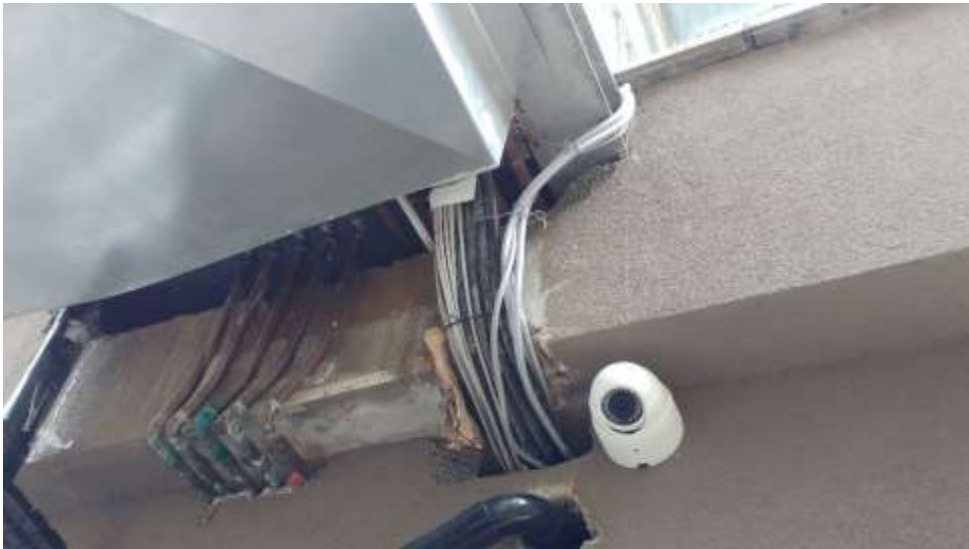
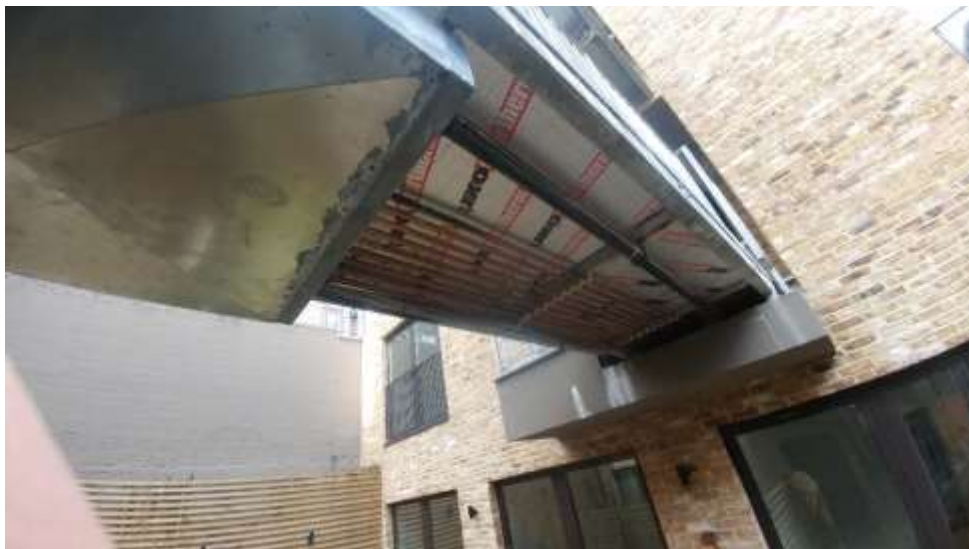
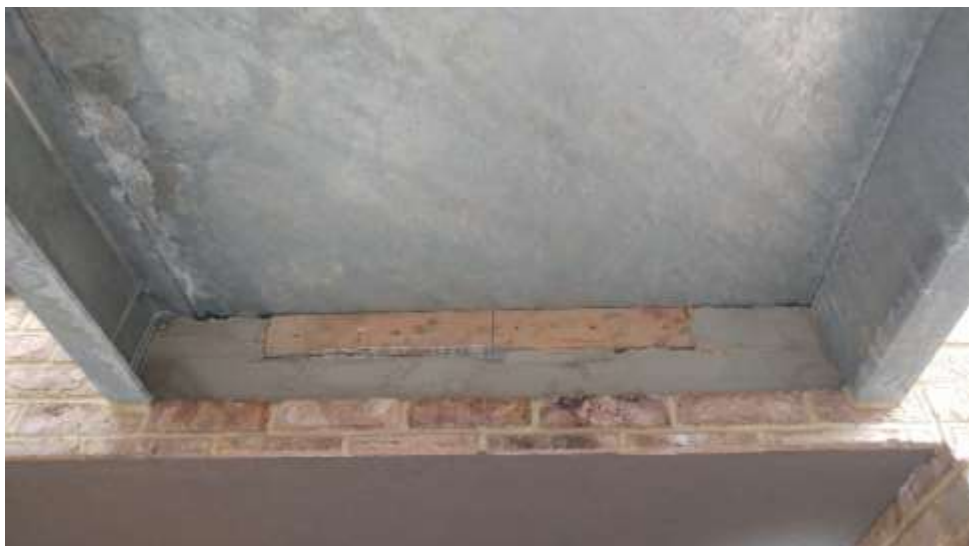
Unboxed cables, unlagged pipes, unprotected wood.

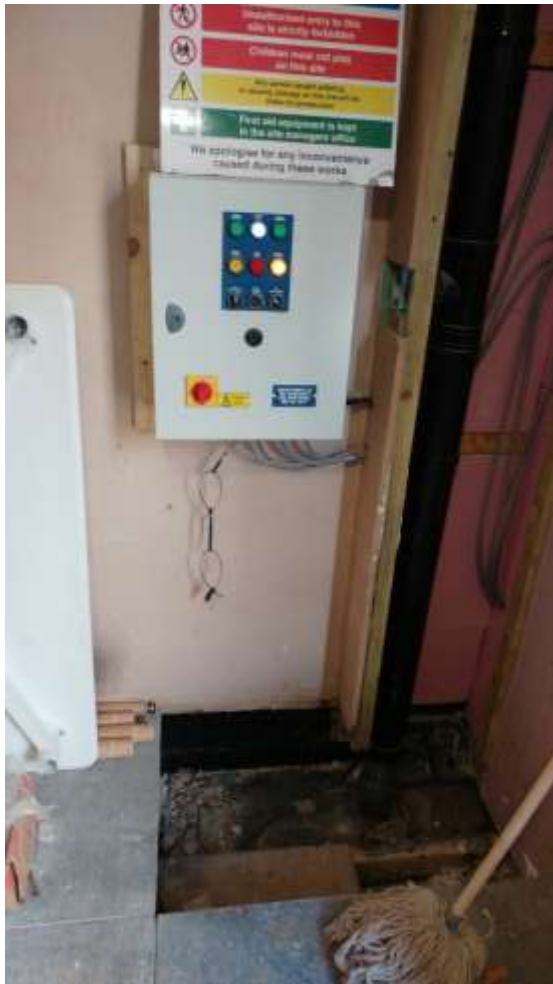
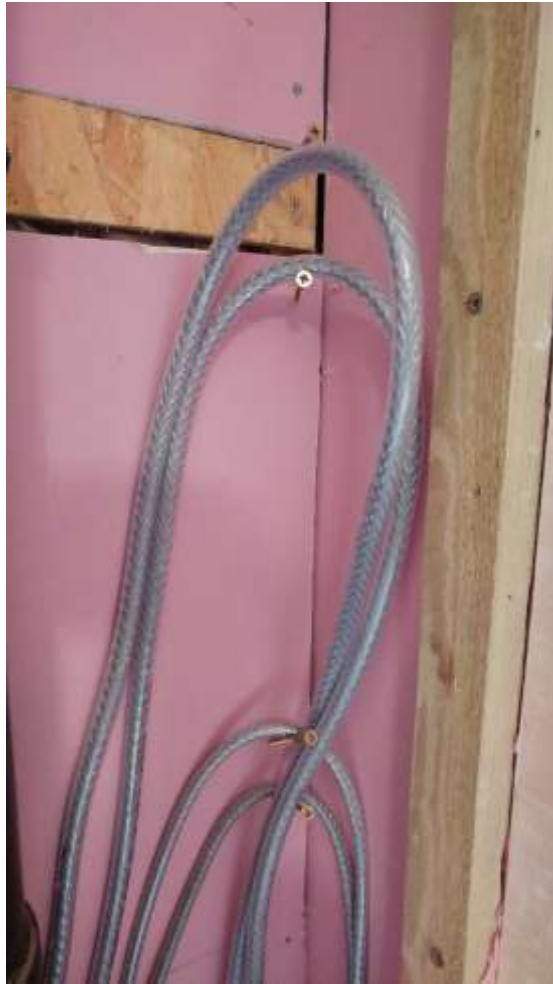
Hole in the floor, unboxed high voltage cables hanging on screws.

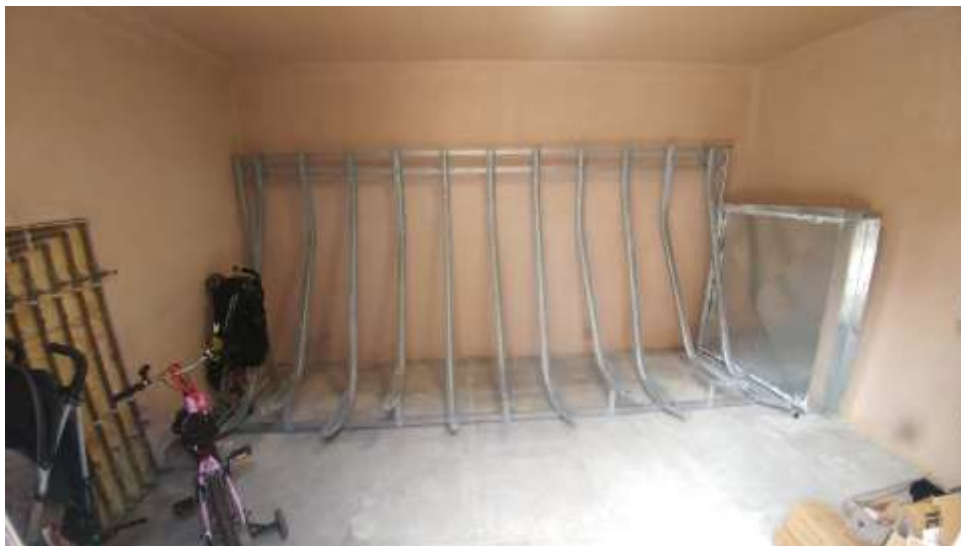
Unpainted, racking not screwed to wall.

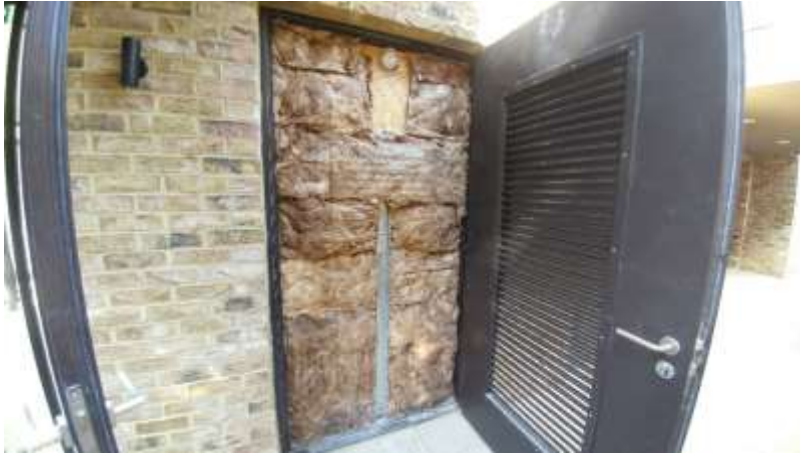
Where the office's refuse store should be, according to the plans.

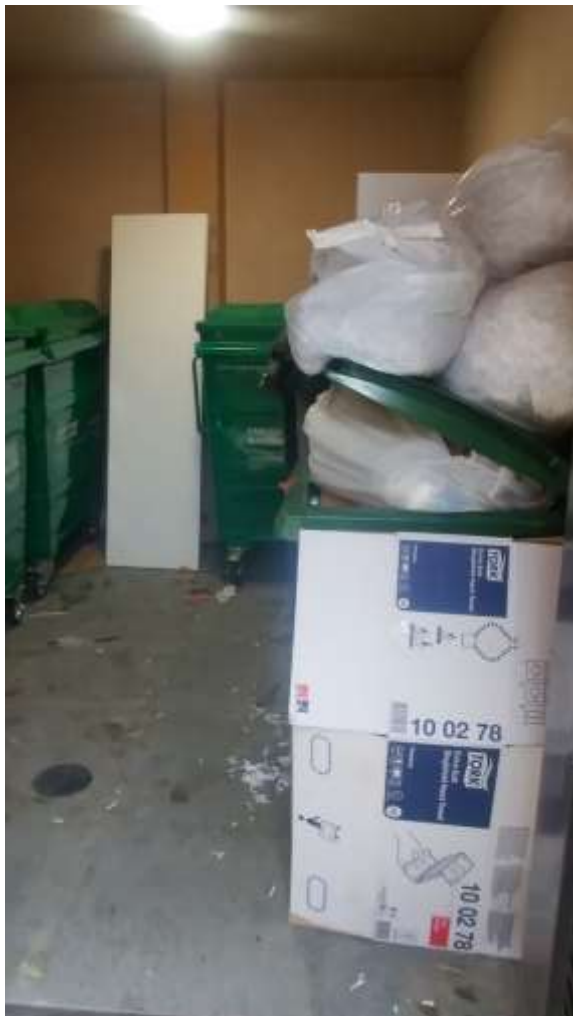
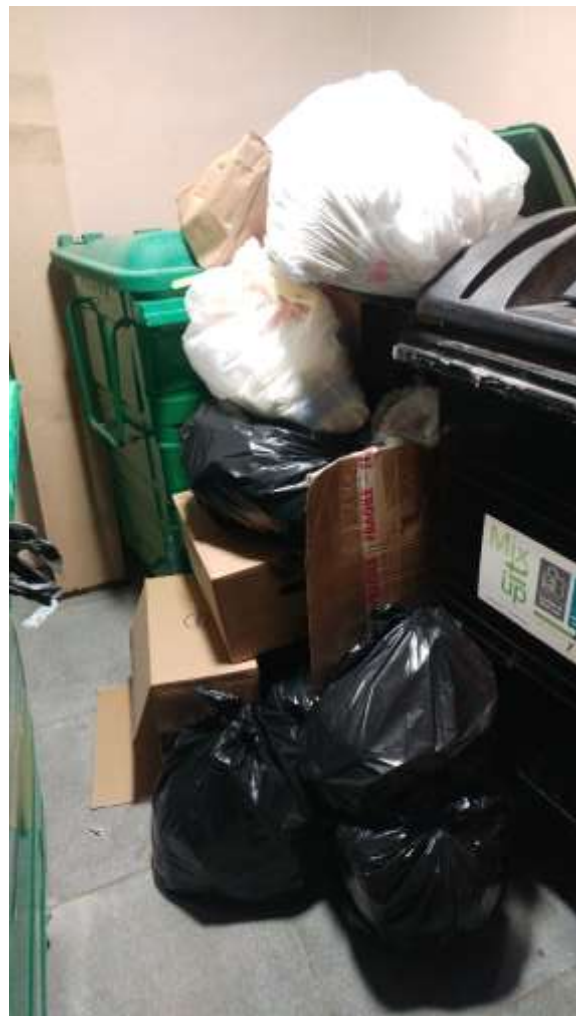
Commercial waste sometimes requires significant space. Black sacks on floor because office doesn't have a refuse bin of its own.

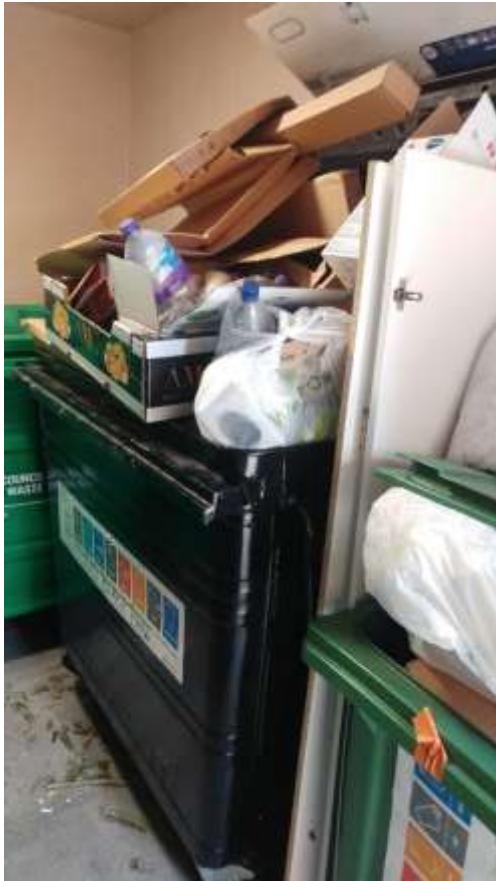
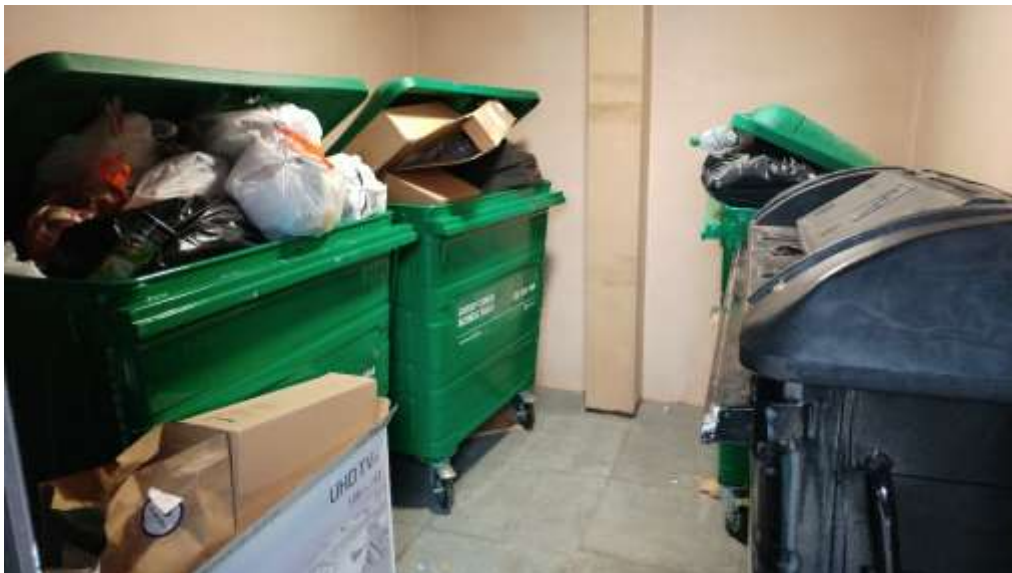
Residential waste already seems close to capacity on occasion.
