Asbestos Survey Report
Project Ref. No: 104134
Wolsey Mews
Demolition survey

Wolsey Mews

Survey Type: Demolition survey

Project Reference Number: 104134

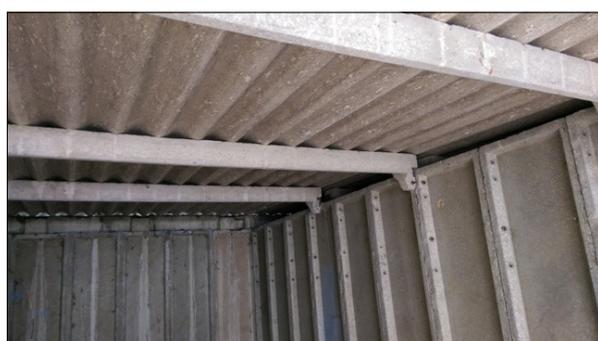
Asbestos Sample Record - 01a

| General | | | |
|---|---|---|---|
| Asbestos?: | Identified | | |
| Asbestos type(s): | Chrysotile | | |

| Risk Analysis | | | |
|---|---|---|---|
| Condition: | Low damage | Accessibility: | Occasional disturbance likely (1) |
| Position: | Outdoors (0) | RISK: | VERY LOW (4) |

Asbestos moulded cement roof sheets 40m2

| Action required: | Remove | | |
| Next action due date: | Prior to disturbance | Approx cost: | |

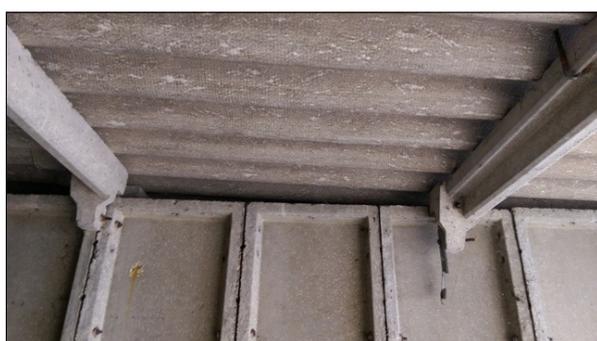
Asbestos Sample Record - 02a

| General | | | |
|---|---|---|---|
| Asbestos?: | Identified | | |
| Asbestos type(s): | Chrysotile | | |

| Risk Analysis | | | |
|---|---|---|---|
| Condition: | Low damage | Accessibility: | Occasional disturbance likely (1) |
| Position: | Outdoors (0) | RISK: | VERY LOW (4) |

Asbestos moulded cement roof sheets 40m2

| Action required: | Remove | | |
| Next action due date: | Prior to disturbance | Approx cost: | |

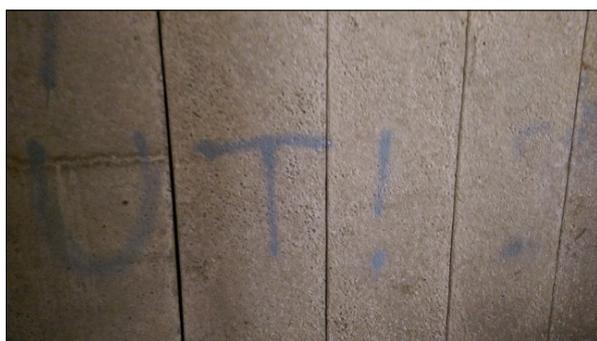
Asbestos Sample Record - 03a

| General | | | |
|---|---|---|---|
| Asbestos?: | No asbestos detected | | |

Non asbestos concrete walls 80m2

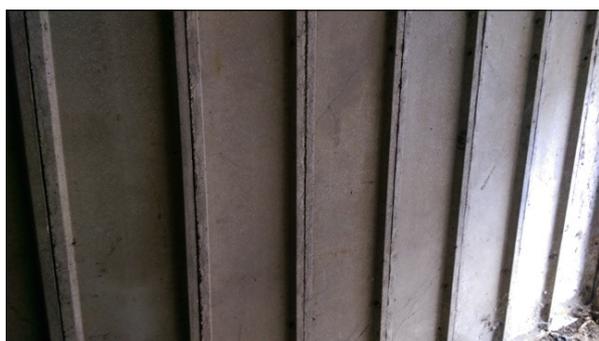
Asbestos Sample Record - 04a

| General | | | |
|---|---|---|---|
| Asbestos?: | No asbestos detected | | |

Non asbestos moulded concrete walls 80m2

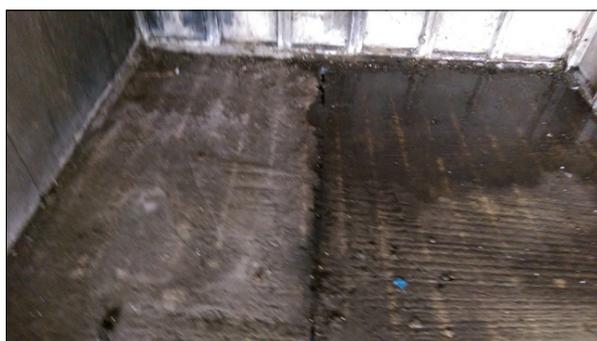
Asbestos Sample Record - 05a

| General | | | |
|---|---|---|---|
| Asbestos?: | No asbestos detected | | |

Non asbestos moulded concrete floor 40m2

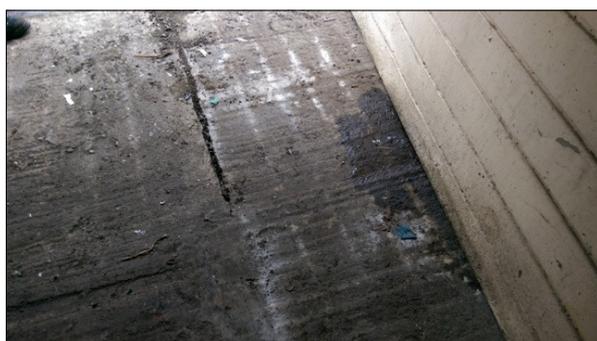
Asbestos Sample Record - 06a

| General | | | |
|---|---|---|---|
| Asbestos?: | No asbestos detected | | |

Non asbestos mouled concrete floor 40m2
