FAO Camden Borough Council Planning Department

Representations regarding planning application 2018/1696/P

2018/1696/P Representations - Annex

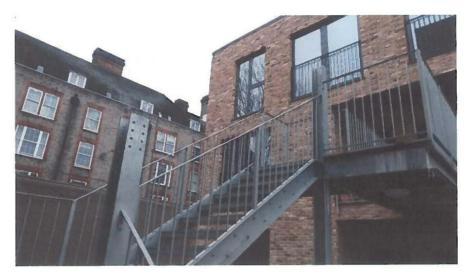
The access staircase for the roof extension will involve an additional four flights of stairs to gain two full stories in height (see 2016/4687/P drawing P-07-1 Proposed East Elevation). This extension of the staircase will dominate much of the view from the lounges and bedrooms of the existing apartments in the back block. Clearly it is therefore important that the staircase is positioned as close to the wall of the front block as possible, to minimise the intrusion into these apartments'

aspects. The two feet of difference between the built staircase and the plans will have a significant impact if allowed to extend over four flights of stairs.

Illustrating the degree to which the staircase, when extended, will dominate the view from the maisonettes.

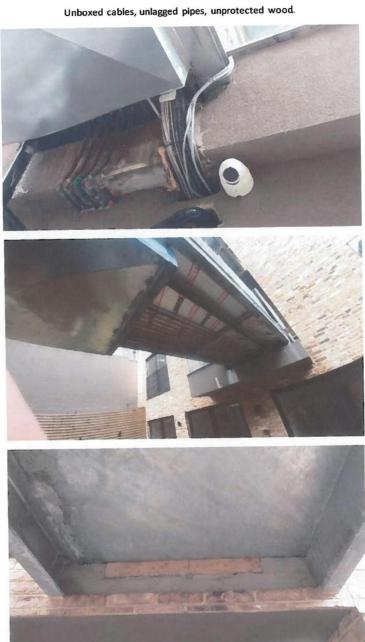
There are issues of quality and safety with the current state of the staircase. It appears to have been constructed with the paving bedded into sand and cement rather than a waterproof epoxy. The additional failure to use any kind of waterproof grouting has resulted in the cement leaching out of

the render. This can clearly be seen in the formation of streaking and "stalactites" and has already resulted (after less than two years) in some of the paving becoming loose. As this situation continues to deteriorate, the staircase will become increasingly hazardous.

Staircase – State of Completion/Poor Standard
Streaking and stalactites caused by leaching.

- Correct the finish of the existing staircase to meet that specified in the drawings, namely PPC RAI 9011:
- Submit for approval drawings of the subsequent extension of the staircase to provide evidence that the extended staircase will be built in such a way as to minimise the impact on the view from existing dwellings in the back block;
- Take up and re-lay the paving in such a way that it is properly waterproofed and doesn't present a future safety issue;
- Properly box in and protect the electrical cables.

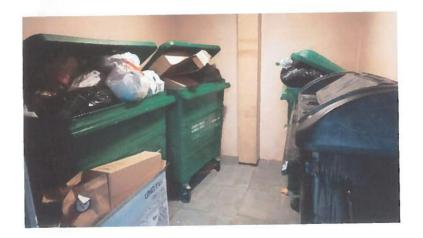
- 2013/1614/P condition 6 (Details of waste storage). The plans submitted by the developer with this application specifically T 1 482 101 J proposed ground floor plan show an enclosure designated as the "office refuse store". This was in fact converted by the developer himself into a toilet. The commercial unit has since been sharing the residential refuse store, having no replacement facility of its own, and doesn't even seem to have its own refuse bins (for which there is barely space in any case). In parallel with this reduction in overall refuse capacity, the developer has been making his application for permission to increase the number of residential units and the consequent residential refuse requirements. With the development at only 50% of potential occupancy, it is not at all clear that sufficient refuse capacity exists. The developer should be required to rectify this breach, or at least submit new calculations demonstrating that sufficient capacity exists, before being granted permission.

Residential waste already seems close to capacity on occasion.
